Stability investigation and stabilization of a heavily fractured and loosened rock slope during construction of a strategic hydropower station in China

# Stability investigation and stabilization of a heavily fractured and loosened rock slope during construction of a strategic hydropower station in China

This paper presents a case history of the 205 m high intake slope at the Huangjinping (HJP) hydropower station on the Dadu River. Deformation and cracks developed on the cut slope during excavation, and the deformation extended onto the natural slope above the cut, giving rise to serious safety concerns. Research was conducted to study the engineering geological conditions and the deformation characteristics of the slope during excavation. In situ monitoring data and possible causes of cracking were analyzed. The results show that the zone of loosened rock mass extended much deeper into the rock mass than it did at other sites in the region because of the tectonic history of the site and cutting. The empirically designed cable anchors with lengths of 40 m or 45 m were insufficient to stabilize the slope, while the remedial cable anchors as long as 100 m successfully stabilized th

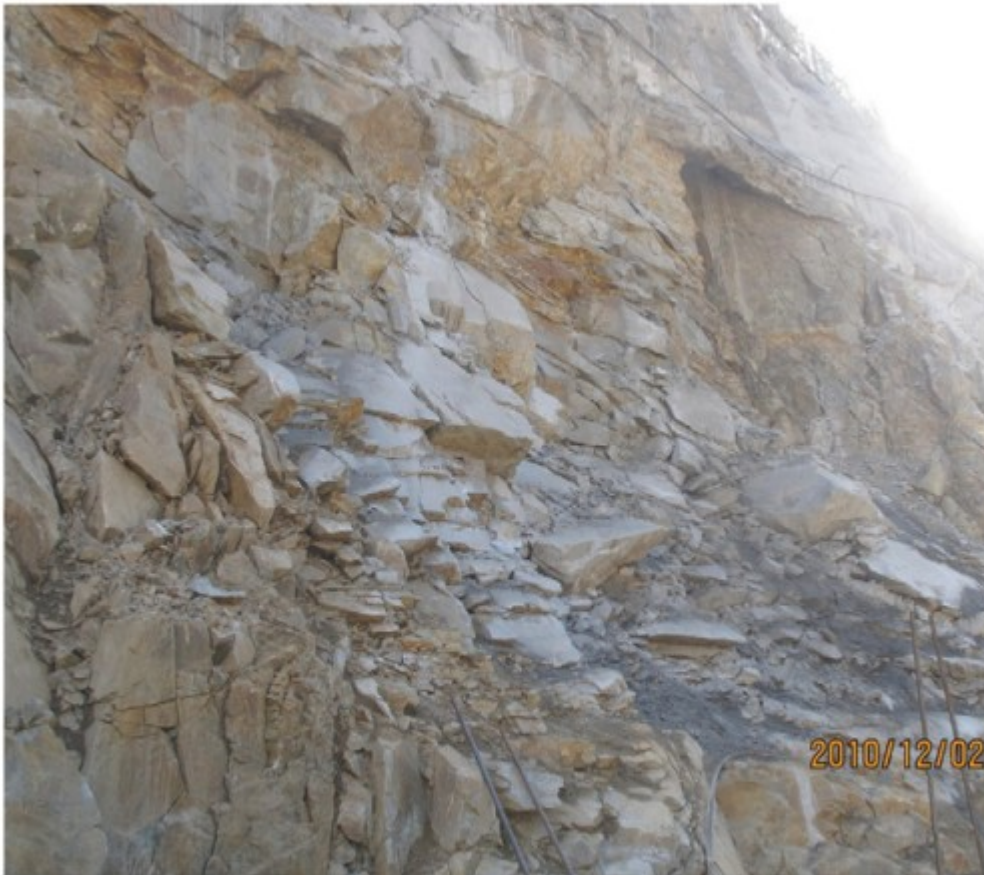
Fig. 6. The fractured and highly permeable rock mass.

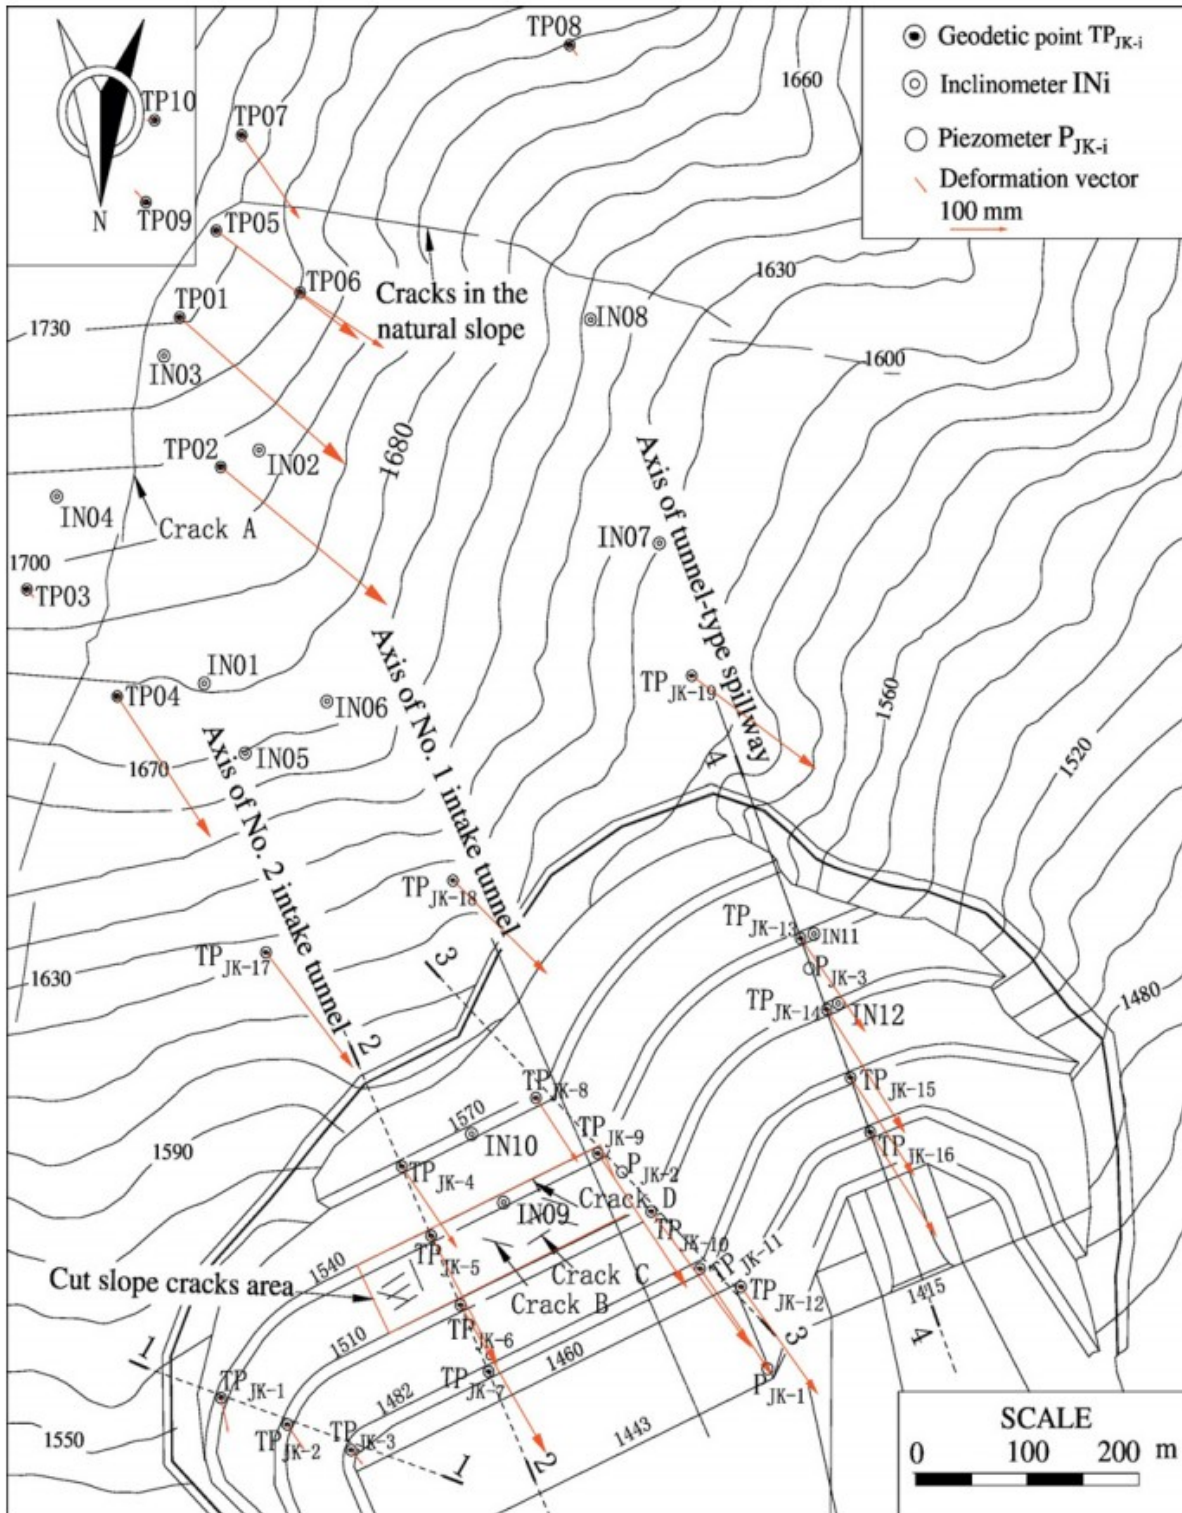
The deformation vectors for the entire intake slope, as plotted in Fig. 7, indicate that the whole slope was deformed to the northwest. Although the installation of multipoint extensometers lagged behind excavation, the extensometer results still indicate that the excavation had an obvious influence on the deformation. A typical curve of deformation-time is shown in Fig. 10. For  $M_{JK-7}^4$ , just during the excavation from elevation 1460 m to elevation 1415 m. Fig. 11 shows a typical curve of deformation-horizontal depth at cross section 2-2. The results indicate that the maximum depth of deformation was around 65 m, which is roughly the horizontal distance to the base of the heavily loosened zone. Fig. 11 also shows that the largest deformation occurred above elevation 1481 m, i.e. the elevation at the outcrop of the loosened fractured layer in the cut slope. Therefore, the major deformed body was the loosened fractured zone, and the depth of which was beyond the designed cable length of 60 m. As a result, the designed cable bolts had a limited capacity to control deep deformation, and the deformation of the natural slope was the result of structural adjustments of loosened fractured zone. In addition, curves of deformation - horizontal depth (in Fig. 11) indicate that the deformation characteristics of the slope were similar to those of particles. And there were no preferred structural planes, which have a significant influence on the deformation.

Fig. 7. Cracks and deformation vectors of the intake slope. Note: digital photos of cracks A - D are shown in Fig. 9.

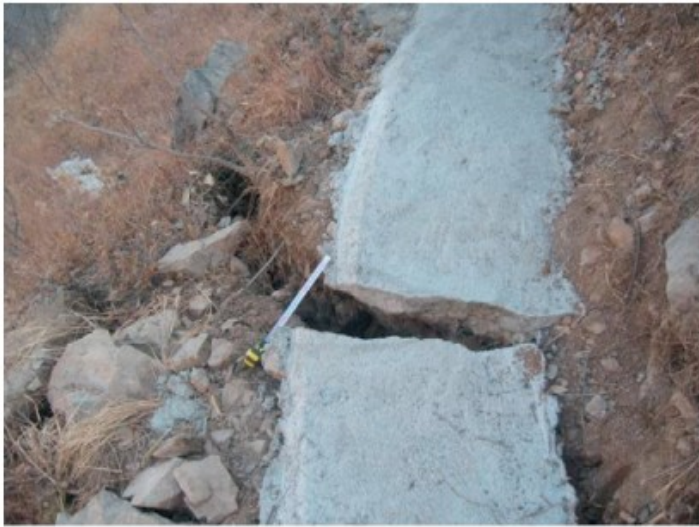
Excavation began in June 2010. During the first year, excavation went smoothly, although the reinforcing work was slightly delayed. In August 2011 (line 1 in Fig. 10), the excavation was down to elevation 1482 m, and extension cracks were first noticed in the natural slope (Crack A in Figs. 7 and 9(a)). Excavation was therefore forced to cease from August 2011 to October 2011. In September 2011 (line 2 in Fig. 10), cracks were observed in the cut slope between benches at 1510 and 1540 m (Cracks B and C in Figs. 7 and 9). Although reinforcing work was expedited, the deformation continued. In November 2011 (line 3 in Fig. 10) the extension cracks in the natural slope extended, and a persistent, armchair-shaped crack was

(a) Crack A on the natural slope.

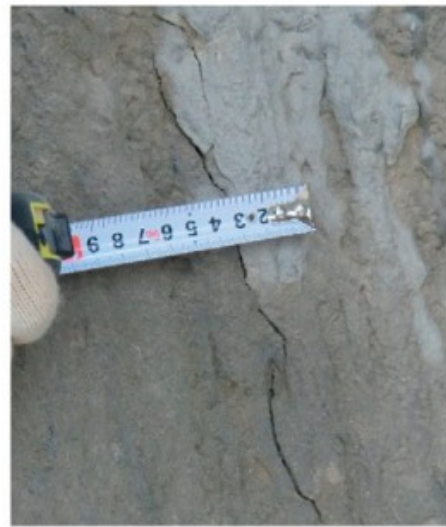
(b) Crack B on the cut slope.

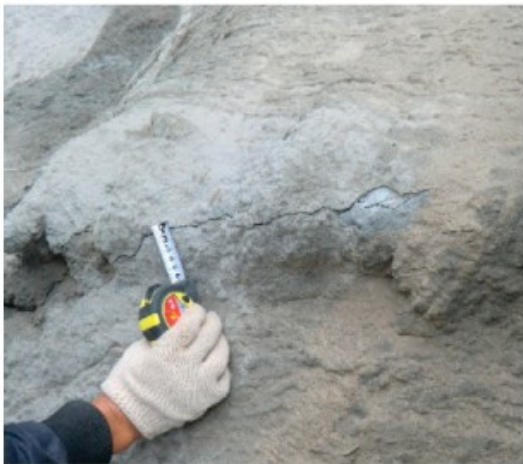
(c) Crack C on the cut slope.

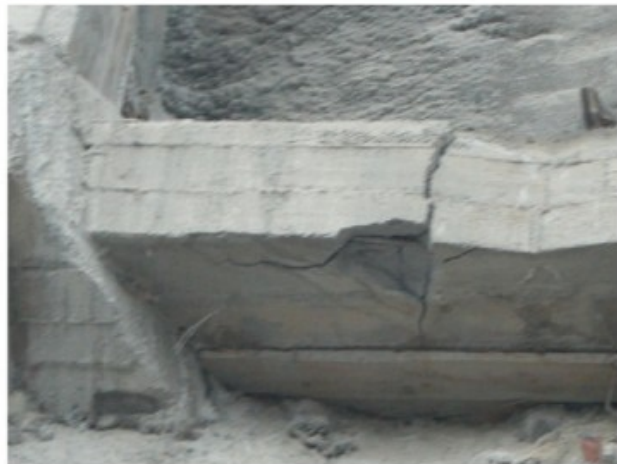
Field investigations showed a diabase vein ( $\beta\mu 6$ ) and three sets of discontinuities (L1, L2, and L3) in the cut slope cracks area. The mean orientations of those discontinuities are listed in Table 2. Block theory analysis of the joint data identified two removed infinite blocks: block 0000 and block 1100, as shown in Fig. 13. Worse still, the reinforced concrete lattice was not used in this area, because the rock mass in the zone had more widely spaced joints. Therefore, the cracking was most likely caused by the moving of the key blocks, i.e., the deformation was localized in the zone without lattice support.

(d) Crack D on reinforced concrete lattice

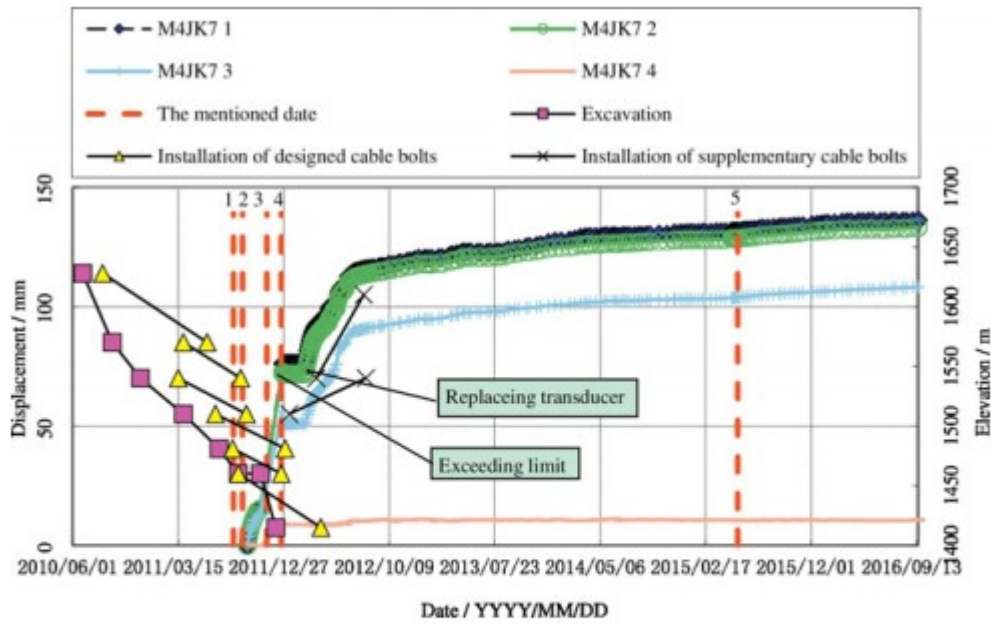
formed. Despite the ongoing deformation, excavation resumed. In December 2011 (line 4 in Fig. 10), even though the installation of the designed cable anchors was mostly complete, the deformation continued. The tensile cracks in the natural slope were still expanding rapidly, and numerous new cracks appeared in the cut slope between elevation 1570 and elevation 1580 m. Some lattice beams also fractured in that zone (Crack D in Figs. 7 and 9(d)). By the end of February 2012, the maximum horizontal displacement of the fractures on the natural slope reached 231 mm, and the maximum vertical settlement displacement was 150 mm. The deformation was brought about under control only when supplementary reinforcement was installed in June 2012 (in Fig. 10).

**Fig. 10.** Displacement vs excavation and reinforcement. Note: M4JK-7 is a multipoint extensometer, the depth of points 1, 2, 3, 4 is 0 m, 10 m, 54 m, 62 m respectively; the red dotted lines 1-5 are the important dates mentioned in this paper. (For interpretation of the references to color in this figure legend, the reader is referred to the web version of this article.)

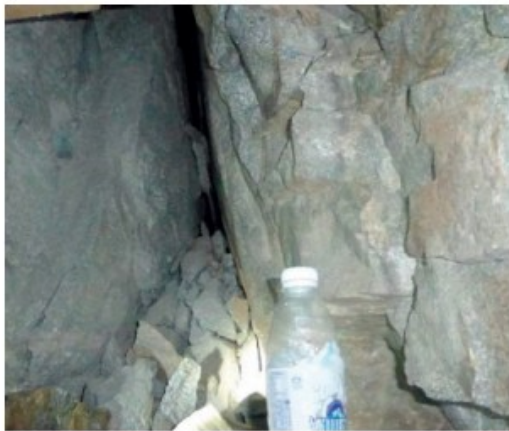
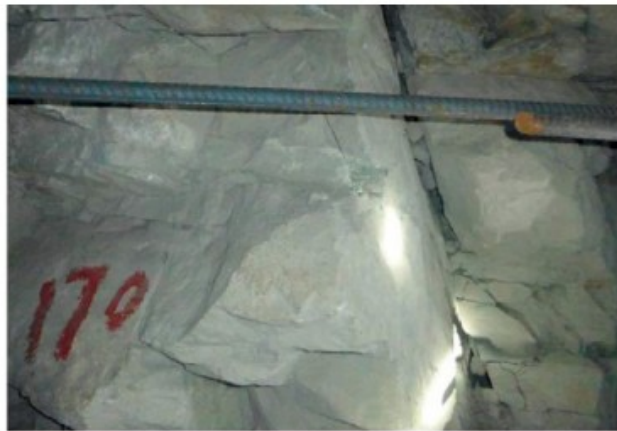
Fig. 16. Typical open joints in the loosened rock mass on the HJP intake slope.

In Table 3, the authors has summarized the maximum in-situ stress at the underground powerhouse, and the horizontal loosened depth of the bank slopes of four hydropower projects on the Dadu River. Then, the relationship between the above results and the distance from the Gongga Mountains (GGM) are drawn in Fig. 14. These comparisons indicate that the closer the site to the Gongga Mountains (GGM), the lower the in-situ stress magnitude and the larger the horizontal loosened depth. Among the four projects, the horizontal depth of the loosened zone is the greatest at the HJP project site, while the measured maximum in-situ stress is the lowest. Second, in order to study the influence on the rock mass structure, the authors compared the distribution of discontinuities between the left abutment intake slope of the HJP and the right abutment slope of CHB, which is somewhat far from the Gongga Mountains. For the HJP intake slope, 733 discontinuities divided into 21 sets were mapped, as shown in Fig. 15(a). For the right abutment slope of CHP, only 341 discontinuities divided into 9 sets were mapped, as shown in Fig. 15(b). These results indicate that the discontinuities on the HJP intake slope are abundant and essential; no persistent and dominating discontinuity trends were identified. In addition, the joints and fractures remained open, and did not progressively close with depth, as would be expected with increasing overburden stress (in Fig. 16).

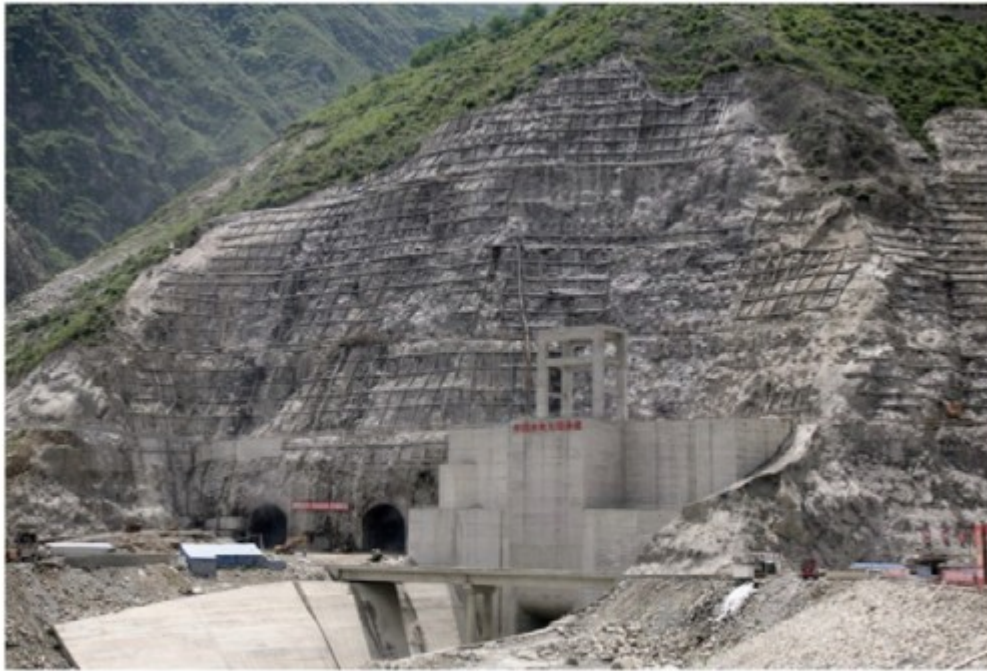
The final configuration of the HJP intake slope is shown in Fig. 21. The project began impounding water on May 15, 2015 (line 5 in Fig. 10), the first turbine began generating power on September 3, 2015, and the slope is performing well.

**Fig. 21.** Overall view of the HJP intake slope after completion.

Based on the above analysis, remedial measures using conventional rock mass stabilization measures were considered feasible, and cable anchors offered the most optimal means for reinforcement. Consequently, the design parameters of the remedial cable anchors were adjusted as follows: first, the length of the as-yet uninstalled cable anchors at elevations between 1481 and 1510 m were increased to 70 m or 75 m, up from the initial 40 m or 45 m. After January 11, 2012, these lengths were further extended to 100 m, in order to provide anchorage beyond the zone of significant loosening of the rock mass. Second, new cable anchors were added from elevation 1510 m to elevation 1610 m, on a 4 × 4 m grid with an installed capacity of 2500 kN or 3000 kN. The installation of cable anchors was carried out in two phases. The first phase took place at elevation 1510–1540 m, and the second phase took place at elevations 1540–1610 m.
