HVS Test Results on Fast-Setting Hydraulic Cement Concrete, Palmdale, California Test Sections, South Tangent

## **HVS Test Results on Fast-Setting Hydraulic Cement Concrete**

### **Palmdale, California Test Sections, South Tangent**

Research report prepared for the  
California Department of Transportation by:

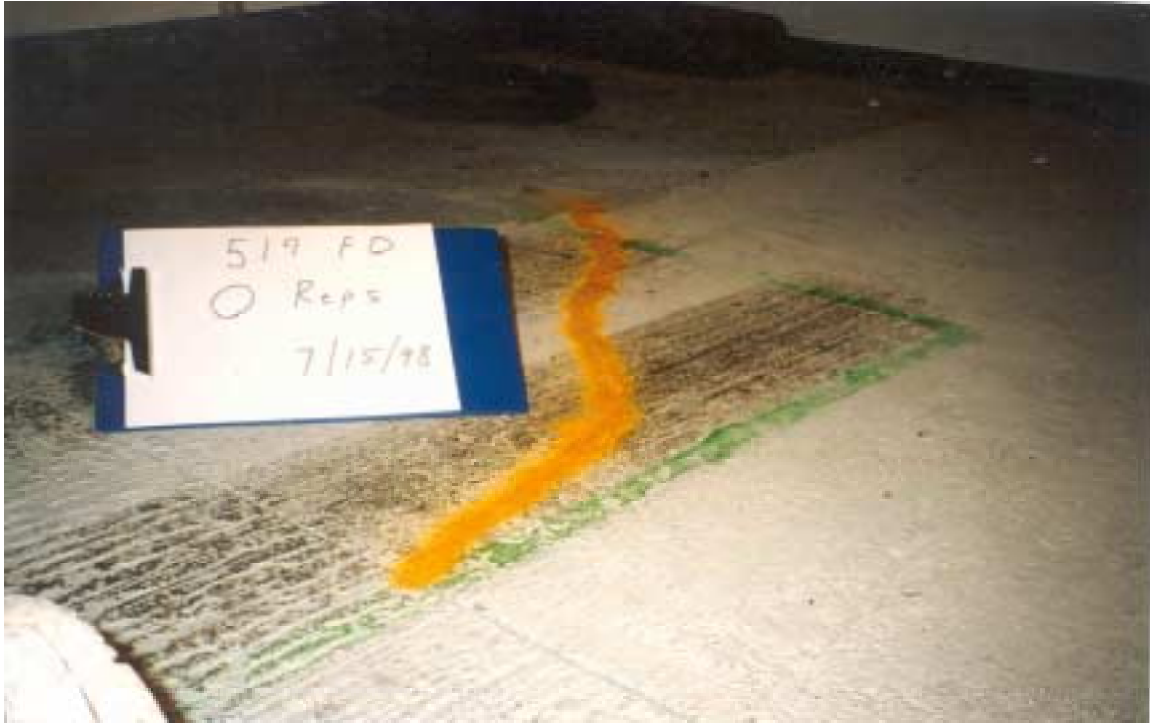
The crack pattern, as it developed with time, can be seen in Figure 4.1. Prior to the start of any loading on Section 519FD, a crack starting at joint 4 and the edge of the slab had developed, most likely from construction traffic (Photograph 4.1).

**Photograph 4.1. Corner crack prior to start of test, Test Section 519FD.**

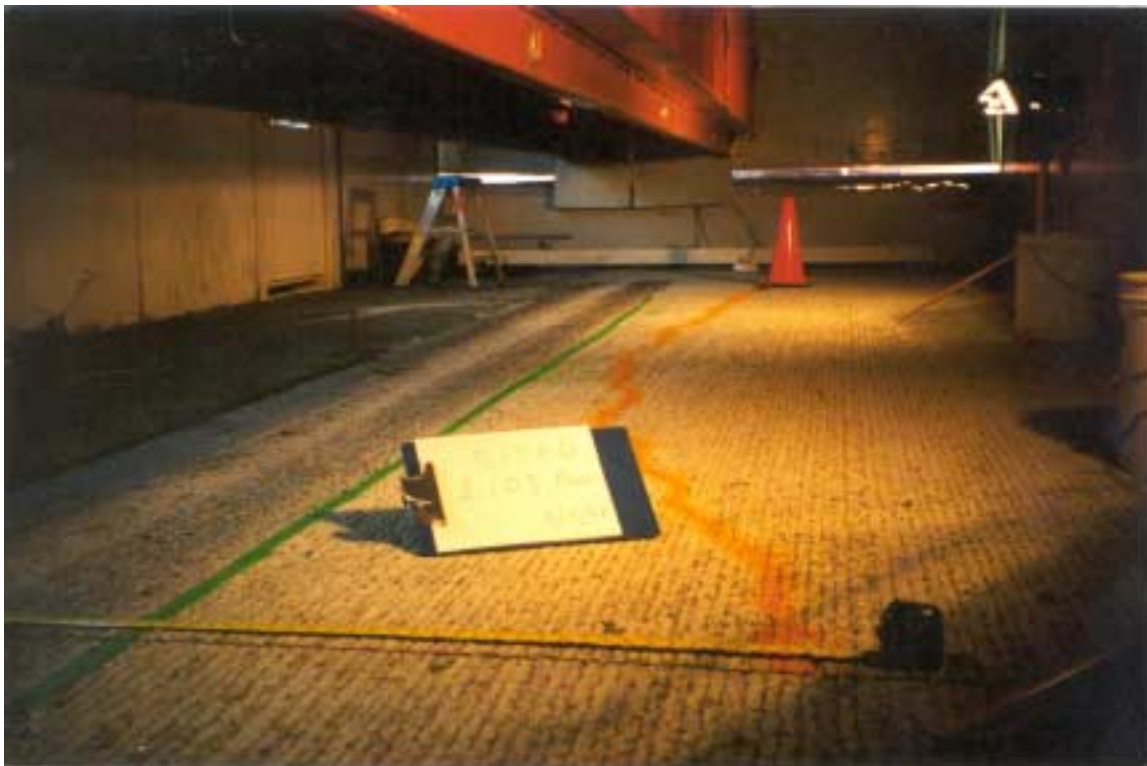
After approximately 2,000 25-kN load repetitions, a longitudinal crack developed throughout the length of the middle slab (slab 4) between both joints, about 1.4 m from the edge (Photograph 4.2). This type of crack indicates a loss of support under the slab and/or excessive slab warping causing an unsupported edge (4). This crack was followed by two corner cracks on either side of slab 4 (one in slab 3 and one in slab 5), which developed at approximately 25,000 repetitions (Photographs 4.3 and 4.4). As the test progressed, more edge and corner cracks developed. The final crack pattern is displayed in Photograph 4.5 and Figure 4.1.

**Photograph 4.2. Longitudinal crack after 2,105 repetitions, Test Section 519FD.**

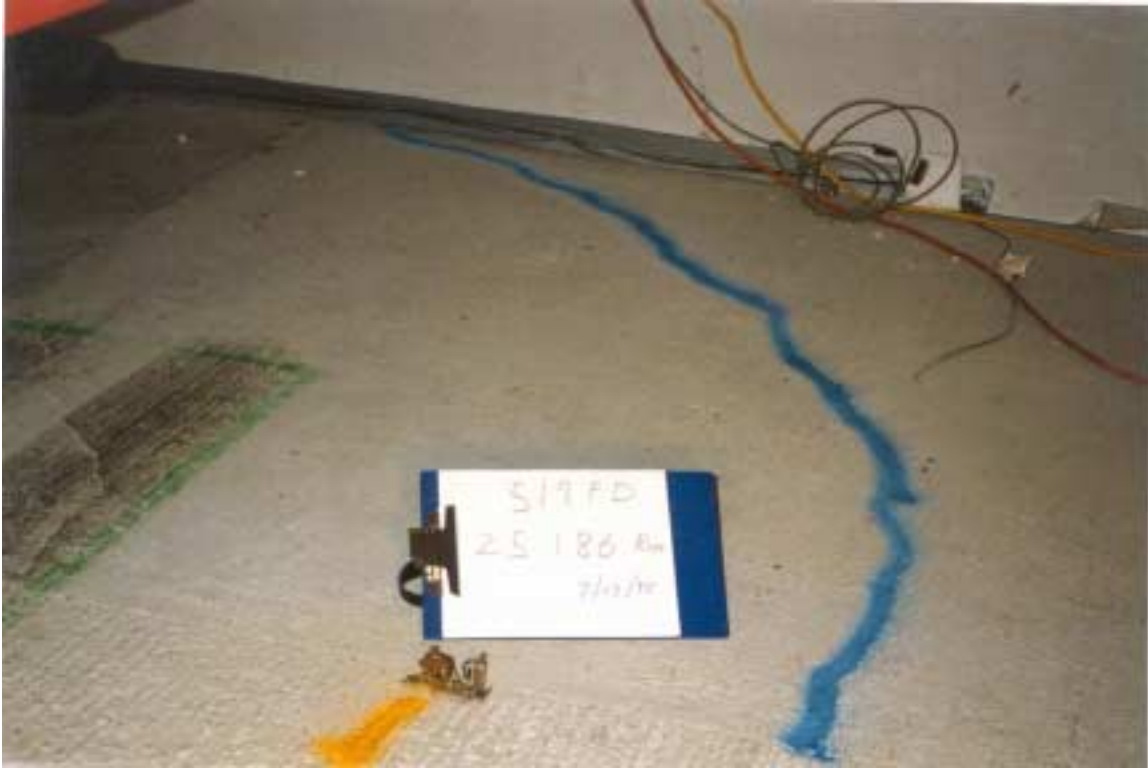
**Photograph 4.3. Corner crack on slab 5 after 25,000 repetitions, Test Section 519FD.**

On the slab 3 side of joint 3, the deflections stayed constant up to the point when the corner crack developed (25,186 repetitions) (see Photographs 4.3 and 4.4). At this point the deflections decreased by about 60 percent from the original N10 measurements, from 4,699 microns at the beginning of the test to 2,053 microns after 25,186 repetitions.

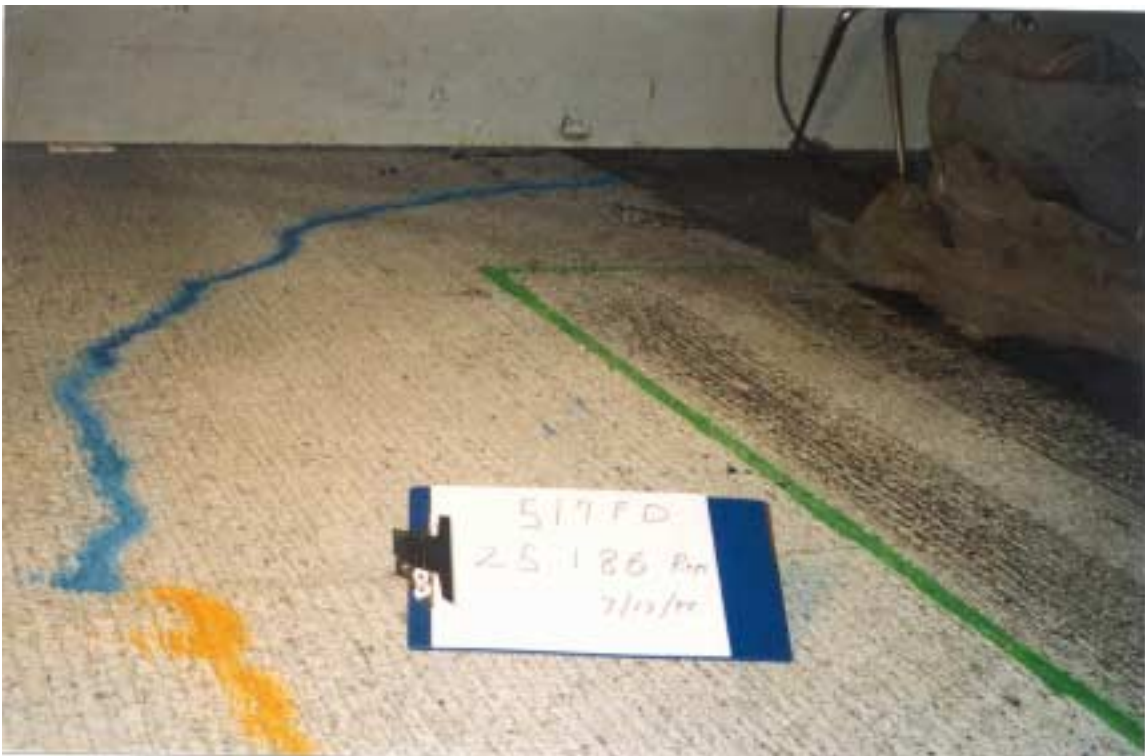
**Photograph 4.4. Corner crack on slab 3 25,000 repetitions, Test Section 519FD.**

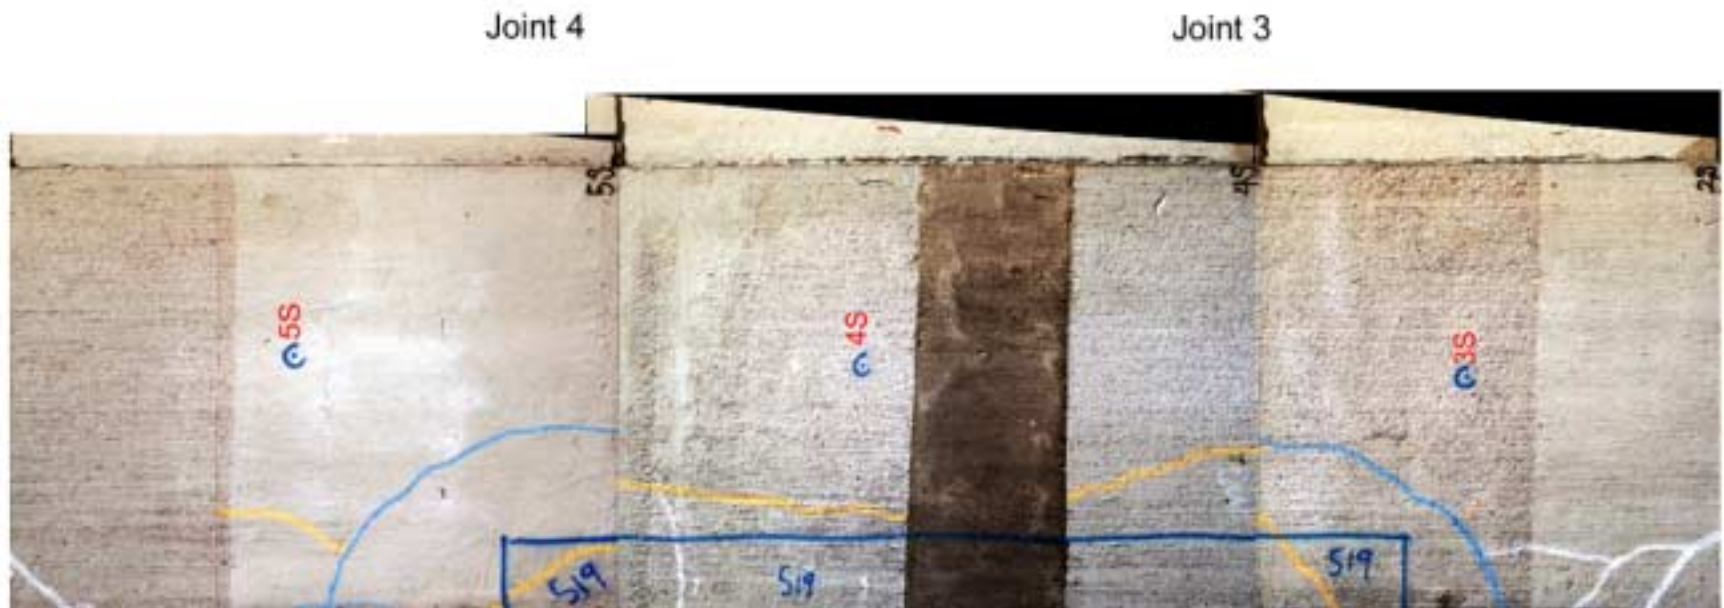
**Photograph 4.5. Composite photograph of final crack pattern, Test Section 519FD.**

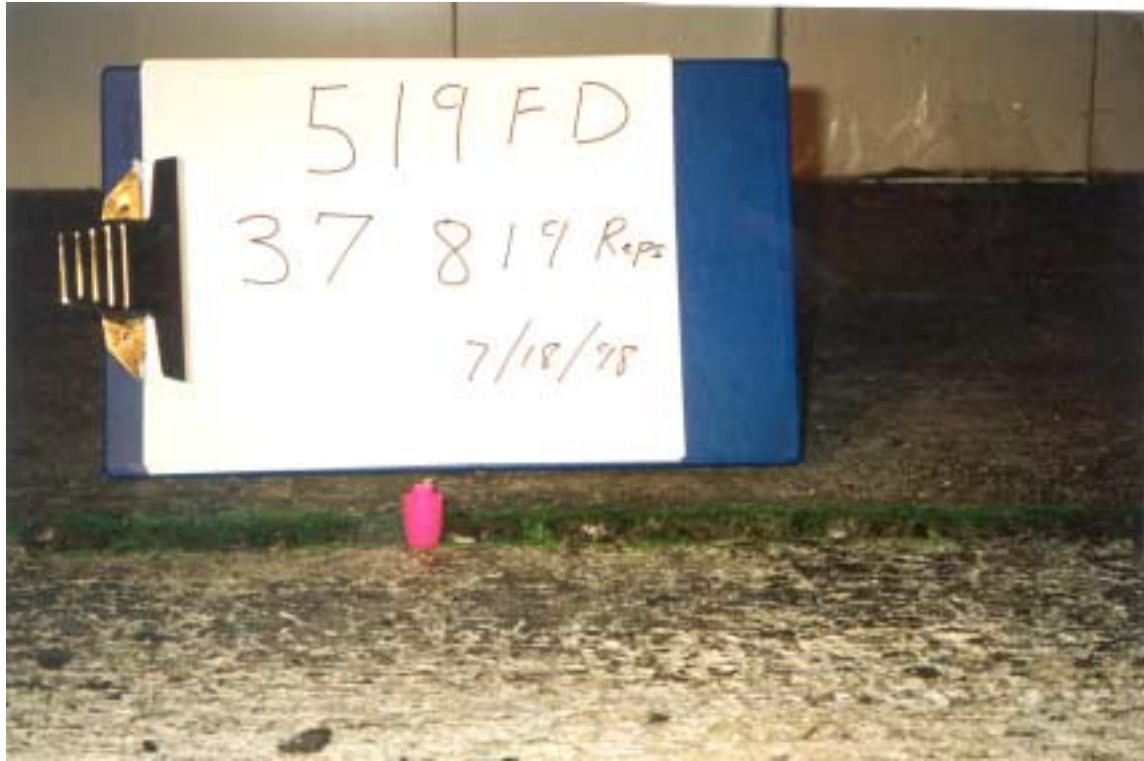
One interesting observation is the amount of permanent deformation along the edge of the slab. Prior to the HVS test, the concrete slab was flush with the asphalt concrete shoulder all along the edge of the concrete slab. As the test progressed, the concrete edge slowly started to move downward into the aggregate base. The total permanent deformation after 37,819

**Photograph 4.6. Permanent deformation at shoulder after 37,000 repetitions, Test Section 519FD.**

repetitions recorded along the edge at the interface between the concrete slab and the adjacent asphalt shoulder was around 20 mm (see Photograph 4.6).

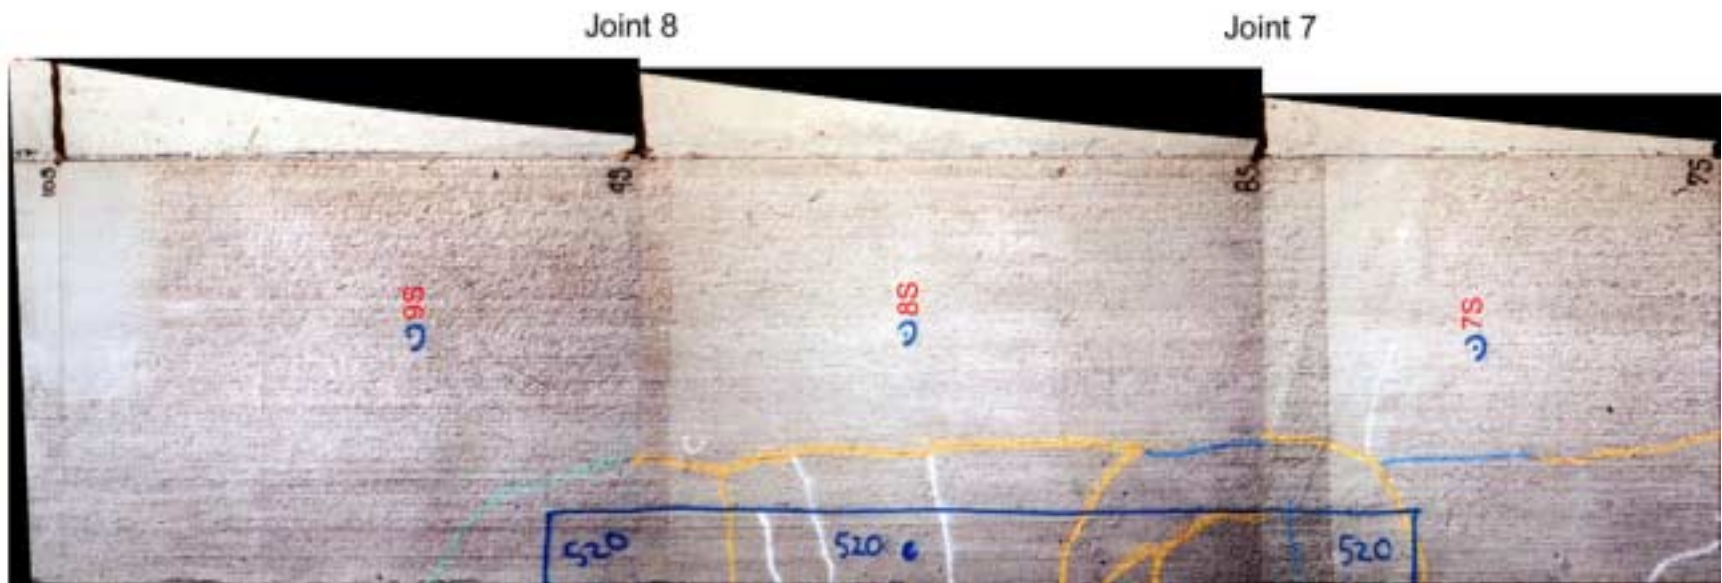
Photograph 4.7. Composite photograph of final crack pattern, Test Section 520FD.

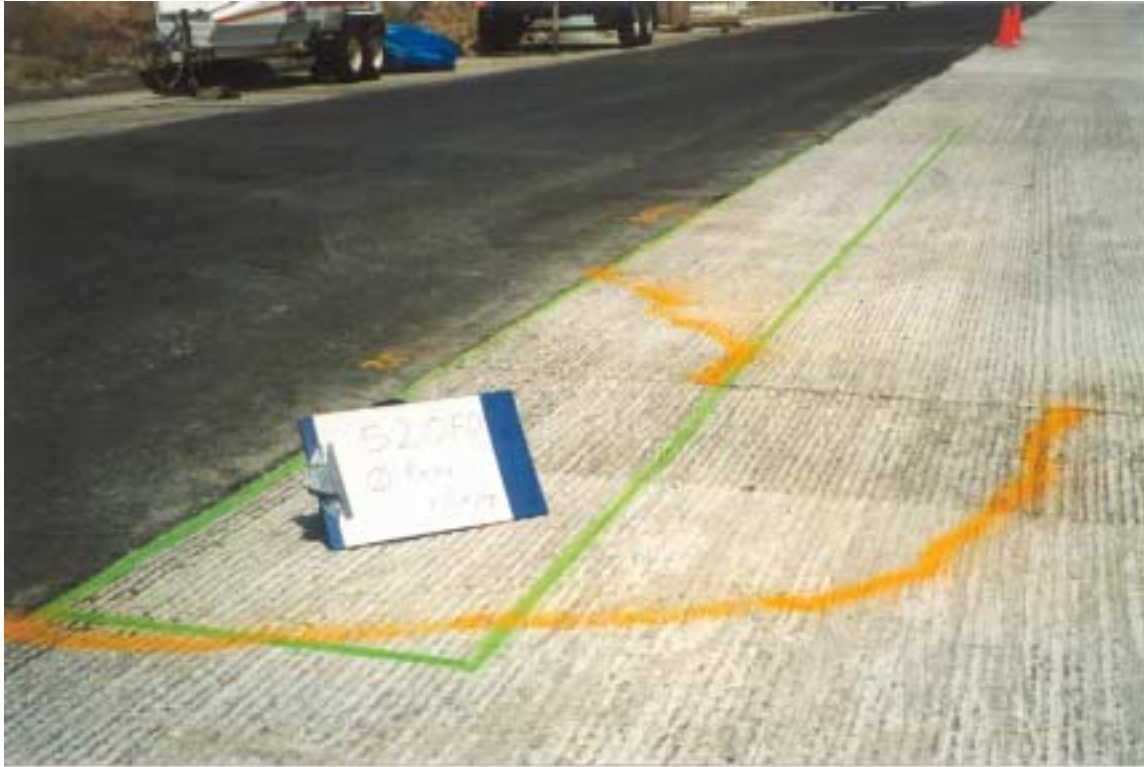
**Photograph 4.8. Corner cracks at start of test, Test Section 520FD.**

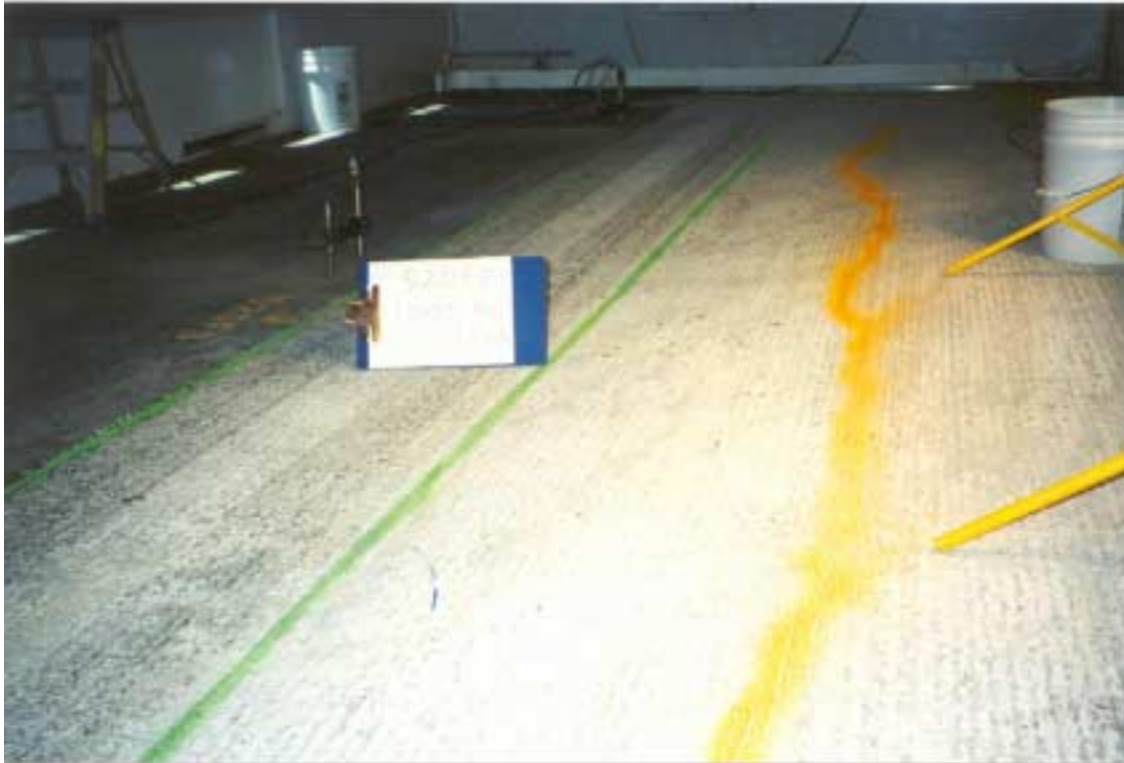
After about 1,000 load repetitions at 35 kN, a longitudinal crack developed along nearly the entire length of the middle slab (slab 8) between both joints, about 1.1 m away from the edge (Photograph 4.9). After 2,000 repetitions, the longitudinal crack had extended to link up with the

**Photograph 4.9. Longitudinal crack after 1,000 repetitions, Test Section 520FD.**

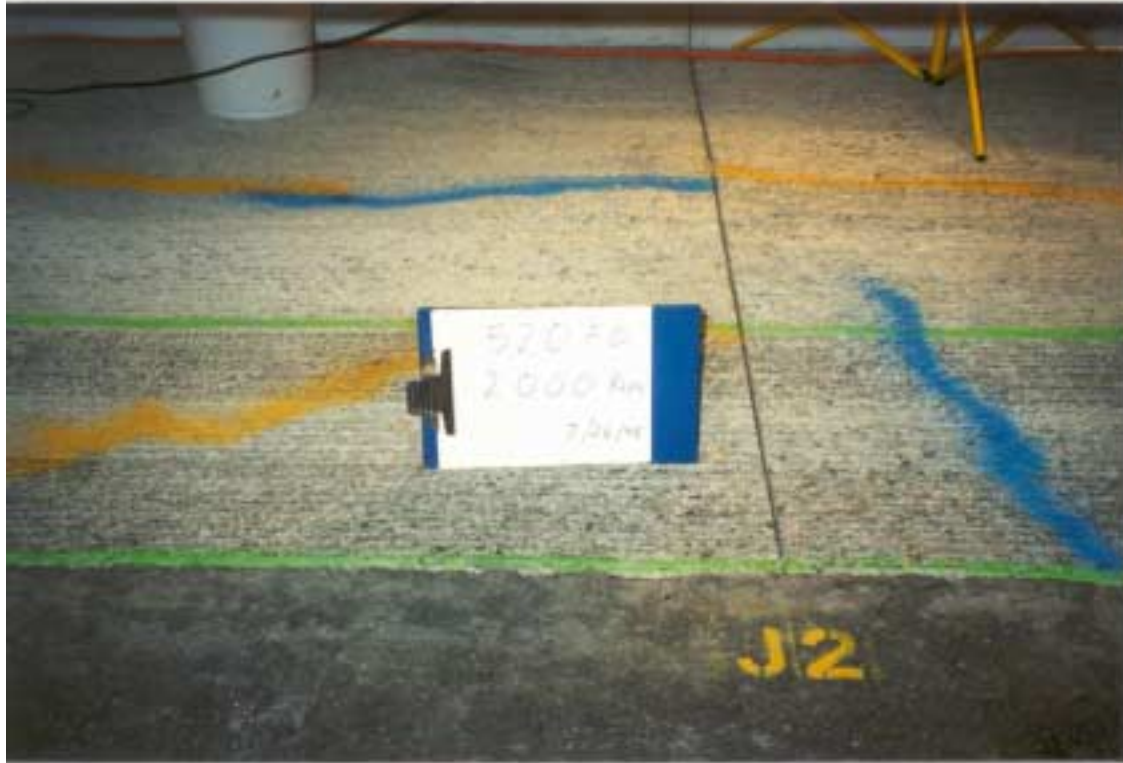
**Photograph 4.10. Cracks at joint 7 (J2) after 2,000 repetitions, Test Section 520FD.**

existing corner crack (which existed prior to the start of the test), and a transverse crack starting about 500 mm right of joint 7 had developed in slab 7 (Photograph 4.10).

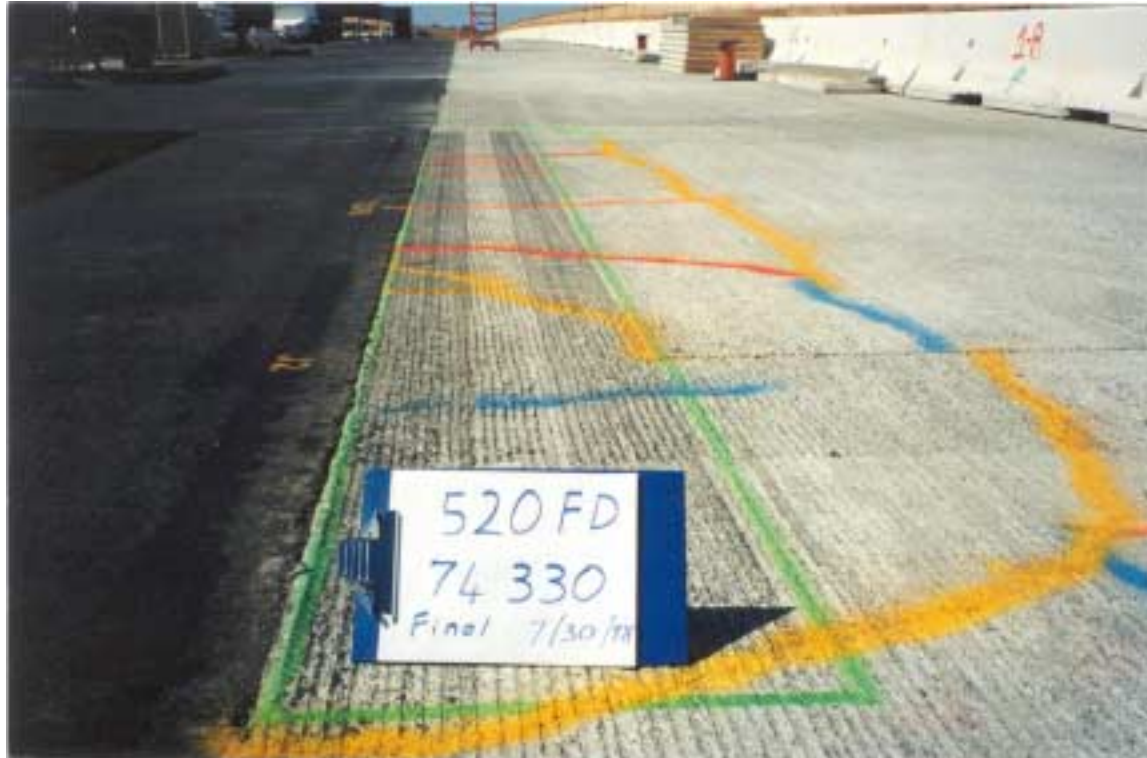
**Photograph 4.11. Final crack pattern after 74,000 repetitions, Test Section 520FD.**

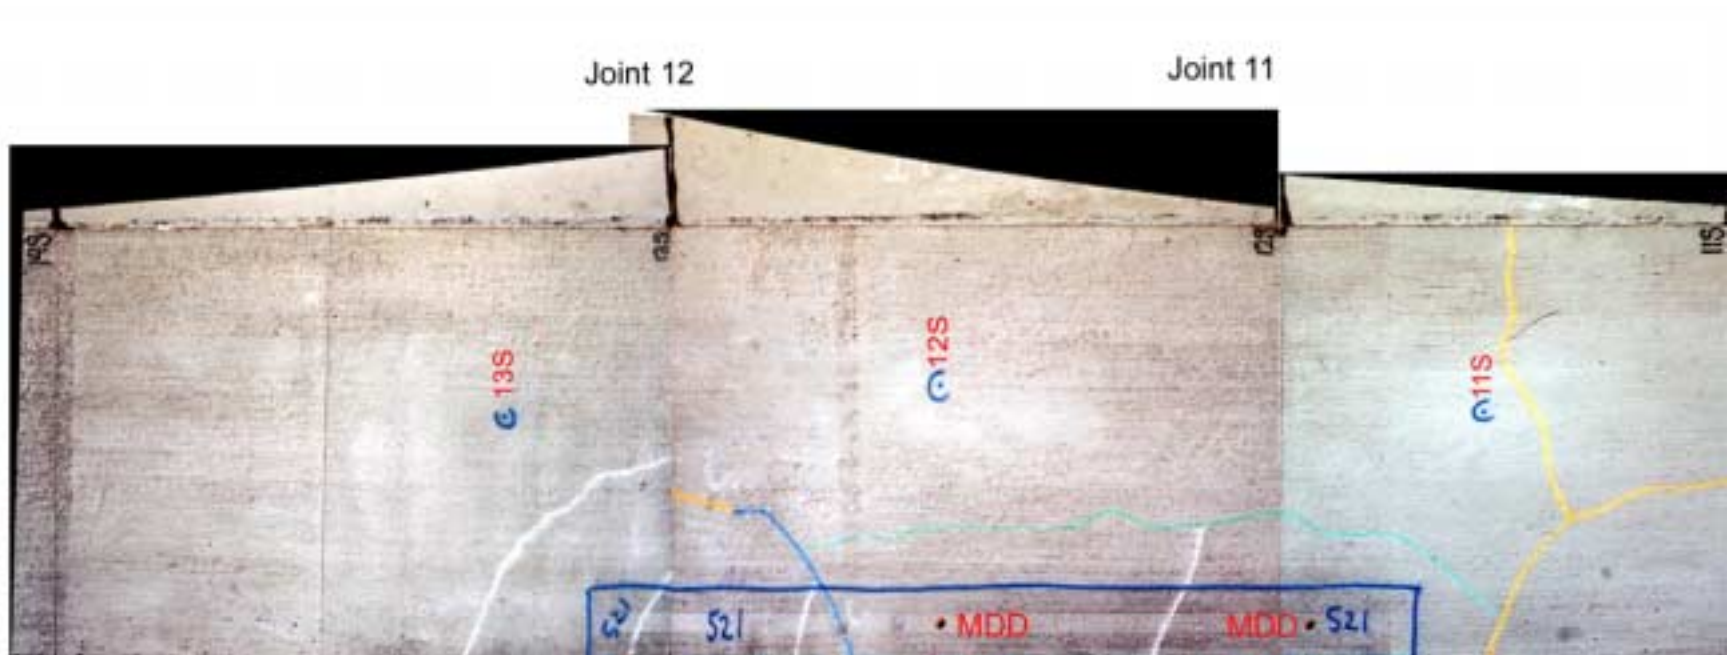
Photograph 4.12. Composite photograph of final crack pattern, Test Section 521.

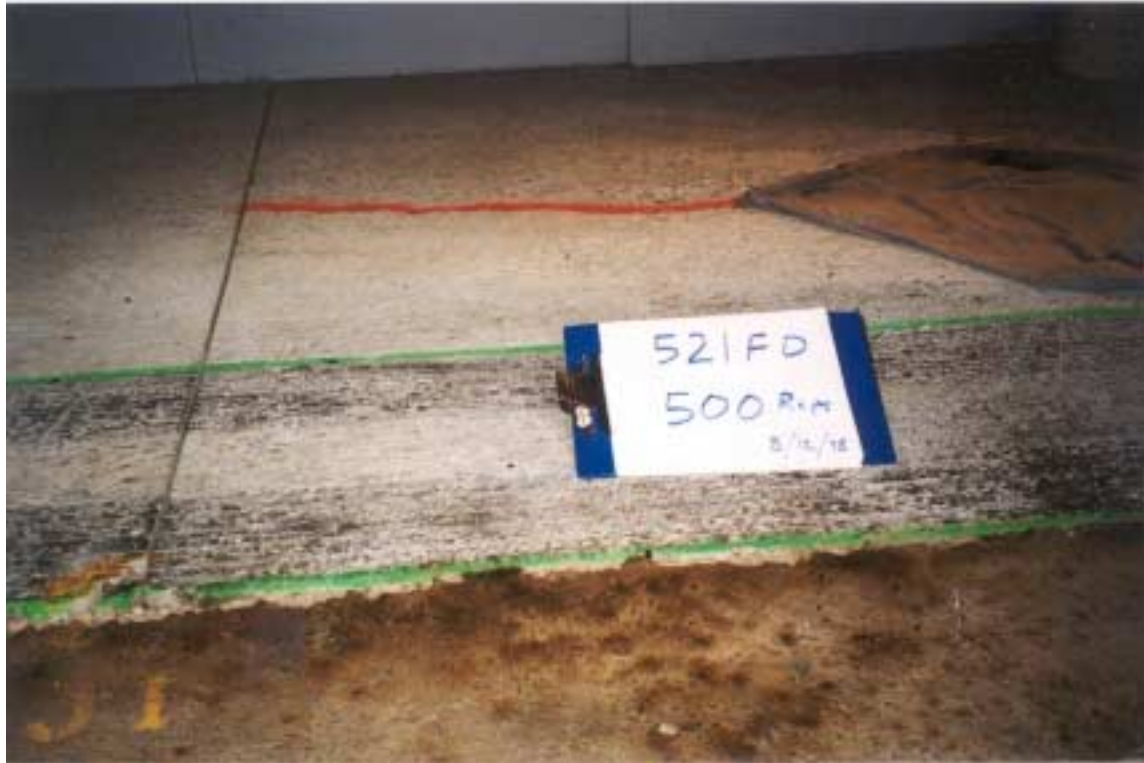
**Photograph 4.14. Longitudinal crack on slab center after 500 repetitions, Test Section 521FD.**

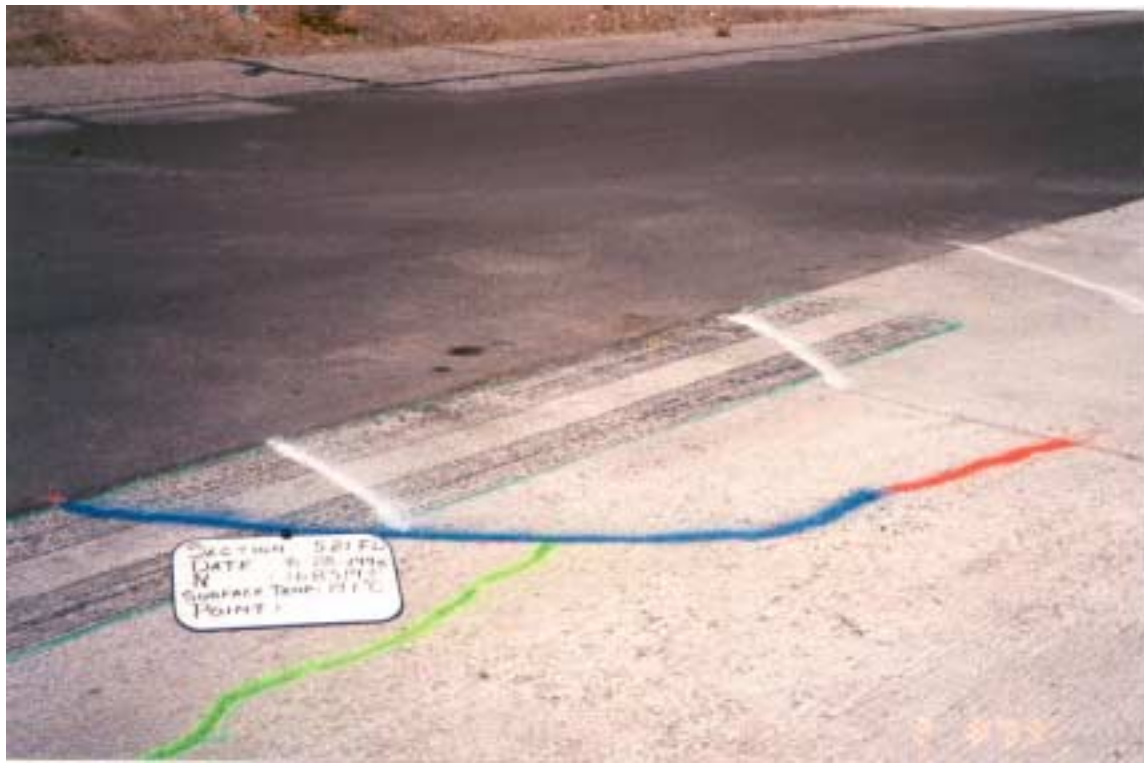
**Photograph 4.15. Crack pattern after 168,000 repetitions, Test Section 521FD.**

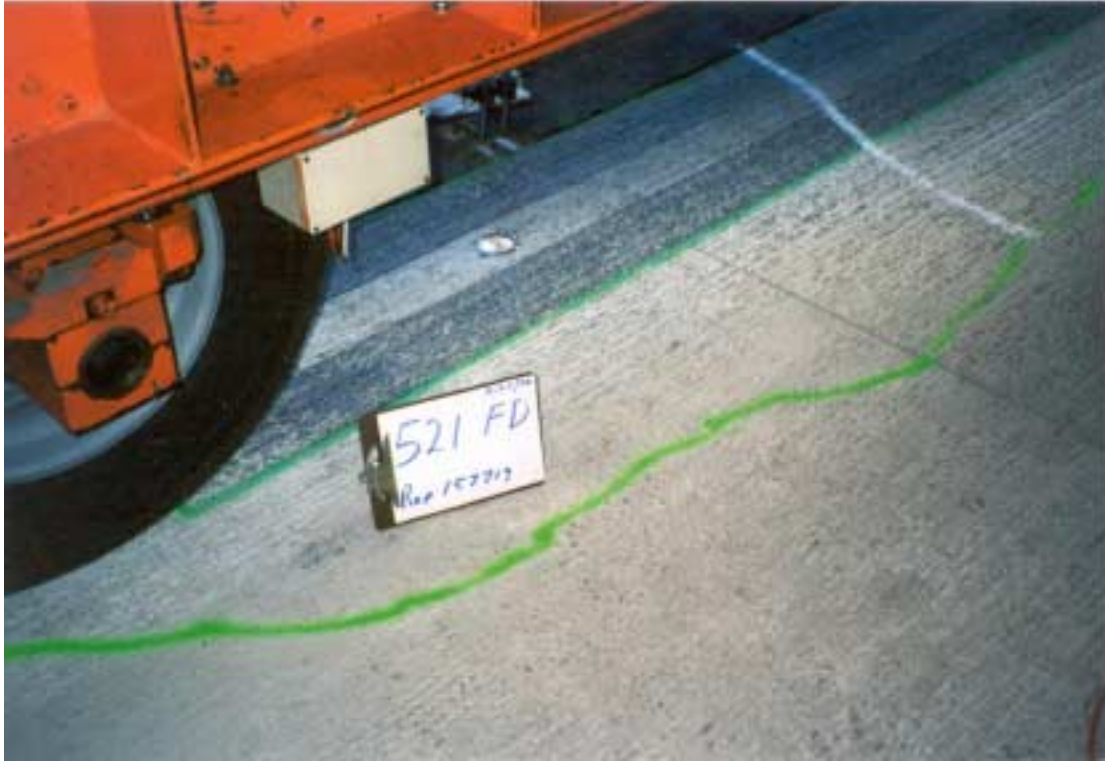
**Photograph 4.16. Corner cracks at joint after 157,000 repetitions, Test Section 521FD.**

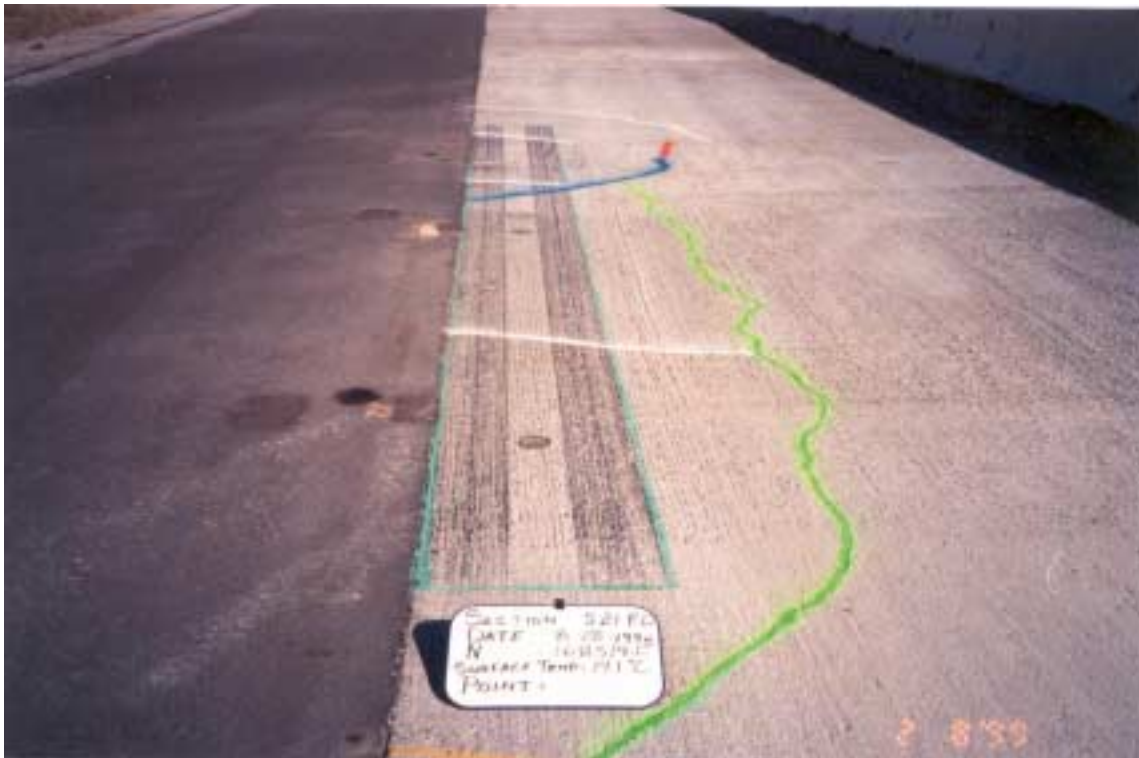
These corner and edge deflections are high for such a small load (20 kN). The most likely explanation is that the edge of the concrete slab, similar to the slabs in the two previous tests (519FD and 520FD), was permanently curled upwards from the initial construction. After 142,072 repetitions, a longitudinal crack about 1,200 mm from the edge appeared (see Figure 4.6) which caused the edge of the slab to come into full contact with the base. The final position of the tested slab with respect to the asphalt concrete shoulder is shown in Photograph 4.17.

**Photograph 4.17. Final Crack pattern after 168,319 repetitions, Test Section 521FD.**

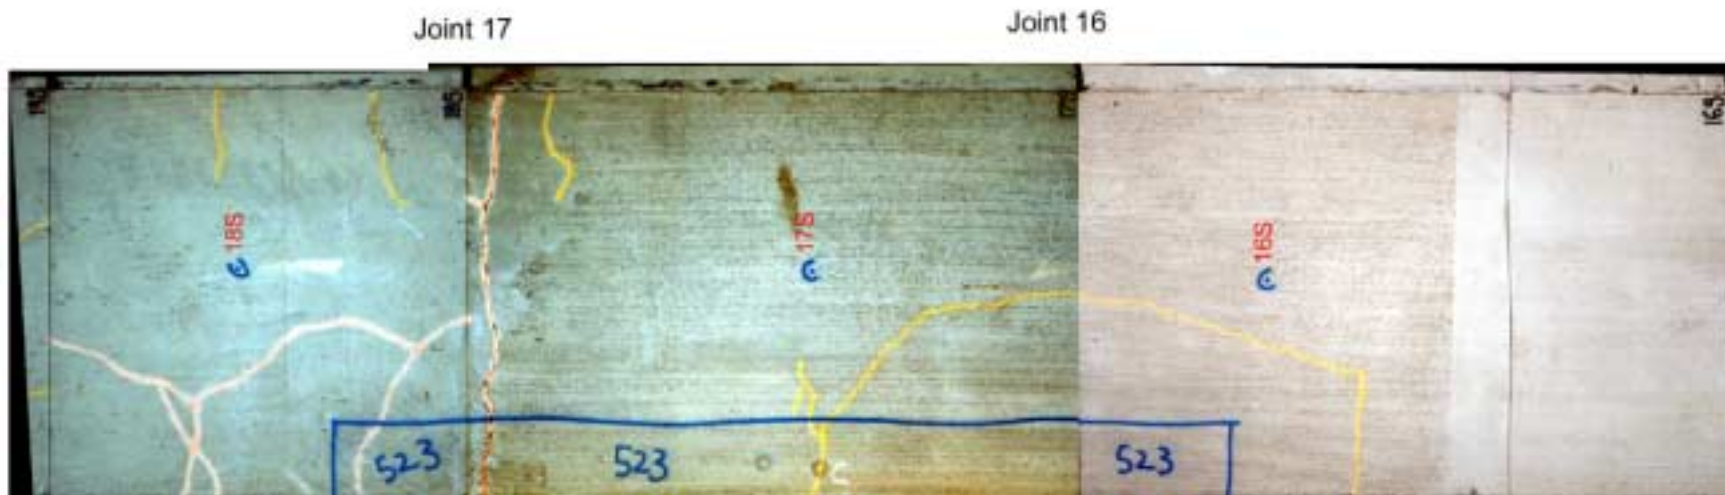
Photograph 4.21 shows an overhead view of the test section and crack pattern. Figure 4.12 shows crack development for Section 523FD. Several cracks existed before trafficking began (see Photograph 4.22). The first crack under applied loading appeared at 89,963 repetitions on slab number 17 as a corner crack and as a longitudinal crack on slab number 16 (Photograph 4.23).

Photograph 4.21. Composite photograph of final crack pattern, Test Section 523FD.

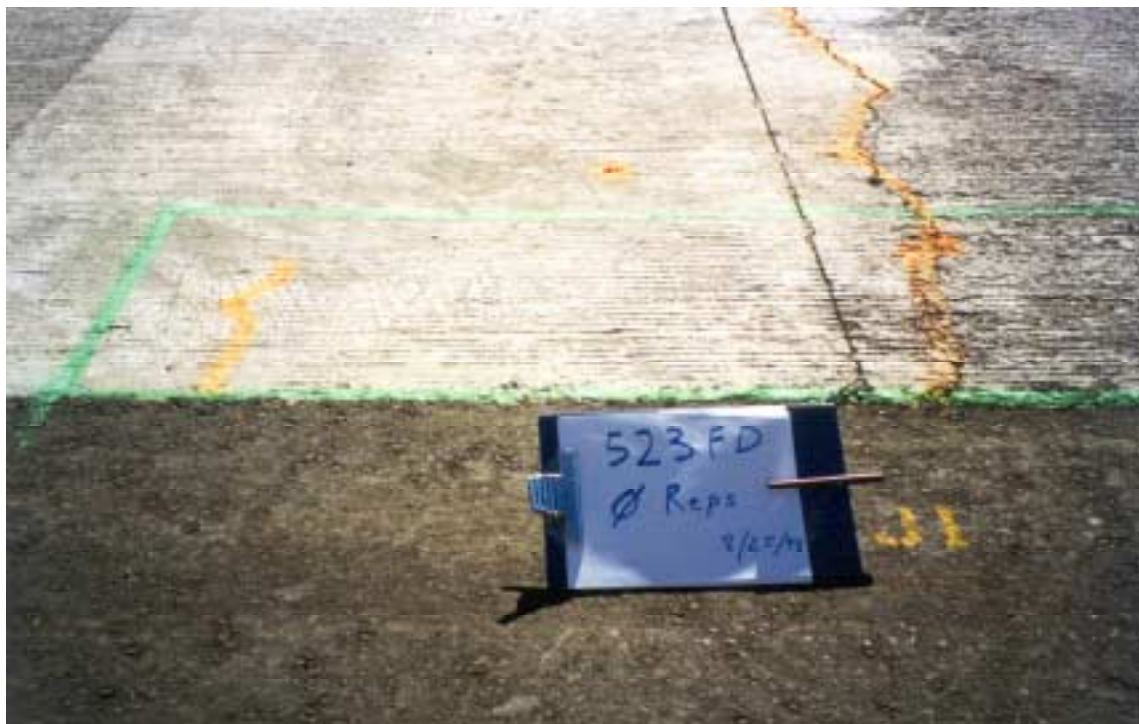
**Photograph 4.22. Crack at transverse joint (joint 17) at start of test, Test Section 523FD.**

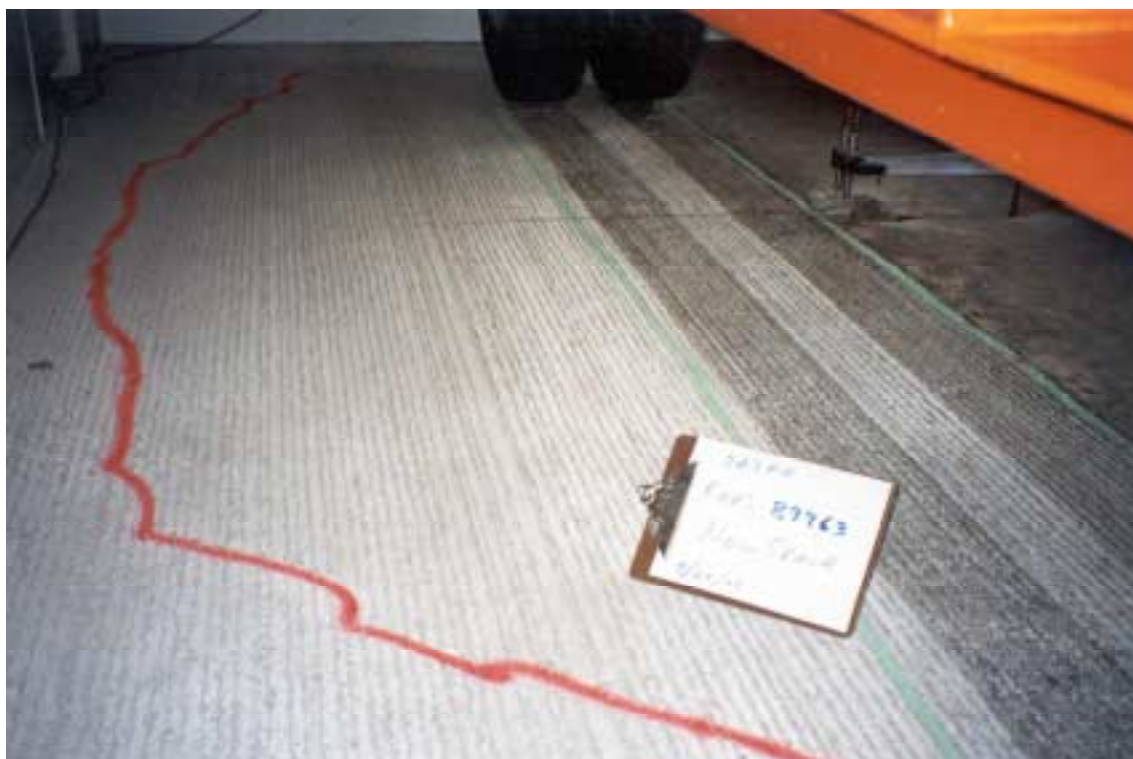
**Photograph 4.23. Crack pattern after 90,000 repetitions, Test Section 523FD.**

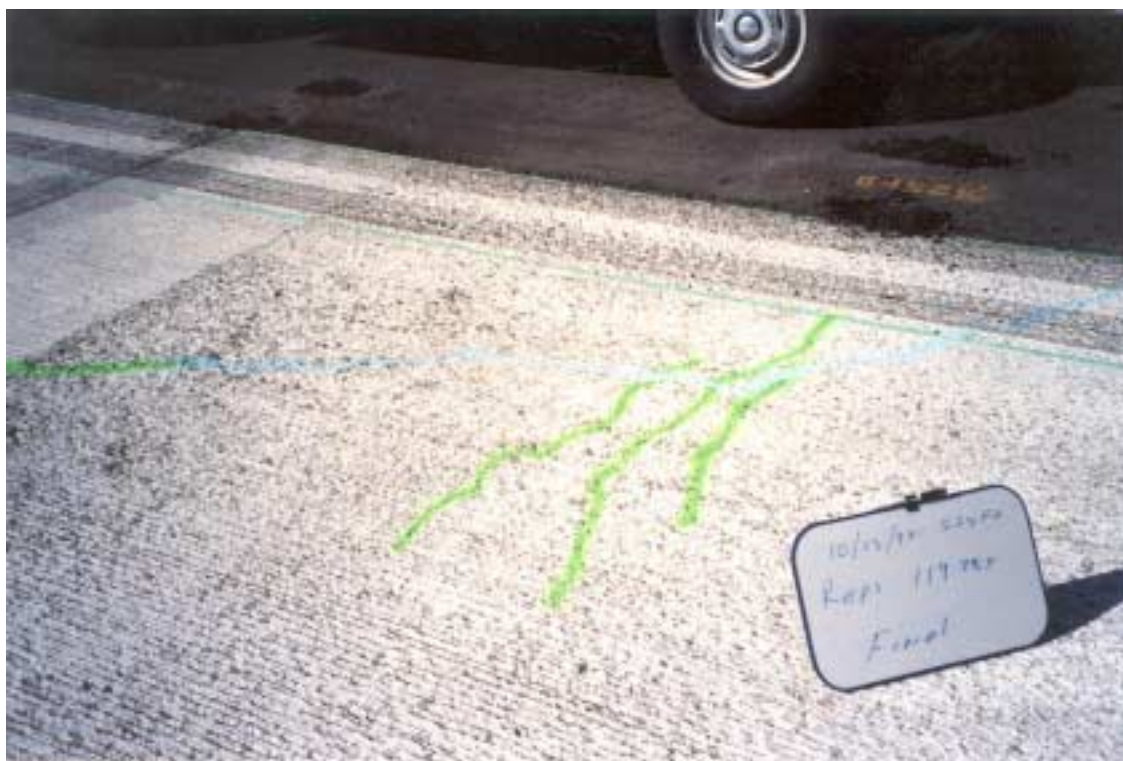
**Photograph 4.25. Crack pattern at completion of HVS trafficking, Test Section 524FD.**

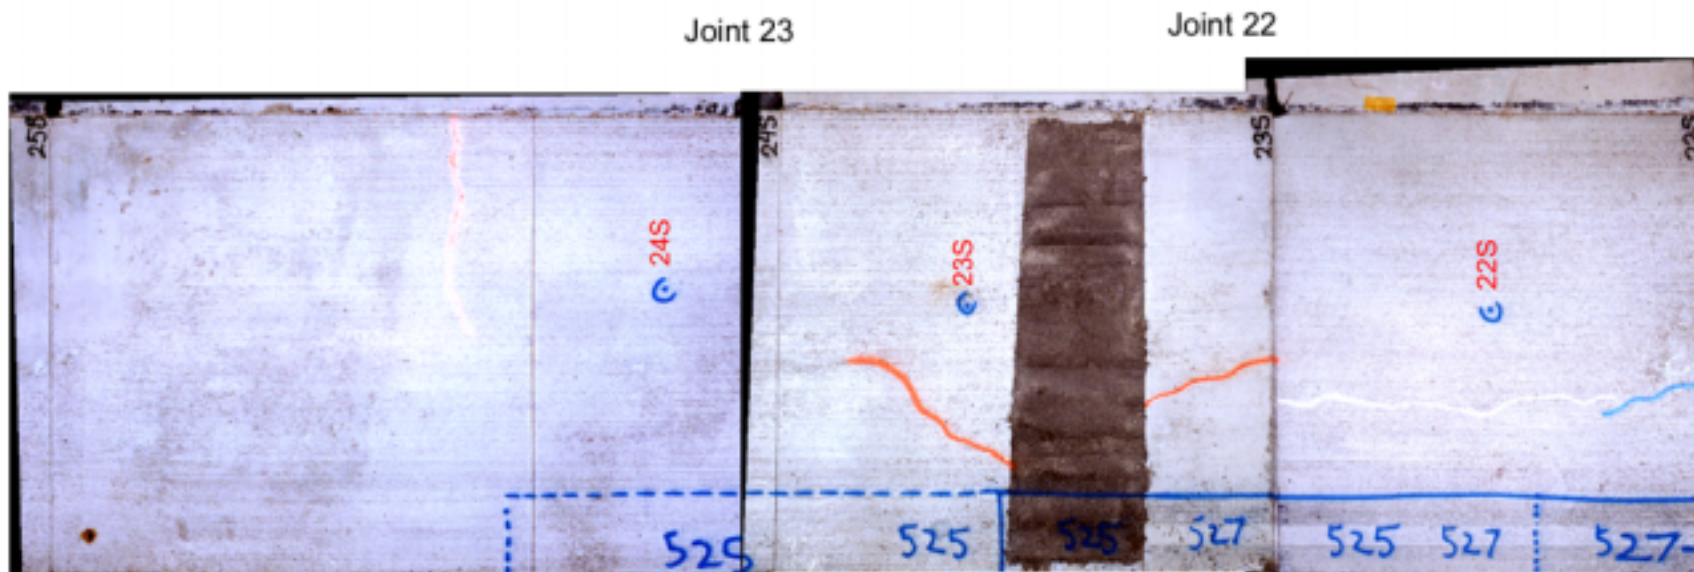
The first crack appeared on the middle slab (slab 23) by 1,000 repetitions. As seen in Photograph 4.26, the HVS produced a corner crack at joint 22 that was approximately symmetrical (1.7 by 1.66 m). This crack was similar to failure modes experienced on the other

Photograph 4.26. Composite photograph of final crack pattern, Test Section 525FD.

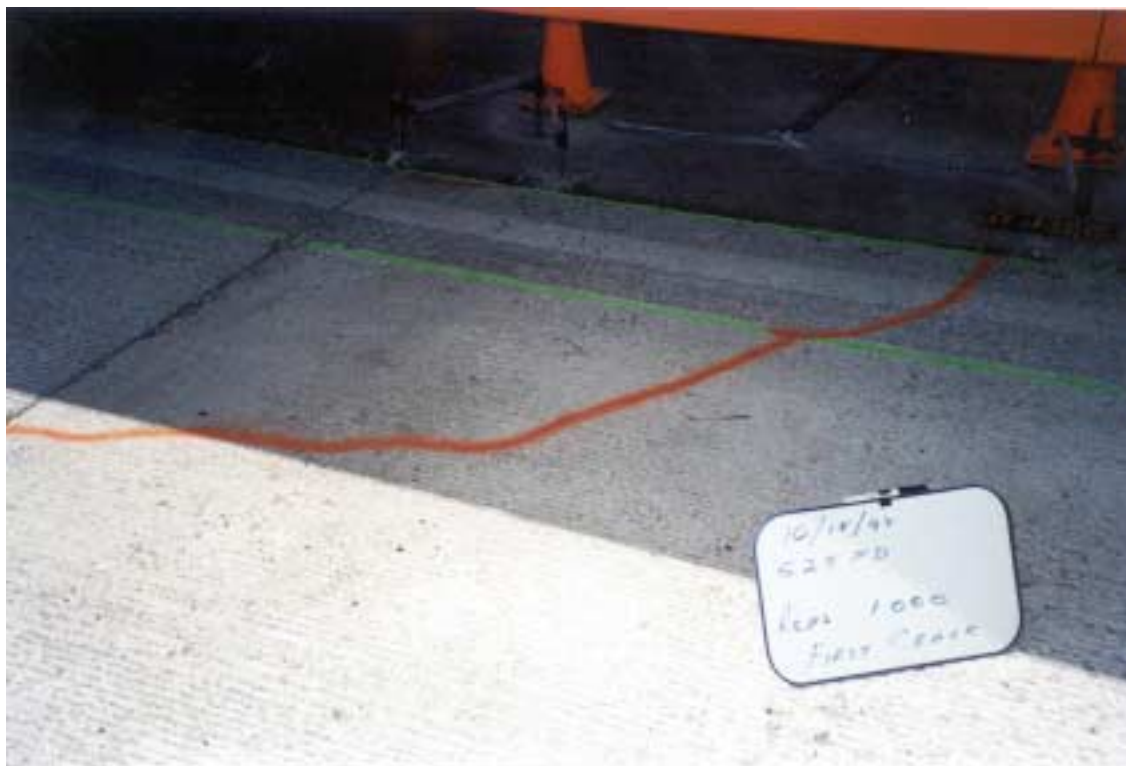
**Photograph 4.27. Corner crack after 1,000 repetitions, Test Section 525FD.**

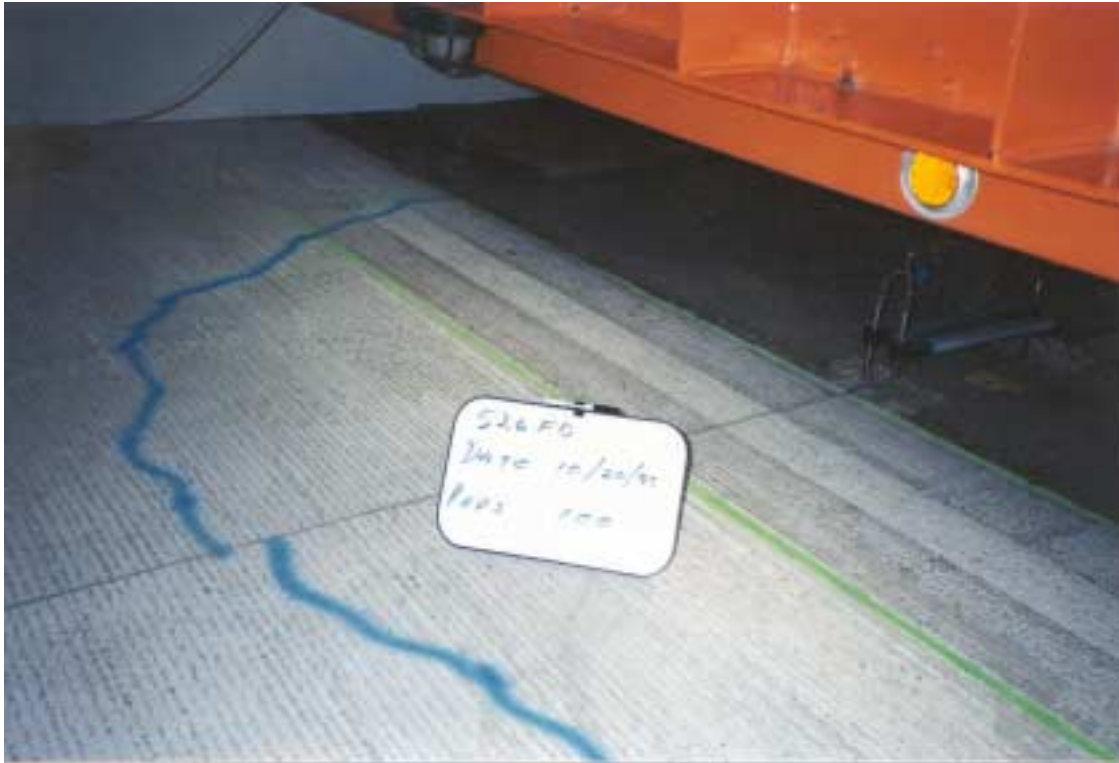
**Photograph 4.28. Corner cracks after 100 repetitions, Test Section 526FD.**

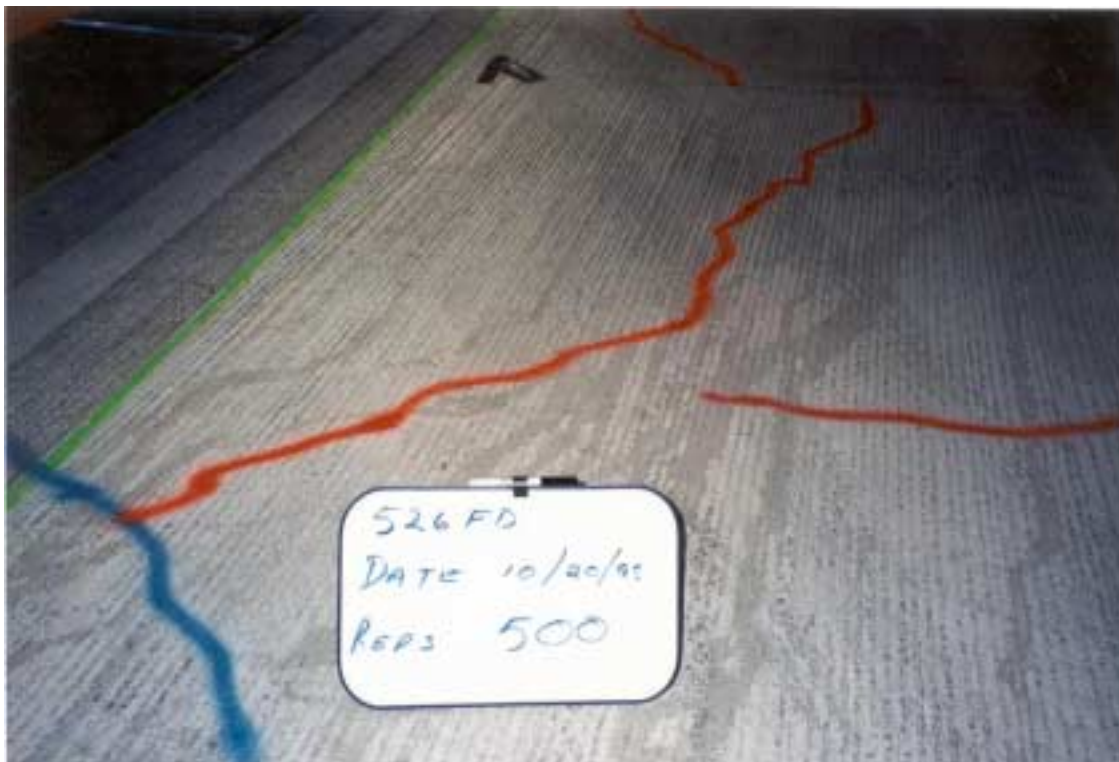
**Photograph 4.29. Crack pattern after 500 repetitions, Test Section 526FD.**
