HVS Test Results on Fast-Setting Hydraulic Cement Concrete, Palmdale, California Test Sections, South Tangent

## **HVS Test Results on Fast-Setting Hydraulic Cement Concrete**

### **Palmdale, California Test Sections, South Tangent**

Research report prepared for the  
California Department of Transportation by:

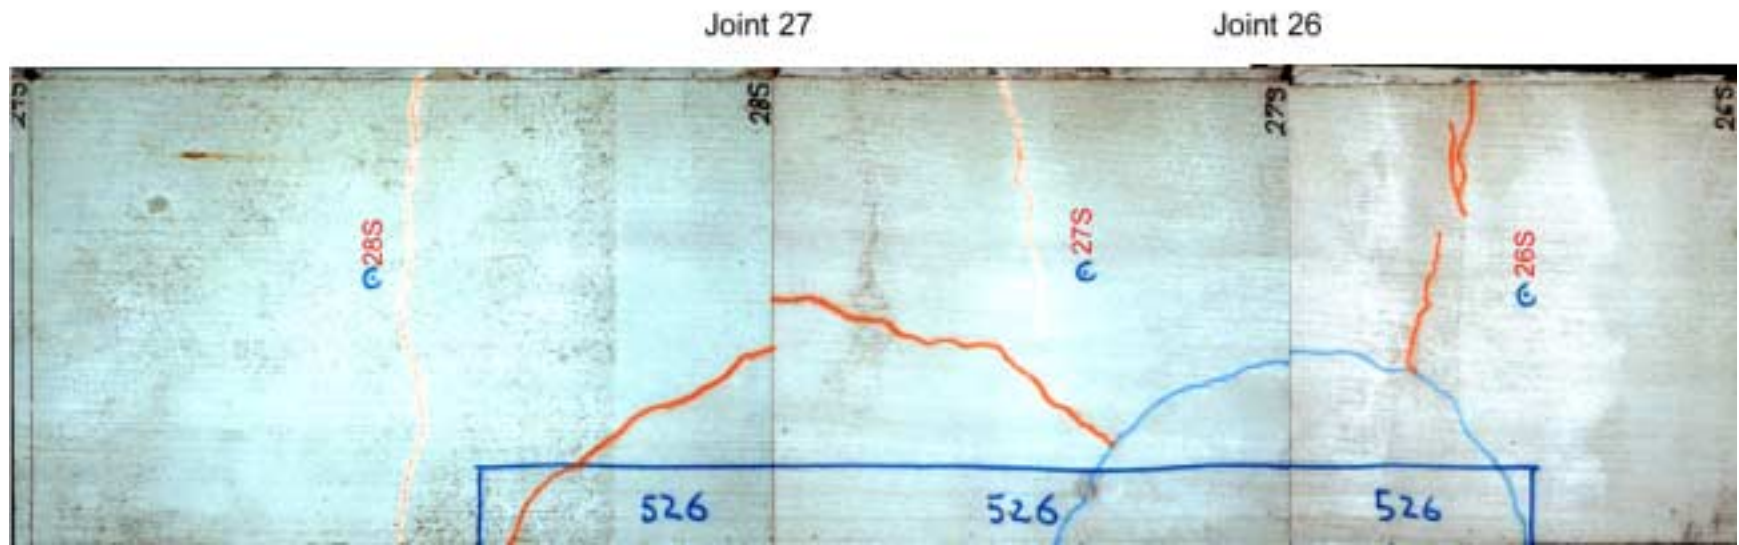
Photograph 4.30. Composite photograph of final crack pattern, Test Section 526FD.

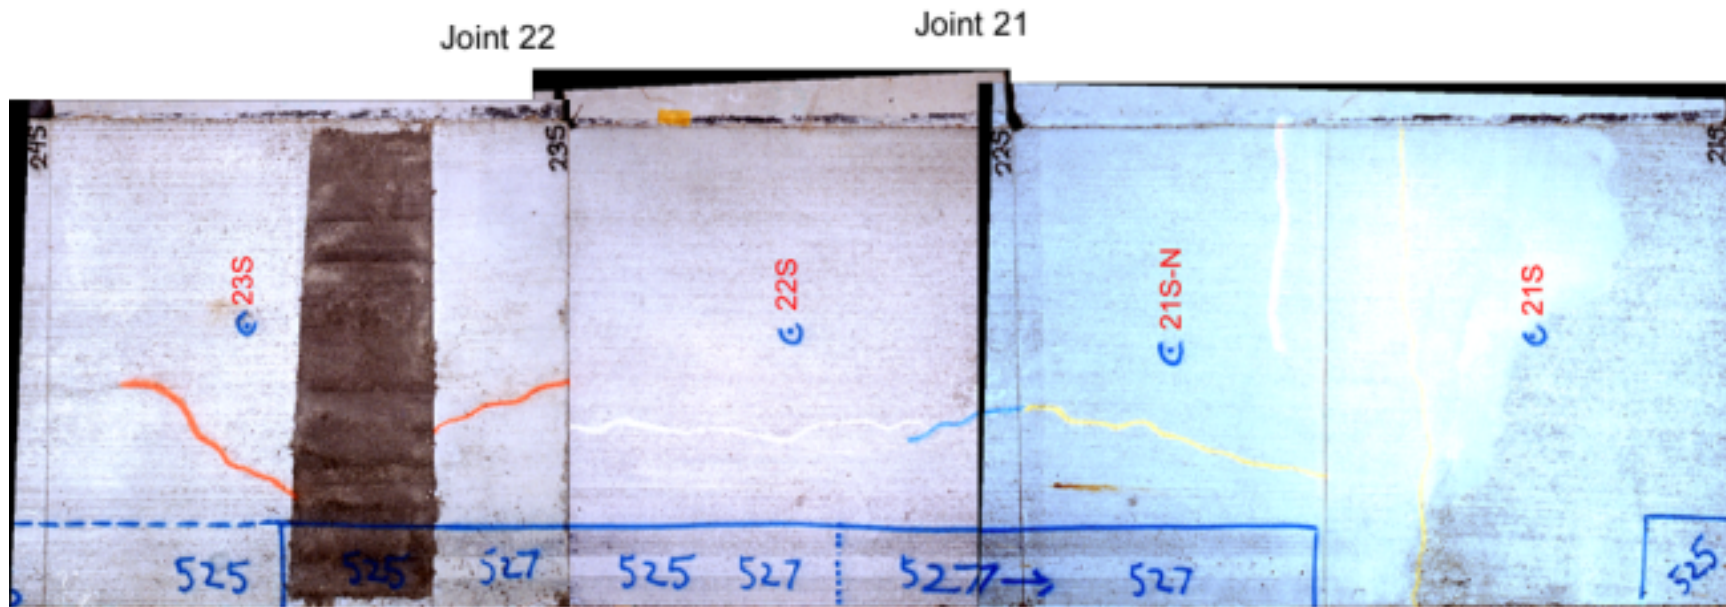
Photograph 4.31. Composite photograph of final crack pattern, Test Section 527FD.

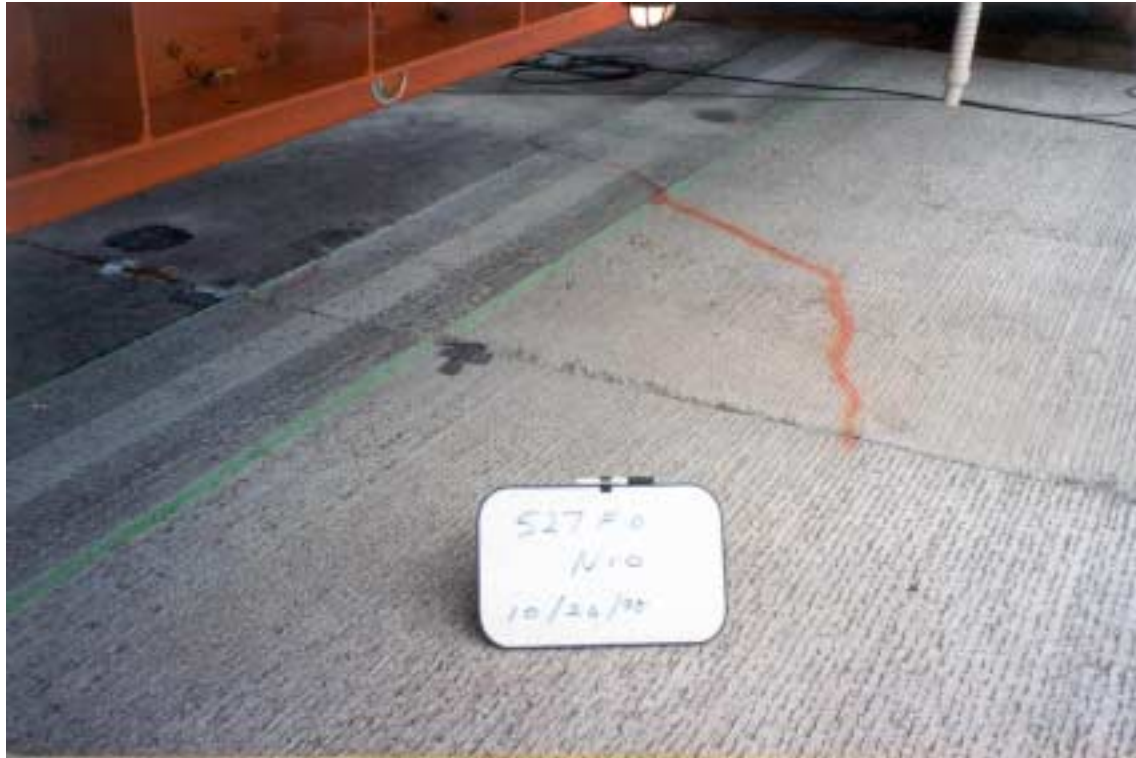
**Photograph 4.32. Corner crack at start of test, Test Section 527FD.**

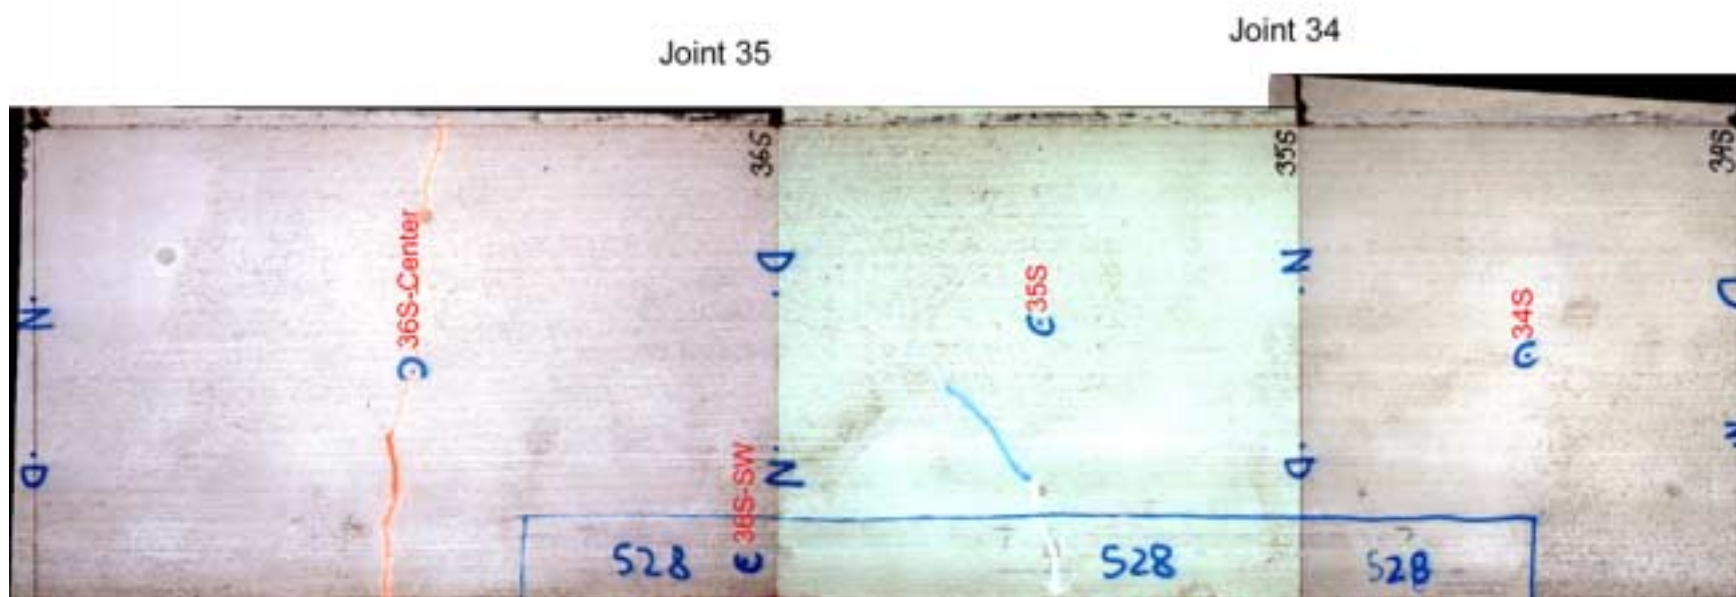
Photograph 4.33. Composite photograph of final crack pattern, Test Section 528FD.

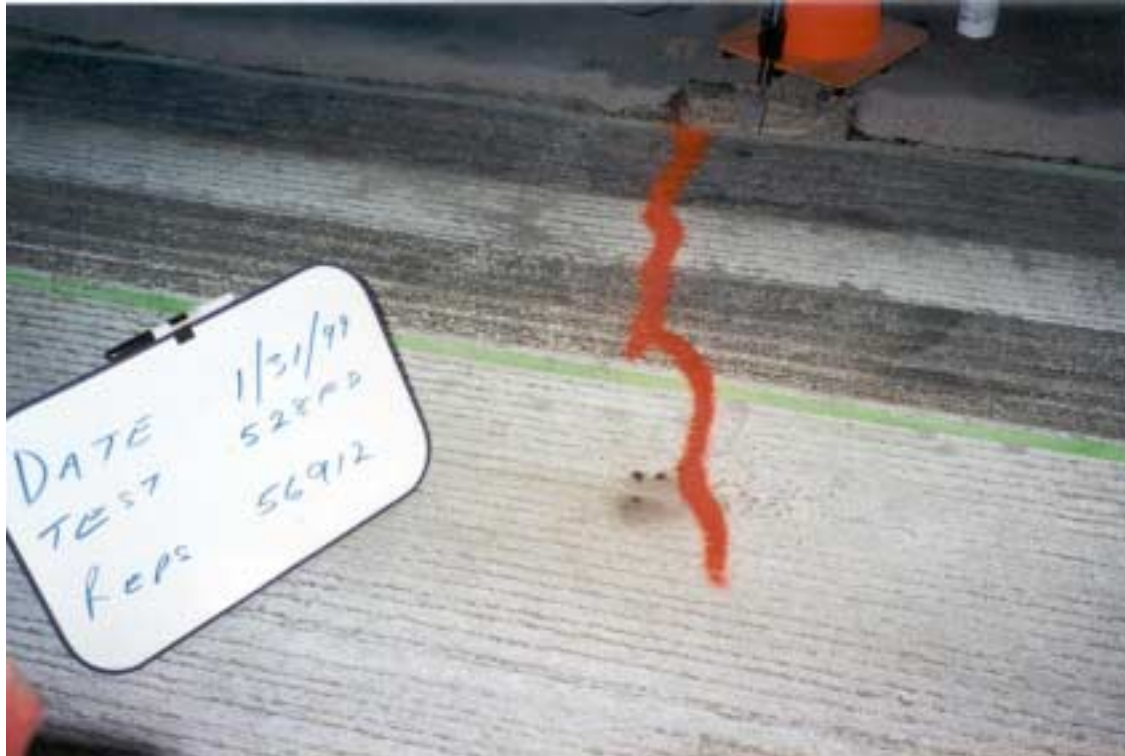
**Photograph 4.34. Transverse crack after 52,000 repetitions, Test Section 528FD.**

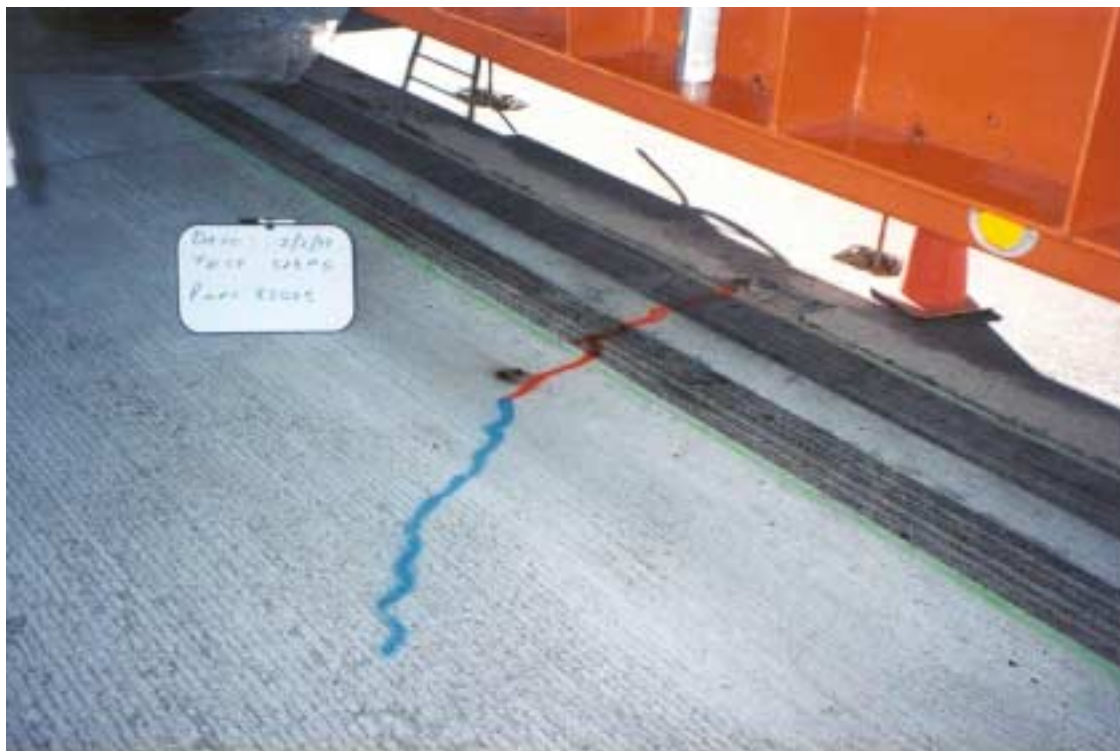
**Photograph 4.35. Final crack pattern after 83,000 repetitions, Test Section 528FD.**

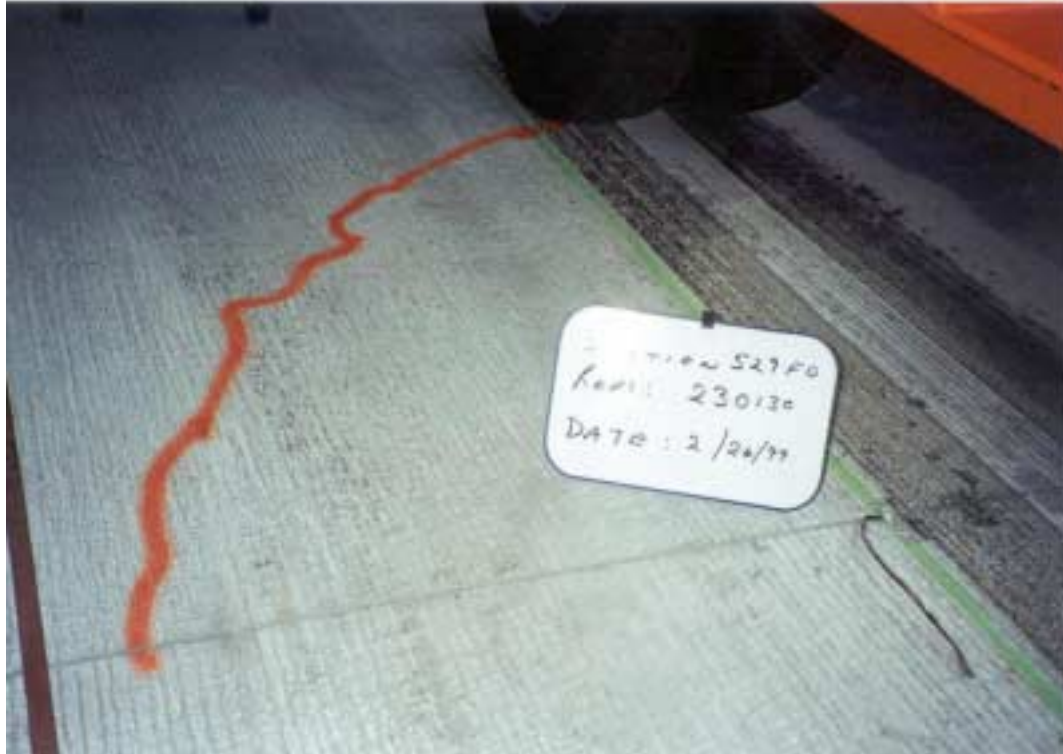
**Photograph 4.37. Corner crack after 230,000 repetitions, Test Section 529FD.**

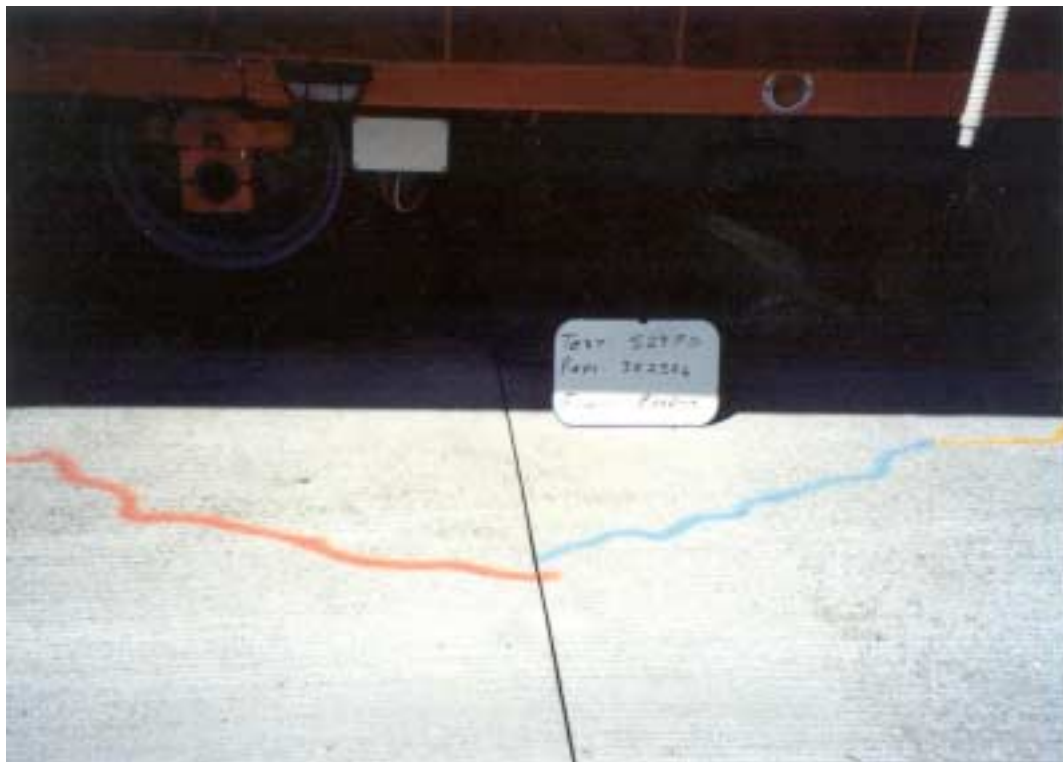
**Photograph 4.38. Final crack pattern after 352,324 repetitions, Test Section 529FD.**

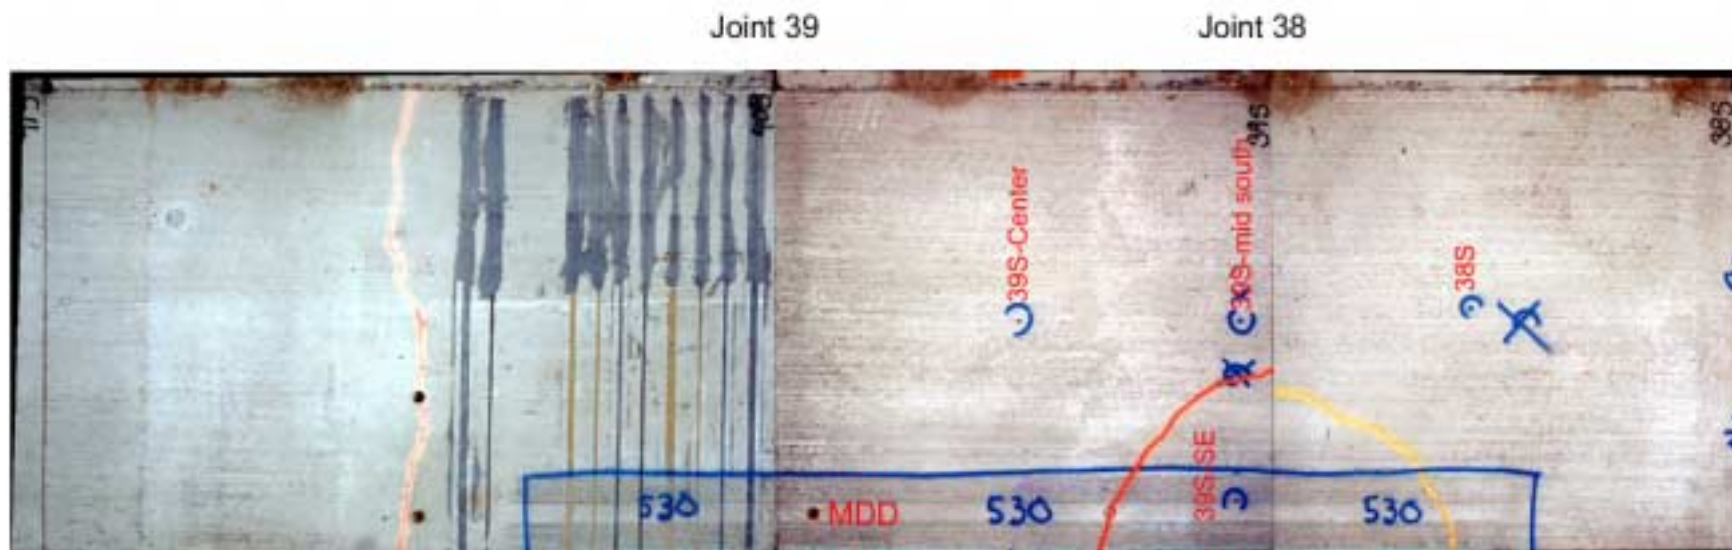
Photograph 4.39. Composite photograph of final crack pattern, Test Section 530FD.

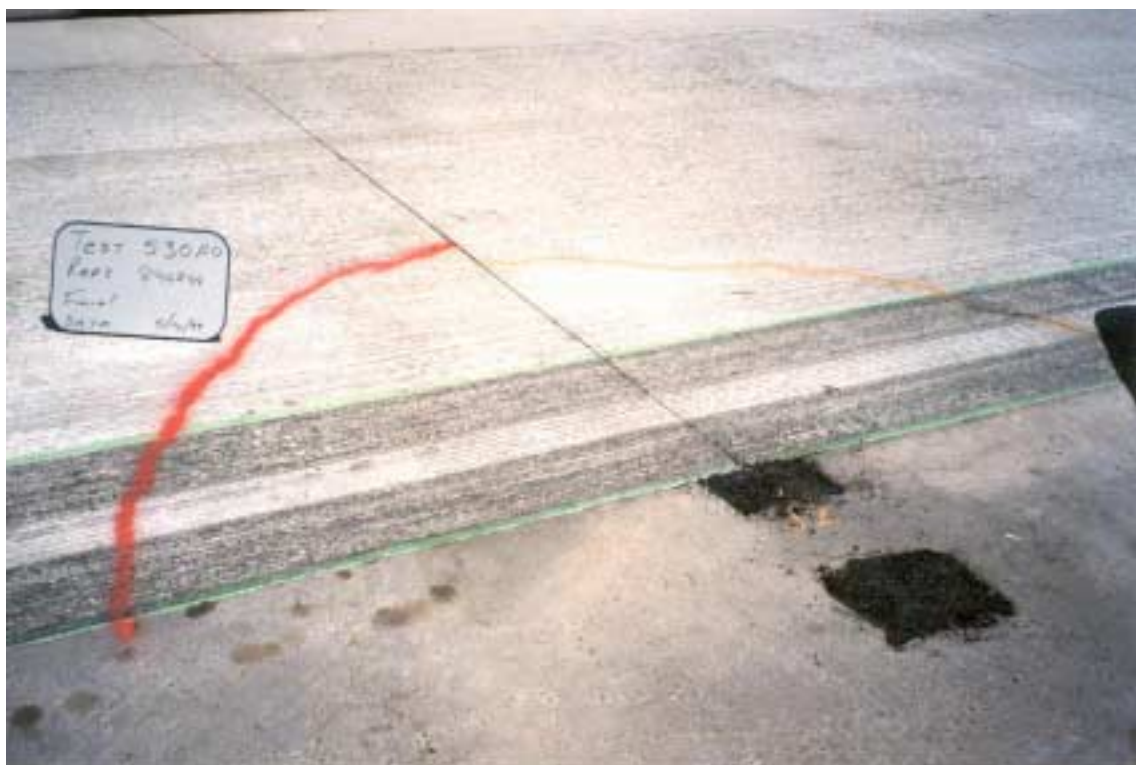
**Photograph 4.40. Final crack pattern at the end of the test (846,844 repetitions), Test Section 530FD.**

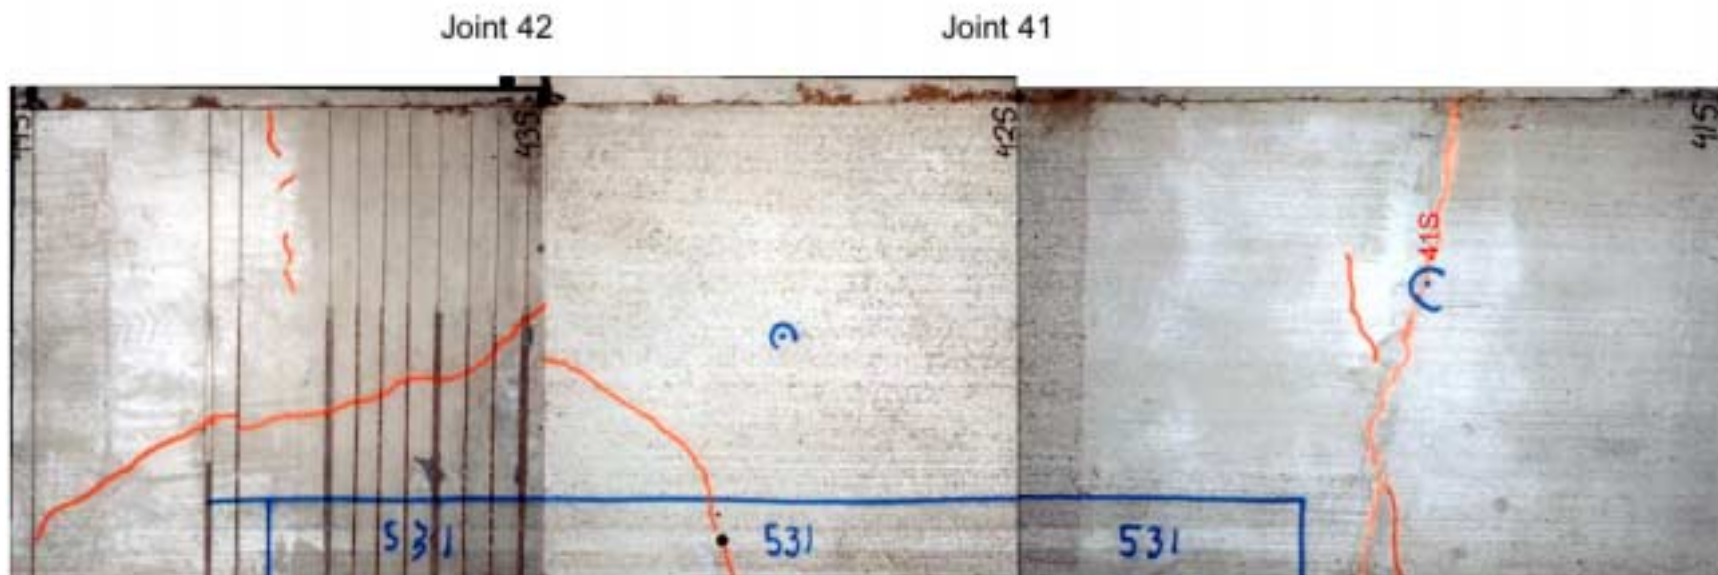
The deflections recorded at both load levels remained relatively constant. The failure that occurred (crack pattern) developed somewhat prematurely, which may be the result of a lack of aggregate interlock at joint 42 due to the installation of the WIM instrumentation.

**Photograph 4.41. Composite photograph of final crack pattern, Test Section 531FD.**

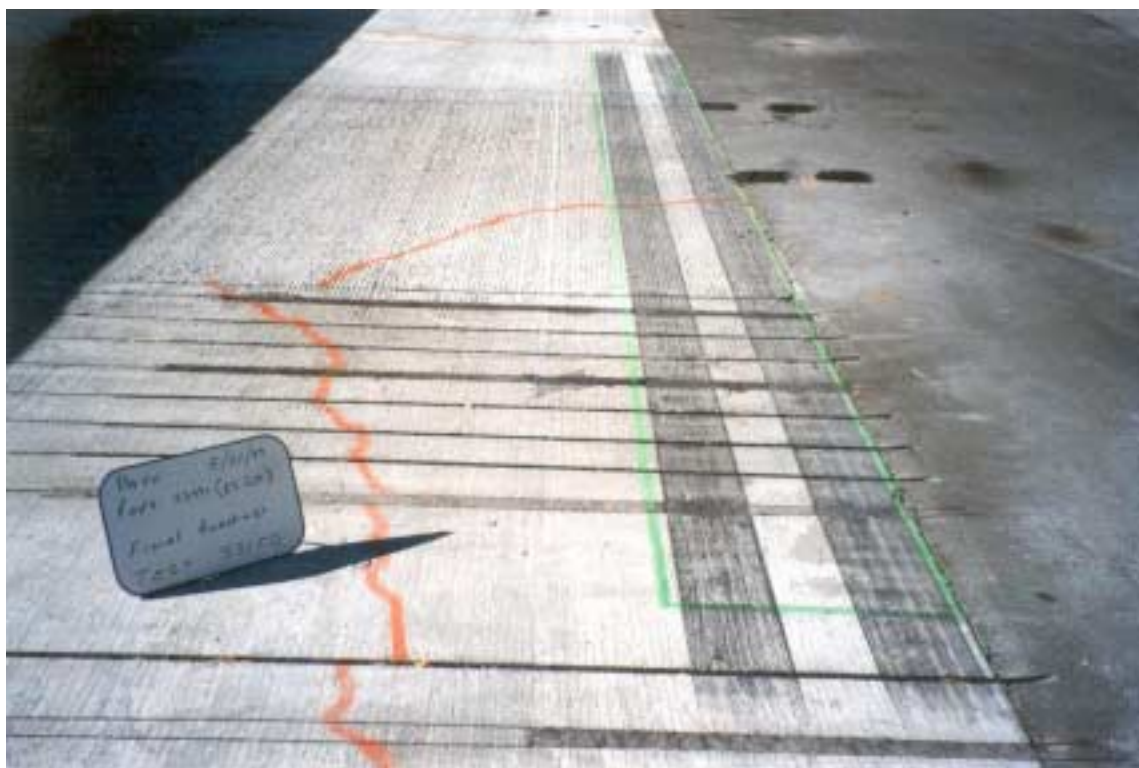
Photograph 4.42. Final crack pattern after 65,315 repetitions, Test Section 531FD.

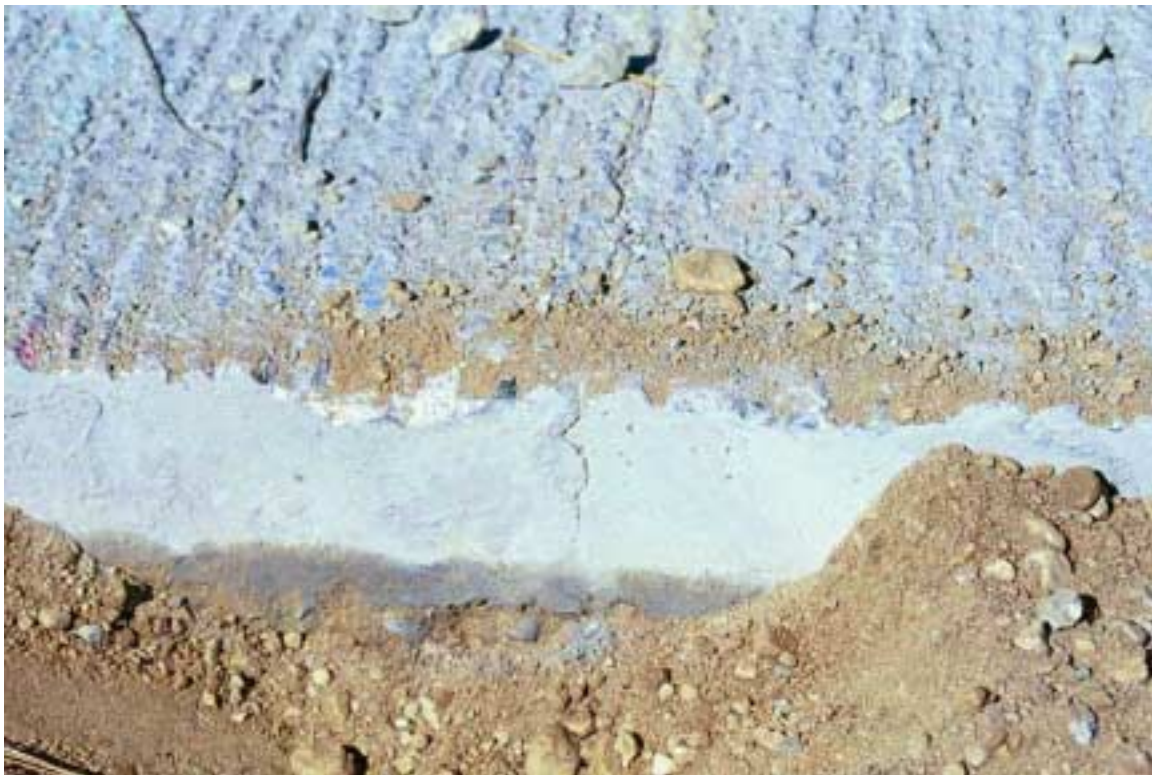
**Photograph 5.2. Crack on Test Section 519FD.**

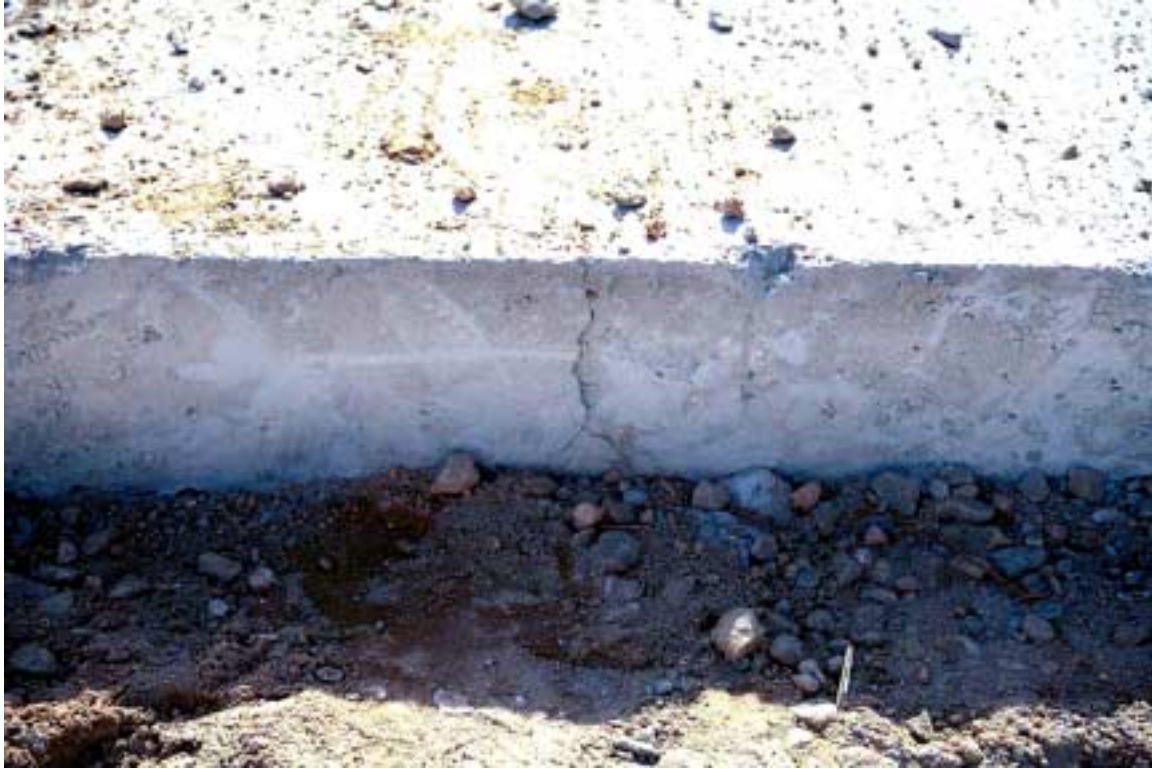
**Photograph 5.3. Crack on Test Section 525FD.**

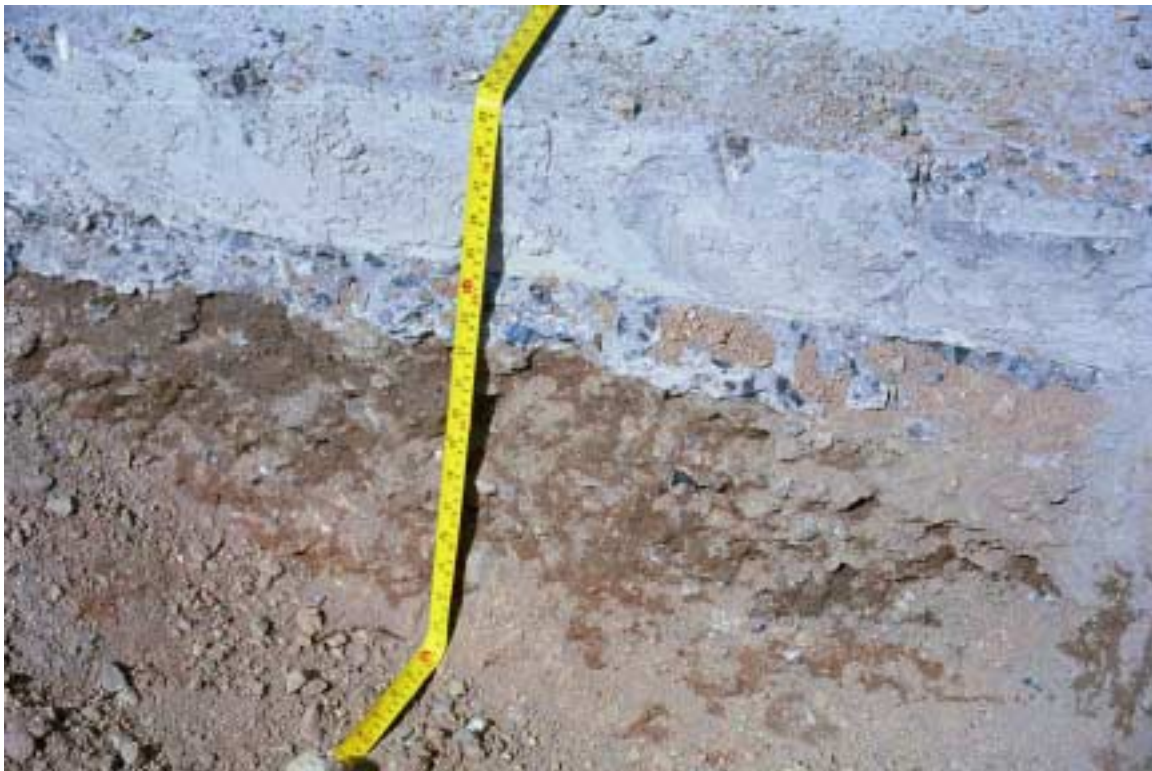
- **Section 5A, Slab 31, Test Section 529FD.** On slab 31 on Section 529FD, a surface crack was reported after 337,530 load applications (see Figure 4.29) but after the test pit was dug it became evident that this was only a surface crack. This crack did not penetrate the concrete to any visible extent (see Photograph 5.4).

**Photograph 5.4. Surface crack that did not propagate to bottom of concrete, Test Section 529FD.**
