Warm-Mix Asphalt Study: Field Test Performance Evaluation

Partnered Pavement Research Center (PPRC) Contract Strategic Plan Element 4.18:  
Warm Mix Asphalt

| <b>DOCUMENT RETRIEVAL PAGE</b> | | <b>Technical Memorandum: UCPRC-TM-2013-08</b> | | | |

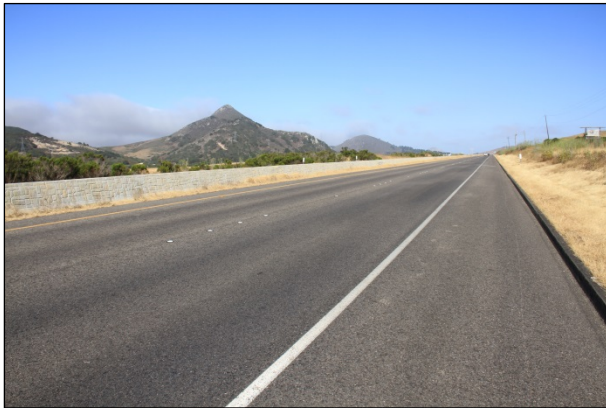
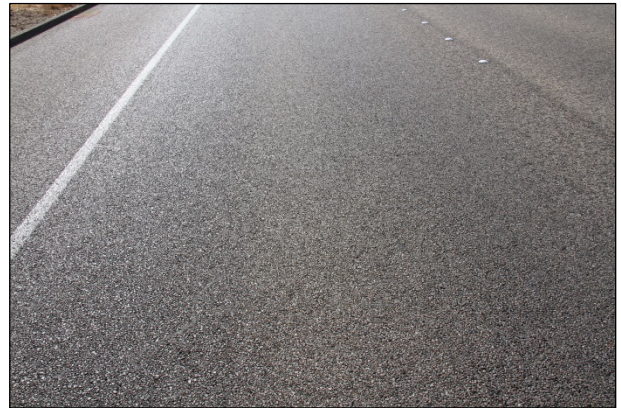
No deterioration compared to the May 2007 baseline measurements was noted on the sections after 60 months of traffic. The track marks were no longer visible on any of the sections.

**Figure 3.3: Morro Bay Control, May 2012 (60 months), track marks no longer visible.**

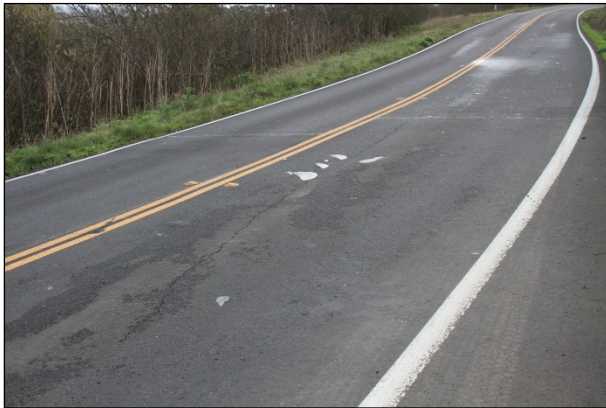
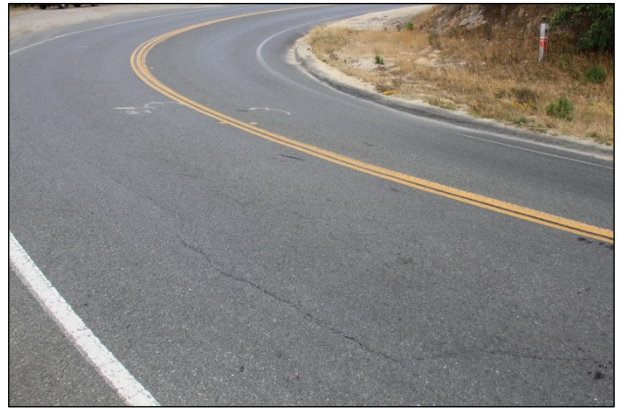
No deterioration compared to the December 2008 baseline measurements was noted on the section after 18 months of traffic. However, some longitudinal cracks were noted on the hill section around postmile 17. This was attributed to slope movement and not to performance of the warm-mix asphalt.

No deterioration compared to the December 2008 baseline measurements was noted on the sections after 23 months of traffic. The number and severity of the longitudinal cracks had not increased. Drainage through the OGFC was still effective.

**Figure 4.3: Point Arena Evotherm, November 2010, showing longitudinal cracks.**

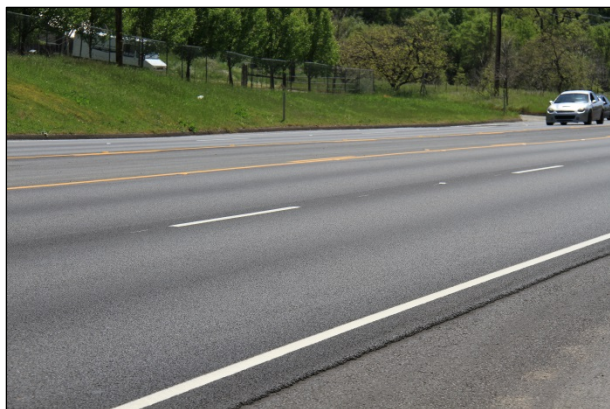
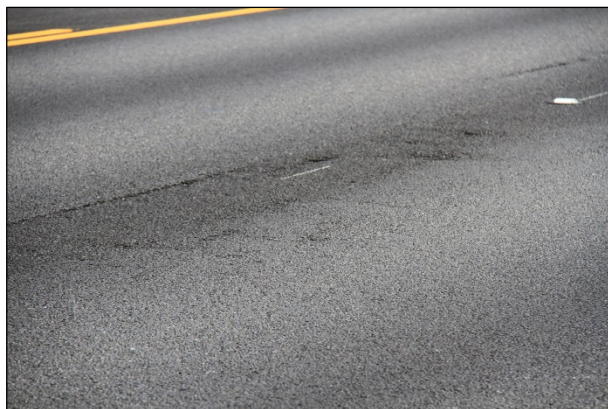
The road surface resembled a typical open-graded friction course and was given an overall rating of “good.” Some localized areas of what appeared to be segregation in the mix were noted. Some open longitudinal joints were also noted. No early stone loss was noted, and no other problems were observed. Water was effectively draining through the friction course and out through the sides of the road.

**Figure 8.2: Auburn Evotherm, August 2010 (0 months). Note segregation and open joint.**

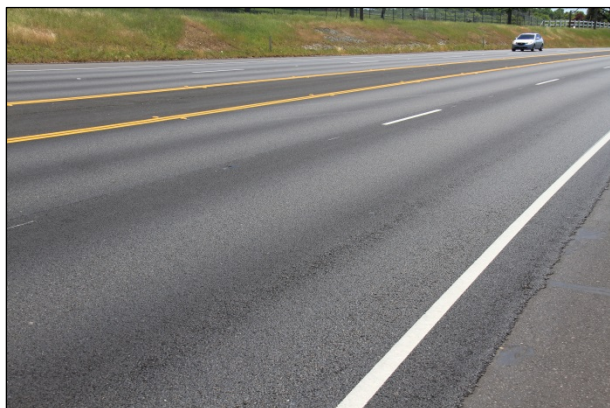
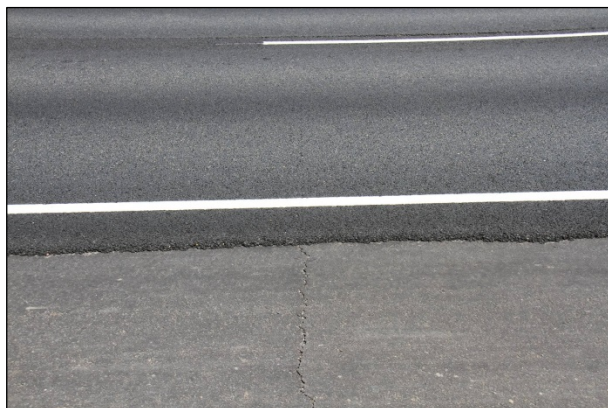
Reflected transverse cracking and some minor raveling in the outside wheelpath of the outside lanes was noted in some areas of the project. Given that no hot-mix control was available for comparison purposes, it was not clear whether these distresses were related to the warm-mix technology, to construction issues, or to other factors. No further deterioration compared to the August 2010 baseline measurements was noted.

**Figure 8.3: Auburn Evotherm, July 2012 (24 months). Note deterioration and reflected crack.**
