Reflective Cracking Study: HVS Test Section Forensic Investigation

D. Jones, B. Steven, and J. Harvey

Partnered Pavement Research Program (PPRC) Contract Strategic Plan Element 4.10:  
Development of Improved Rehabilitation Designs for Reflective Cracking

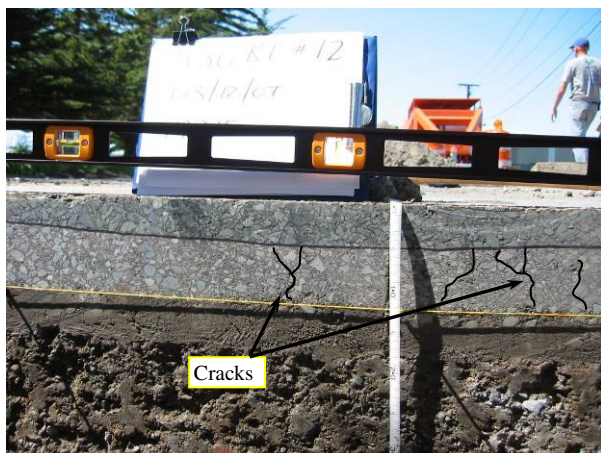
**Figure 3.32: 586RF cracks in underlying DGAC.**

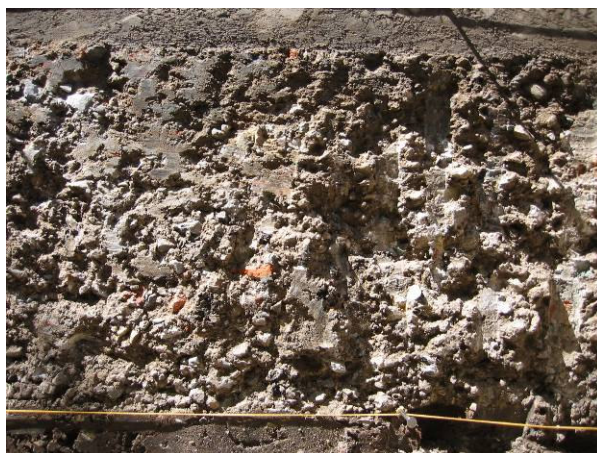
**Figure 3.33: 586RF strongly cemented base.**

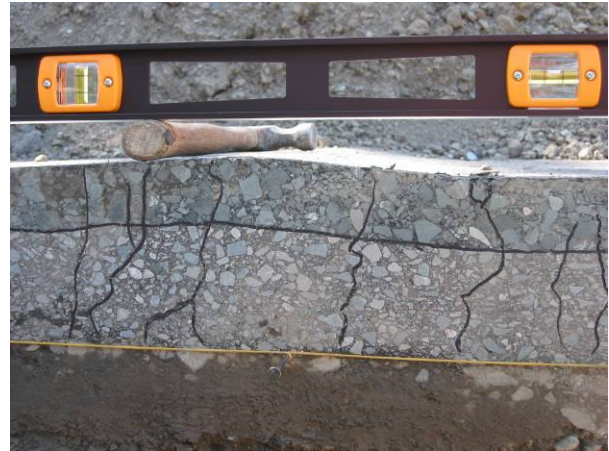
**Figure 3.37: 587RF#4 cracks in overlay and underlying DGAC.**

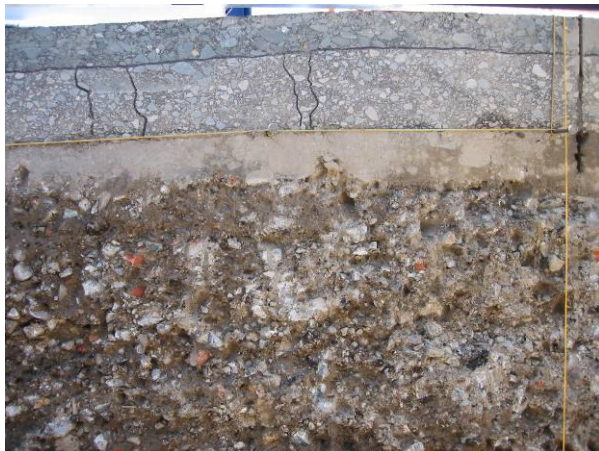
**Figure 3.38: 587RF#4 cracks in underlying DGAC.**

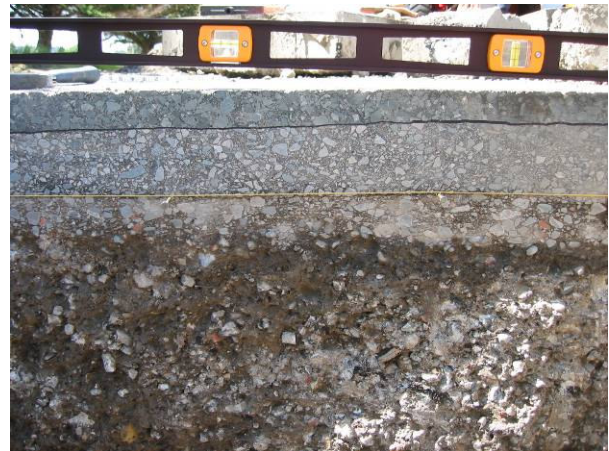
**Figure 3.39: 587RF#12 absence of visible cracks.**

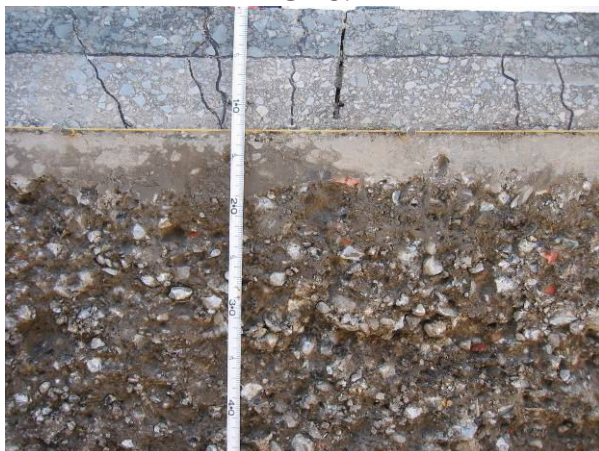
**Figure 3.40: 587RF#4 weaker cemented base material.**

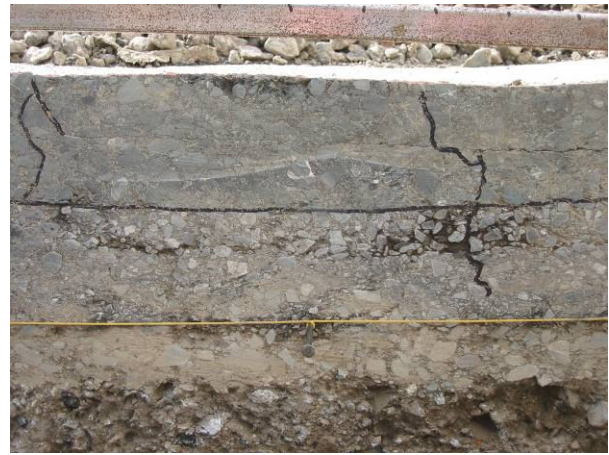
**Figure 3.47: 588RF cracks in overlay and underlying DGAC.**

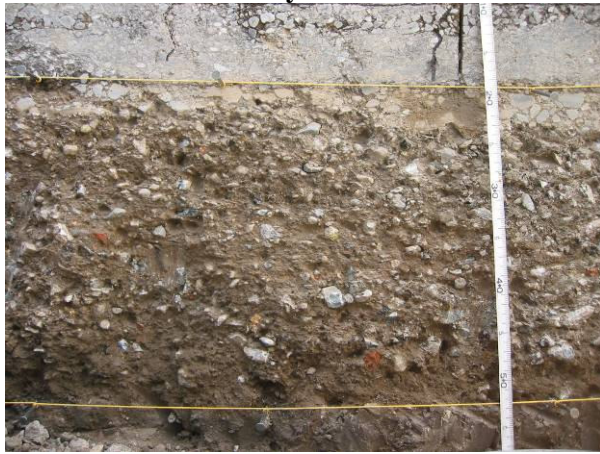
**Figure 3.48: 588RF#12 weaker cemented base material.**

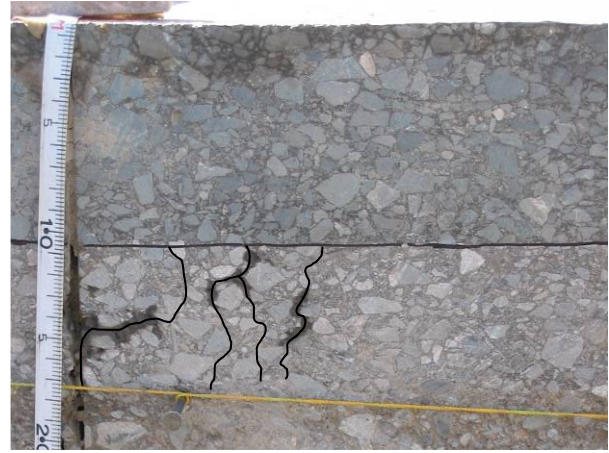
**Figure 3.59: 590RF cracks in DGAC layer.**

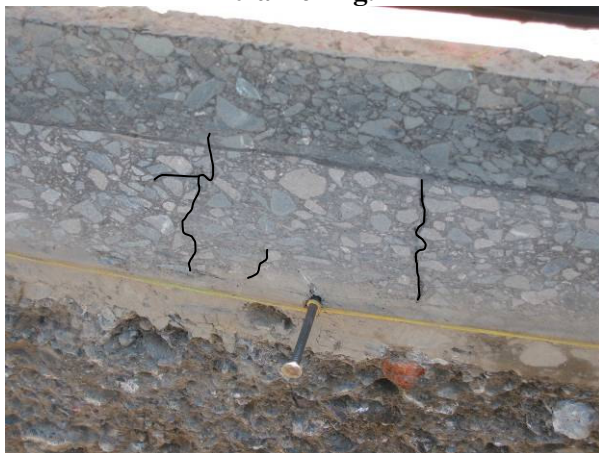
**Figure 3.66: 591RF cracks in underlying DGAC.**

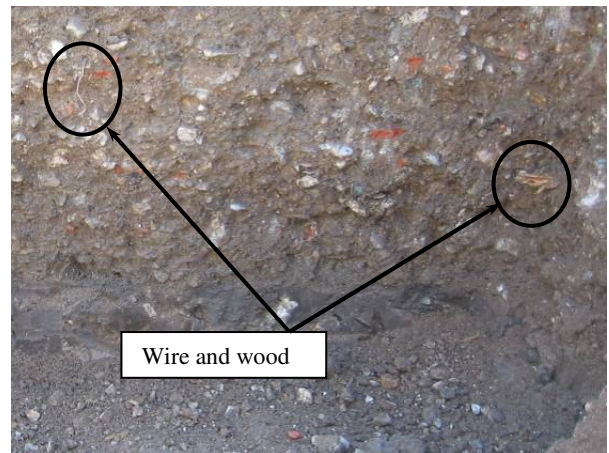
**Figure 3.67: 591RF wire and wood in base material.**

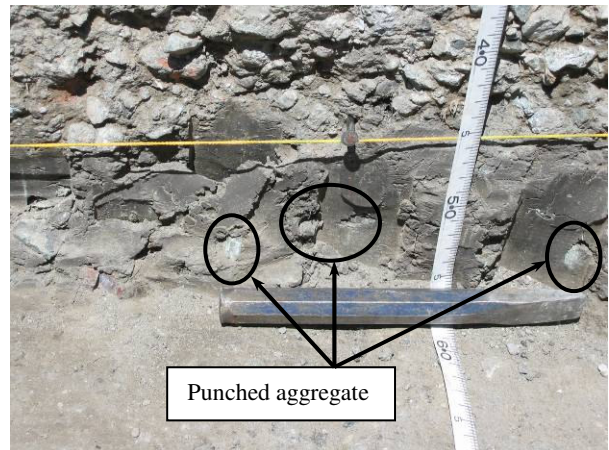
- The subgrade was moist, dark brown clay with medium to high plasticity. Some punching of aggregate from the base was recorded (Figure 3.69). Mottling was evident. Consistency was rated as hard and structure as slickensided. Some organic matter was noted. No hydrochloric acid or phenolphthalein reaction was recorded.

**Figure 3.69: 591RF aggregate punched into subgrade.**

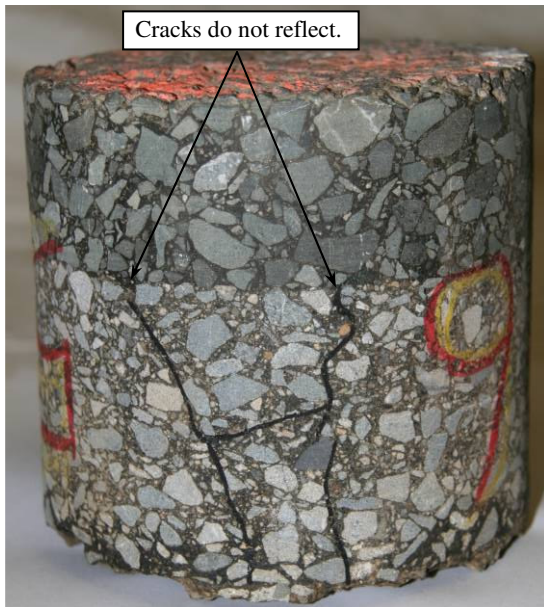
**Figure 3.70: MB15-G: Cracks on core.**

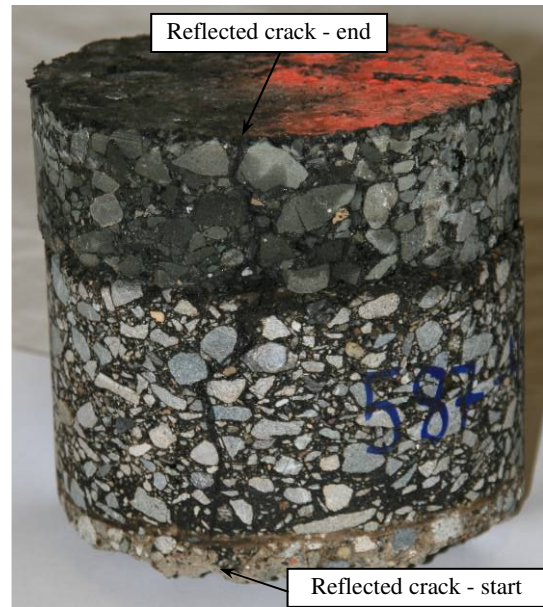
**Figure 3.71: RAC-G: Cracks on core.**

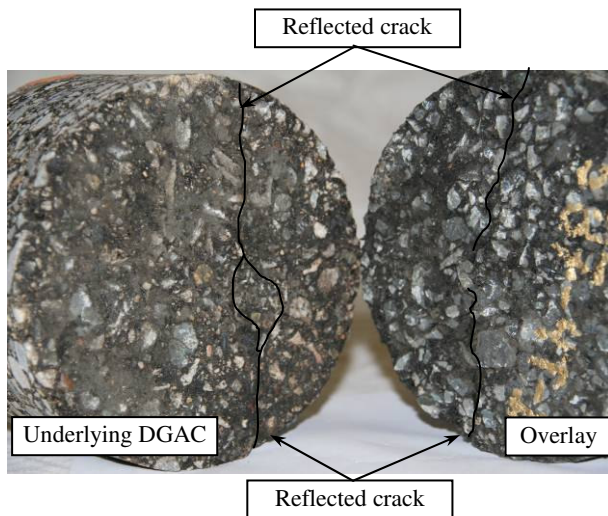
**Figure 3.72: RAC-G: Highlighted reflected crack through both layers.**

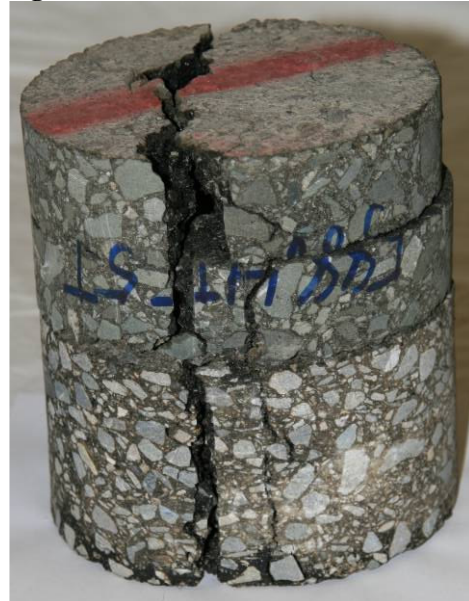
**Figure 3.73: AR4000-D: Cracks on core.**

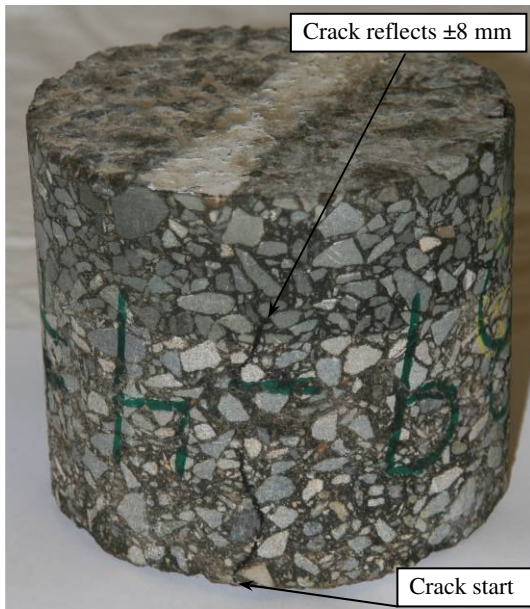
**Figure 3.74: 45 mm MB4-G: Cracks on core.**

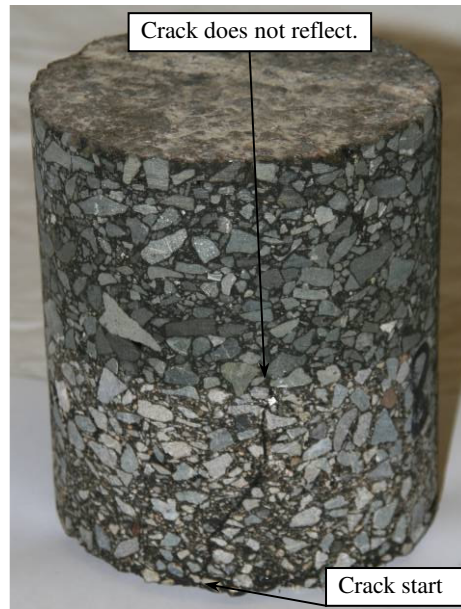
**Figure 3.75: 90 mm MB4-G: Cracks on core..**

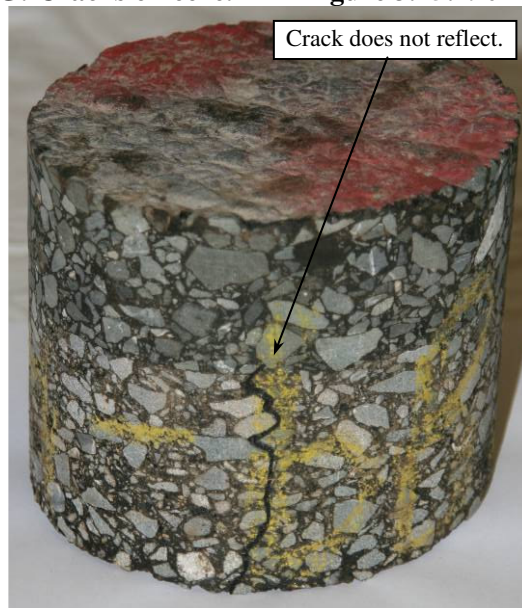
**Figure 3.76: MAC15-G: Cracks on core.**

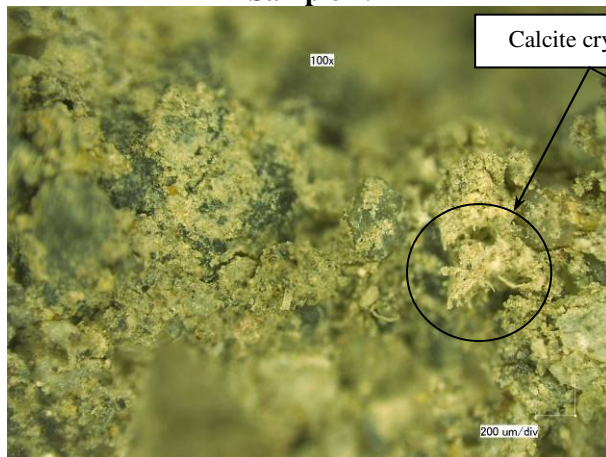
**Figure 3.82: Optical microscope view ( $\pm 100\times$ ) of calcite crystal development associated with cracks.**

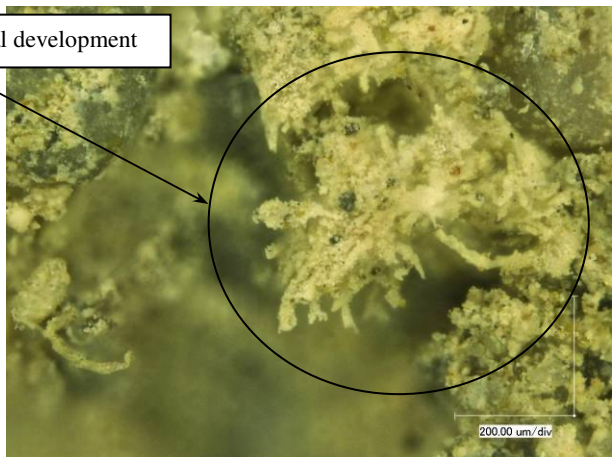
**Figure 3.83: Optical microscope view ( $\pm 200\times$ ) of calcite crystal development associated with cracks.**
