2025 Condition Survey of High RAP Pilot Projects on El Dorado 49, San Bernardino 215, and San Joaquin 26

Report No. UCPRC-TM-2025-04 | November 2025

University of California Pavement Research Center  
UC Davis and UC Berkeley

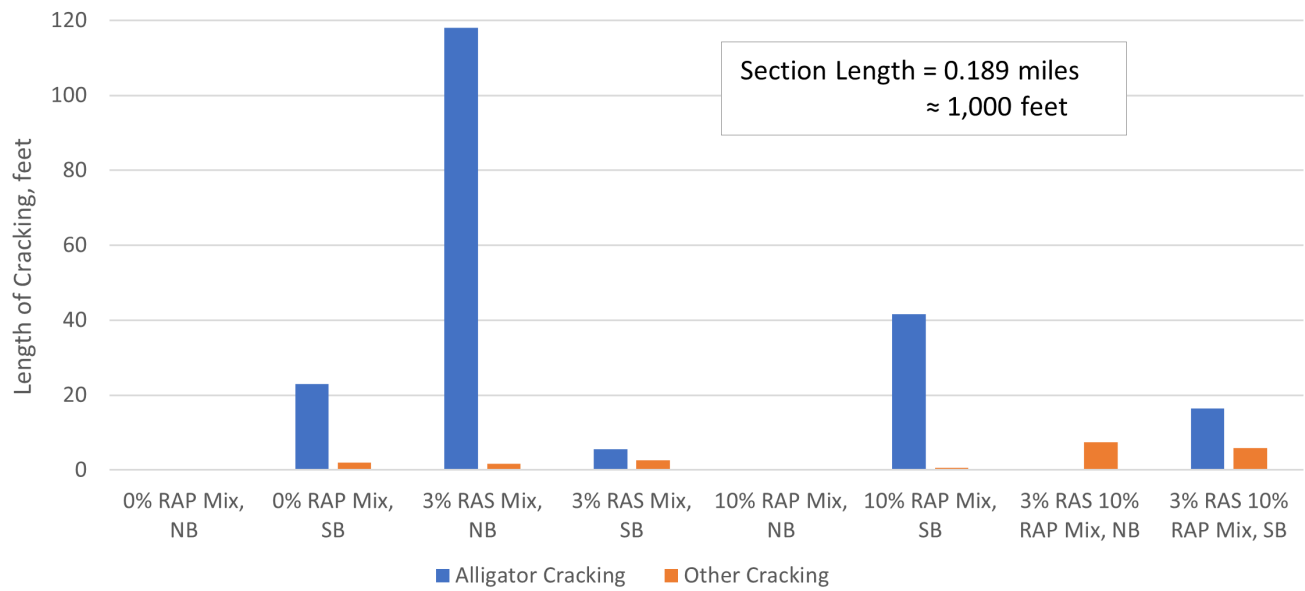
**Figure 3.1. Alligator cracking and other cracking on ED 49.**

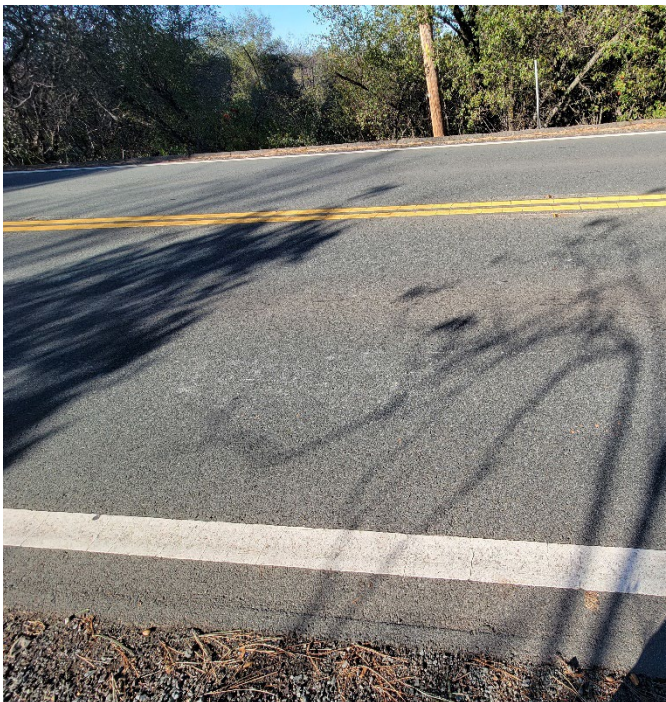
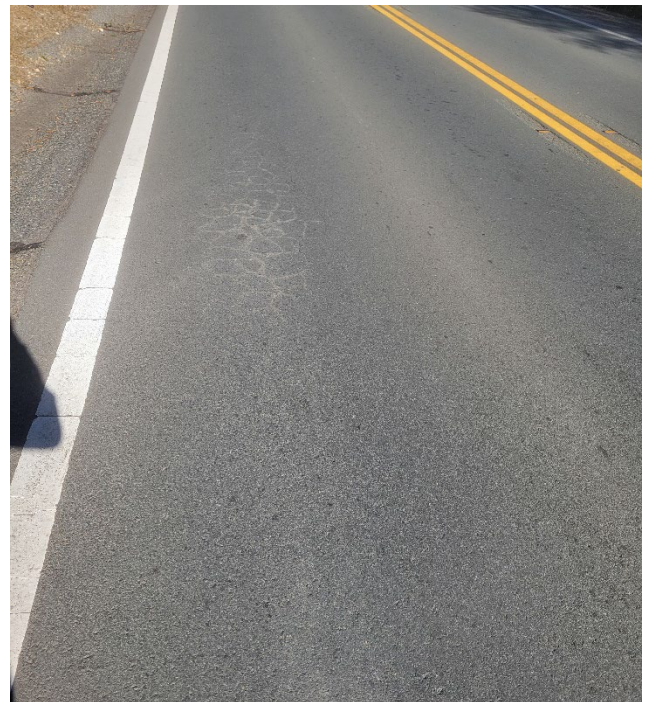
Overall, the sections exhibited mild pumping coming through low-severity cracking, mostly load-related alligator cracking, shown in Figure 3.2, with some longitudinal and transverse cracking. Each mix exhibited at least some alligator cracking in one direction or the other. The 3% RAS mix in the northbound direction, going uphill, showed the most cracking and was the only section to suffer from rutting.

**Figure 3.2. Alligator cracking with mild pumping (evident throughout project).**

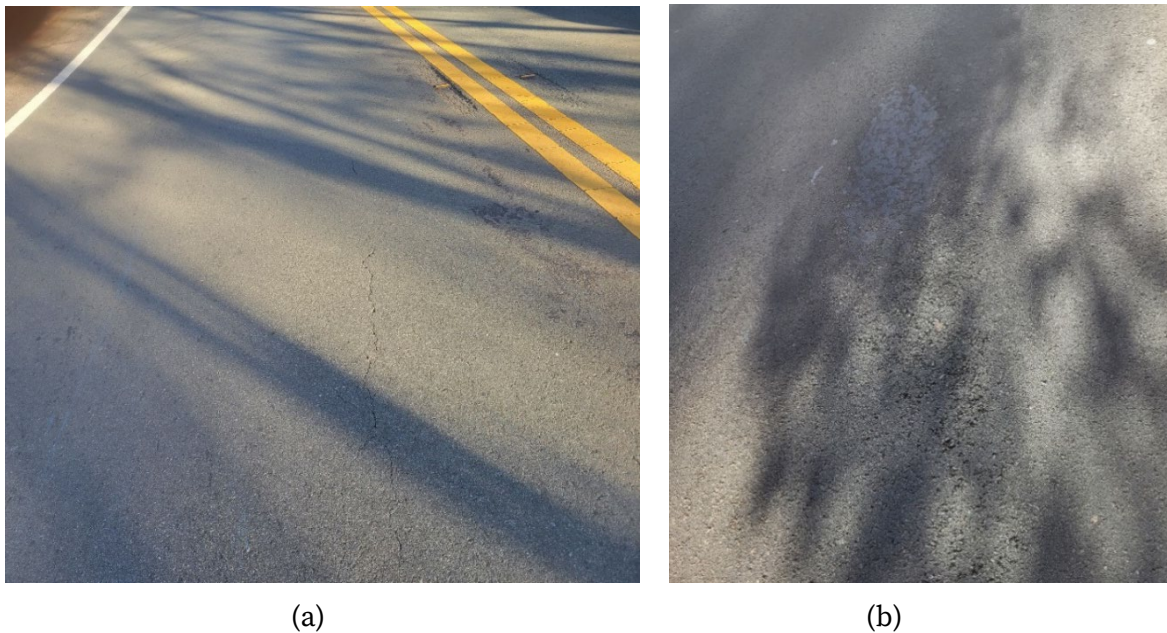
The 3% RAS mix between PM 13.289 and PM 13.478 exhibited the most cracking in this pilot project, with 124 ft., or 6% of the wheelpath length, of alligator cracking. Although slight, the 3% RAS mix was the only section to have rutting over a couple of feet in length, at approximately PM 13.35 southbound. The 3% RAS mix cracking and rutting are shown in Figure 3.3.

**Figure 3.3. (a) Cracking and (b) rutting within the 3% RAS mix.**

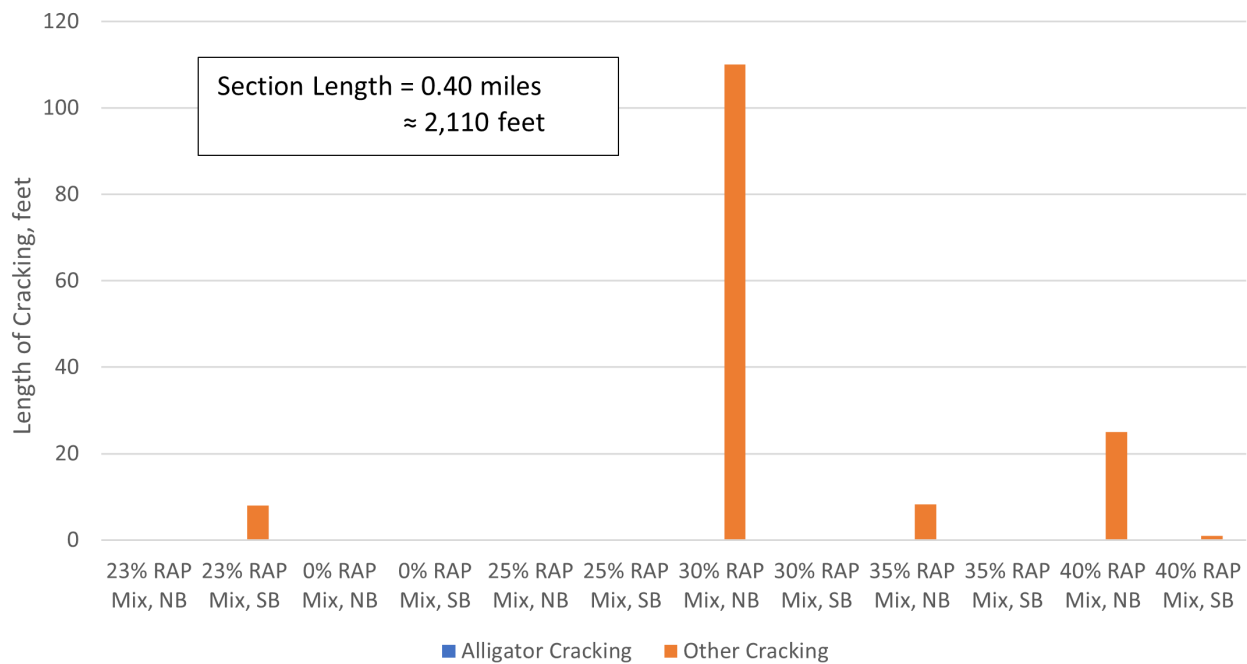
The SBD 215 sections exhibited no load-related alligator cracking. It has some low-severity longitudinal and transverse cracking. These test sections were in very good condition, perhaps aided by the cement-treated base (CTB) which would be expected to limit alligator cracking if the CTB is in good condition. Only the 30% RAP mix between PM 13.8 and PM 14.2 exhibited over 100 ft. of total cracking. In the northbound direction, approximately between PM 14.08 and PM 14.17, the 30% RAP mix had three low-severity longitudinal cracks totaling 110 ft.

**Figure 3.4. Alligator cracking and other cracking on SBD 215.**

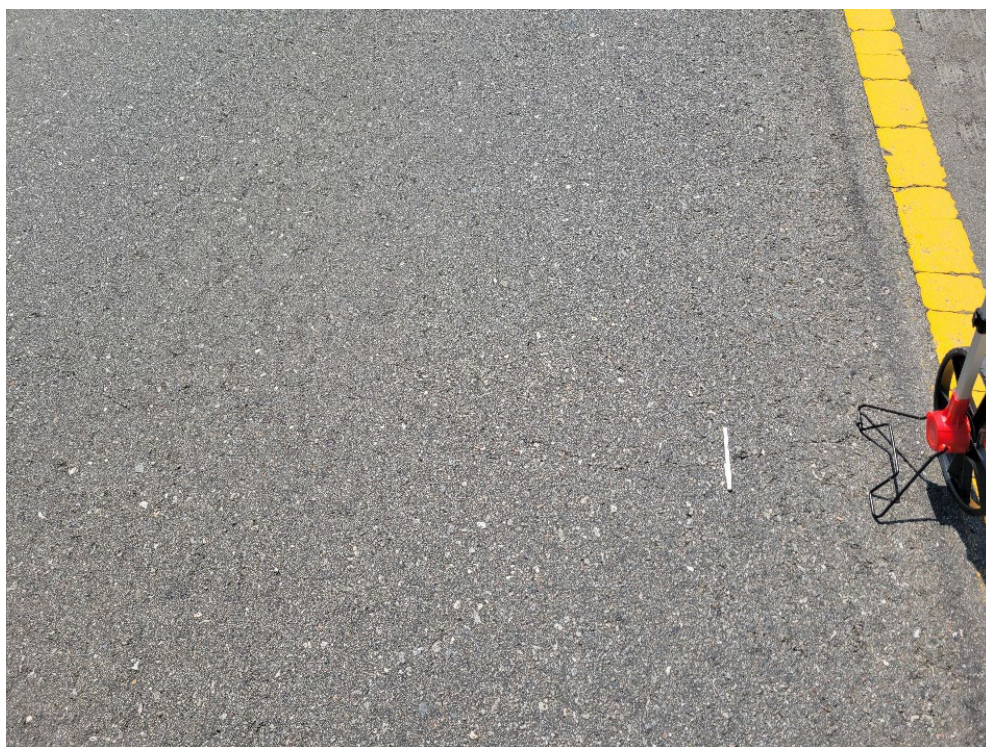
The 40% RAP mix had three low-severity transverse cracks between PM 15.00 and PM 14.99, shown in Figure 3.5 and Figure 3.6. Of transverse cracks in the 40% RAP mix, 25 ft. of the 26 ft. are in the northbound direction. The 40% RAP mix was the only mix with cracking in both directions.

**Figure 3.5. Transverse crack near SBD 215 northbound at PM 14.99.**

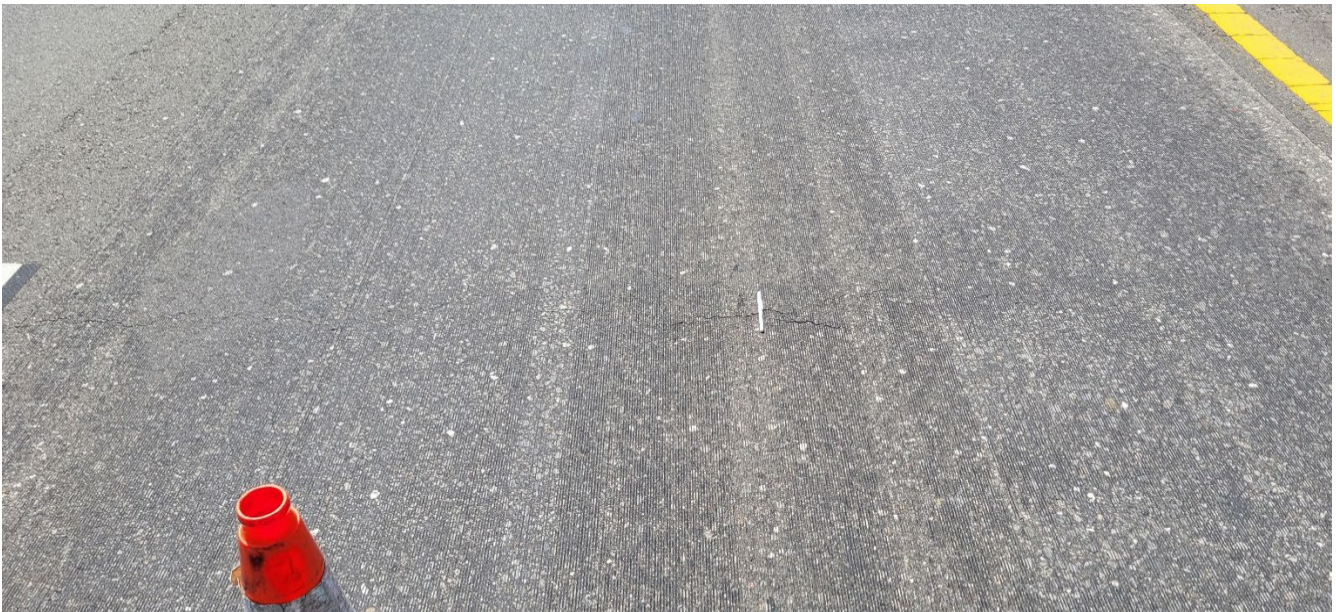
**Figure 3.6. Transverse crack near SBD 215 northbound at PM 15.00.**

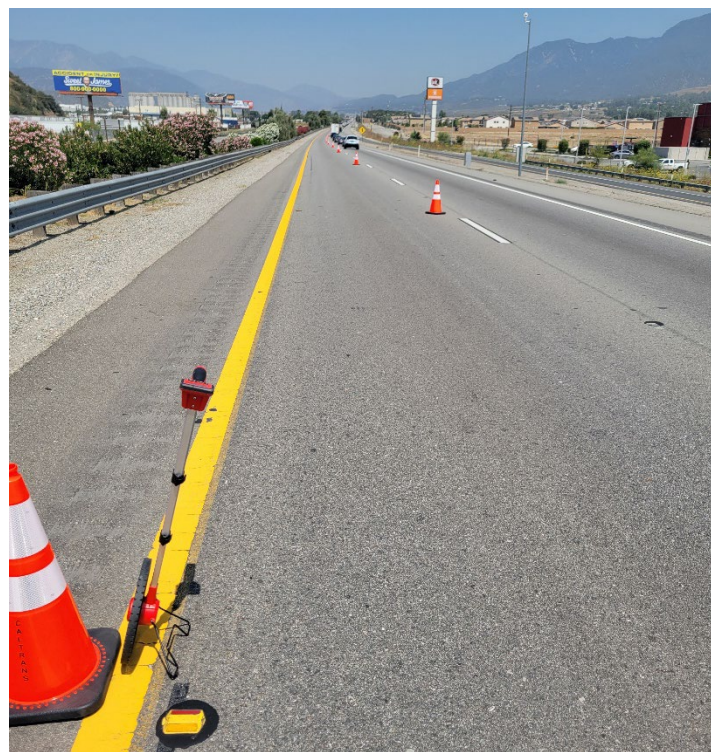
The 35% RAP mix, shown in Figure 3.7, looked very good with only 8 ft. of low-severity longitudinal and transverse cracks in the northbound direction and some slight aggregate loss and pumping, shown in Figure 3.8. The 23% RAP mix is also performing well, with only 8 ft. of low-severity transverse cracking.

**Figure 3.7. SBD 215 northbound at PM 14.20 (start of the 35% RAP mix).**

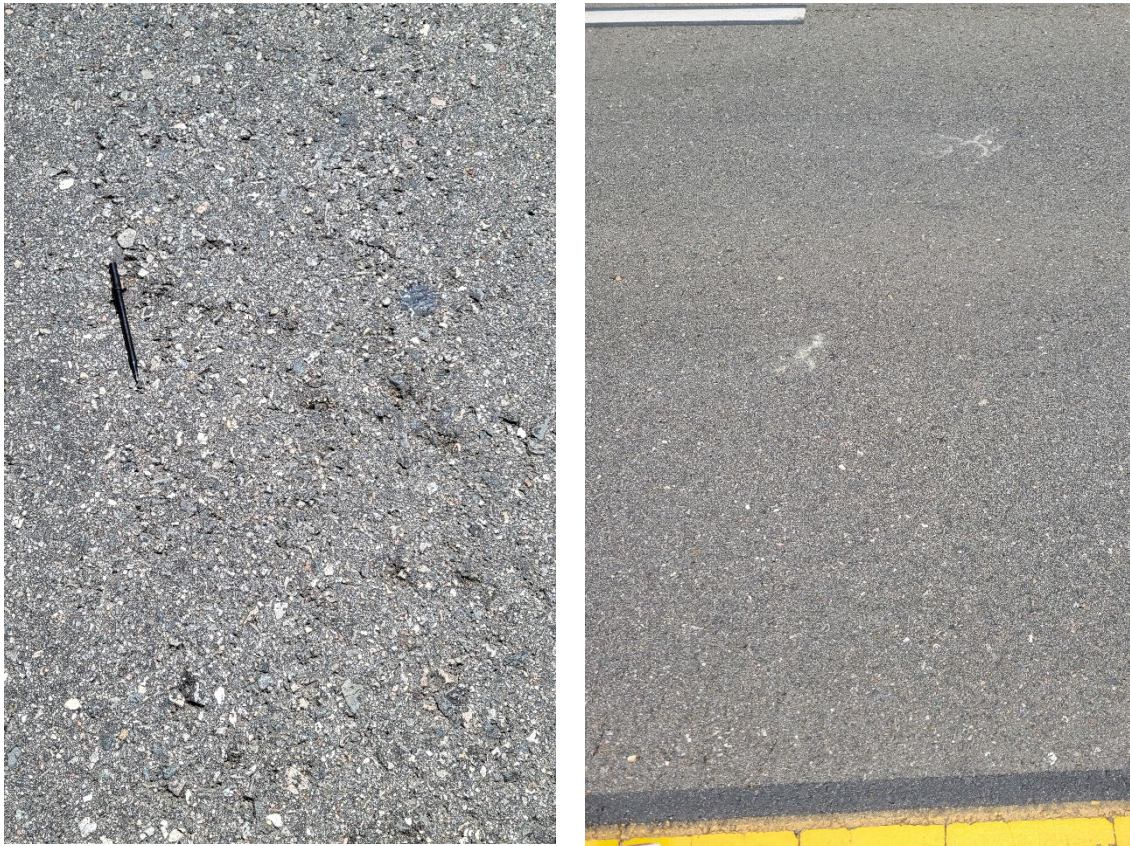
**Figure 3.8. Slight aggregate loss at PM 14.21 and pumping at PM 14.40 in the 35% RAP mix southbound.**

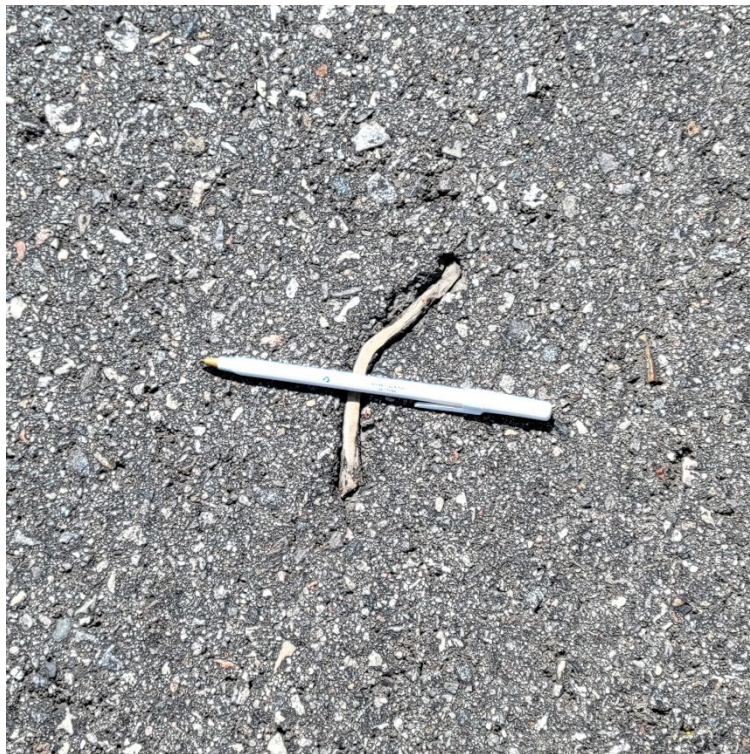
Both the 0% RAP mix between PM 13.0 and PM 13.4 and the 25% RAP mix between PM 13.4 and PM 13.8 had no cracking and, in general, no distresses. Two recurring surface irregularities were wood pieces in the surface and burn lines, shown in Figure 3.9 and Figure 3.10.

**Figure 3.9. Small pieces of wood on the surface in various locations.**

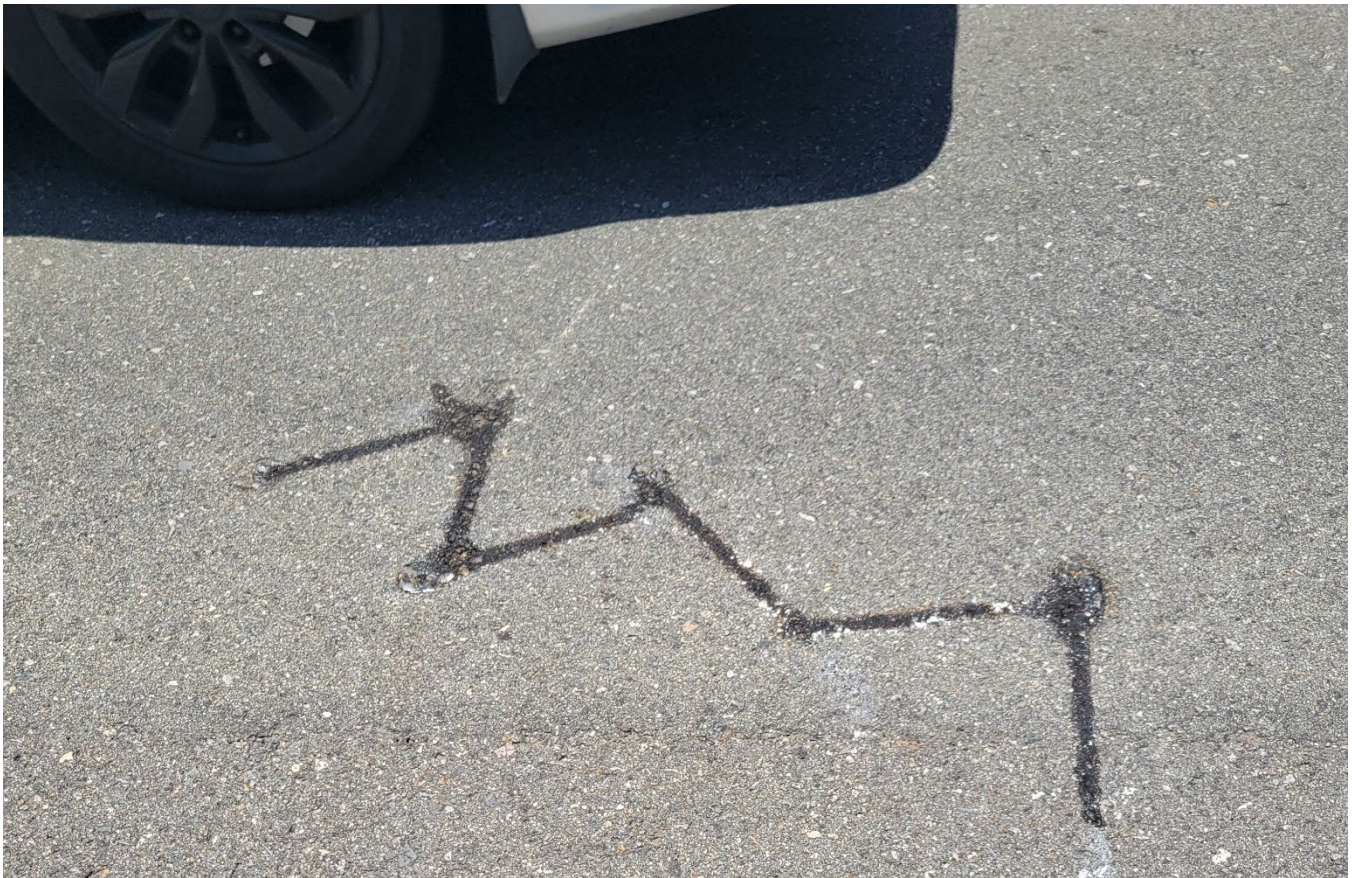
**Figure 3.10. Burn marks on surface in southbound direction between PM 14.0 and PM 15.0.**

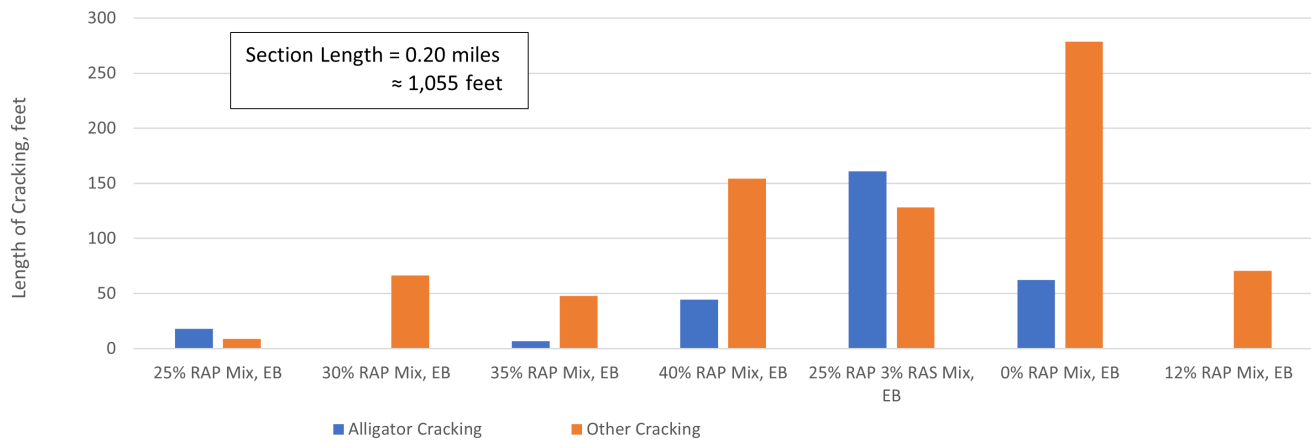
The SJ 26 sections exhibited load-related alligator cracking, longitudinal cracking, and transverse cracking. These test sections were in fair condition as most of the cracking was low severity, though there was some moderate severity transverse cracking in the sections with 35% RAP mix and 40% RAP mix.

**Figure 3.11. Alligator and other cracking on SJ 26.**

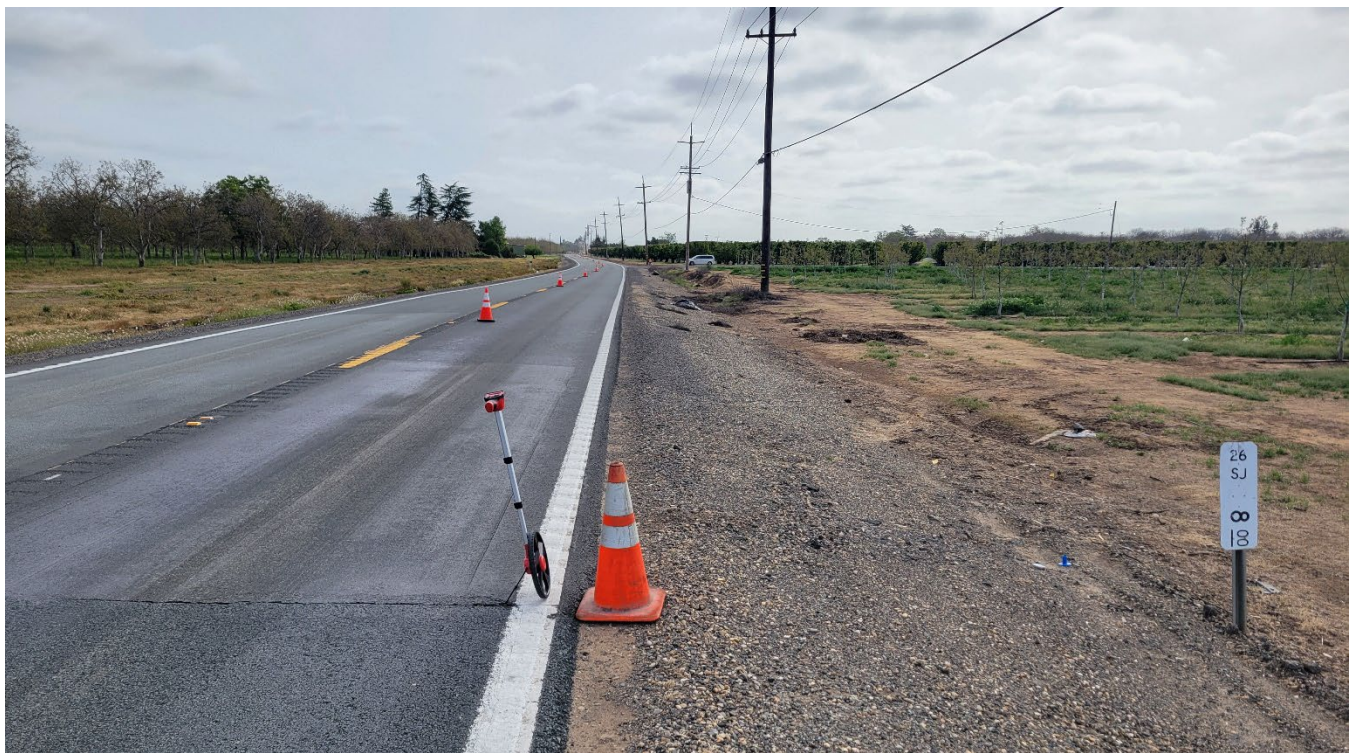
The 25% RAP mix between PM 8.0 and PM 8.2 exhibited the least total cracking, with the least transverse cracking, 2 ft., only 7 ft. of longitudinal cracking, and 18 ft., or 1%, of alligator cracking in the wheelpaths. Figure 3.12 shows the beginning of the eastbound test sections and the transverse cold joint at PM 8.0.

**Figure 3.12. Transverse cold joint at beginning of SJ 26 test sections eastbound at PM 8.0.**

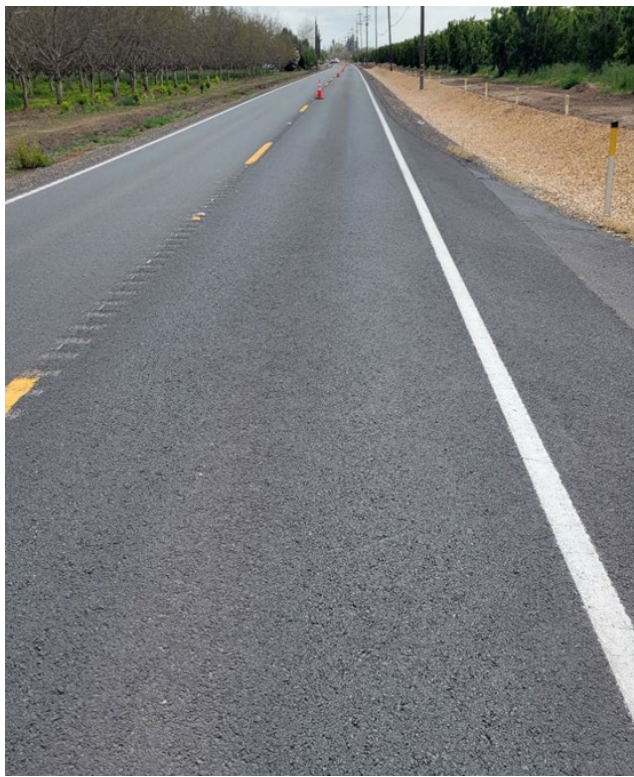
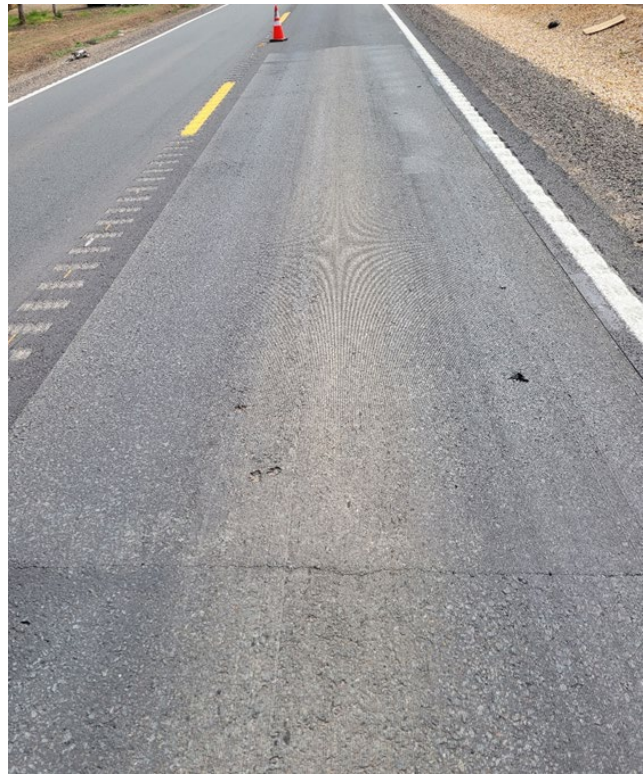
Figure 3.13 provides an example of both a clean and dusty pavement surface that existed throughout the SJ 26 test sections. The dust on the pavement surface likely comes from farmland adjacent to the highway. Figure 3.14 provides an example of transverse cracking in the 40% RAP mix, and Figure 3.15 shows low-severity alligator cracking with low-severity pumping.

**Figure 3.13. Examples of clean (a) and dusty (b) pavement surfaces on SJ 26.**

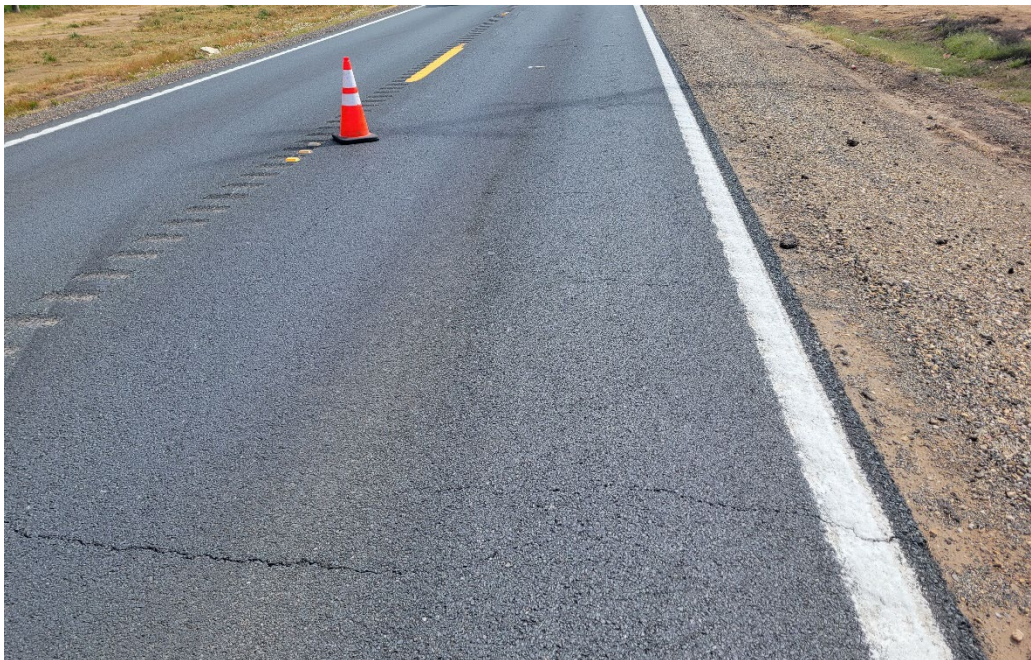
**Figure 3.14. Example of transverse cracking in the 40% RAP mix at PM 8.78.**

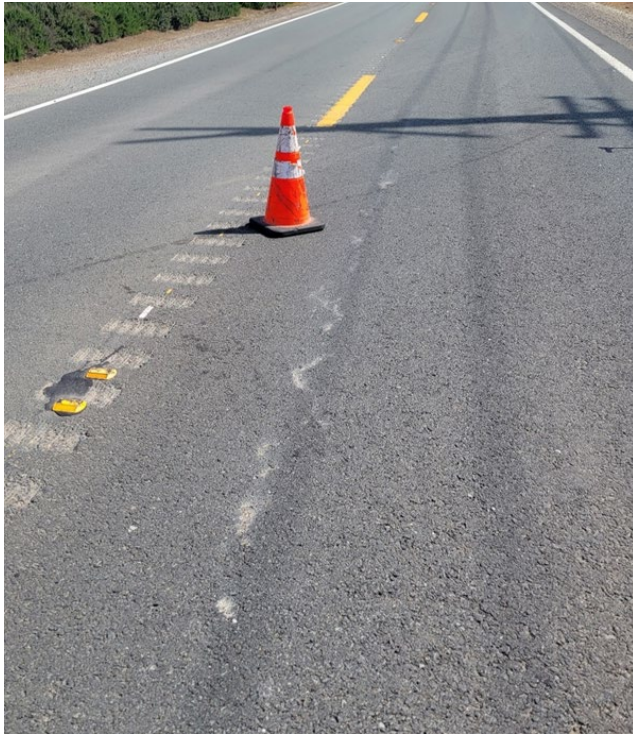
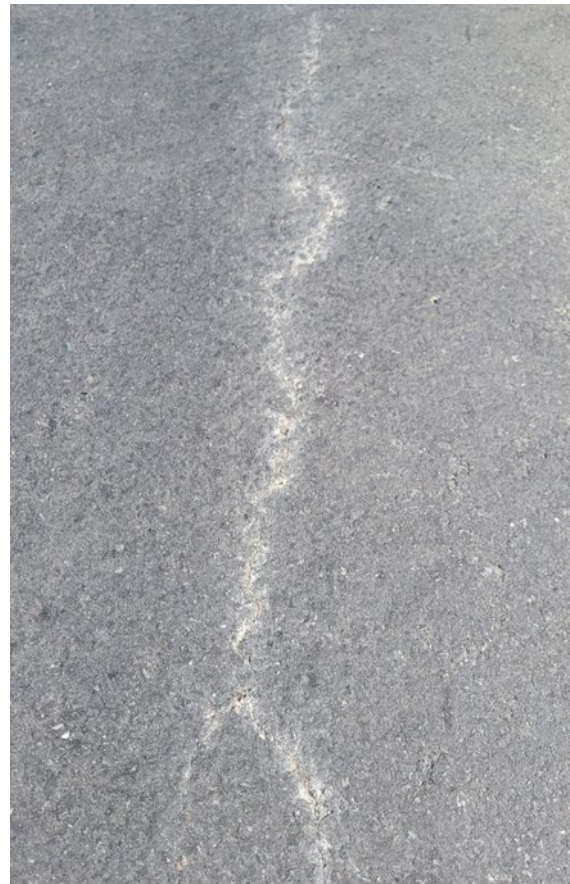
**Figure 3.15. Examples of low-severity alligator cracking with mild pumping in (a) the 40% RAP mix and (b) the 25% RAP 3% RAS mix.**
