Thin Concrete Overlay on Asphalt Pilot Project at Woodland SR 113: Initial Performance

Angel Mateos, John Harvey, Miguel Angel Millan, Fabian Paniagua, and Shuo Yang

Partnered Pavement Research Center (PPRC) Strategic Plan Element 3.54:  
Monitoring Performance of Concrete Overlay Projects (DRISI Task 3812)

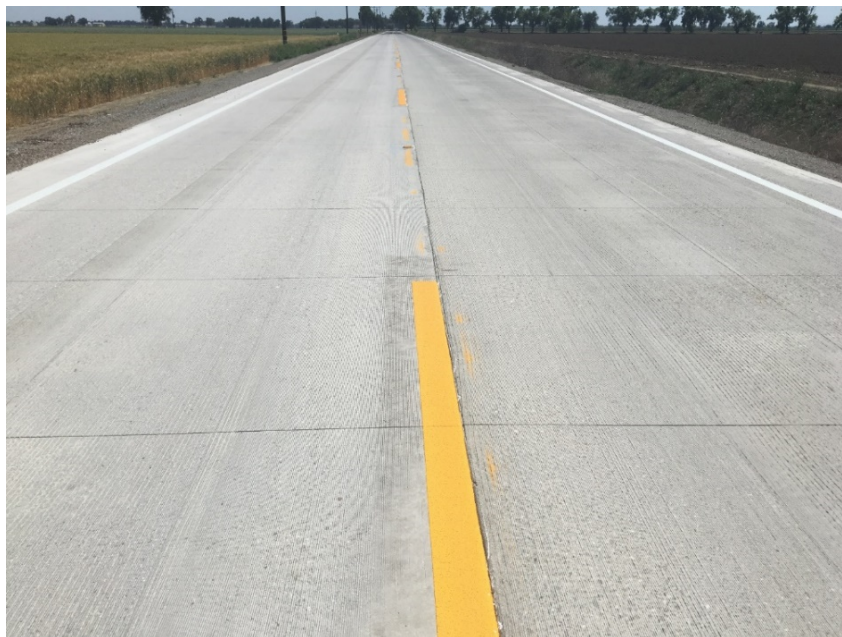
**Figure 1.2: Woodland thin COA pilot.**

The Woodland thin COA pilot site extended over approximately four miles of SR 113, between PM 11.860 and PM 12.890 and between PM 14.760 and PM 17.580 (Figure 1.1). SR 113 is a two-lane road (Figure 1.2) in these areas. The north part of the project, referred to in this report as Segment B (PM 14.760 to PM 17.580), was built in October and November 2018, while the south part, referred to as Segment A (PM 11.860 to PM 12.890), was built in April and May 2019.

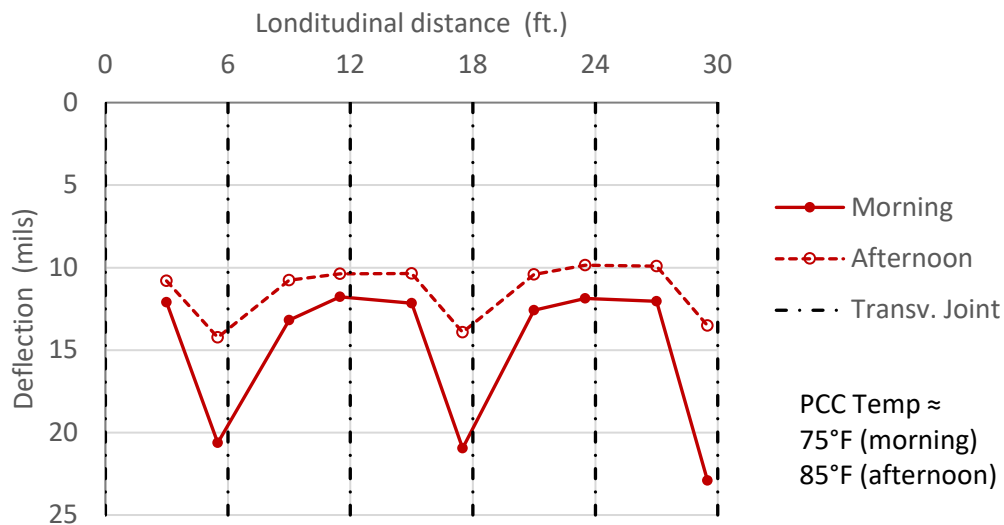
**Figure 3.1: Transverse joint deflection pattern example (FWD Section B-NB3, FWD loading 15.7 kips, August 2019 evaluation, around nine months after Segment B overlay construction).**

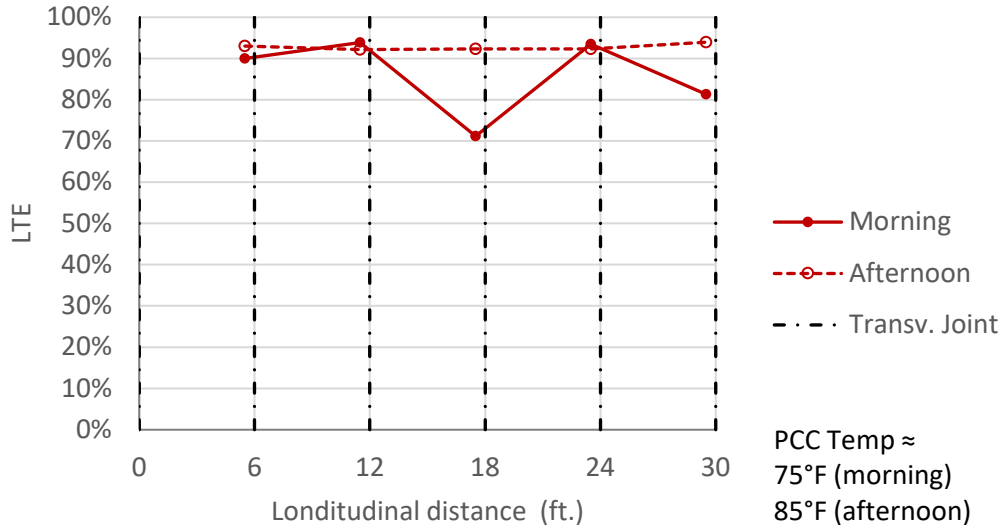
**Figure 3.2: Transverse joint LTE pattern example (FWD Section B-NB3, FWD loading 15.7 kips, August 2019 evaluation, around nine months after Segment B overlay construction).**

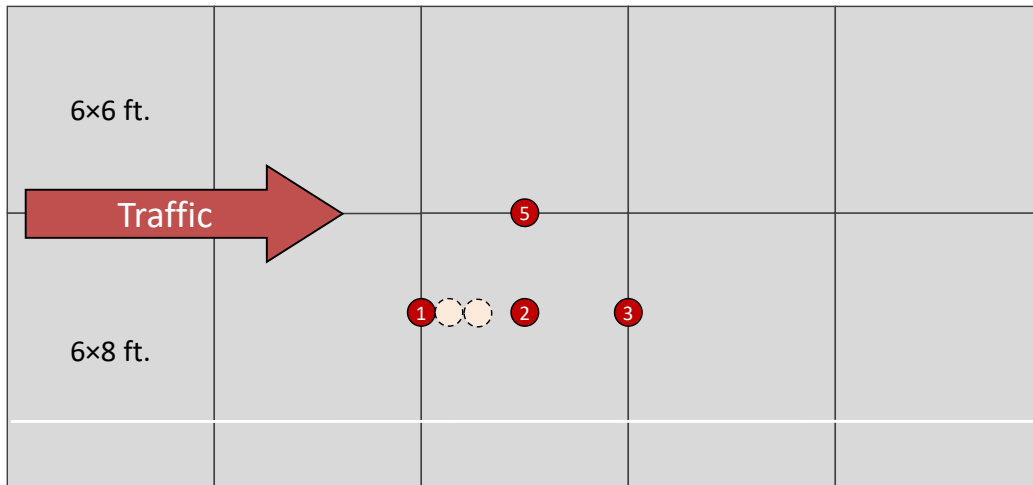
**Figure 3.6: Coring layout.**

A core was extracted at each of the two transverse joints selected in each of the sections. If the coring revealed that the concrete and asphalt were debonded, a series of adjacent cores was extracted to assess the extent of the debonding (see cores adjacent to Core 1 in Figure 3.6). Cores were also extracted at the slab center (Core 2) and longitudinal joint (Core 5), shown in Figure 3.6.

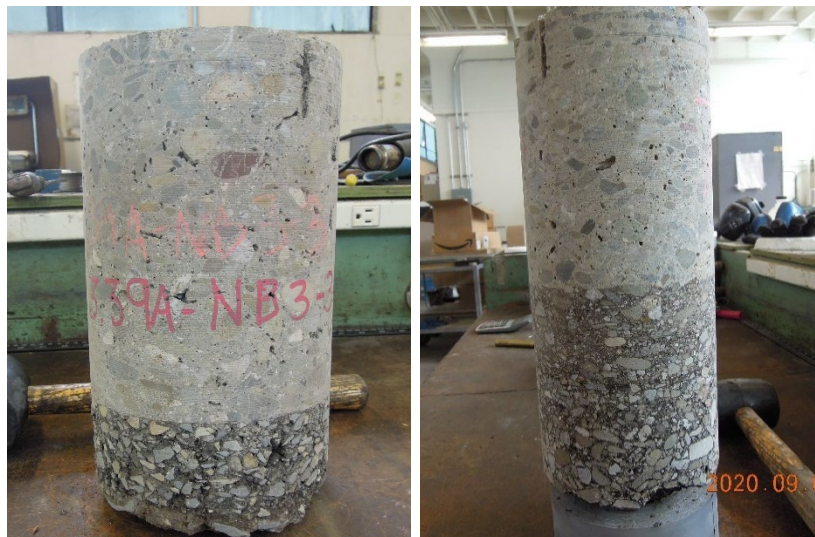
FWD Section A-NB3

**Figure 3.7: Undeployed transverse joints, showing no debonding.**

2. The transverse joints with good LTE in Section A-NB3 and Section B-NB3 had not deployed, shown in Figure 3.7.
3. The transverse joints with poor LTE in Section A-NB3 and Section B-NB3 had deployed, shown in Figure 3.8. The concrete slab and asphalt base were debonded at these joints. In Section A-NB3, with the RHMA-G base, the debonding took place about 0.2 to 0.4 in. below the top of the RHMA-G surface, shown in Figure 3.8 (left). In Section B-NB3, with the old HMA base, the debonding took place at the concrete-asphalt interface, shown in Figure 3.8 (right). The coring revealed that the debonding extended about 10 to 20 in. away from the transverse joints regardless of the type of asphalt base.

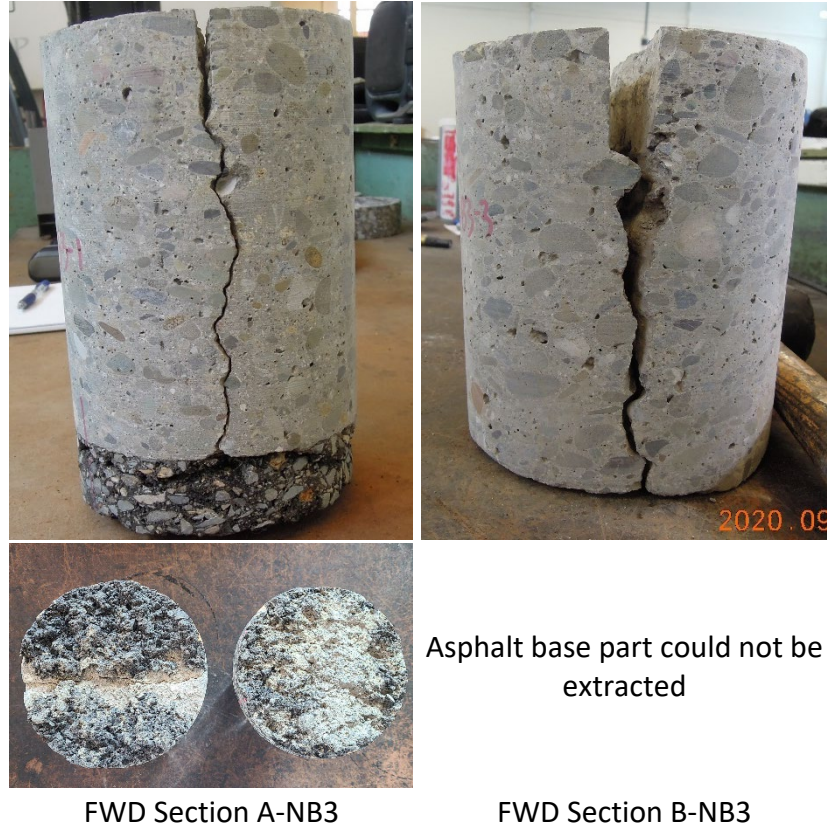
**Figure 3.8: Deployed transverse joints, also showing slab/base debonding.**

The coring showed debonding at the transverse joints that deployed in FWD Section A-NB3 and Section B-NB3, with a 12 ft. effective slab length. This finding agrees with the debonding observed in the thin COA sections with 12×12 ft. slabs that were evaluated in a previous Caltrans research project (1). In the thin COA sections for that study, with RHMA-G base, the debonding took place about 0.2 to 0.4 in. below the top of the RHMA-G surface, just as in the SR 113 Section A-NB3. This indicates that the upward movement of the slab from the large thermal and drying shrinking curling effects resulted in tensile stresses in the RHMA-G that were greater than its tensile strength, which was less than the tensile strength of the concrete/RHMA-G bond.

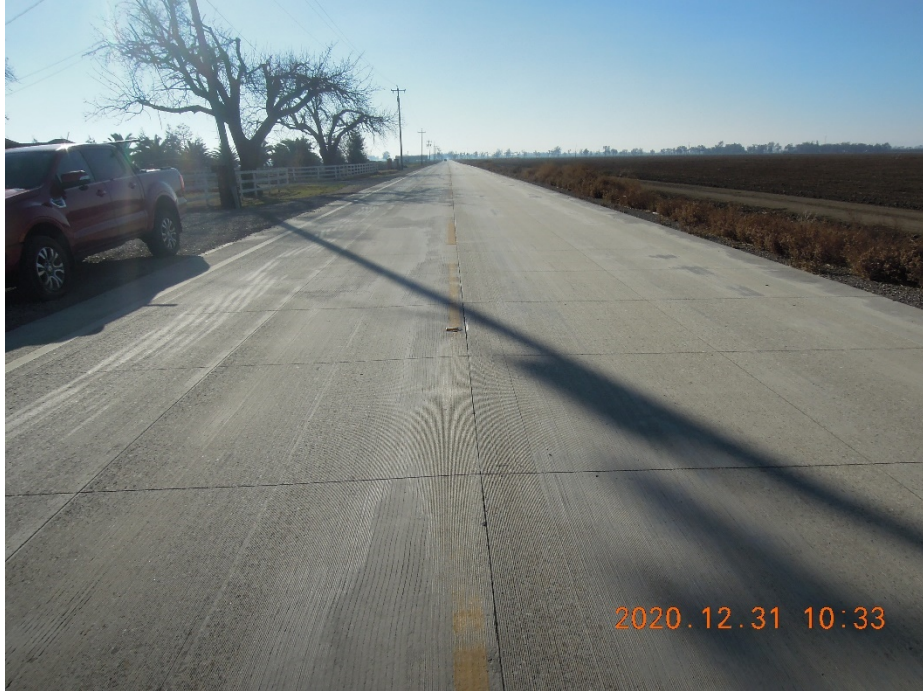
A detailed visual inspection was conducted in December 2020. Overall, the condition of the project was excellent, shown in Figure 4.1. The summary of the visual inspection is as follows:

**Figure 4.1: Typical appearance of the concrete overlay.**

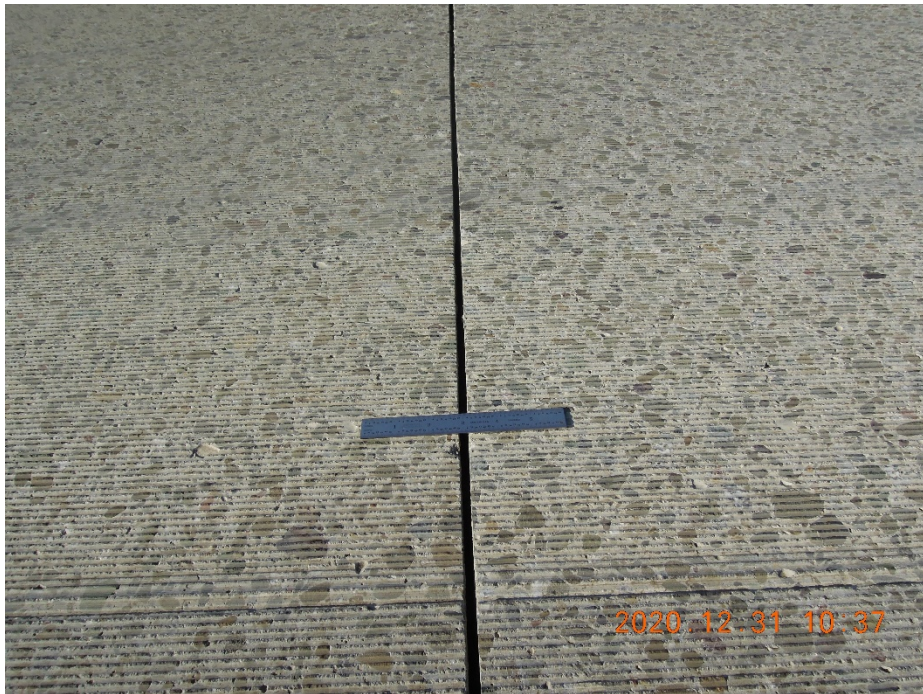
- No cracking was observed.
- No panel migration was observed.
- No slab rocking was observed.
- Faulting was not noticeable, shown in Figure 4.2.
- No fines pumping was observed at the transverse joints.

**Figure 4.2: No faulting at transverse joint.**

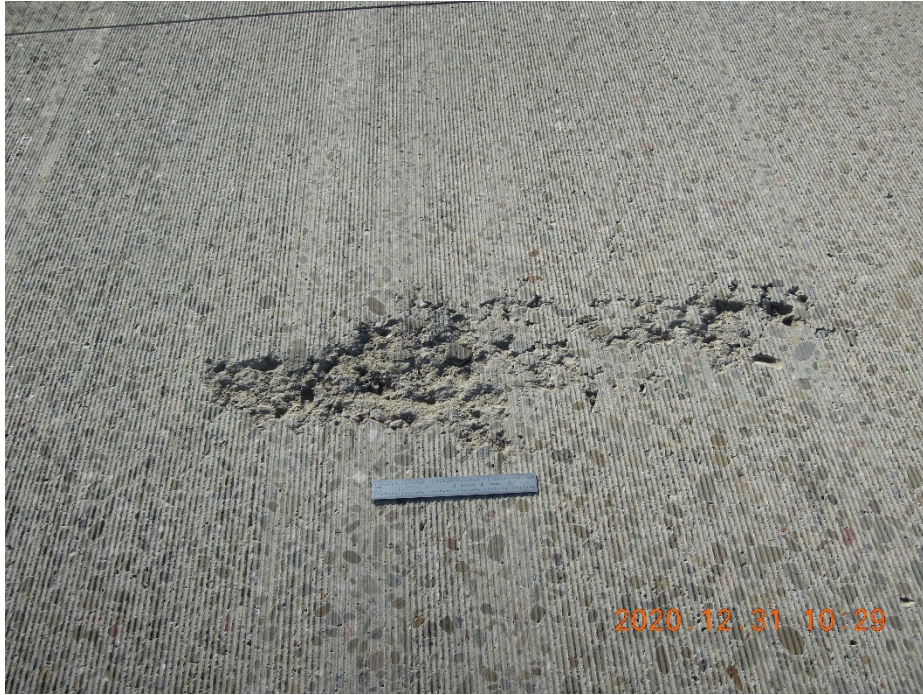
- No material-related distresses were observed.
- Some popouts were detected at the north end of Segment B (Figure 4.3). These popouts were detected a few weeks after the overlay construction, and they remain unchanged. They were most likely related to dirt and debris in the concrete mixture. The concrete may have been contaminated during the paving operation as the paving crew shoveled spilled-over concrete from outside the shoulder back into the paving section. This practice is not recommended, and it was noticed occasionally during the construction of the SR 113 thin concrete overlay.

**Figure 4.3: Popout.**

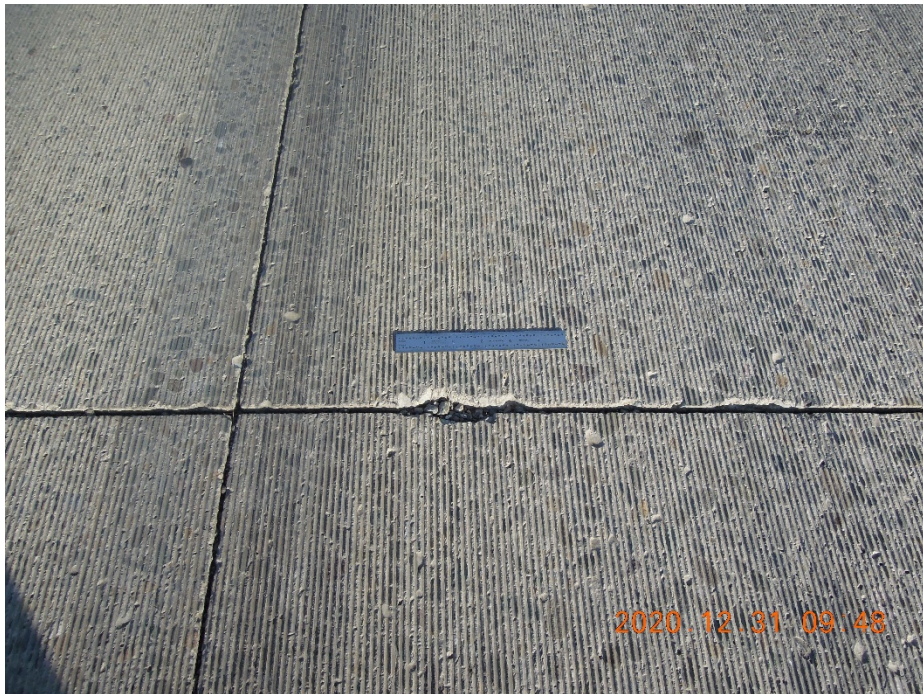
- Low-severity spalling was noticed at some transverse joints (Figure 4.4), particularly at Segment A in the northbound lane. None of the joints would have been rated as “affected by spalling” based on the Federal Highway Administration Long-Term Pavement Performance (LTPP) program’s distress identification manual (6) since the length affected by spalling was minor, much less than 10%.

**Figure 4.4: Low-severity spalling.**

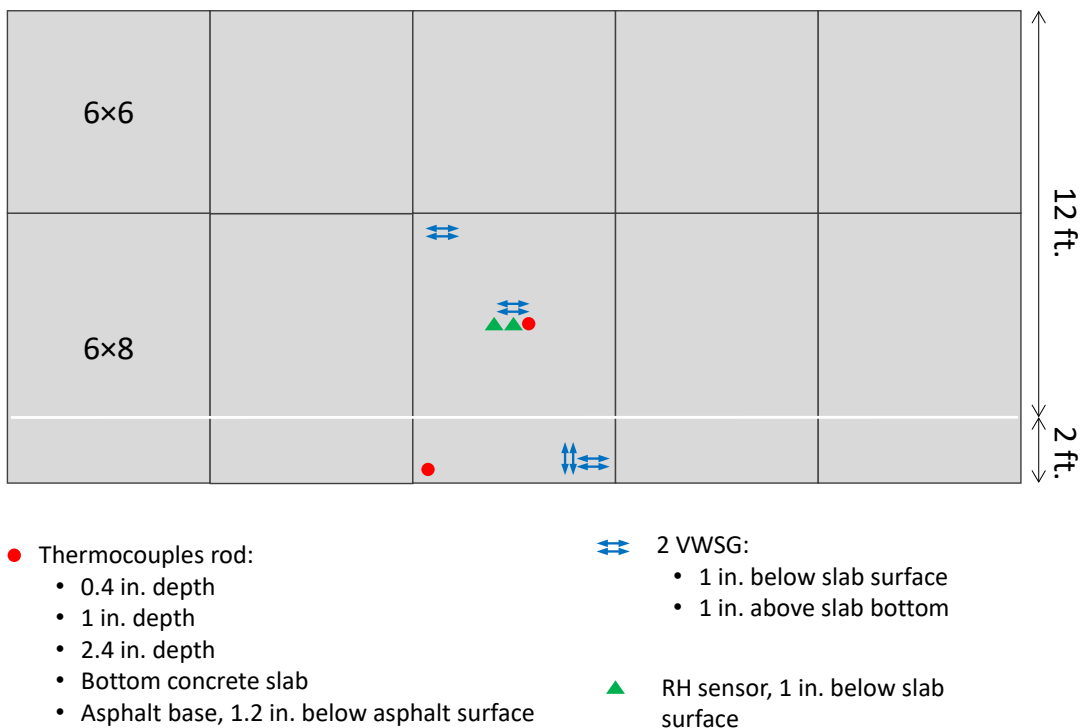
**Figure 5.1: Instrumentation layout.**

The Woodland SR 113 thin COA sections were instrumented with sensors to measure the response of the slabs under hydrothermal actions (thermal and drying shrinkage actions). Thermocouples, relative humidity (RH) sensors, and vibrating wire strain gauges (VWSGs) were installed at several depths, shown in Figure 5.1. The instrumentation shown in Figure 5.1 was installed at three locations, two in Section A2 and one in Section A3, shown in Figure 5.2. Details of the instrumentation installation can be found in a prior thin COA study report (3).

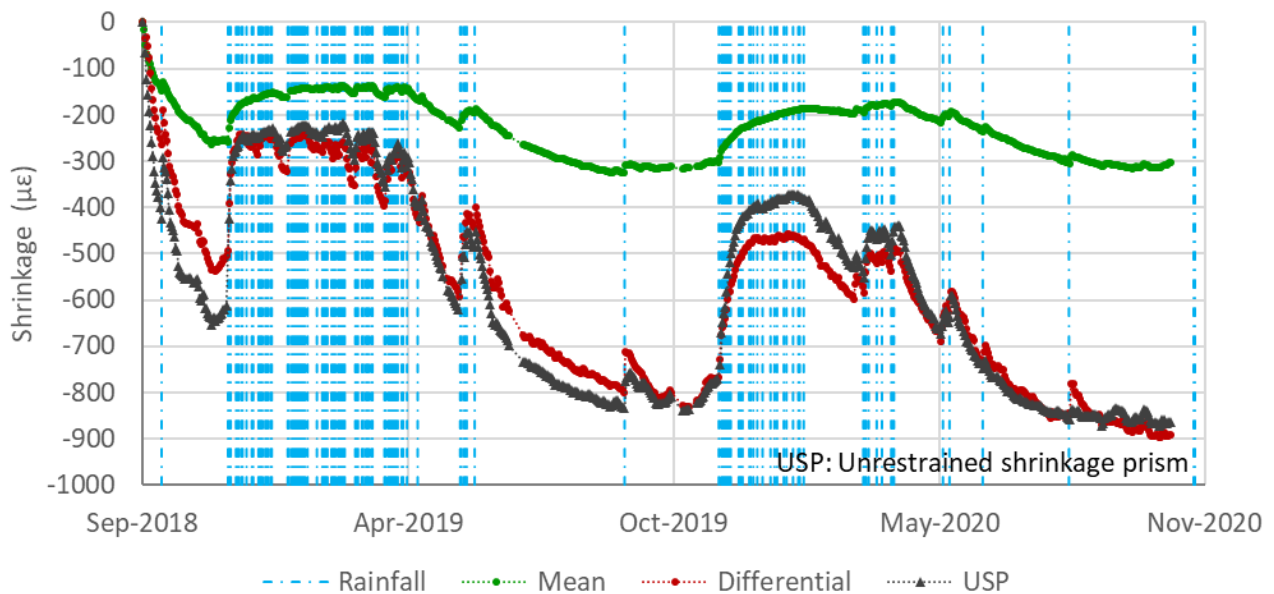
The drying shrinkage estimation from measurements on the trial slabs is shown in Figure 5.4. The series “Mean” represents the slab expansion/contraction (average of the top and bottom of the slab strains), while the series “Differential” represents the slab warping (i.e., top minus bottom of the slab strains). The negative sign of the mean shrinkage indicates slab contraction while the negative sign of the differential shrinkage indicates that the slab curvature is concave upwards (the drying shrinkage is greater at the top). The drying shrinkage estimated for a set of unrestrained shrinkage prisms (USPs) that were built during the construction of the trial slabs is shown as the series “USP.” These prisms were fabricated with the same concrete mixture used to build the trial slabs. The prisms were cured the same way as the trial slabs and then left outdoors near the trial slabs. They were used to measure the unrestrained deformations of the concrete since they were not bonded to any support.

Figure 5.4: Drying shrinkage of the trial slabs.

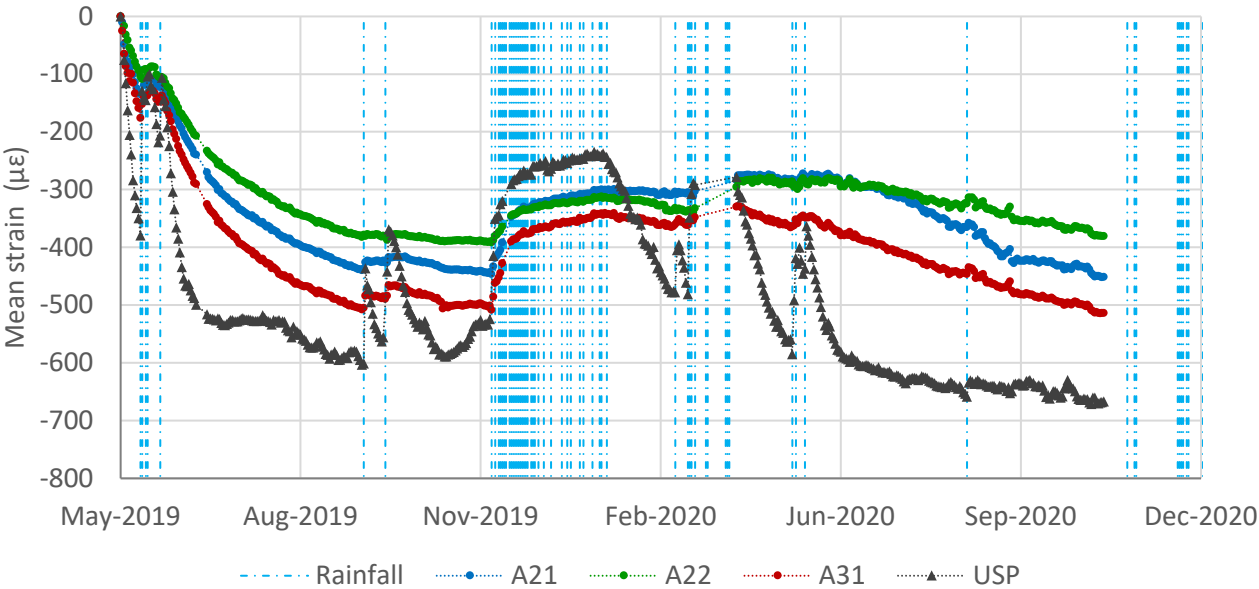
The drying shrinkage estimation from measurements on the Woodland SR 113 thin COA slabs is shown in Figure 5.5 (mean drying shrinkage) and Figure 5.6 (differential drying shrinkage). The series “USP” in Figure 5.5 is the drying shrinkage estimated for the set of unrestrained shrinkage prisms that were fabricated during the construction of the SR 113 overlay. The prisms were fabricated with the same concrete mixture and cured with the same curing compound used in the concrete overlay, and they were left outdoors on the side of the road near the slabs on SR 113.

**Figure 5.5: Mean drying shrinkage of SR 113 slabs.**

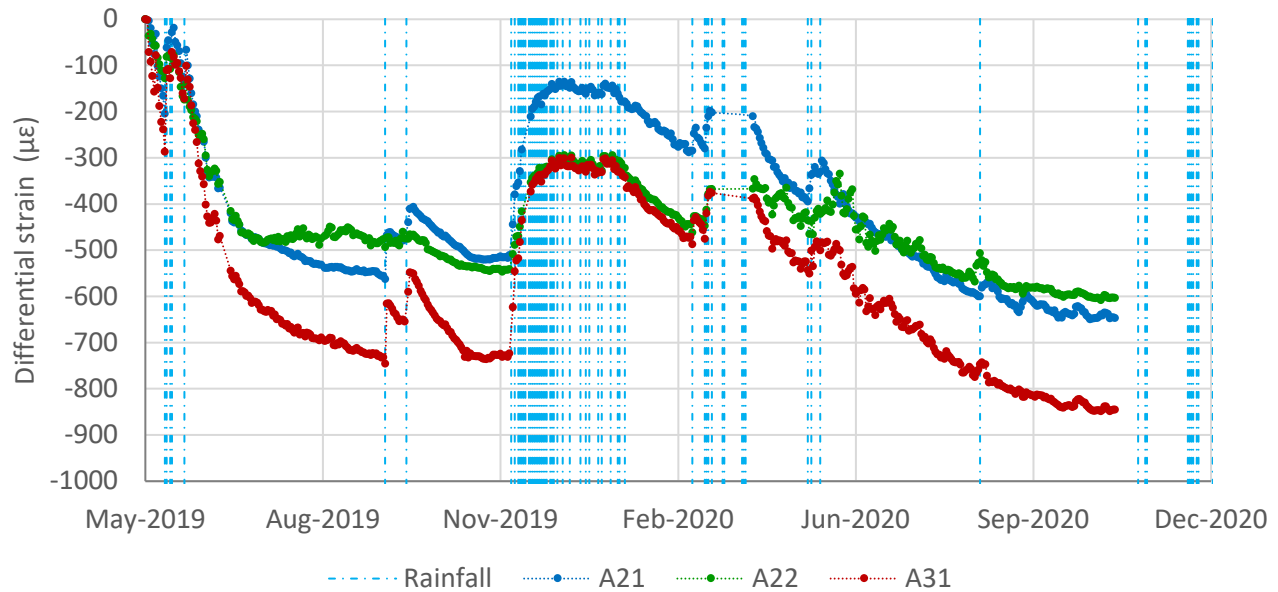
**Figure 5.6: Differential drying shrinkage of SR 113 slabs.**

The trials slabs and SR 113 sections were subjected to very similar weather conditions since they were located close to each other, about 12 miles distance. In both locations, the slabs experienced very high levels of drying shrinkage, particularly during the summer. The differential drying shrinkage (top versus bottom of the slab) reached up to 800  $\mu\epsilon$  in the Woodland thin COA slabs and up to 900  $\mu\epsilon$  in the UCPRC Davis trial slabs. The total drying shrinkage strain reached values up to 750  $\mu\epsilon$  (contraction) at the surface of the slabs. Such high strain is comparable to the shrinkage estimated for the USPs located by the slabs and close to the 1000  $\mu\epsilon$  drying shrinkage measured for the same concrete mixture in the laboratory at 50% air RH following ASTM C157 (3). These results agree with the high drying shrinkage estimated in the previous Caltrans research project for similar slab sizes built with rapid-strength concrete mixtures (7).

- Consider the use of shrinkage reducing admixture (SRA), as a concrete admixture, in COA projects in dry climate regions. The use of this admixture is expected to reduce drying shrinkage to 50%, which will have a positive impact on smoothness seasonal stability and will diminish the risk of concrete cracking and transverse joint faulting.

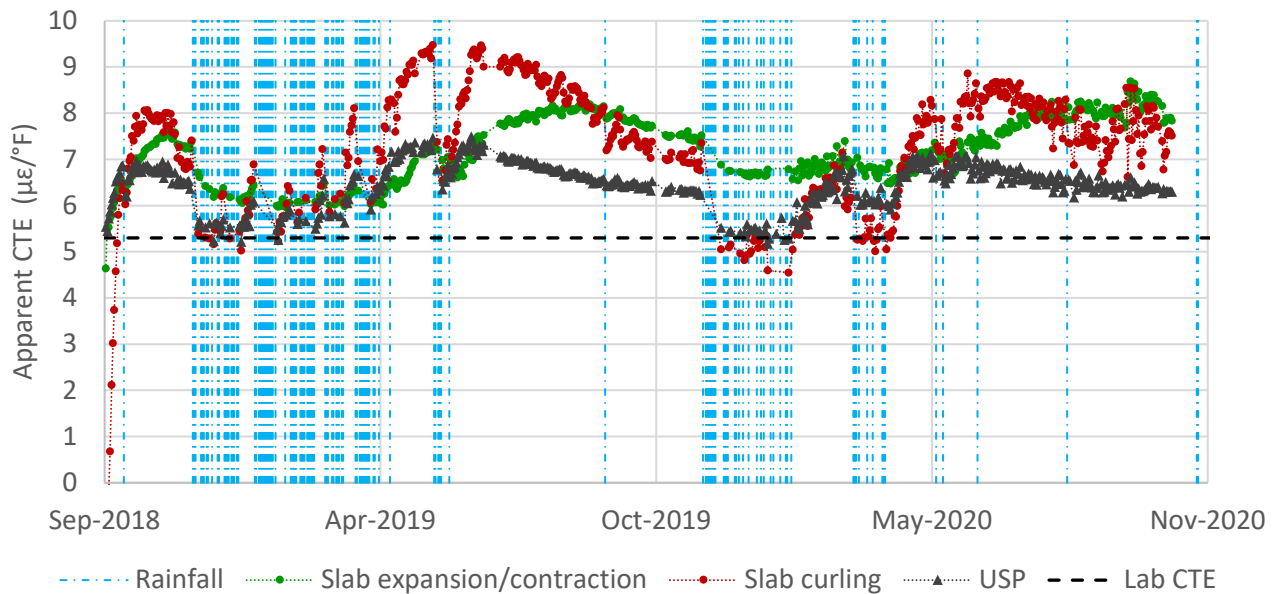
**Figure 5.7: Apparent CTE of the trial slabs.**

As shown in Figure 5.7, the apparent CTE of the slabs can differ considerably from the value determined in the laboratory under saturated conditions, following AASHTO T336. During dry periods (periods between rainfall events), the concrete CTE increases until reaching a maximum. Further drying beyond that maximum results in a drop in CTE. Compared to the laboratory CTE, the apparent CTE of the slabs reached values up to 60% greater for expansion and 76% greater for curling. The apparent CTE of the USPs reached values up to 38% greater than the laboratory CTE.

The pattern of change of the apparent CTE shown in Figure 5.7 agrees with the pattern observed in PPRC Project 4.58B (7). A similar evolution pattern has been reported for decades based on other laboratory studies (10,11).

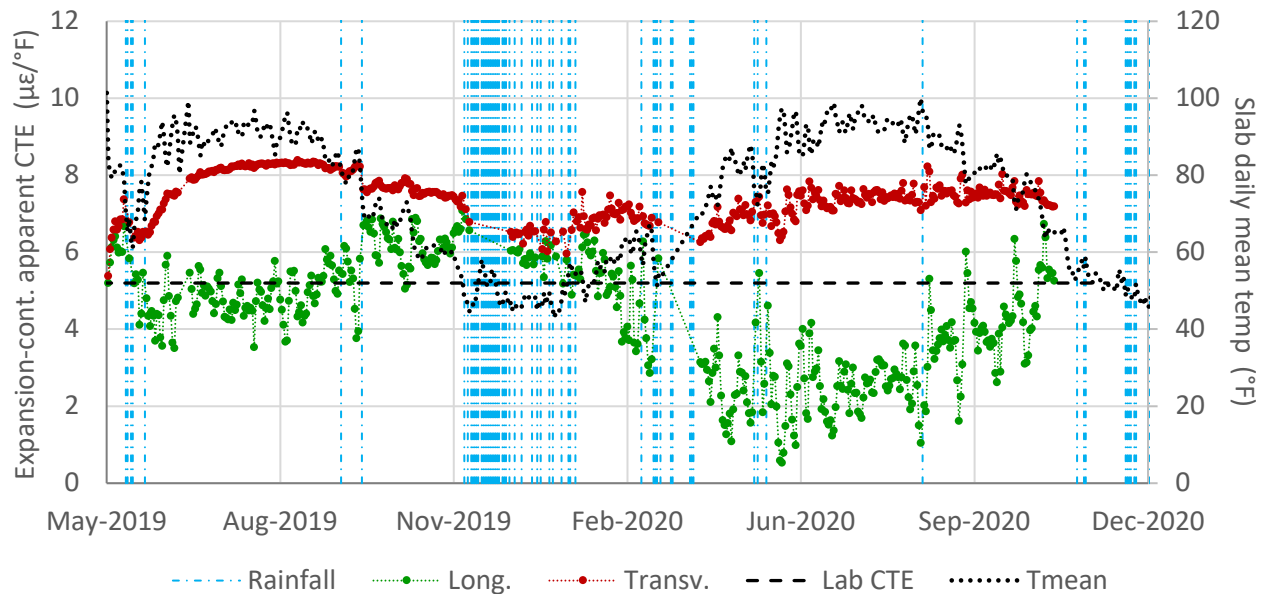
The evolution of the expansion locking during the year-and-a-half period presented in this report can be inferred from Figure 5.13, which shows the apparent CTE based on expansion/contraction of the slabs in the longitudinal and transverse directions. Overall, the apparent CTE in the longitudinal direction is much smaller than in the transverse direction, particularly during summer periods. During summer periods, the apparent CTE in the transverse direction increases due to concrete drying while the apparent CTE in the longitudinal direction cannot increase since the slabs are restricted from expanding. The expansion locking was more severe during the second summer (2020) than during the first summer (2019).

**Figure 5.13: Slab restriction effect on apparent CTE (SR 113, average all instrumented points [IP]).**

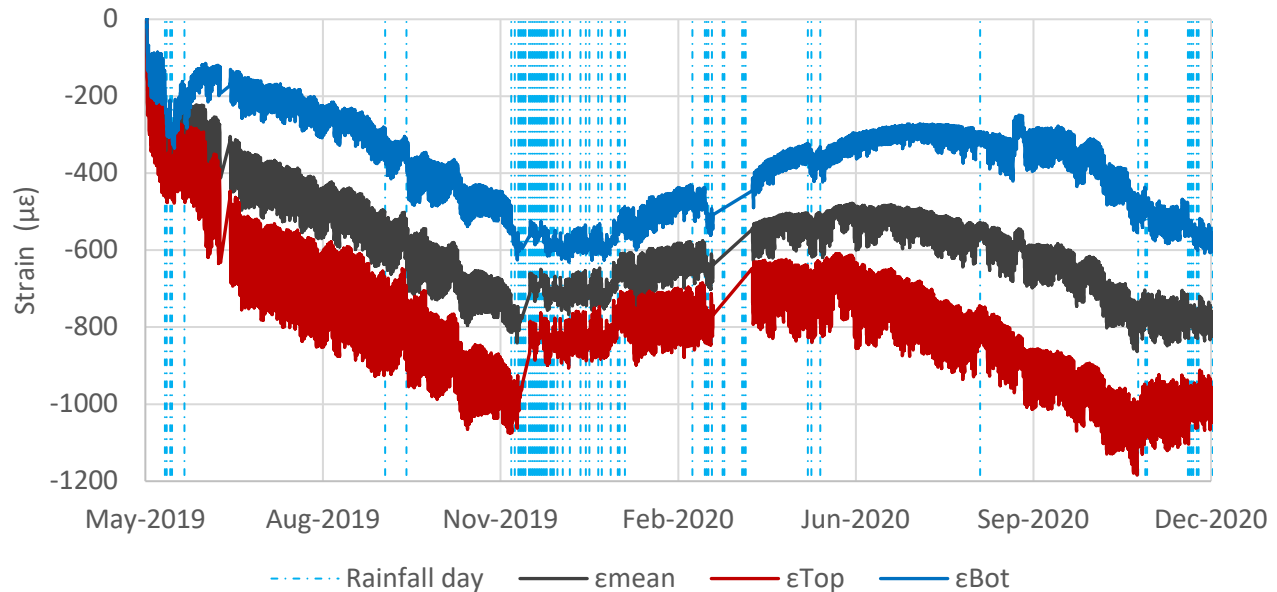
It is believed that the clogging of the transverse joints with dirt/dust played a main role in the expansion locking. The raw strain measured with VWSGs is shown in Figure 5.14. The data shown in this graph correspond to the average strain of all VWSGs installed in SR 113 slabs (three instrumented points, four pairs of VWSGs per instrumented point). The slabs experienced a net contraction after the construction. If the transverse joints had remained clean, the slabs should have been free to expand at any time. The fact that the expansion locking is much more severe during the second summer than during the first summer (Figure 5.13) is consistent with the transverse joints clogging during the 2019-20 rainfall season. Part of the dirt/dust might also have come from the grinding residue. (Note: The grinding of Segment A slabs took place in the second half of May 2019.)

**Figure 5.14: Strain measured in SR 113 slabs (average all IP).**

Figure 5.14 includes the mean strain measured in the thin COA slabs (average of the top and bottom of the slab) together with the extrapolated strain at the top and bottom of the slabs. Figure 5.15 show that the slab contraction versus depth is not uniform, as expected. At the top of the slabs, the slabs contract more than at the bottom, mainly because of the drying shrinkage. Consequently, the compression forces that prevent the slabs from expanding in the longitudinal direction are most likely exerted at the bottom of the slabs. This is likely the reason why little joint spalling was observed in the SR 113 project. The long-term consequences of the slab expansion locking are hard to predict.

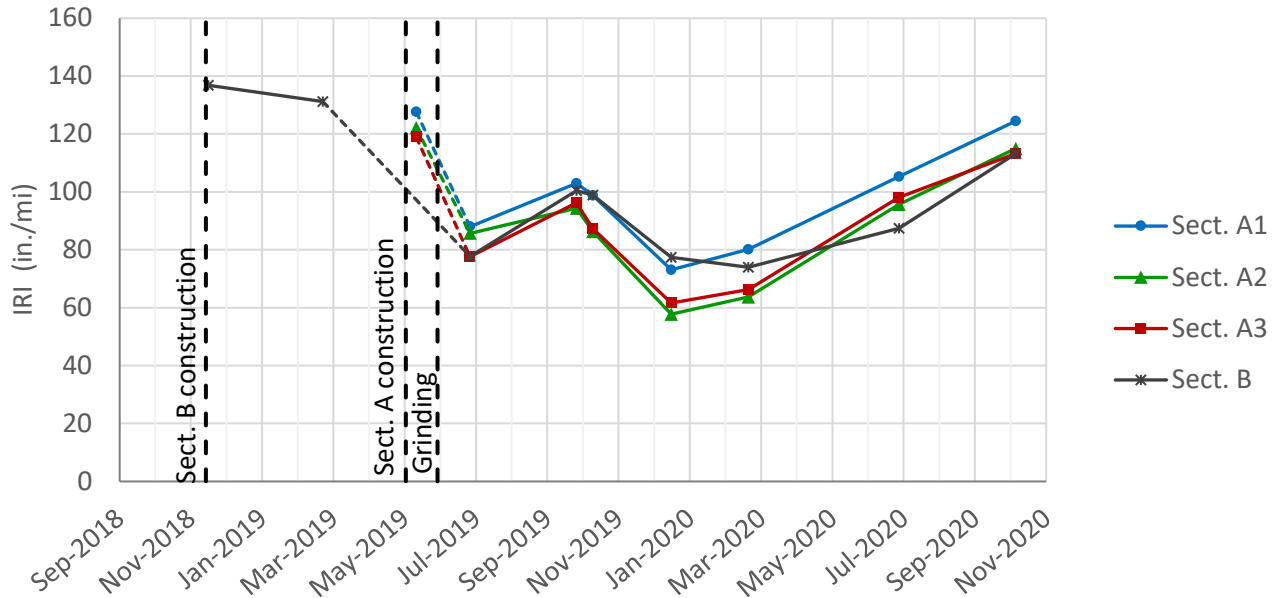
smoothness improved considerably (i.e., the IRI decreased) after the grinding. Then, it fluctuated considerably with an overall tendency to increase. In fact, the IRI increased about 50 in./mi. between the December 2019 and October 2020 evaluations. The results presented in Sections 6.1 and 6.2 show that these IRI changes were not related to any structural damage of the concrete overlay or faulting, but to slab curvature due to drying shrinkage.

**Figure 6.1: Evolution of IRI.**

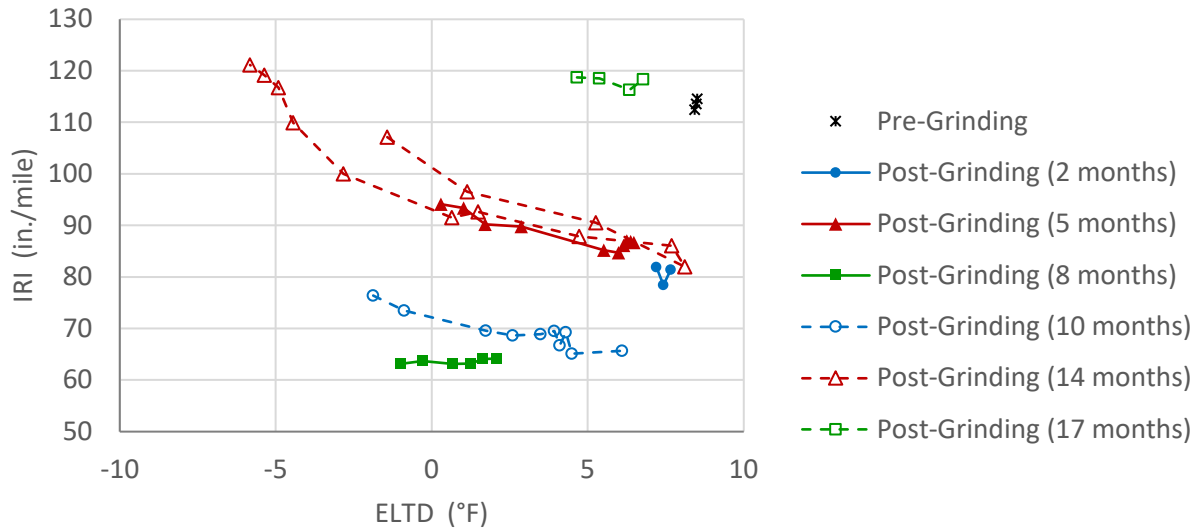
A number of studies show that daily and seasonal changes in slab curvature may considerably impact the IRI (12-14), and this impact was also observed in the SR 113 thin COA project. Figure 6.2 shows the IRI measured in Section A3 in the northbound direction. The IRI measured in each of the evaluations is plotted against the slab equivalent linear temperature difference (ELTD). The ELTD was measured with thermocouples embedded in the slabs. The points correspond to each of the profiler passes for each evaluation. For example, the evaluation “Post-Grinding (10 months)” included 10 passes of the profiler with the ELTD varying between -3°F and +12°F.

**Figure 6.2: Example of impact of slab temperature gradient on IRI (Section A3, North).**

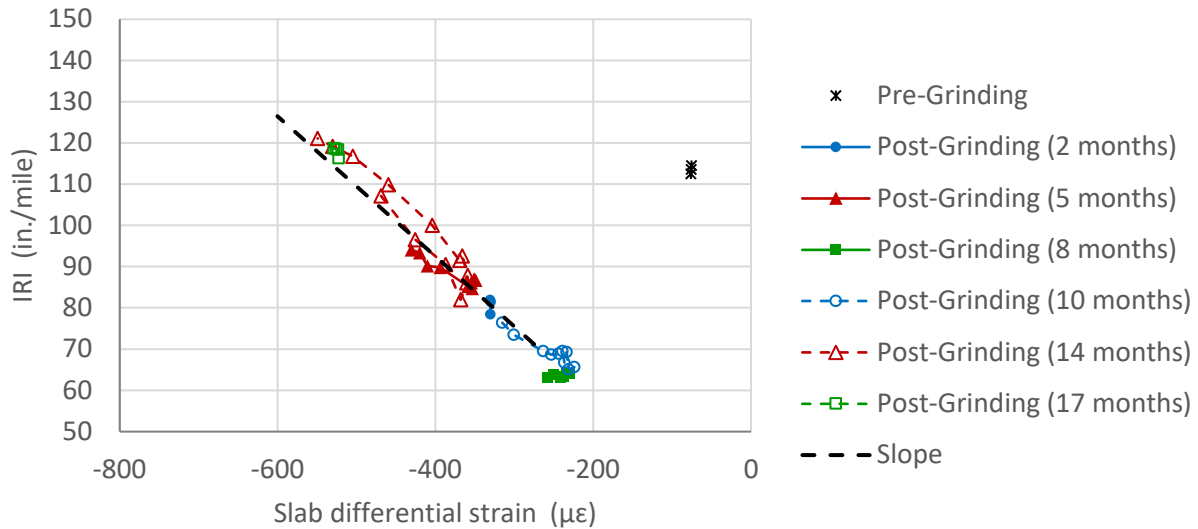
The single line in Figure 6.5 indicates that the changes in IRI were not related to any structural damage in the pavement but to changes in slab curvature. The slab curvature changes because of the changes in thermal gradient through the slab thickness and the changes in differential drying shrinkage. The data shown in Figure 6.5 is only an example, and a similar pattern was observed in the rest of the sections.

**Figure 6.5: Example of impact of slab curvature on IRI (Section A3, North).**

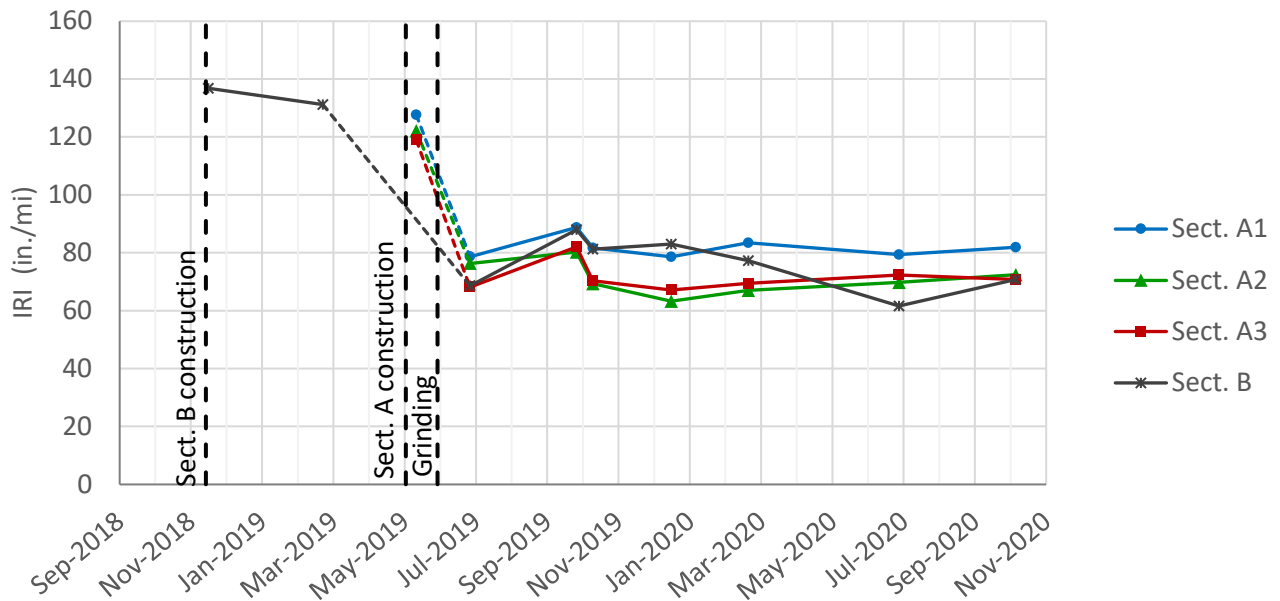
The evolution of the corrected IRI is shown in Figure 6.6, which shows that the IRI remained constant after the grinding operation. The fluctuation observed in Section B is most likely because the slab differential strain adopted for the curvature correction was not measured in Section B but in Section A2 and Section A3. The Section B slab curvature may differ from the curvature of the Section A2 and Section A3 slabs because the Section B overlay was built about six months before the Section A2 and Section A3 overlays, and the Section B slabs are slightly thicker than the Section A2 and Section A3 slabs (around 1 in. thicker).

**Figure 6.6: Evolution of slab curvature-corrected corrected IRI.**

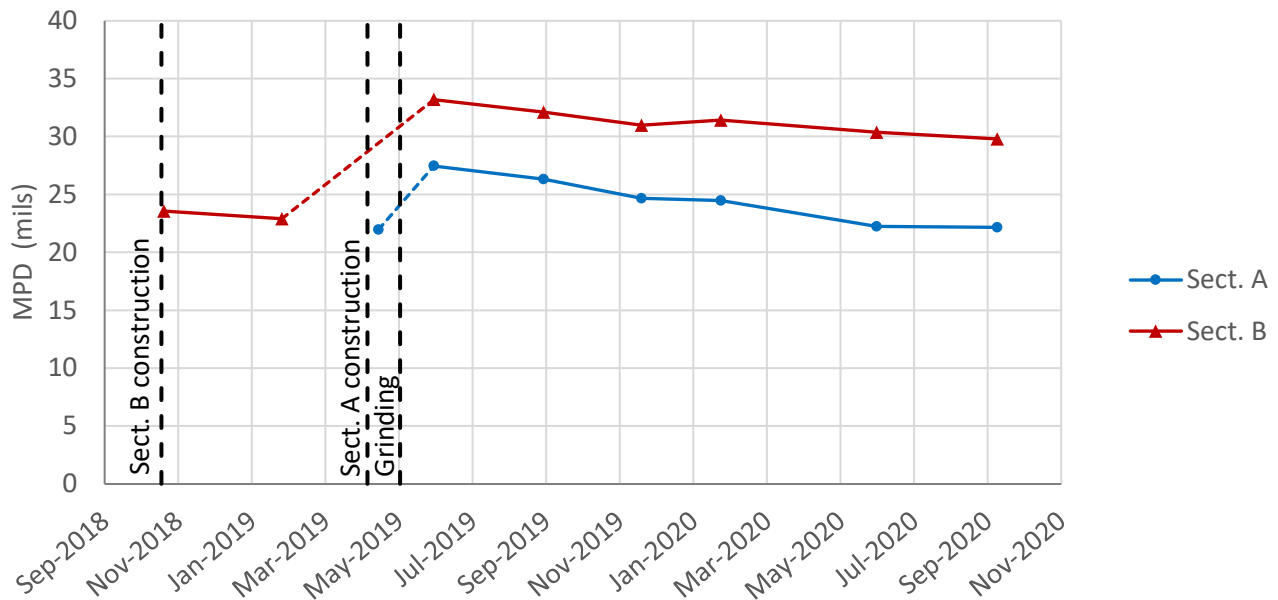
The MPD evolution is shown in Figure 7.1. As expected, the MPD increased after the grinding operation. The grinding operation leaves a surface with closely spaced grooves separated by ridges (Figure 7.2). After the grinding, the MPD slowly decreased, most likely due to the breaking of the tips of the concrete ridges left by the grinding operation.

Figure 7.1: Evolution of the mean profile depth (MPD).

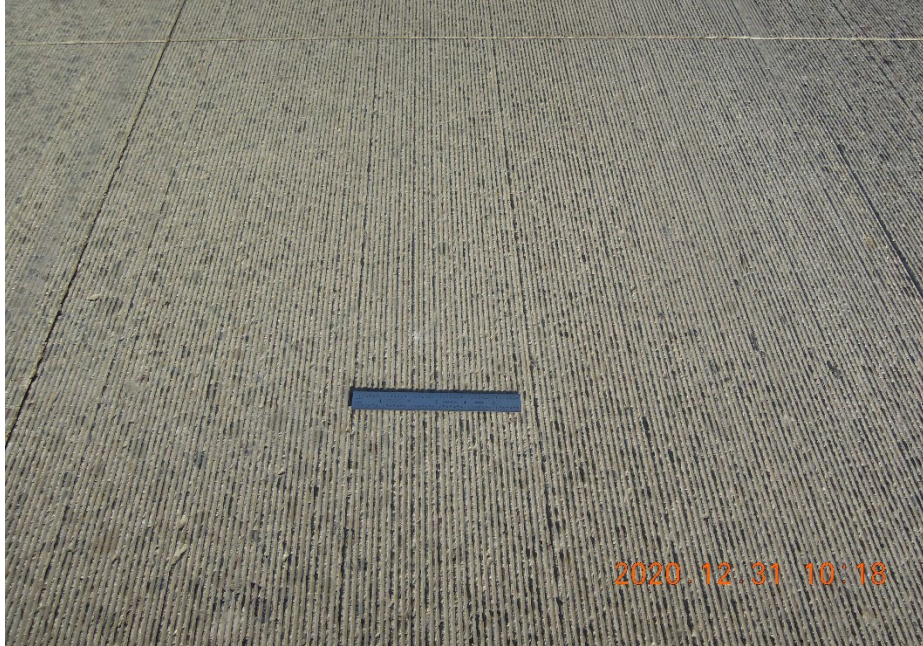
**Figure 7.2: Grinded concrete surface.**

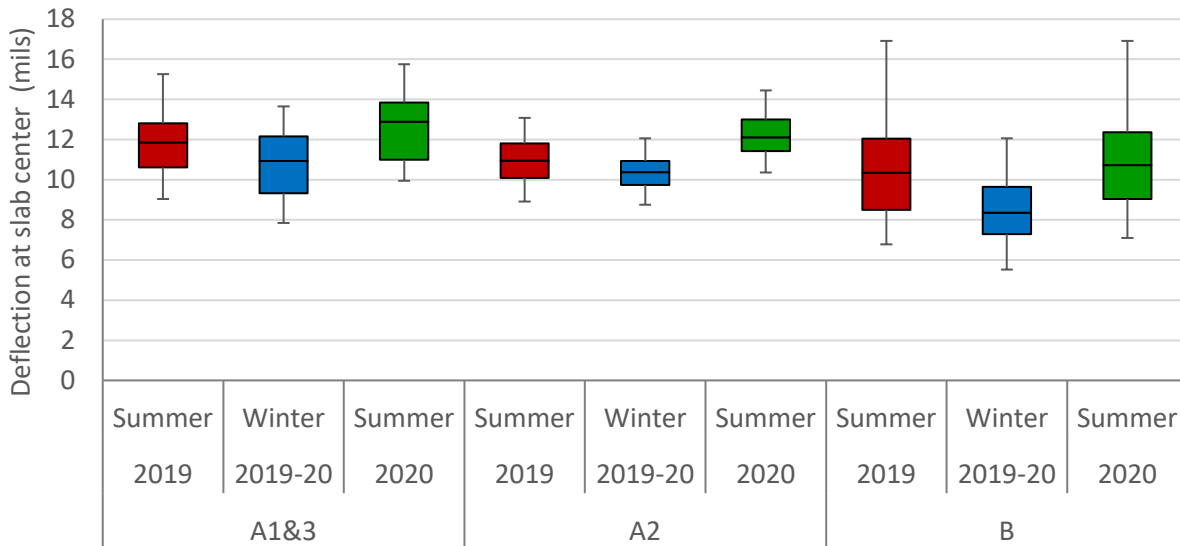
The box plots of the deflections measured at the center of the slabs in each of the sections and for each of the FWD evaluations (Summer 2019, Winter 2019-20, and Summer 2020) are shown in Figure 8.2. Similarly, the LTE and deflections measured at the transverse joints are shown in Figure 8.3 and Figure 8.4, respectively. The deflections and LTE in all figures correspond to an FWD loading of 15.7 kips.

**Figure 8.2: Deflection at slab center (FWD loading = 15.7 kips).**

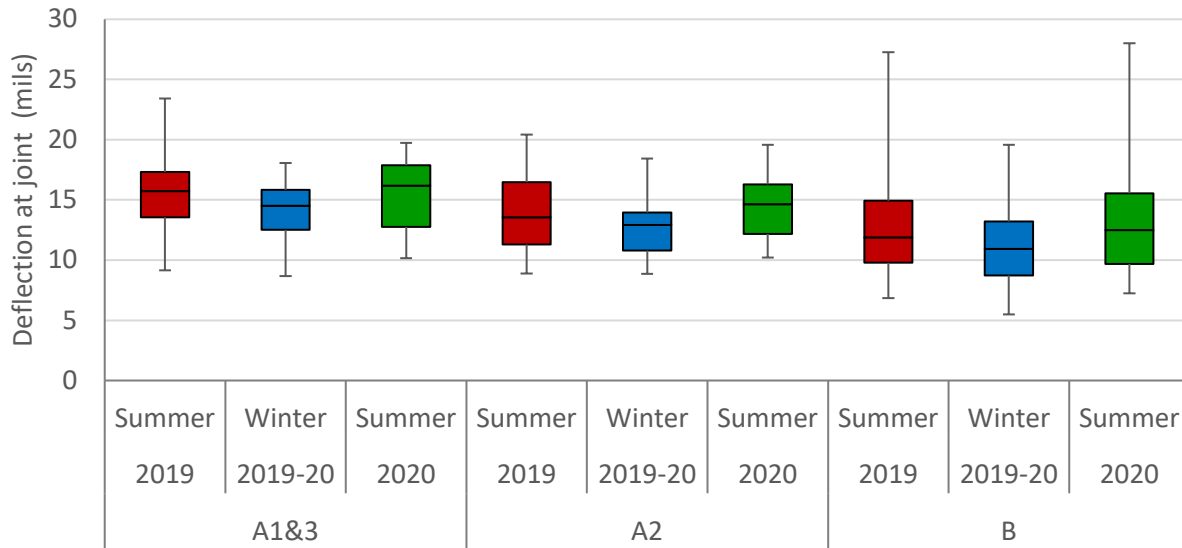
**Figure 8.3: Deflection at transverse joint (FWD loading = 15.7 kips).**

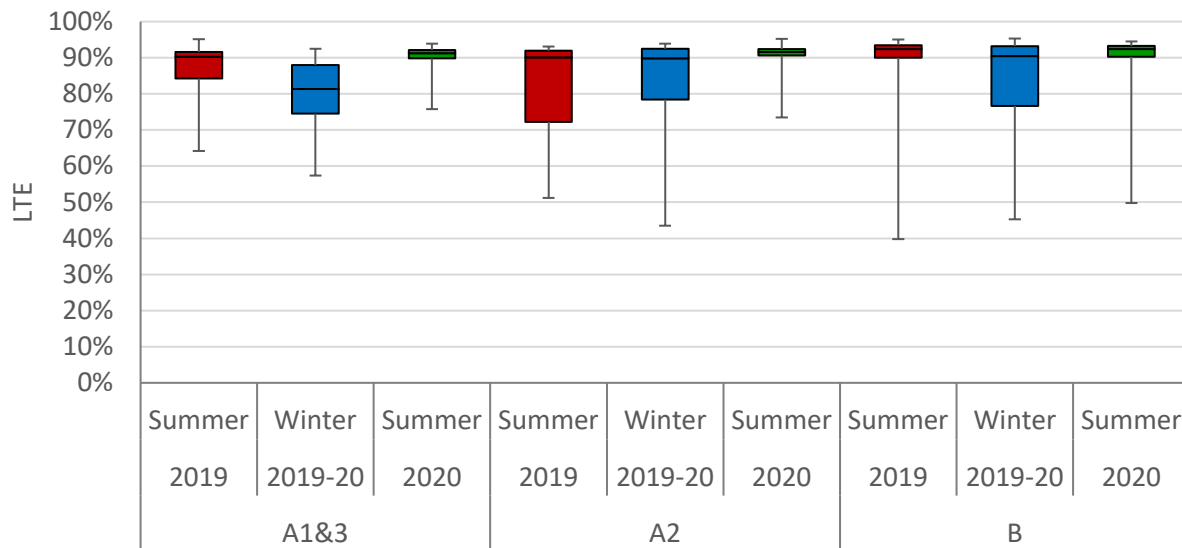
**Figure 8.4: Transverse joint LTE (FWD loading = 15.7 kips).**

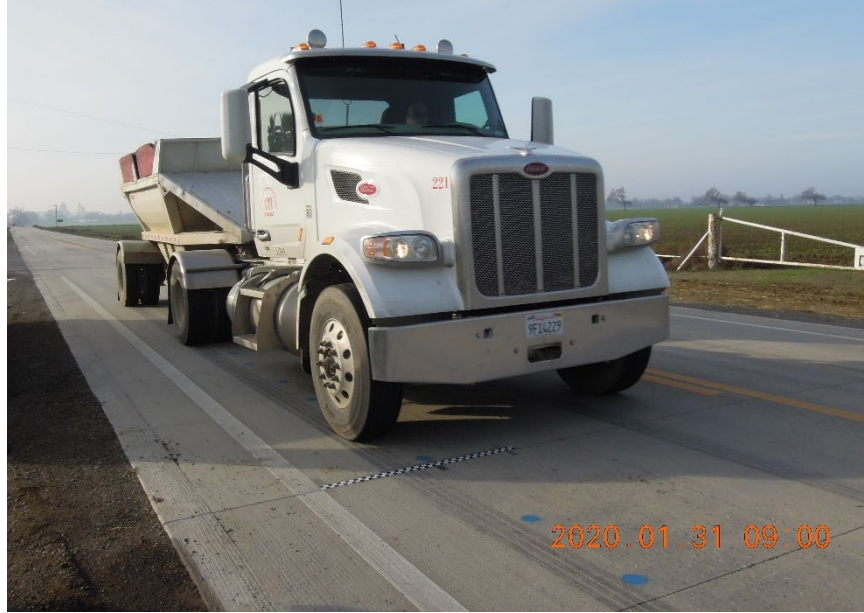
The same truck model with a similar load was used for the three RLT evaluations (Figure 8.20). The truck has three single axles. The three single axles were each weighed with a portable scale. The weights of the three axles (steering, drive, and truck axles) were around 9.6, 20.6, and 19.1 kips, respectively. The offset (the distance between the wheel edge and white strip) was measured by using a tape measure placed on the pavement surface, shown in Figure 8.20. An operator standing by the test sections recorded the offset of each truck pass. The majority of the passes were conducted at 45 mph.

**Figure 8.20: Experiment truck passing over instrumented slab (IP A21).**

In each of the three RLT evaluations, between 80 and 110 truck passes were recorded starting early in the morning (around 8:00 a.m.) and ending late in the afternoon (around 5:00 p.m.). The goal of testing during a relatively long time period was to capture the effects of changes in the slab temperature profile. The resistive strain gauge data were recorded with two National Instruments portable data acquisition systems—one for IP A21, IP A22, and IP A31 and one for IP A32. The slab temperature data were collected by a Campbell Scientific permanent data acquisition system (Figure 8.19).
