The Tsunami of April 1, 1946

F. P. SHEPARD, G. A. MACDONALD, AND D. C. COX

BULLETIN OF THE SCRIPPS INSTITUTION OF OCEANOGRAPHY
OF THE UNIVERSITY OF CALIFORNIA
LA JOLLA, CALIFORNIA

Volume 5, No. 6, pp. 391-528, plates 6-33, 21 figures in text

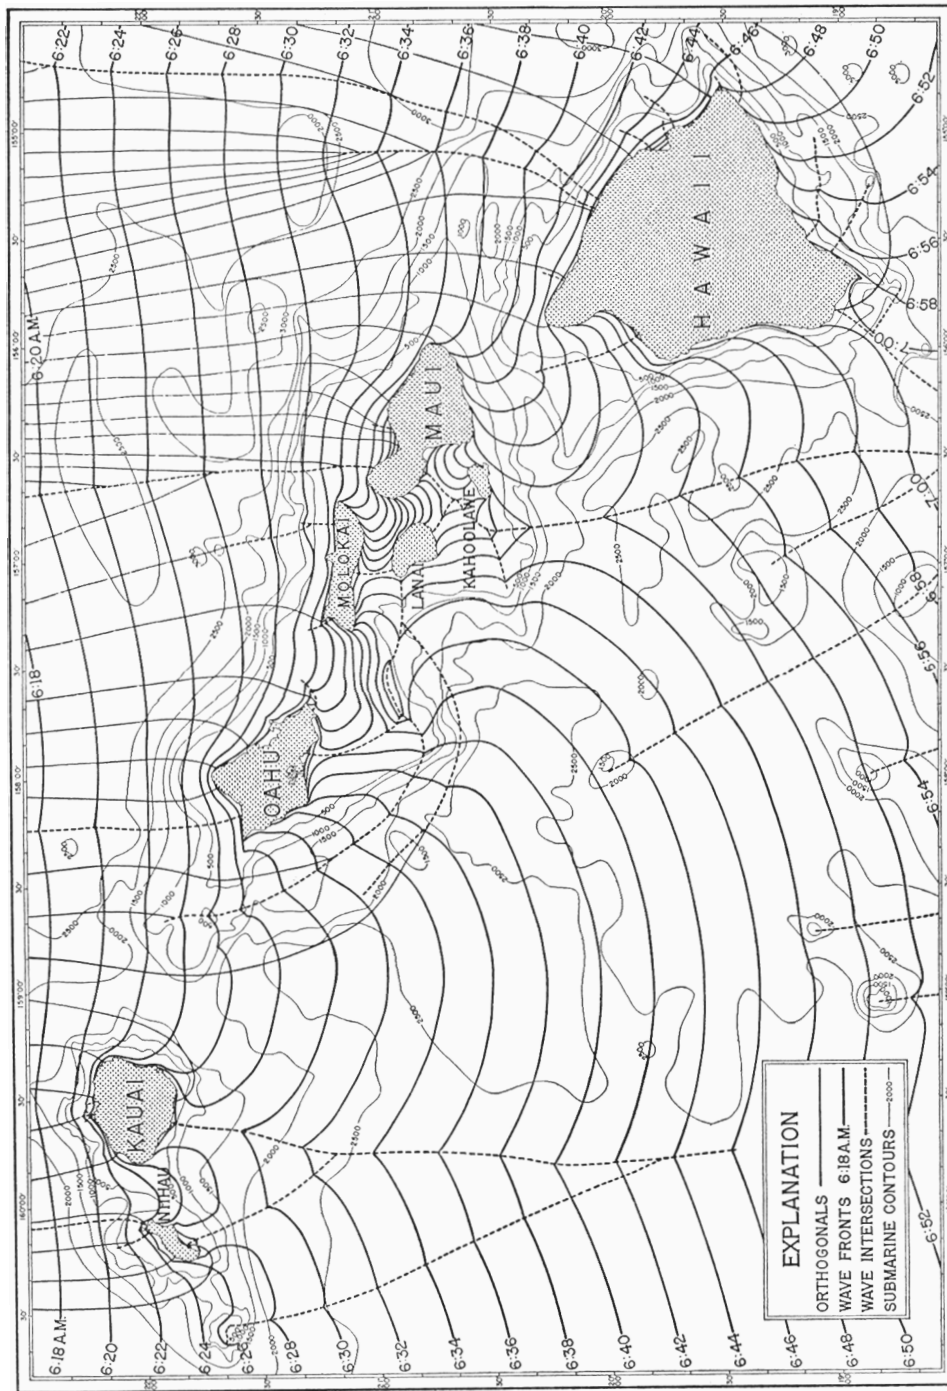
Fig. 2. Map of the Hawaiian Islands, showing submarine topography (contours in fathoms), wave fronts, and orthogonals of the tsunami. Times refer to computed time of arrival of first wave.

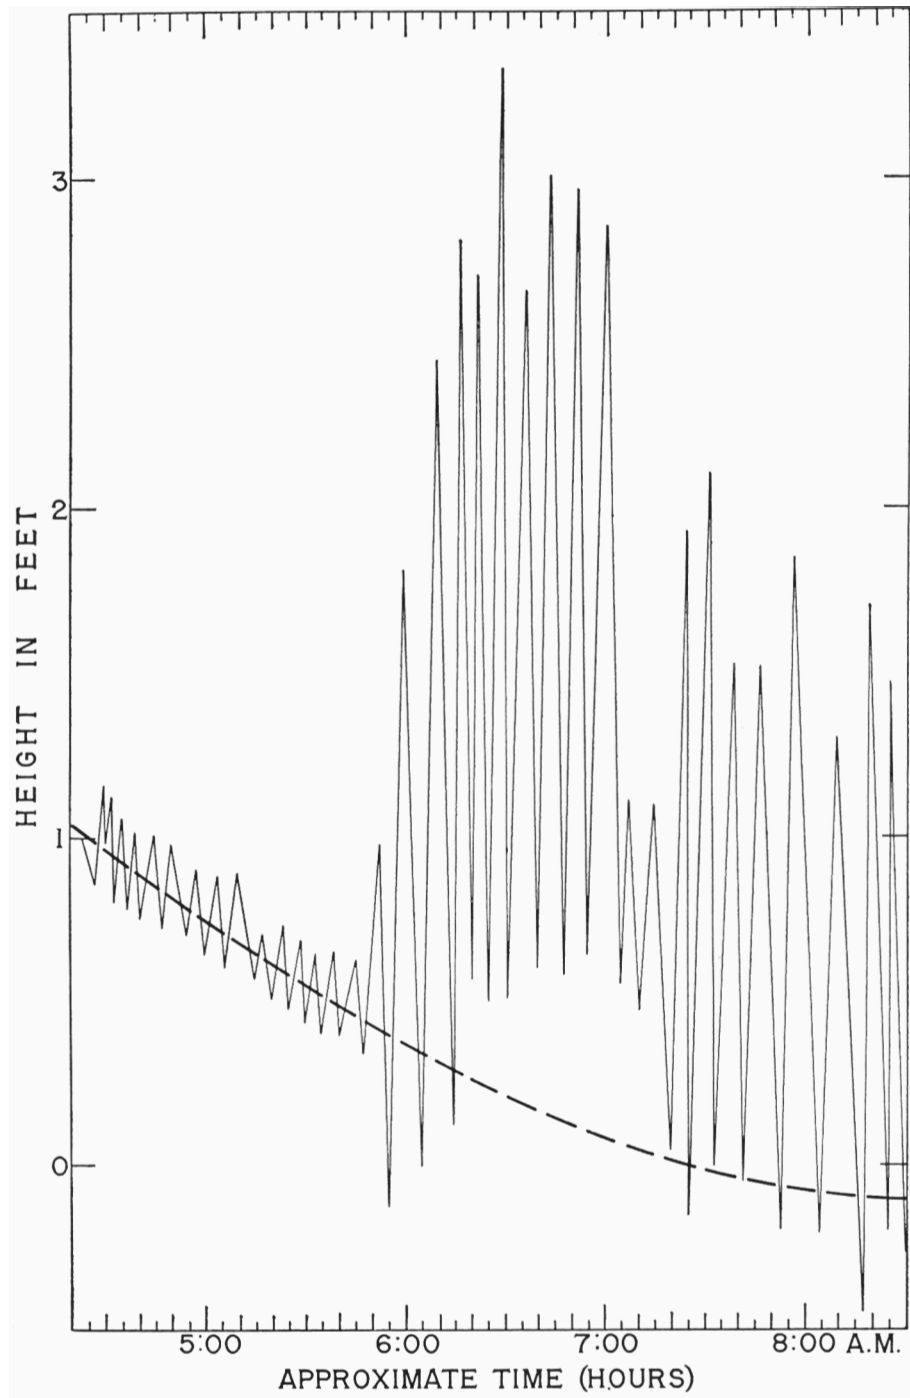
Fig. 5. Record of the tsunami of April 1, 1946, on the water-stage recorder in the estuary of the Waimea River, Kauai.

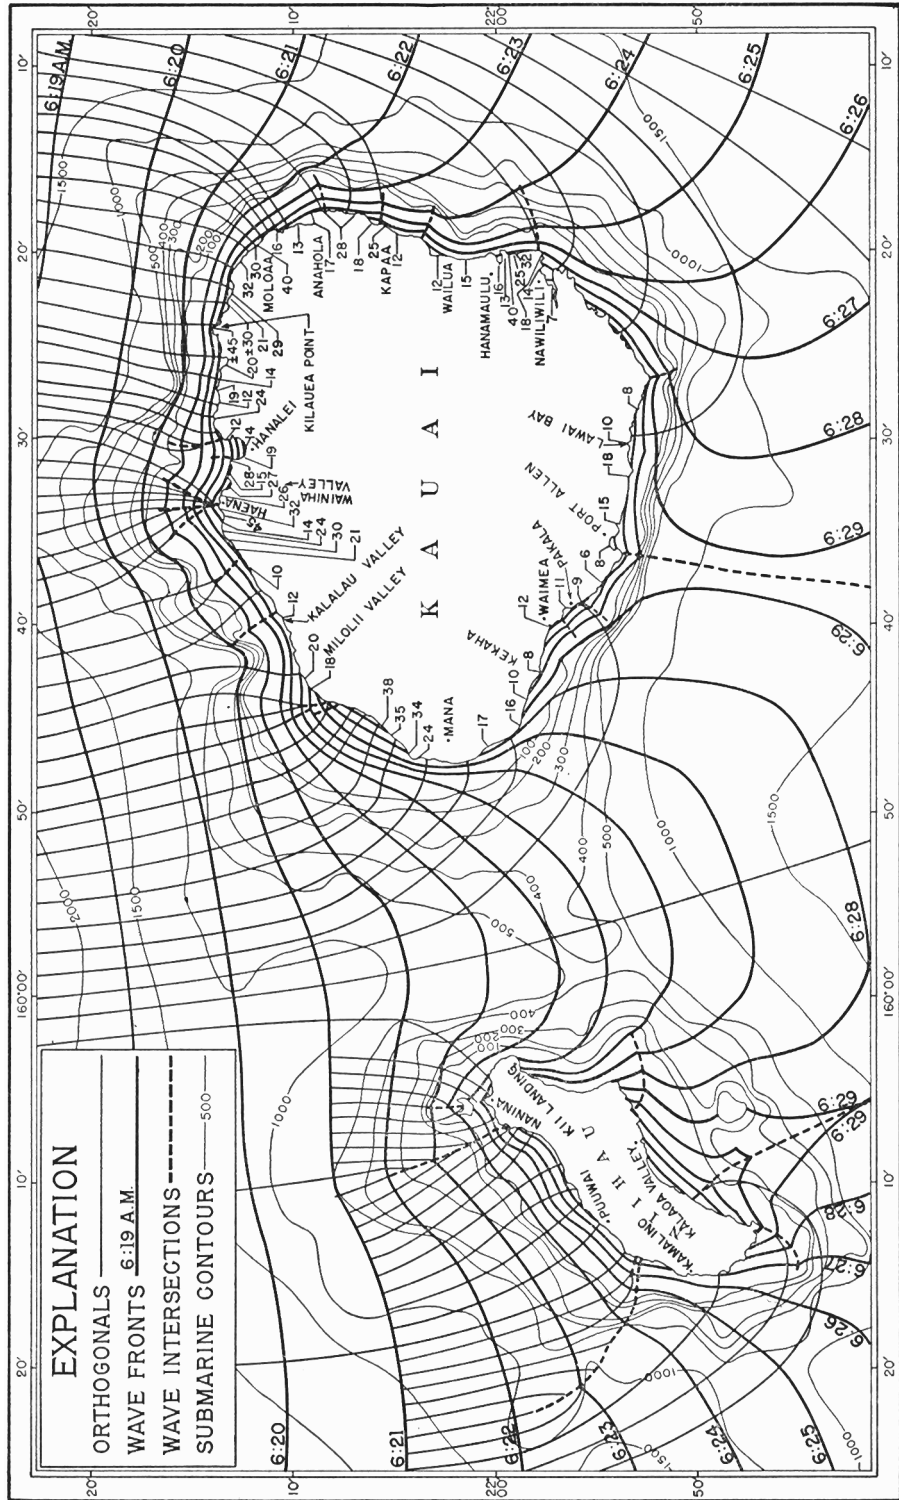
Fig. 6. Map of the islands of Kauai and Niihau, showing heights (in feet above lower low water) reached by the water during the tsunami, wave fronts, orthogonals, and submarine contours (in fathoms). Times refer to computed time of arrival of first wave.

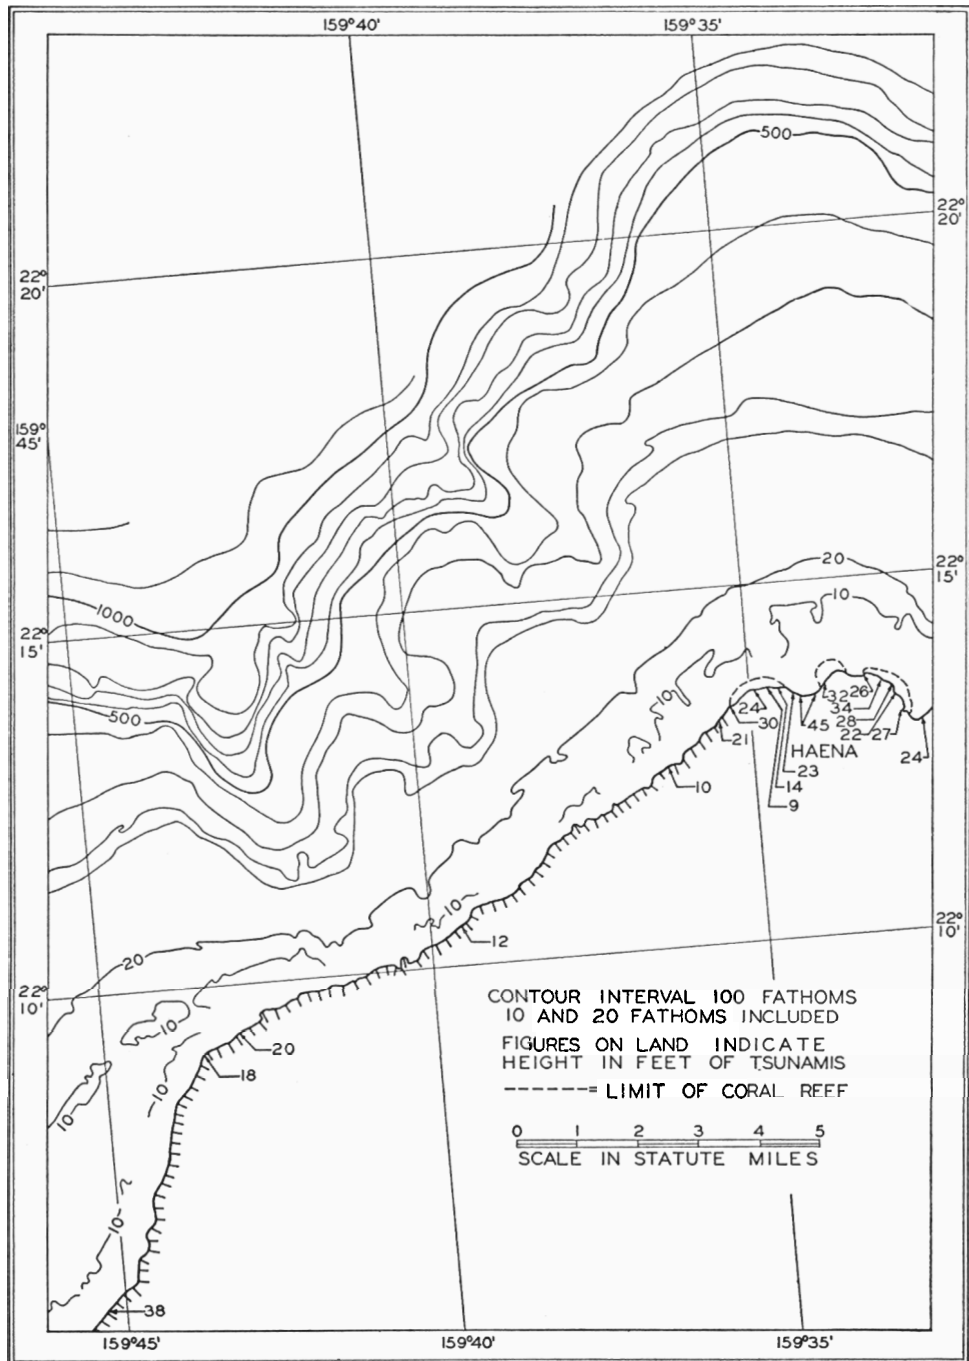
Fig. 7. Northwest corner of Kauai, showing relation of heights to submarine topography and to coral reefs.

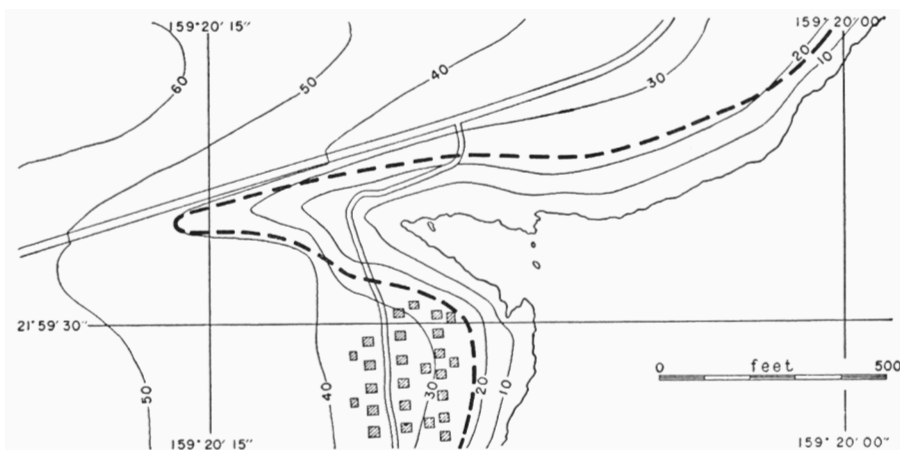
Fig. 8. Map of the small inlet and valley just south of Ahukini, Kauai, showing the height reached by the water during the tsunami (indicated by the dashed line). Altitudes are in feet above lower low water.

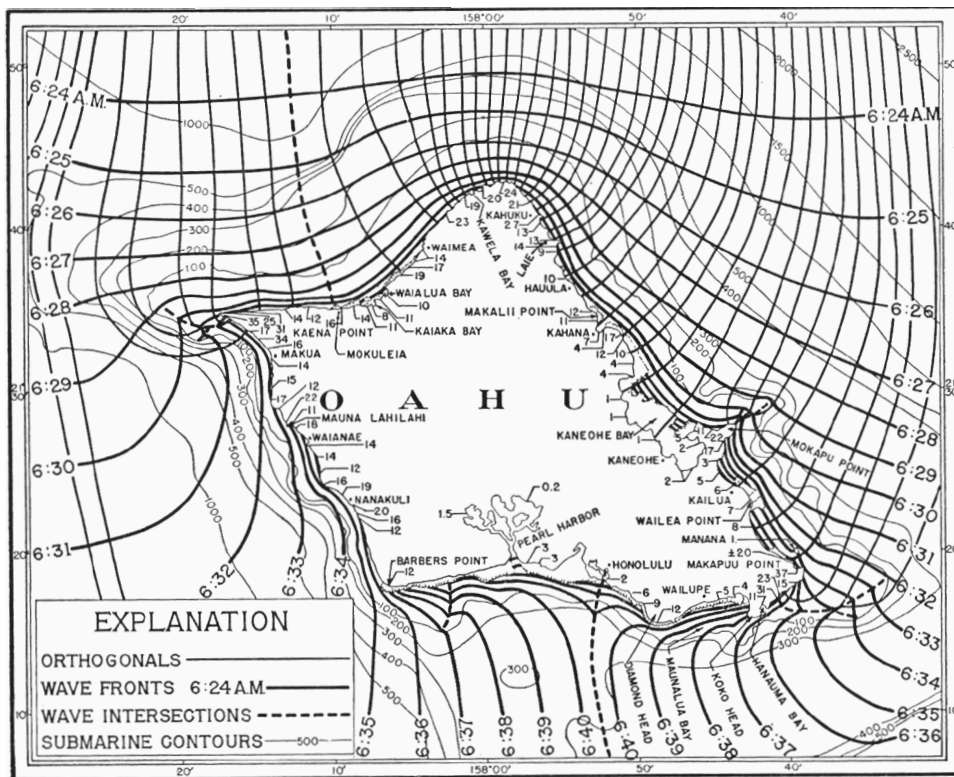
Fig. 9. Map of the island of Oahu, showing heights (in feet above lower low water) reached by the water during the tsunami, wave fronts, orthogonals, and submarine contours (in fathoms). Times refer to computed time of arrival of first wave.

The shore line of Oahu (fig. 9) is much more angular than that of Kauai. The island consists of two elongate northwesterly-trending shield volcanoes which have been joined together and deeply eroded. Later volcanic cones cluster around the southeastern end of the eastern shield. There are four prominent points on the island, all of which are prolonged as ridges below sea level. These are Kaena Point, which forms the sharp western end of the island; Kahuku Point on the north; Mokapu Point on the northeast, which partly encloses

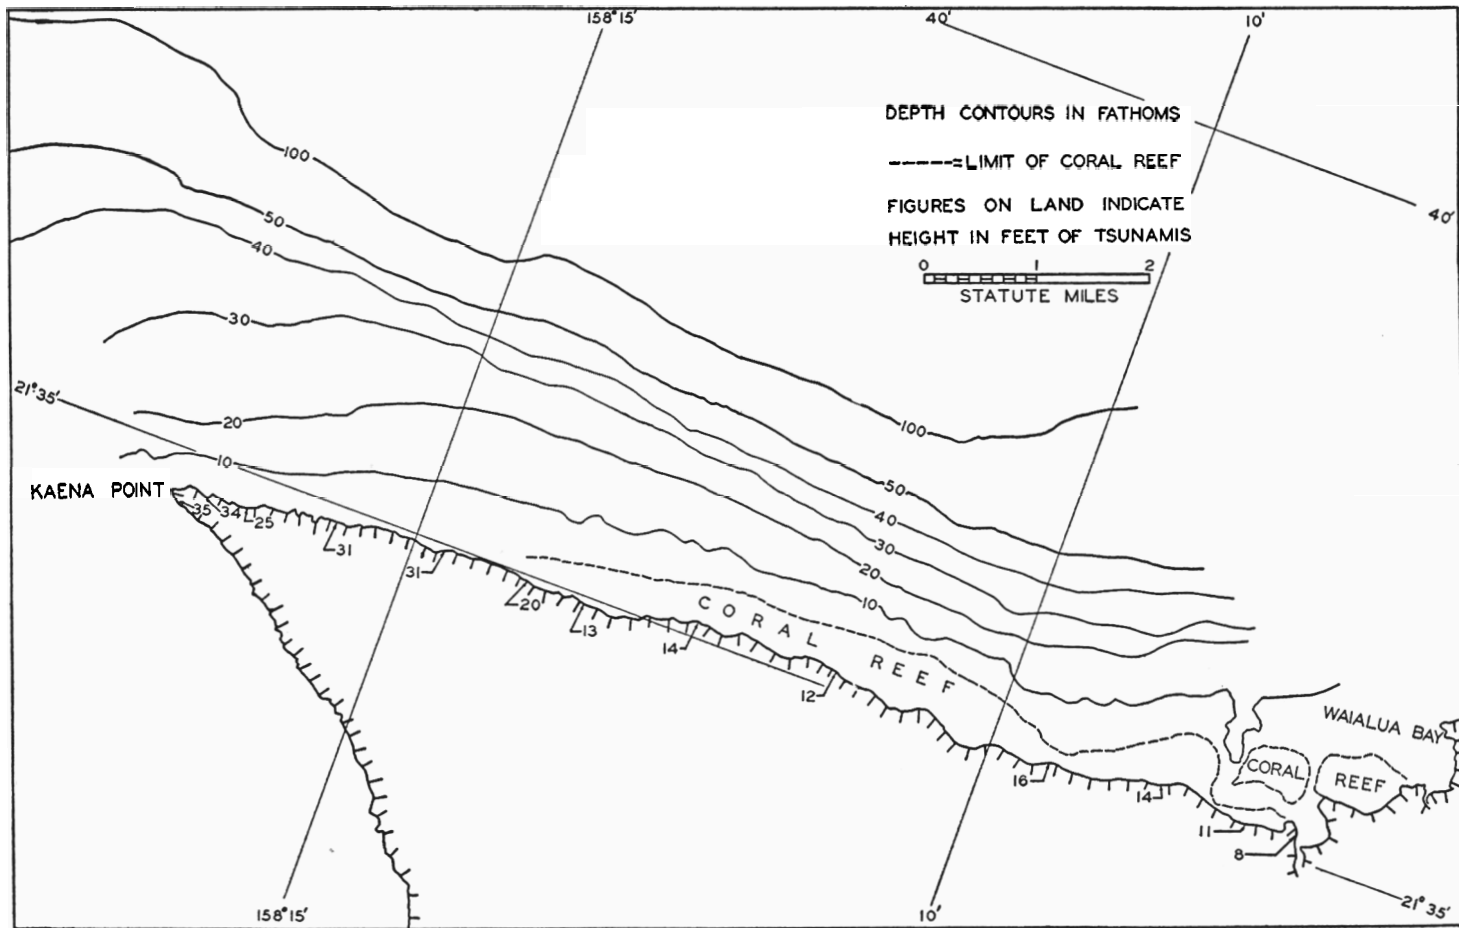
Fig. 10. Northwest corner of Oahu, showing relation of coral reef to heights reached by the water.

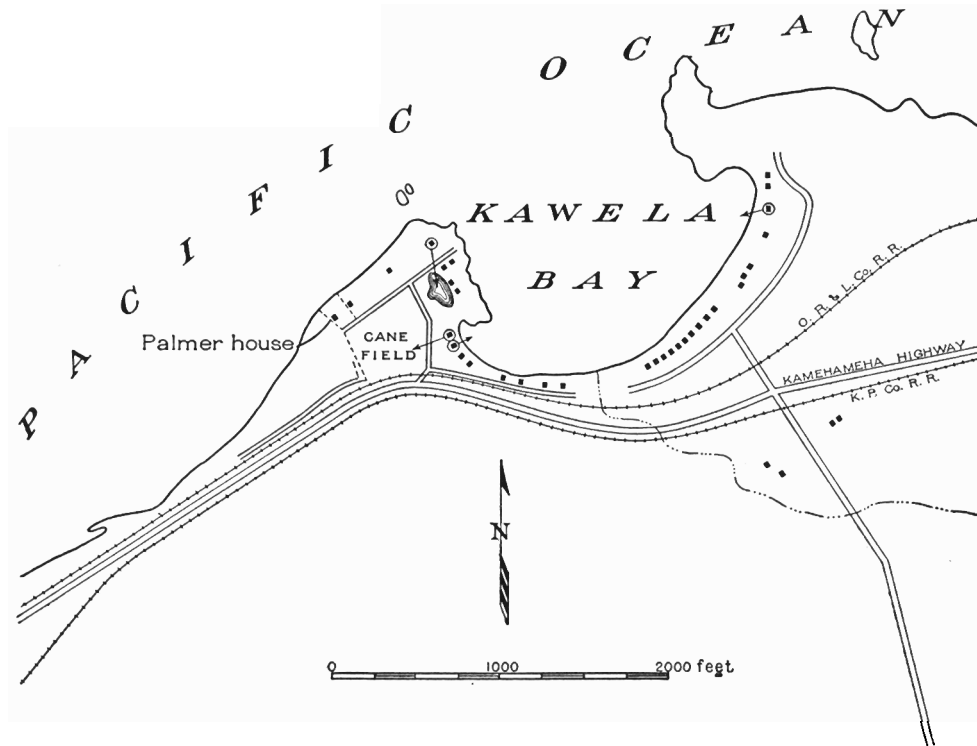
Fig. 11. Map of Kawela Bay, Oahu (after H. S. Palmer). The arrows show the direction of movement of houses shifted by the tsunami.

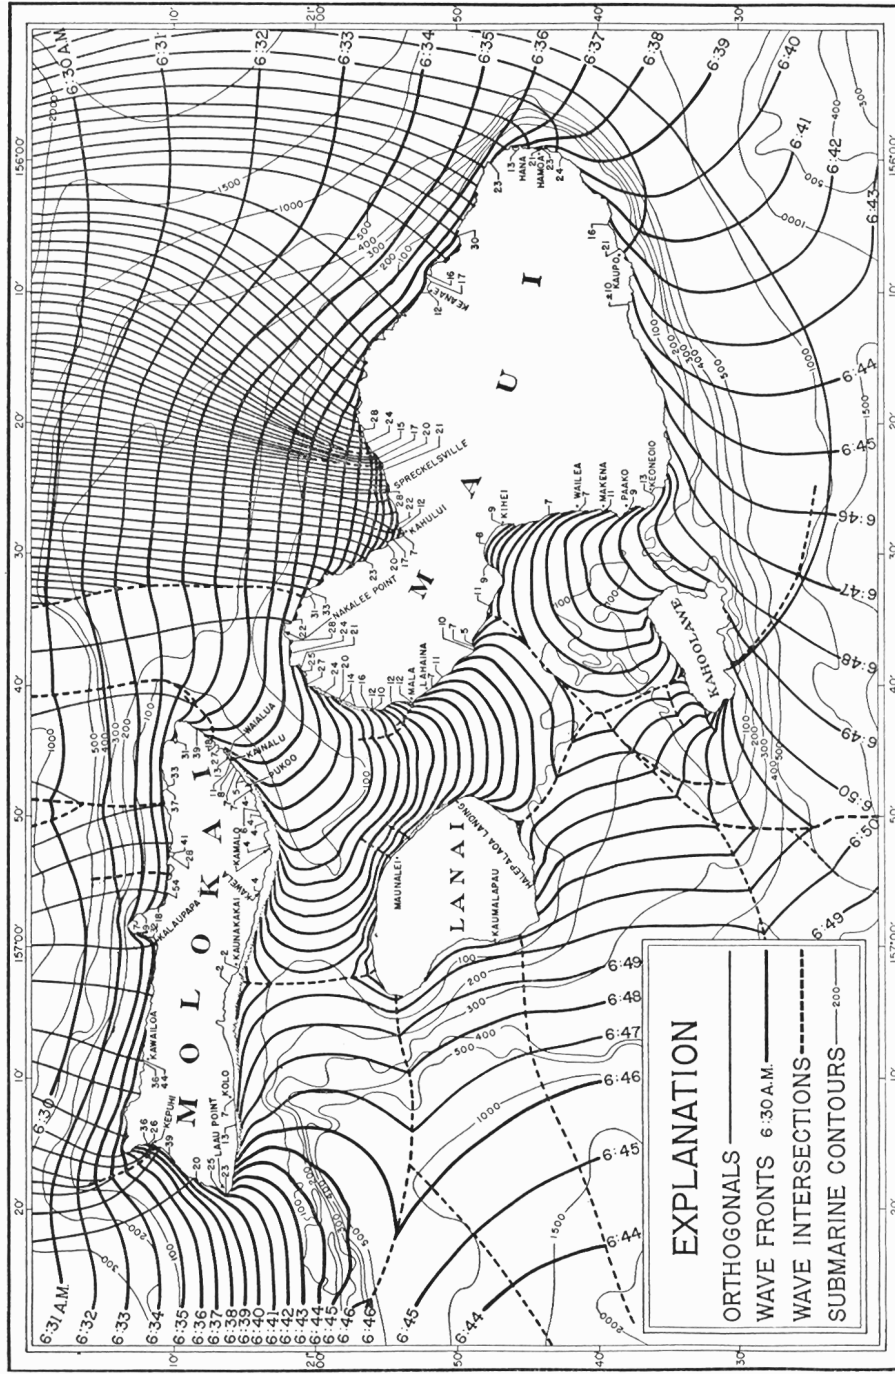
Fig. 12. Map of the islands of Molokai, Maui, and Lanai, showing heights (in feet above lower low water) reached by the water during the tsunami, wave fronts, orthogonals, and submarine contours (in fathoms). For detailed submarine topography see figure 13. Times refer to computed time of arrival of first wave.

Along the beaches for about 6 miles east of Kahului (fig. 12) the waves rose 17 feet or more above sea level. At Spreckelsville the waves reached an elevation of 28 feet and swept inland as much as 800 feet, although there is a fairly

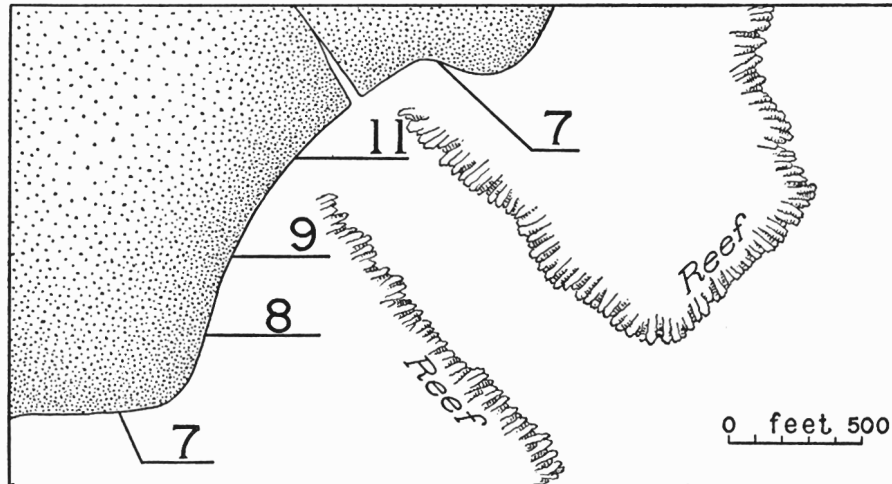
Fig. 14. Map of Kainalu area, on the southern coast of East Molokai, showing heights reached by the water during the tsunami (in feet above lower low water) in relation to a channel through the fringing coral reef.

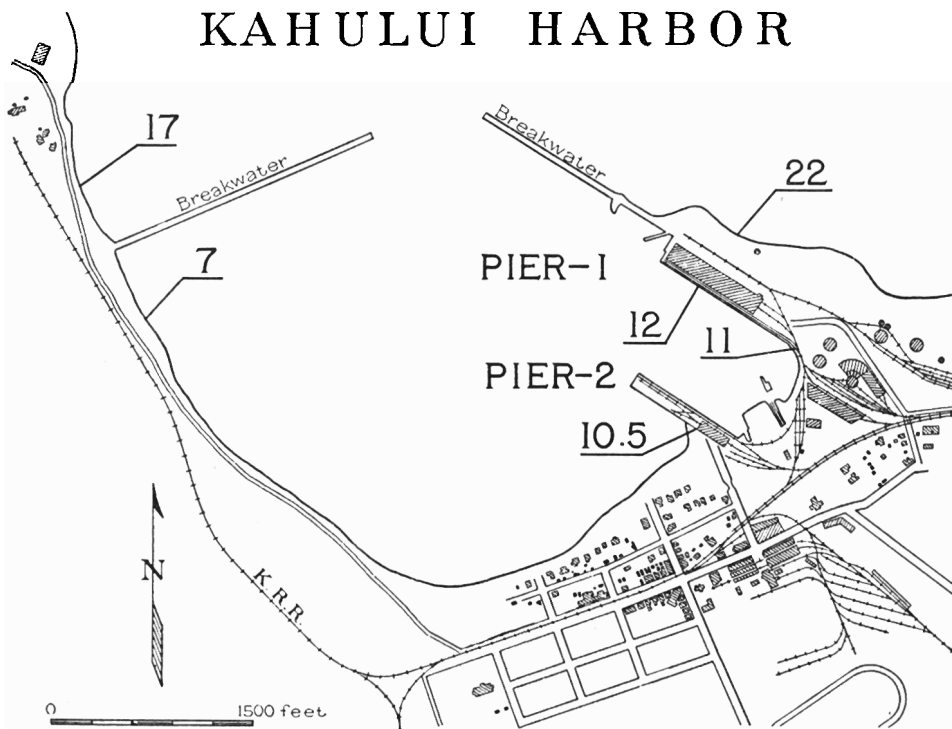
Fig. 15. Map of Kahului Harbor, Maui, showing heights reached by the water during the tsunami of April 1, 1946. Heights are in feet above lower low water.

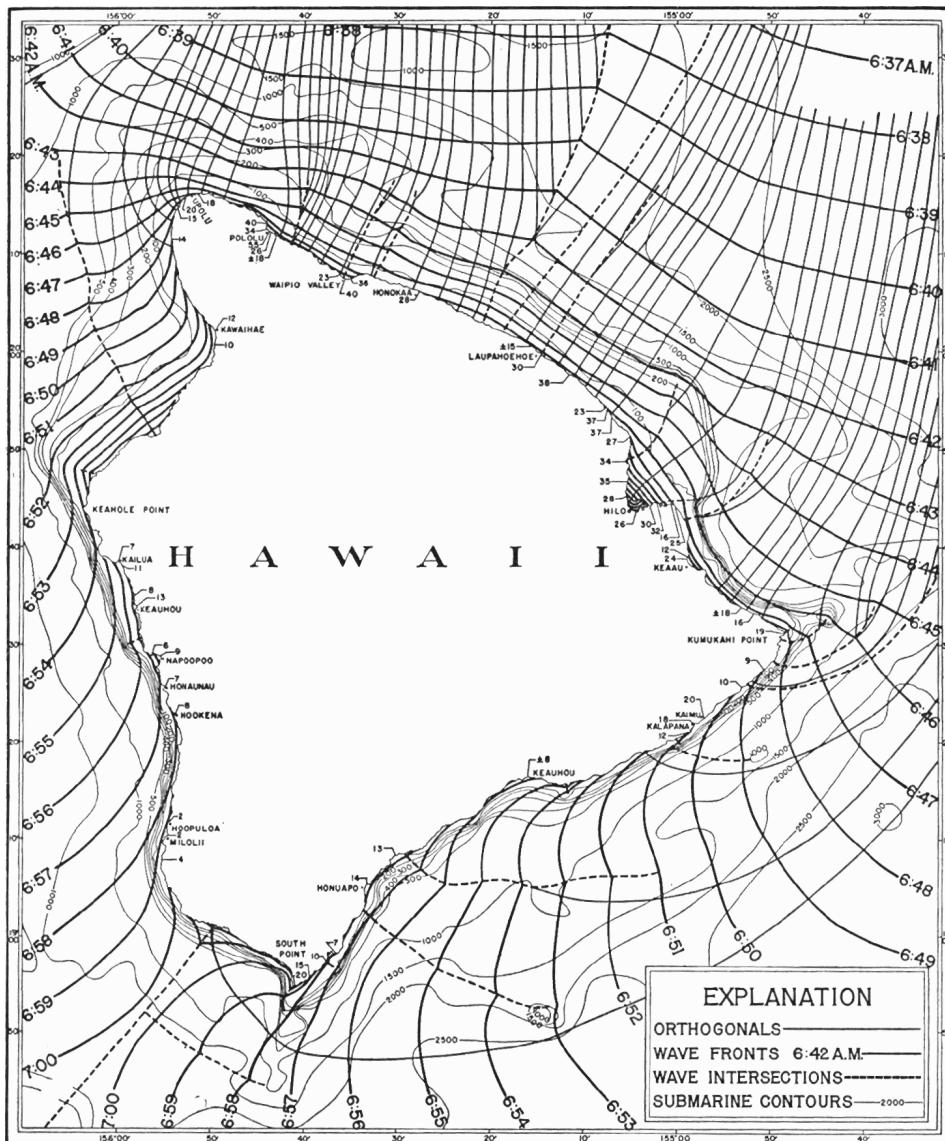
Fig. 16. Map of the island of Hawaii, showing heights (in feet above lower low water) reached by the water during the tsunami, wave fronts, orthogonals, and submarine contours (in fathoms). Times refer to computed time of arrival of first wave.

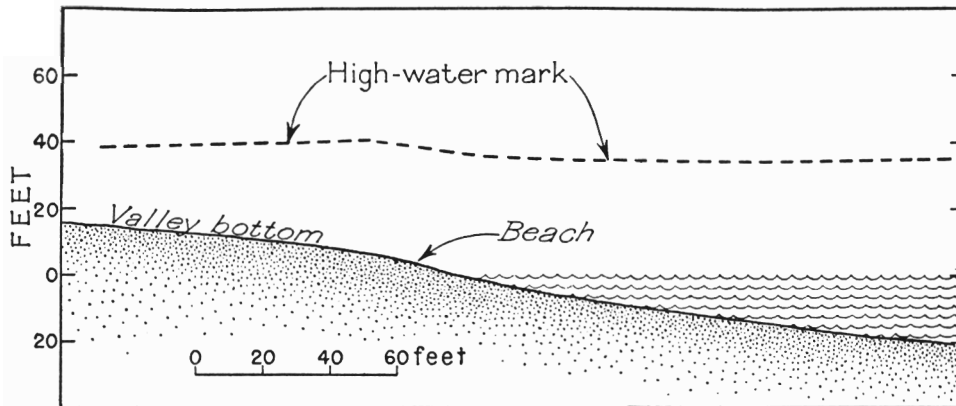
Fig. 17. Profiles of the high-water mark along the northwestern wall of Pololu Valley, Hawaii, and of the valley bottom. Note the hump in the high-water mark just above the beach.

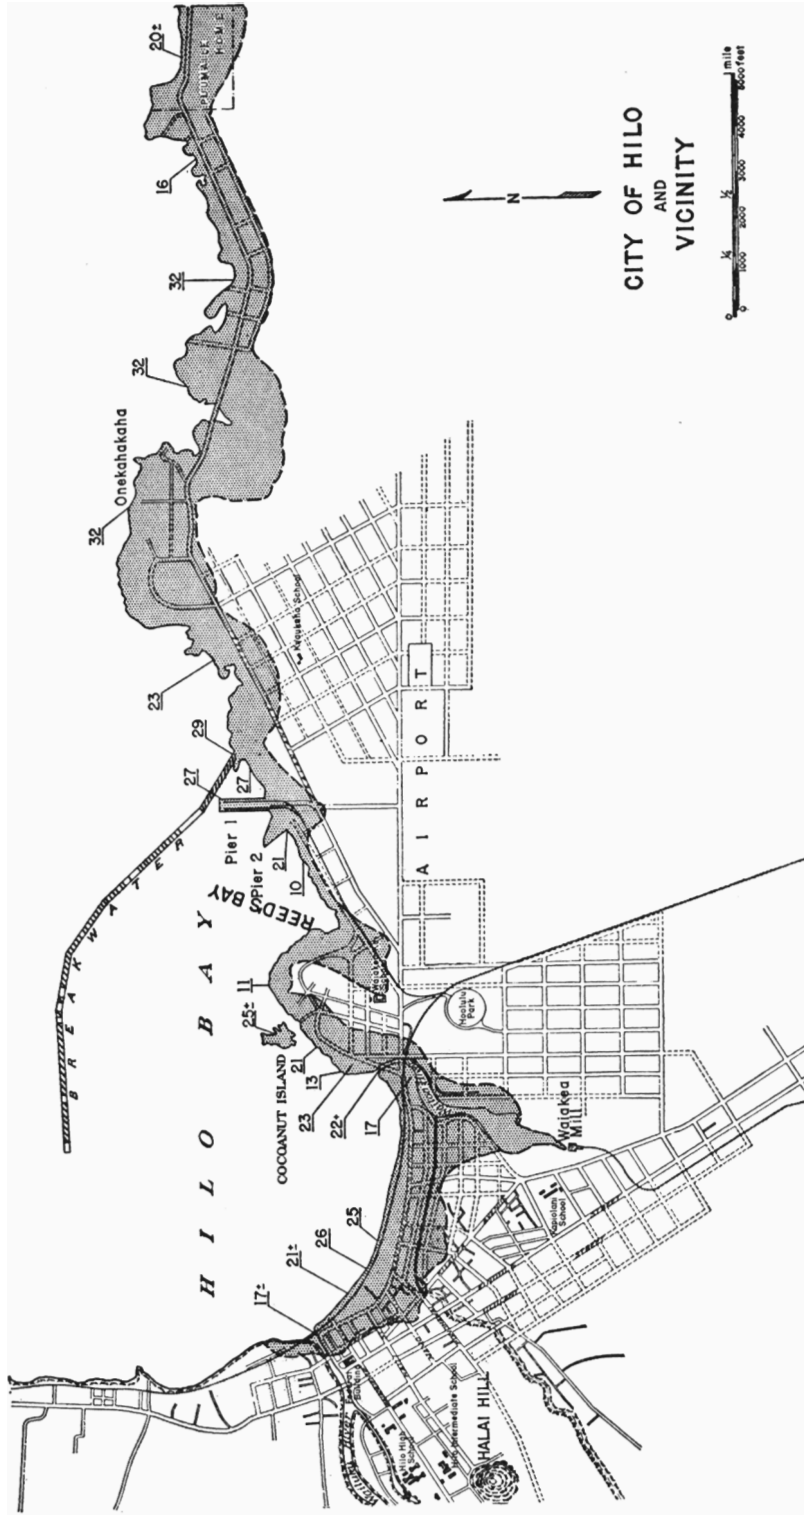
Fig. 18. Map of the Hilo area, Hawaii, showing the heights reached by the water, the area of flooding, and the sections of breakwater destroyed, during the tsunami of April 1, 1946. Heights are in feet above lower low water.

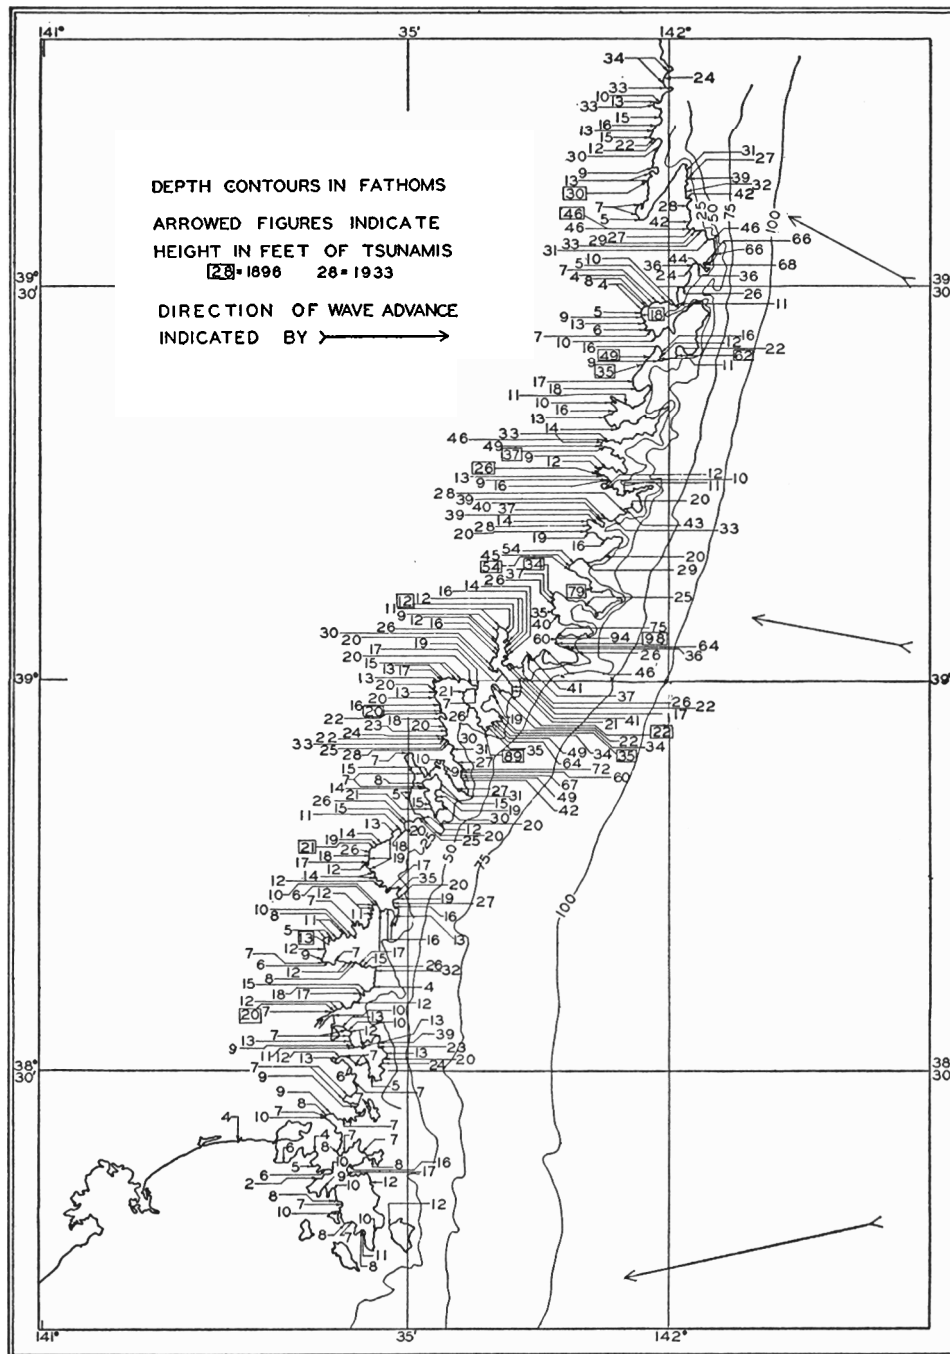
Fig. 19. Map showing the heights reached by the tsunamis of 1896 and 1933
 in the Sanriku district, Japan.

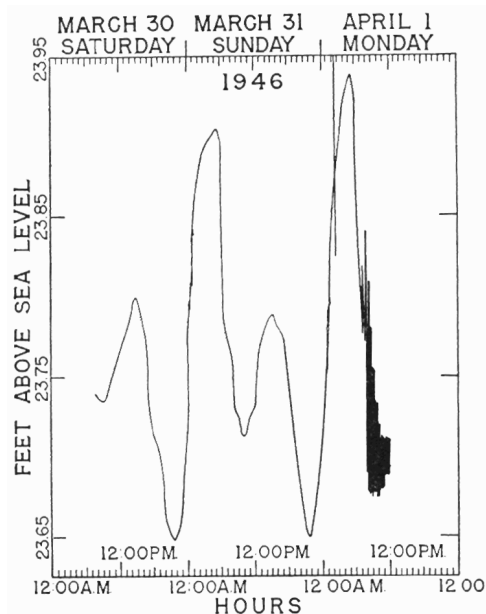
Fig. 21. Record of the tsunami of April 1, 1946, on the water-stage recorder in the Thomas Square artesian well (drilled well 83), Honolulu.

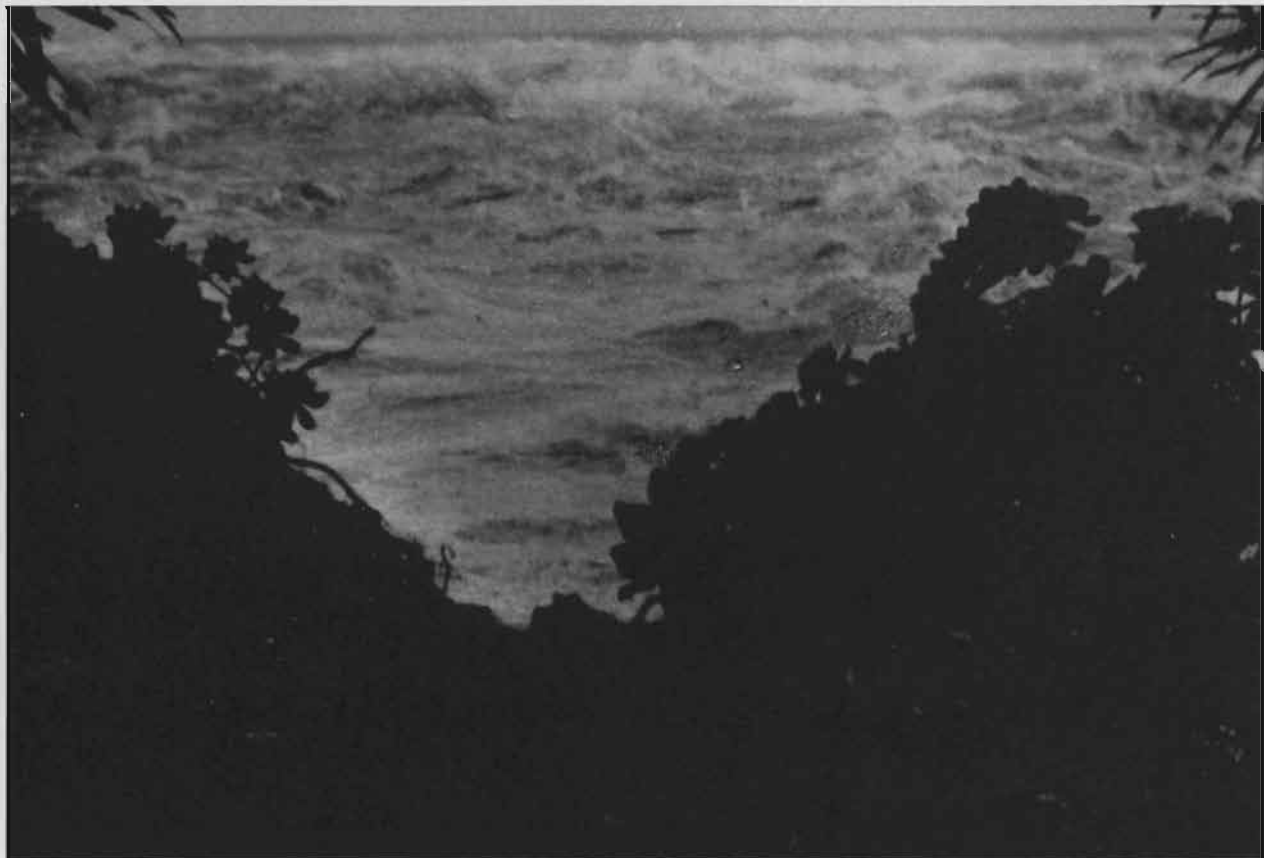
PLATE 6

Tsunami crossing the reef and lagoon near Kawela Bay, Oahu. A few seconds after the picture was taken the wave swept across the low ridge in the foreground. Note the turbulence in the normally protected lagoon. Photo by F. P. Shepard.

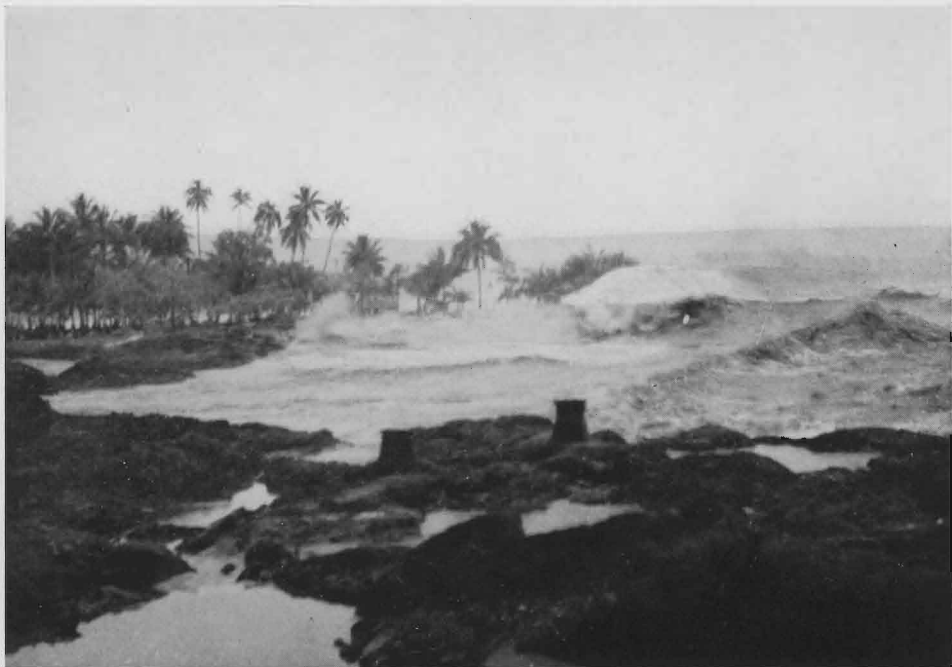
a

- a.* One of the late, relatively small waves of the tsunami sweeping over Coconut Island, in Hilo Bay.
- b.* Water draining from shore during the recession of the same wave.
Photos by Millard Mundy.

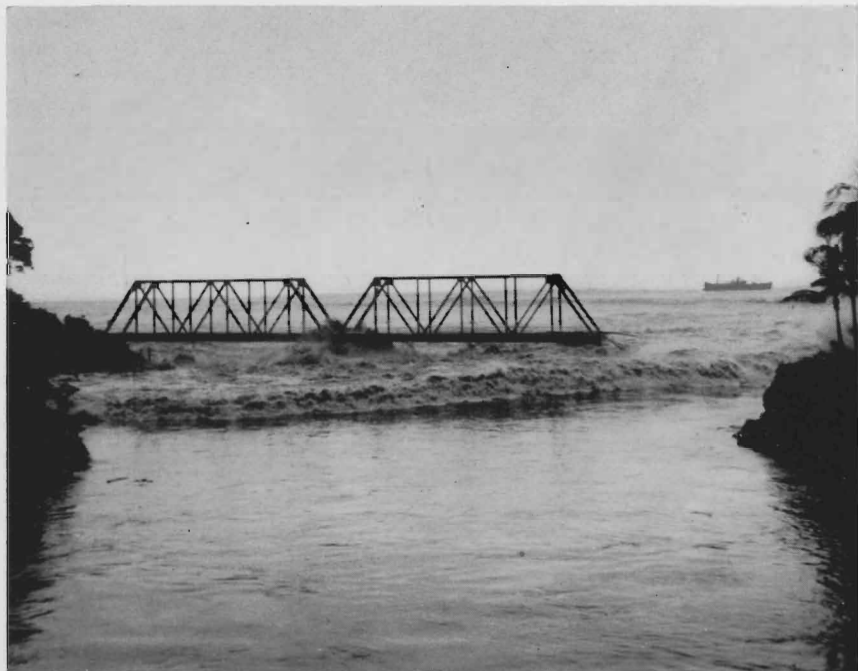
a

- a.* Bore advancing past the railroad bridge at the mouth of the Wailuku River, Hilo. A previous wave had removed one span of the bridge, Note the steep front, the turbulence of the water behind the bore, and the placidity of the water in front of it. Photo by Shigeru Ushijima.

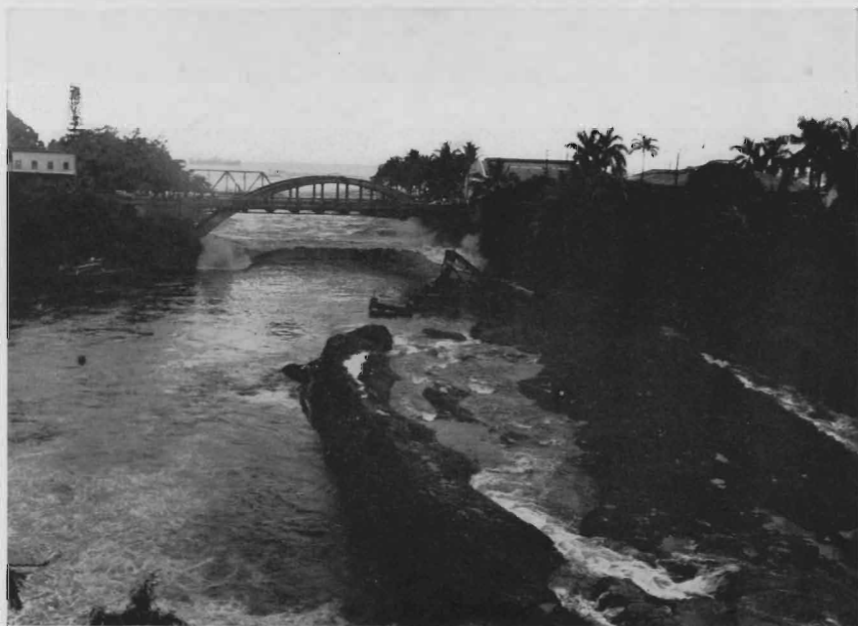
b

- b.* Advance of one of the later waves into the Wailuku River. This photograph was taken from the bridge next upstream from that shown in *a*, above. Photo by Francis Lyman.

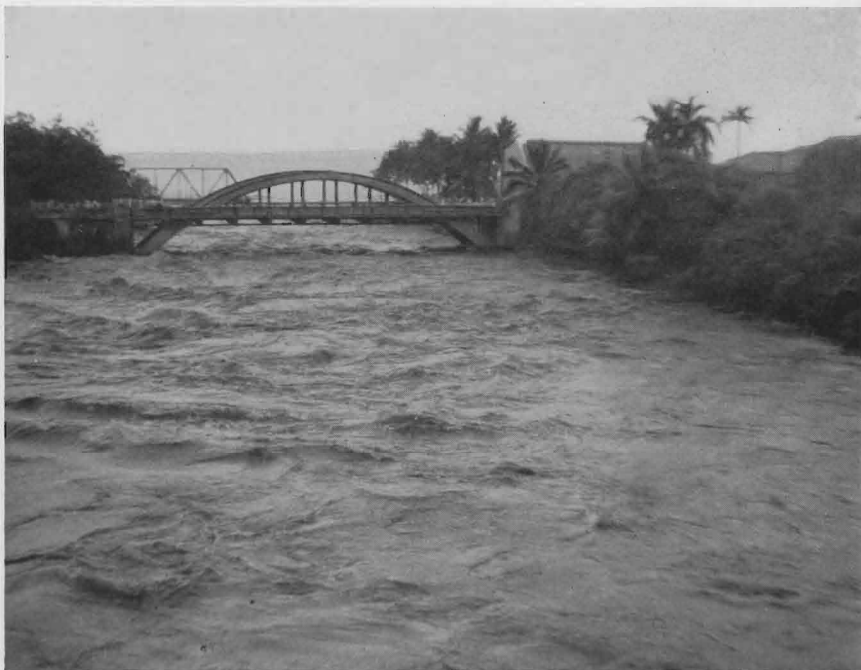
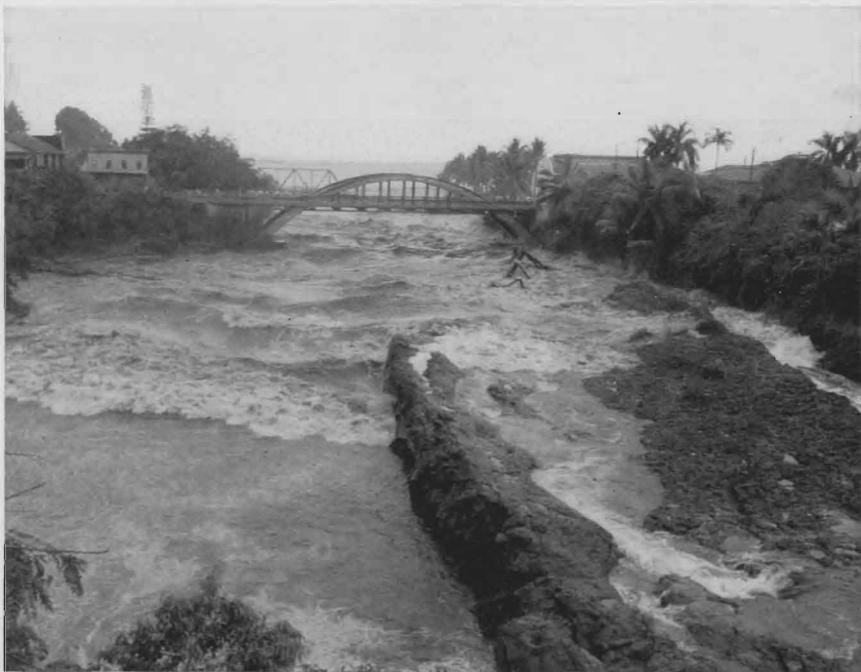
PLATE 9

Later stages in the advance of one of the later waves into the Wailuku River. Photos by Francis Lyman and Warren Flagg.

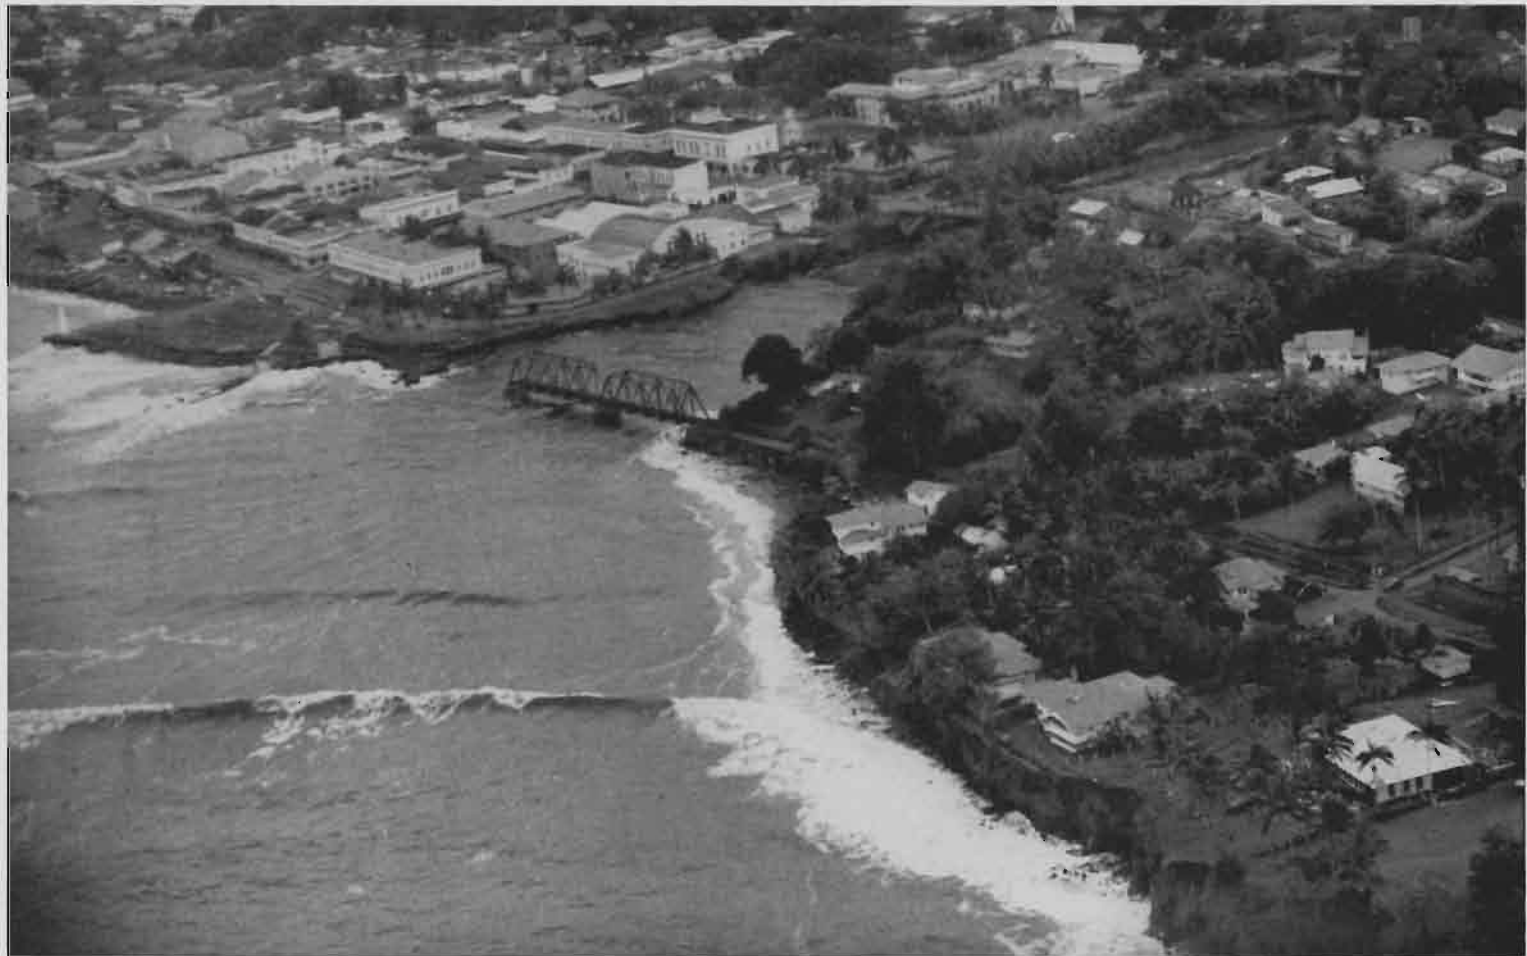
PLATE 10

One of the late waves approaching the Wailuku River, Hilo. Part of the ruined Hilo water front is seen to the left. Photo by U. S. Army Transport Command.
