The Tsunami of April 1, 1946

F. P. SHEPARD, G. A. MACDONALD, AND D. C. COX

BULLETIN OF THE SCRIPPS INSTITUTION OF OCEANOGRAPHY
OF THE UNIVERSITY OF CALIFORNIA
LA JOLLA, CALIFORNIA

Volume 5, No. 6, pp. 391-528, plates 6-33, 21 figures in text

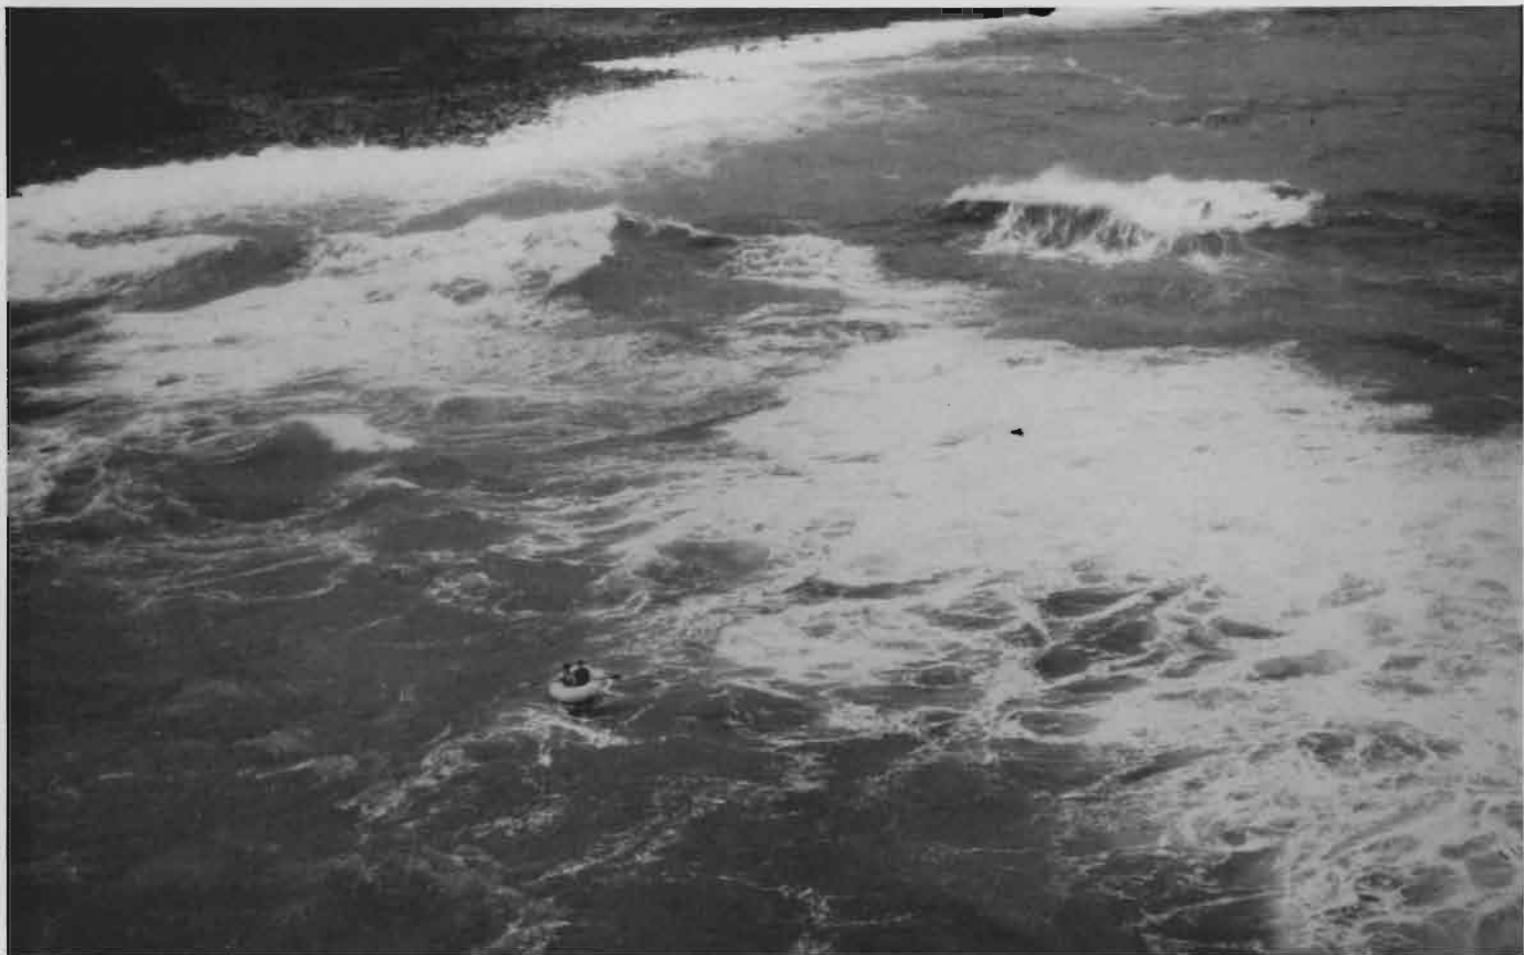
PLATE 11

Photo by the U. S. Navy which apparently shows one of the waves of the tsunami spread over the coast near Laupahoehoe. Note raft dropped by Air Force plane to rescue persons swept to sea by waves which crossed Laupahoehoe Peninsula. Part of the turbulence is evidently due to wind waves, but the crest which is apparently moving along the coast is probably due to the tsunami.

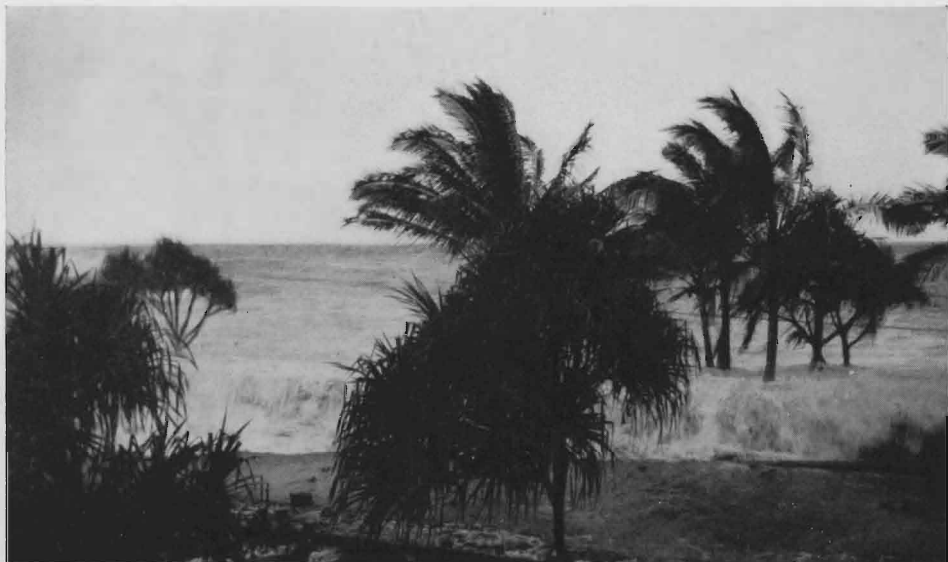
a

- a.* An early wave flooding over the sea wall at the Puu Maile Hospital near Hilo. Note the broad, relatively flat crest of the tsunami with smaller storm waves superimposed. Photo by Mrs. Pearl Welsh.
- b.* Grove of pandanus trees pushed over by the waves, and blocks of coral thrown up on the shore platform near Haena, Kauai. Photo by G. A. Macdonald.

- a.* The sea wall at the Puu Maile Hospital at Hilo after the tsunami. See also plate 12, *a*. Photo by Mrs. Pearl Welsh.
- b.* The same sea wall partly collapsed after the huge wind waves of January, 1947, which produced more damage than the tsunami at this locality. Photo by F. P. Shepard.

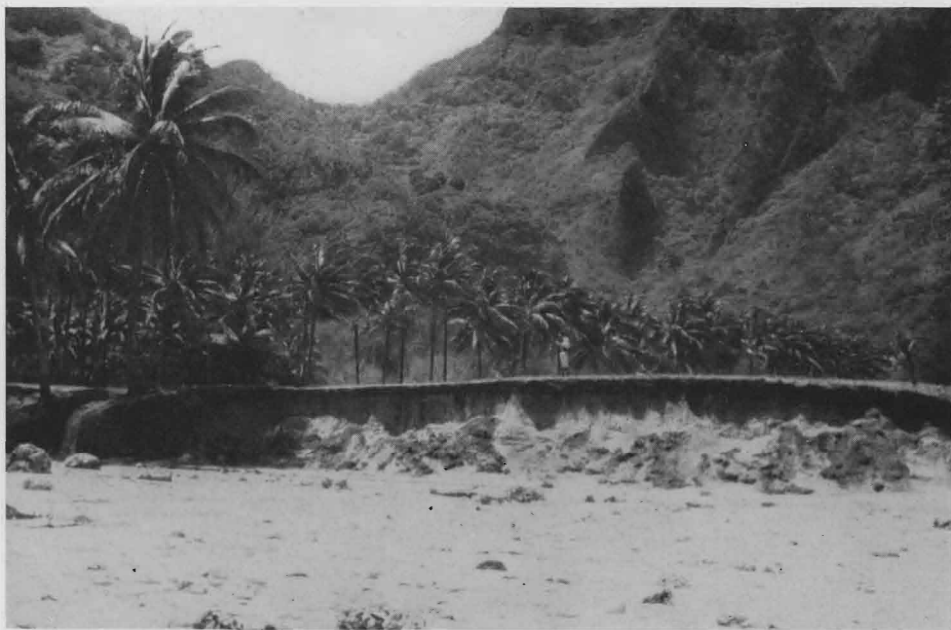
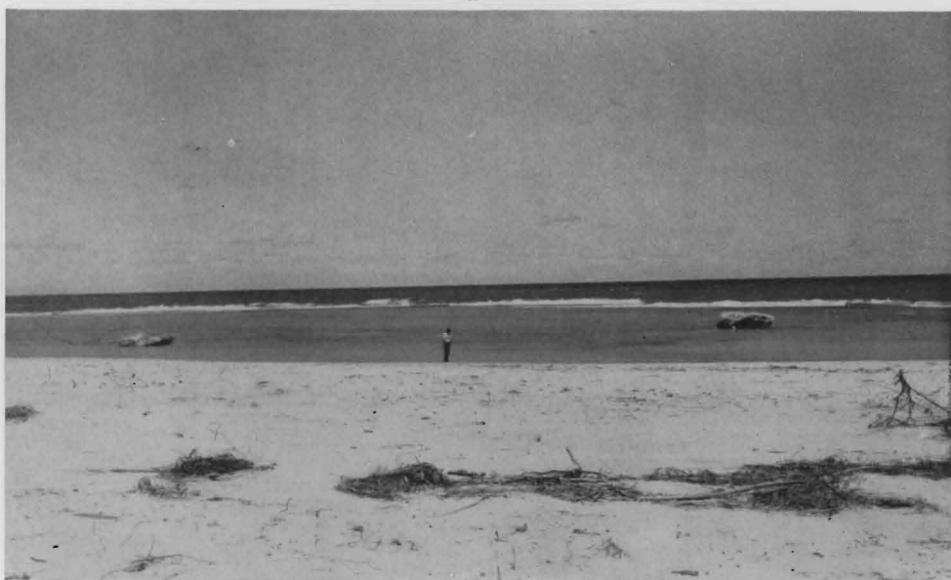
- a.* Scarp cut by the tsunami near Haena, Kauai. Photo by F. P. Shepard.
- b.* Large block of concrete and limestone carried out to the fringing reef by the tsunami near Haena, Kauai. Photo by G. A. Macdonald.

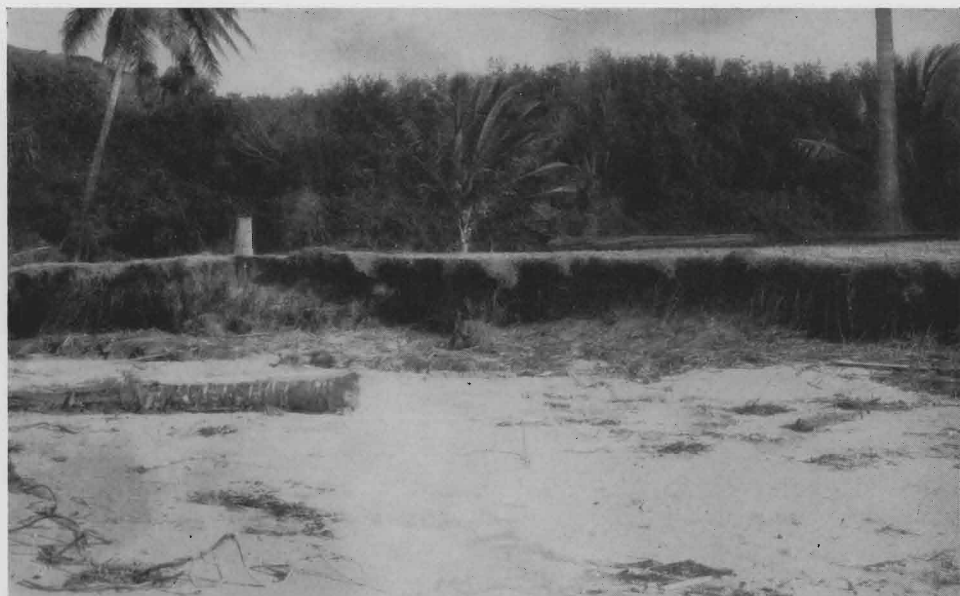
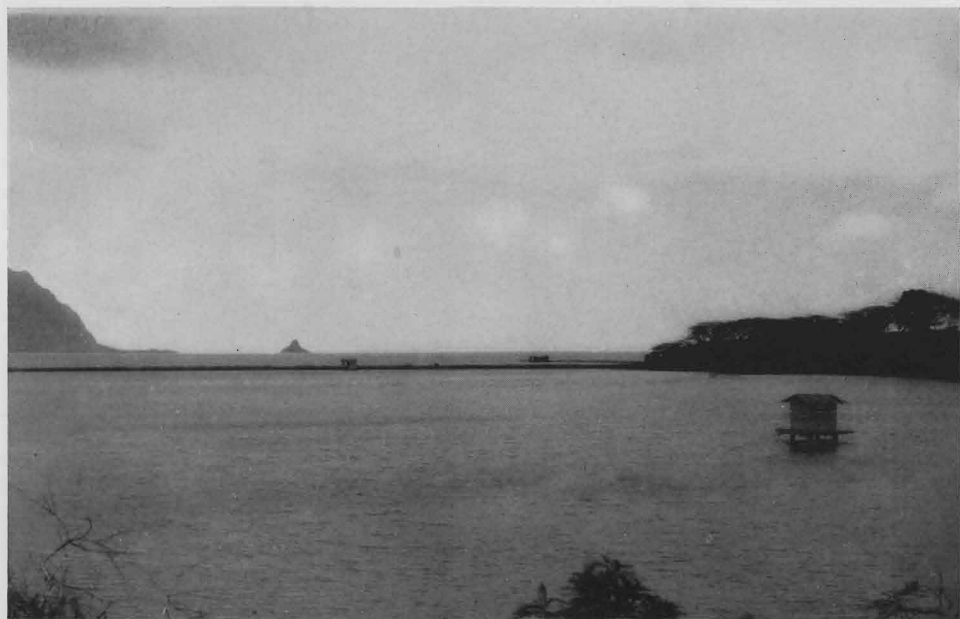
- a.* Scarp 6 feet high cut by the tsunami at the head of the beach at Moloaa, Kauai. Note the roots exposed on the bank. Photo by G. A. Macdonald.
- b.* Shacks and pier close to sea level in Kaneohe Bay, Oahu, untouched by the tsunami. Photo by G. A. Macdonald.

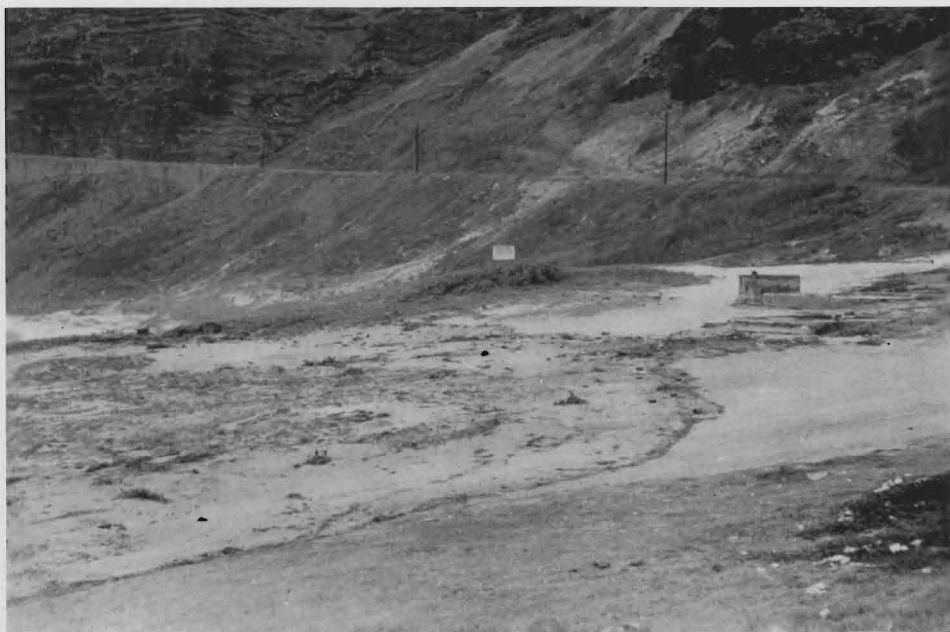
a

- a.* Swash marks left by the tsunami 37 feet above sea level in the small embayment just northwest of Makapuu Head, Oahu. Photo by John Isaacs, University of California.
- b.* Highway east of Koko Crater, Oahu, washed out by the tsunami. Photo by F. P. Shepard.

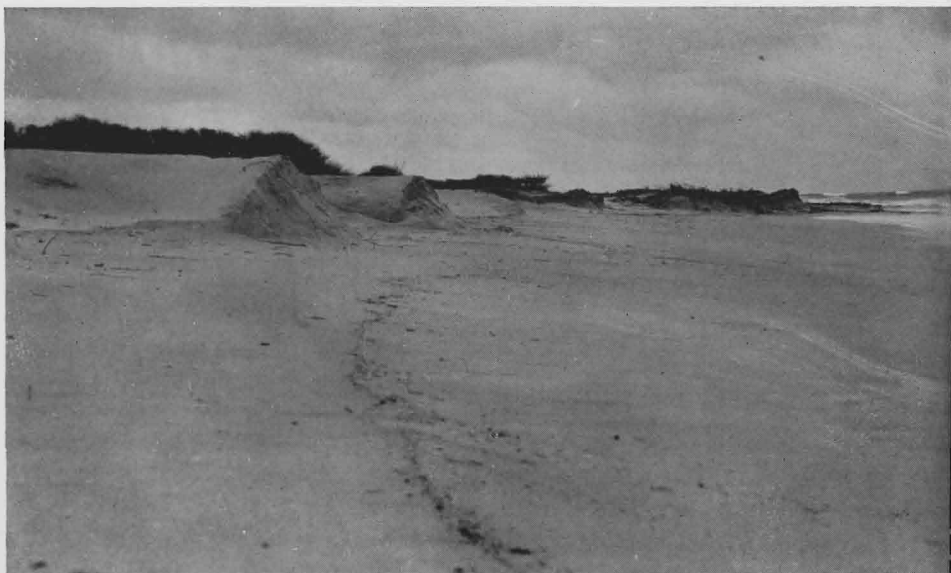
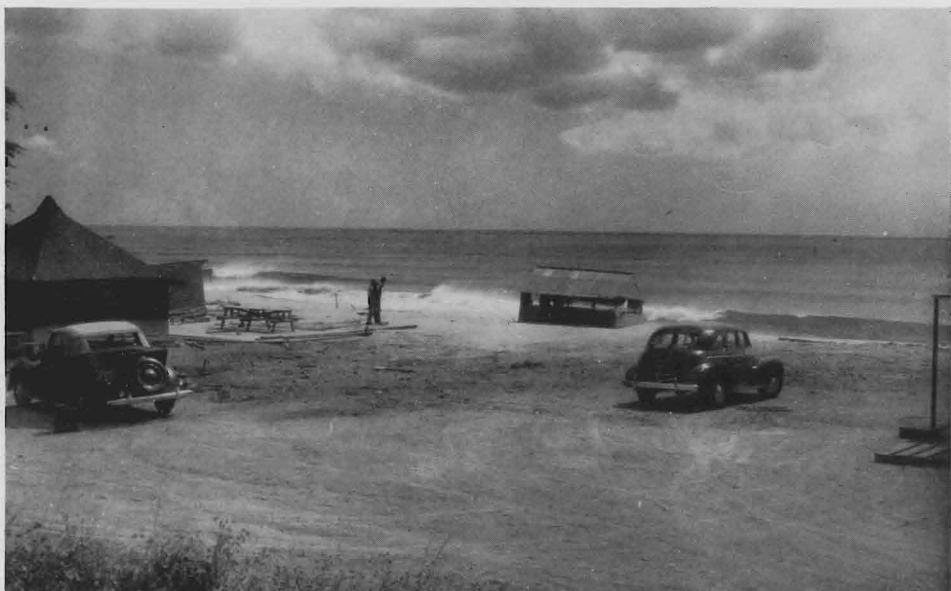
- a.* Beach cusps 6 feet high and with sharply truncated ends, formed by the tsunami east of Koko Crater, Oahu. Photo by John Isaacs, University of California.
- b.* House swept seaward near the mouth of Limaloa Gulch, Oahu, by the tsunami. Its former position is marked by the concrete foundation platform. Photo by G. A. Macdonald.

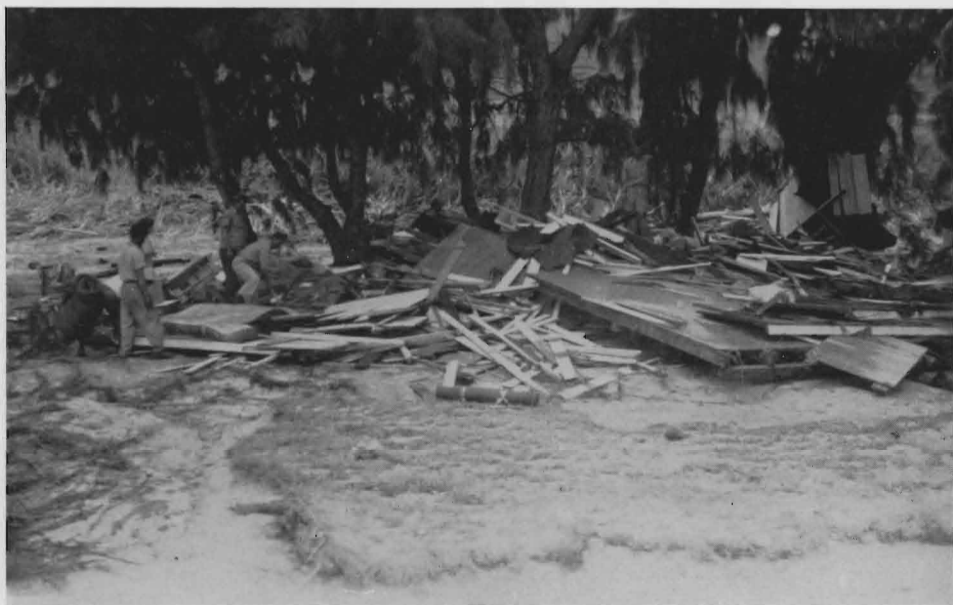
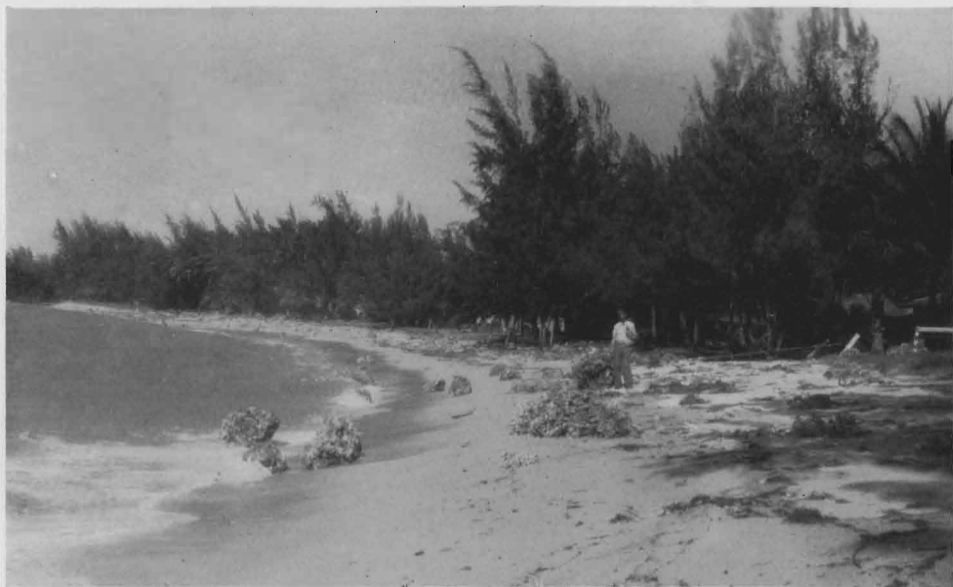
- a.* House at Kawela Bay, Oahu, demolished by the tsunami. Sugar cane in the background was knocked over by the waves. Photo by H. S. Palmer.
- b.* Coral blocks washed ashore by the tsunami at the head of Kawela Bay, Oahu. The blocks were quarried from the reef on the floor of the bay. Photo by G. A. Macdonald.

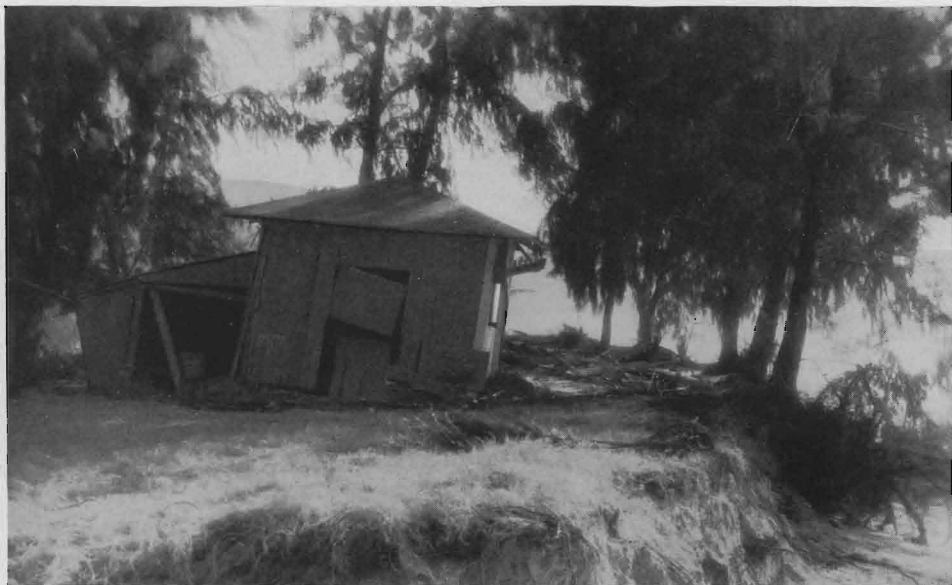
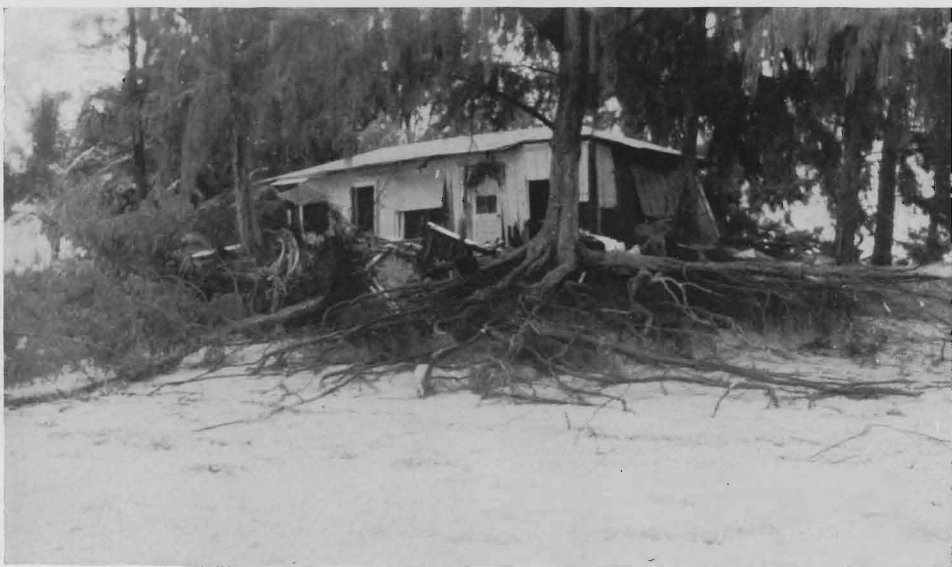
- a.* Palmer house at Kawela Bay, Oahu, badly damaged by the tsunami. A glassed-in lanai (porch) along the front of the house was demolished. Note the escarpment which was largely a product of the waves. The ironwood trees served as some protection to the house. Photo by H. S. Palmer.
- b.* Another view of the Palmer house.

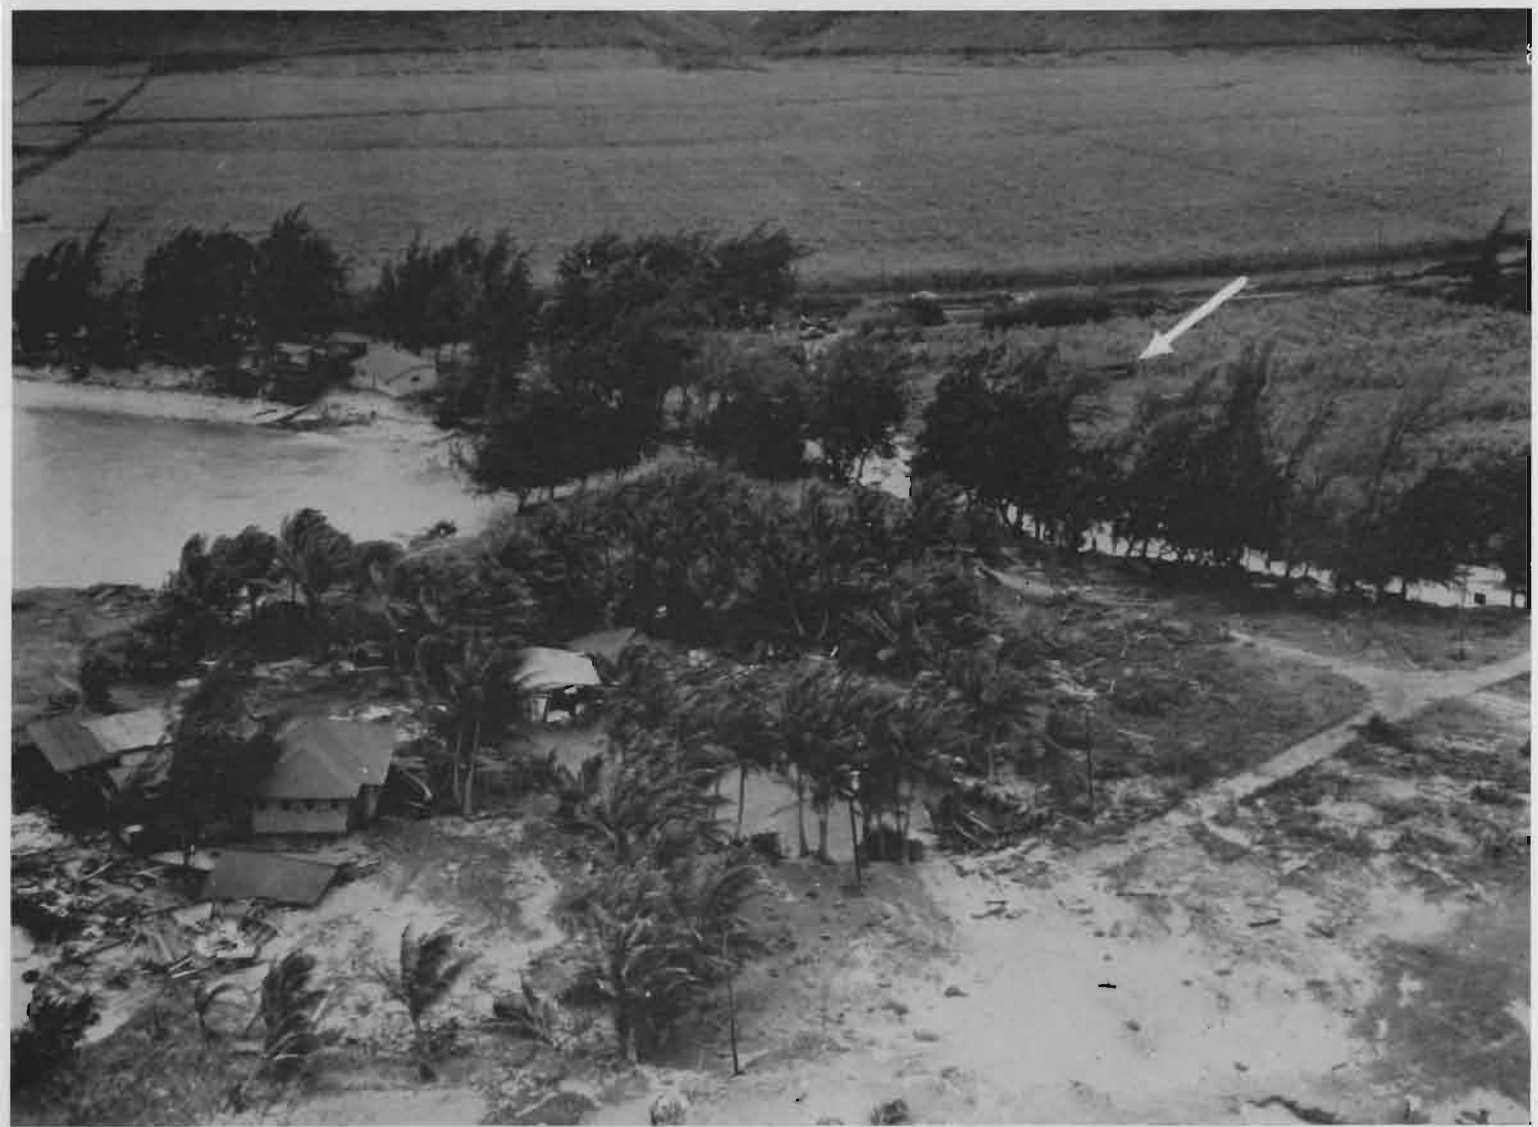
PLATE 20

Houses shifted and wrecked by the tsunami, at the southeastern side of Kawela Bay, Oahu. In the center foreground two houses have been washed into a sinkhole lake, and the house shown by the arrow was carried 200 feet into the cane field without damage to its furnishings or occupants. Photo by U. S. Navy.

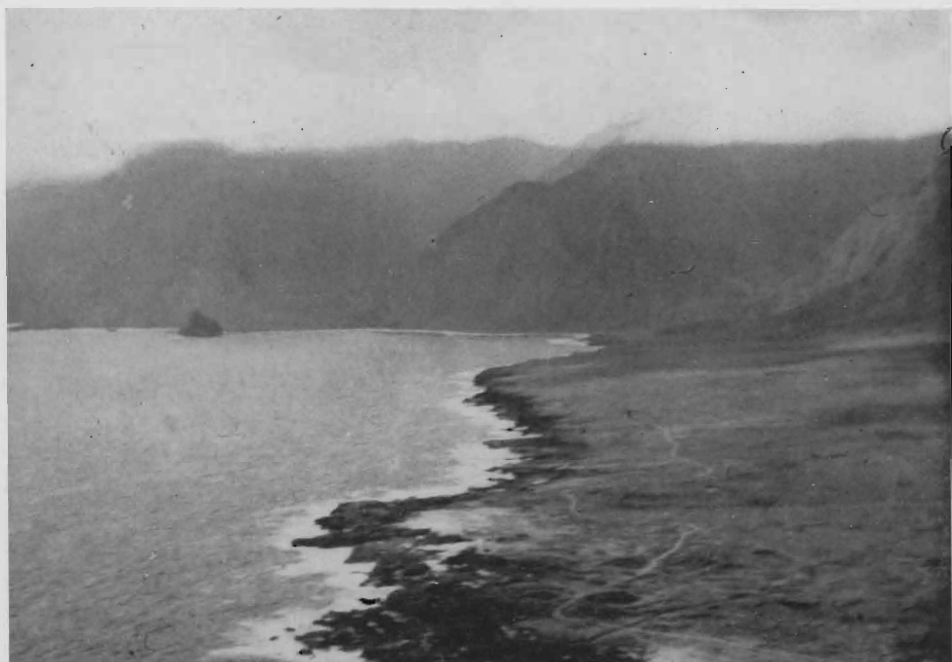
- a.* View of Kalaupapa Peninsula, Molokai, from the air. At the end of the peninsula (foreground) the wave rose only 8 feet, whereas it attained 54 feet on the side of the canyon in the left background. Photo by F. P. Shepard.
- b.* Line of driftwood (at the man's feet) left by the tsunami 8 feet above sea level near the end of Kalaupapa Peninsula, Molokai. A higher line of driftwood left by winter storms can be seen just over the man's head. Photo by G. A. Macdonald.

Promontories bordered by deep water.—In general, pronounced coastal promontories are prolonged in submarine ridges. Some, however, like Kalaupapa Peninsula on the north coast of Molokai (see fig. 13), project into deep water. At such places the heights which the tsunami reached on shore were considerably less than those in adjacent areas, because of the short interval of transition from deep water to shallow water conditions. At the end of Kalaupapa Peninsula the waves of the tsunami reached a height of only 7 feet. In contrast, along the coast east and west of the peninsula, where a moderately wide belt

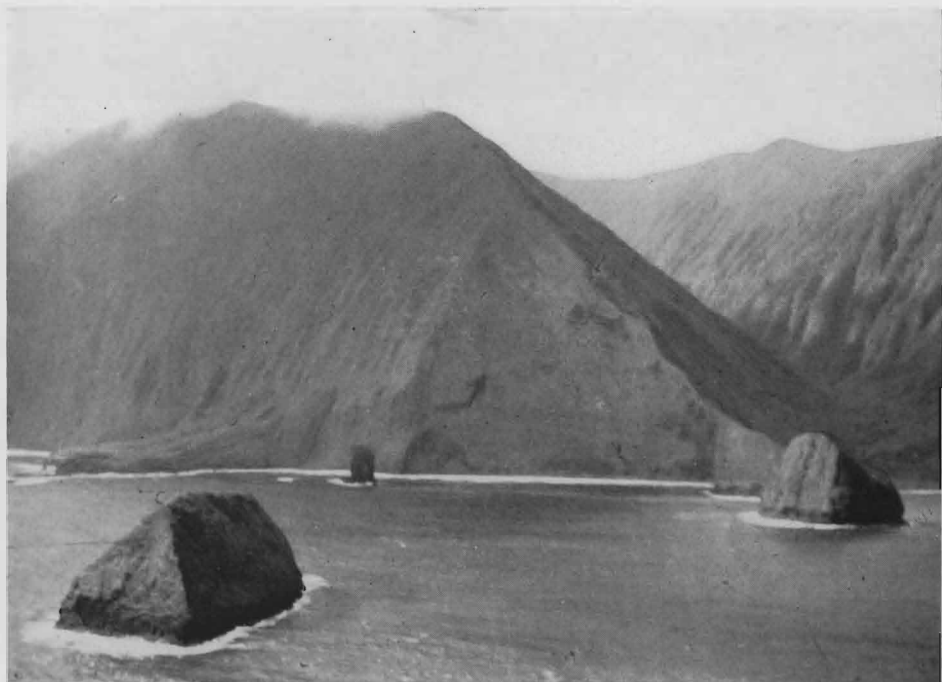
a

- a.* Air view of Waikolu Valley, Molokai, where the water rose 54 feet above sea level. Note the small islands which may have helped funnel the water into this valley. Photo by F. P. Shepard.
- b.* View of Halawa, northeastern Molokai, on April 2. The land was swept so clean that it could serve as an airport. Photo by F. P. Shepard.

The great height of 54 feet reached by the water at Waikolu Valley, Molokai, may have resulted partly from funneling between Kalaupapa Peninsula and the headland and small islands east of the mouth of the valley (see fig. 13).

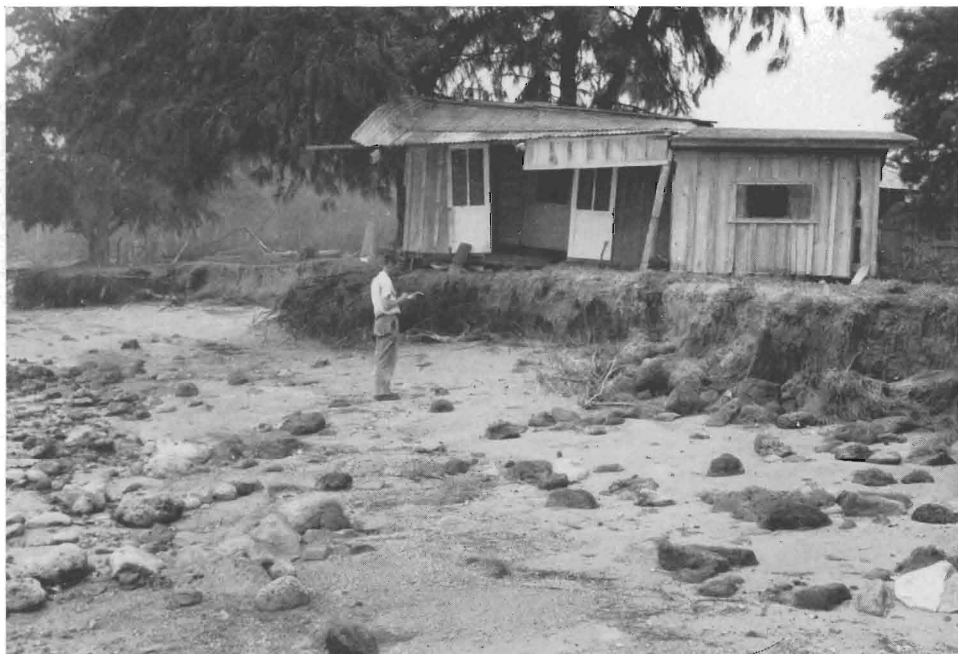
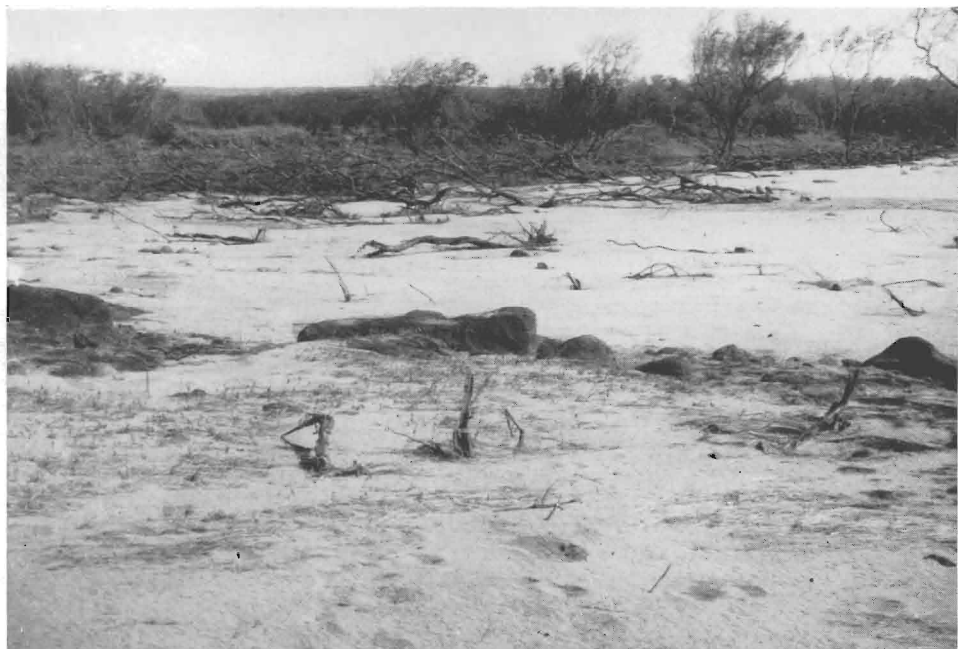
- a.* Damaged house and escarpment cut by the tsunami at the head of the beach at Kainalu, Molokai. The beach head was cut back at least 10 feet. Photo by G. A. Macdonald.
- b.* Kiawe (algaroba) trees pushed over by the tsunami, near Kapuhi on the western end of Molokai. Photo by G. A. Macdonald.

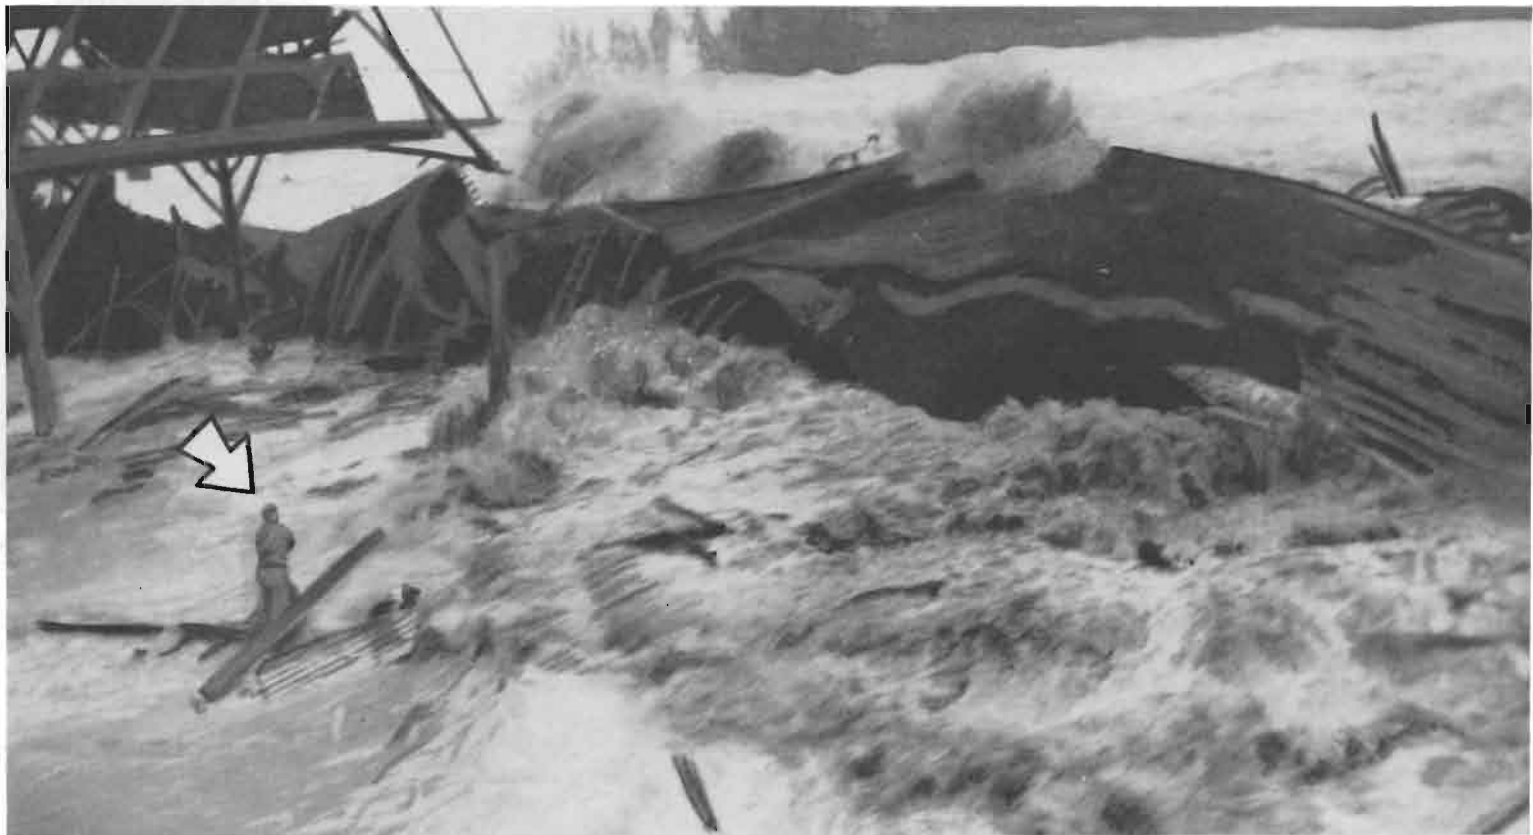
PLATE 23

An early wave, probably the third of the series, breaking over Pier 1, Hilo, and sweeping away part of the shed. Arrow points to a man facing the approaching torrent of water and subsequently lost. Photo from the deck of a vessel lying at the pier, published by permission of Press Association, Inc.

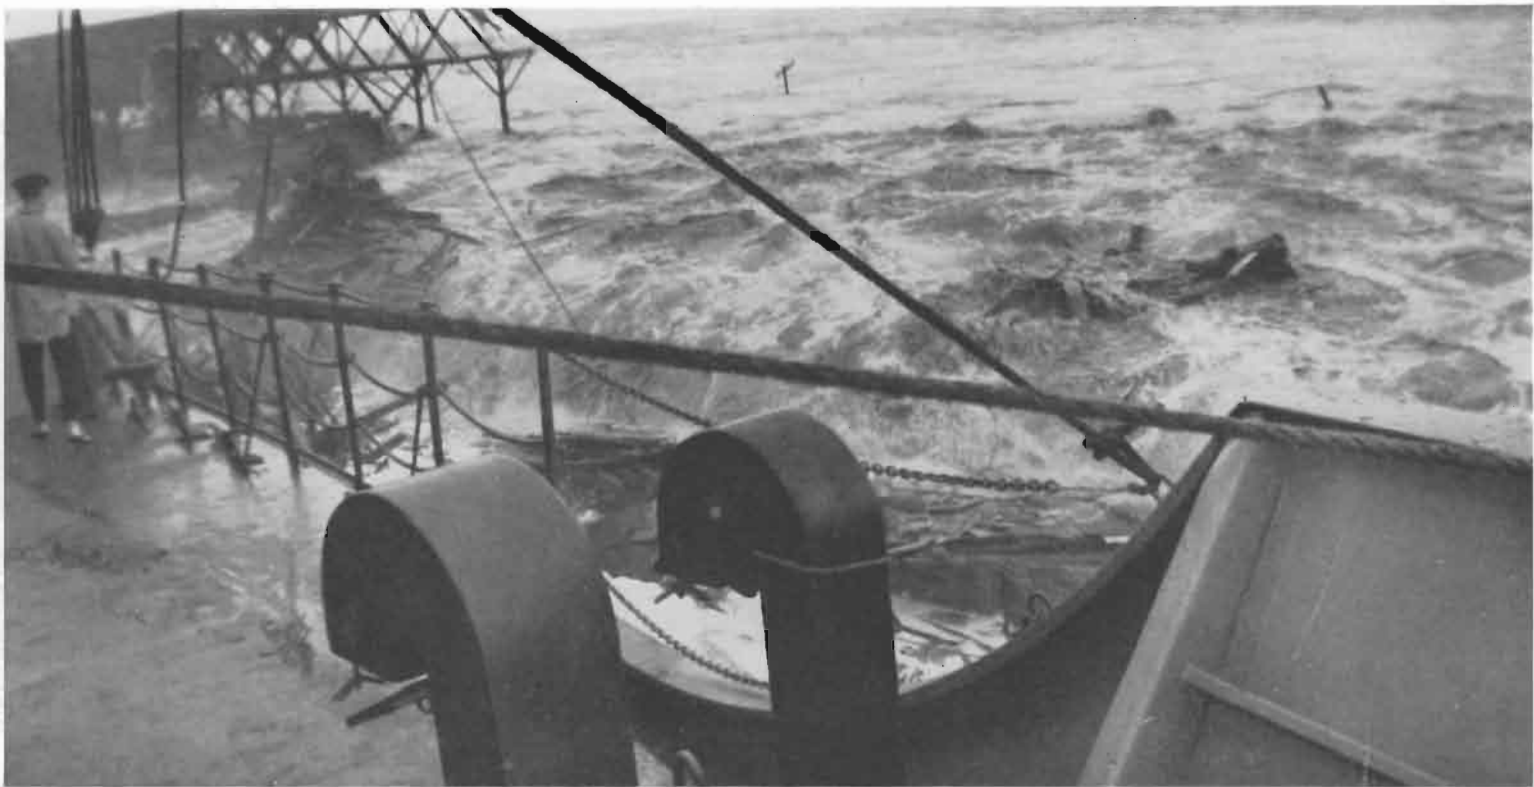
PLATE 24

View of the next wave at a later stage, indicated by the smaller degree of turbulence. Photo from the deck of a vessel lying at Hilo pier, published by permission of Press Association, Inc.

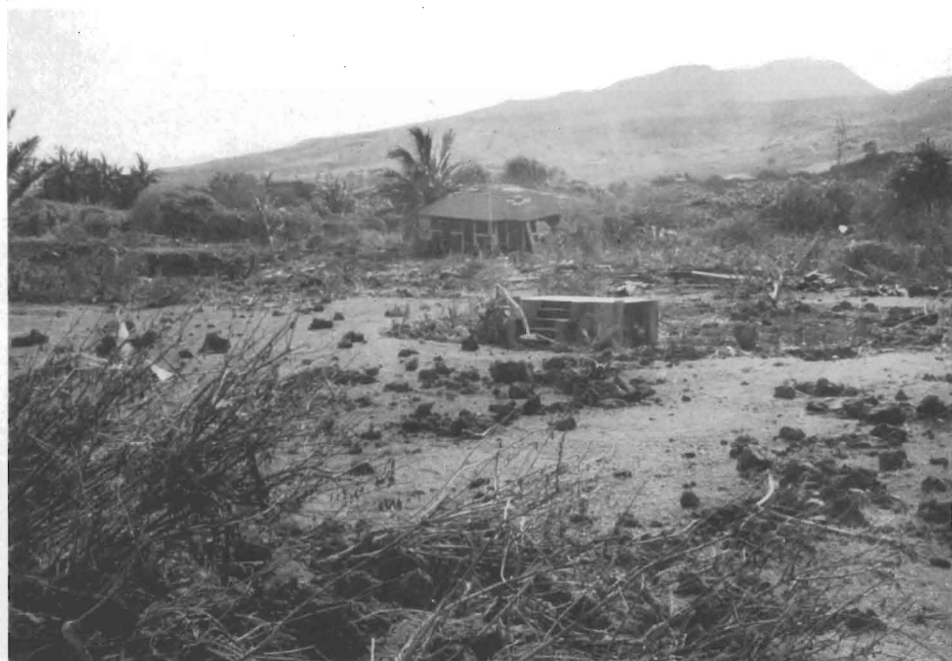
a

- a.* House floated inland 200 feet by the tsunami and left essentially intact, at Hamoa, Maui. Its former position is indicated by the concrete steps in the foreground. Other houses in the area were destroyed. Photo by G. A. Macdonald.

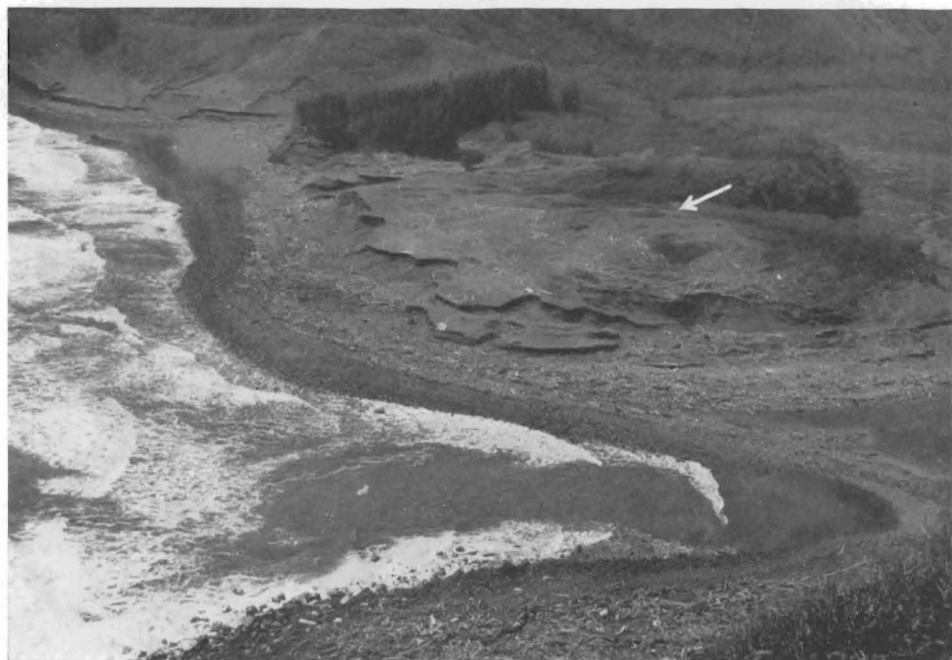
b

- b.* Beach and dune ridge at mouth of Pololu Valley, Hawaii, showing erosion caused by the tsunami on the side and end of the dune ridge. High-water mark of 55 feet indicated by arrow. Photo by G. A. Macdonald.

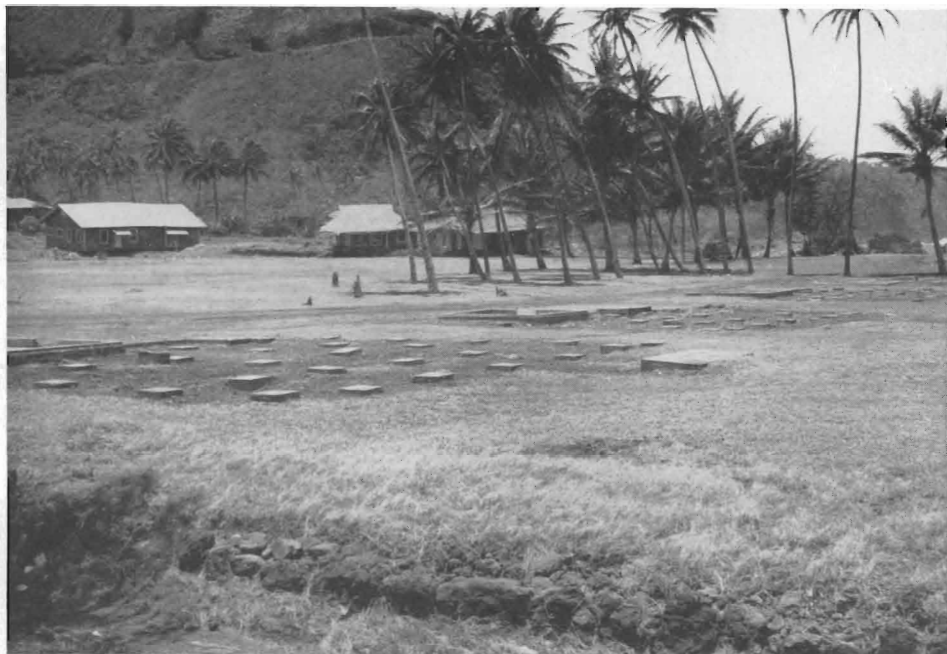
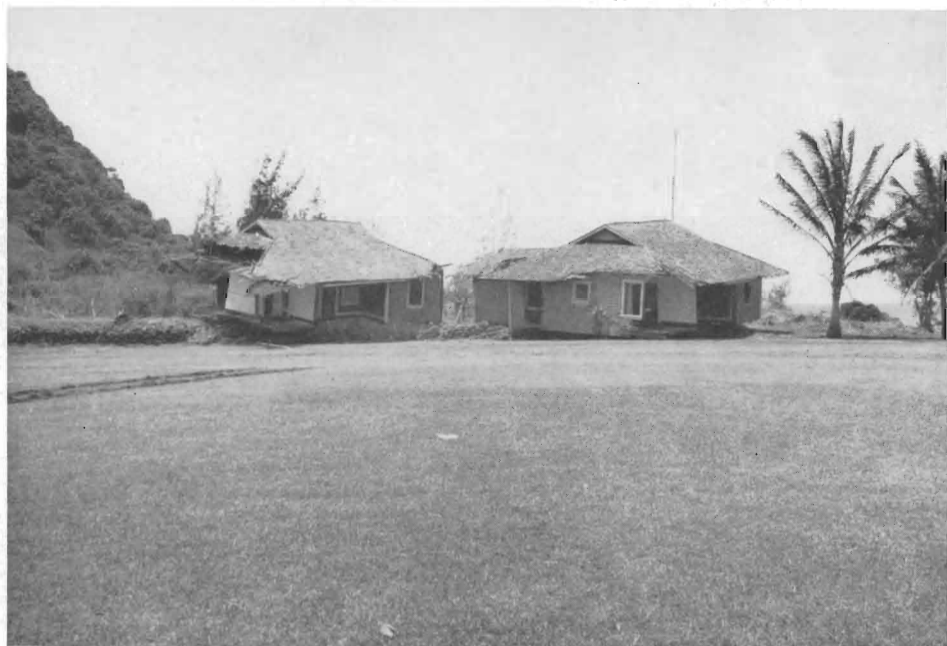
- a.* Houses swept 500 feet from their foundations by the tsunami at Laupahoehoe, Hawaii. The two houses in the central background formerly stood on the concrete footings in the foreground. Other houses swept more to the right were carried into the sea.
- b.* Closer view of houses shown in *a*, above. Photos by G. A. Macdonald.

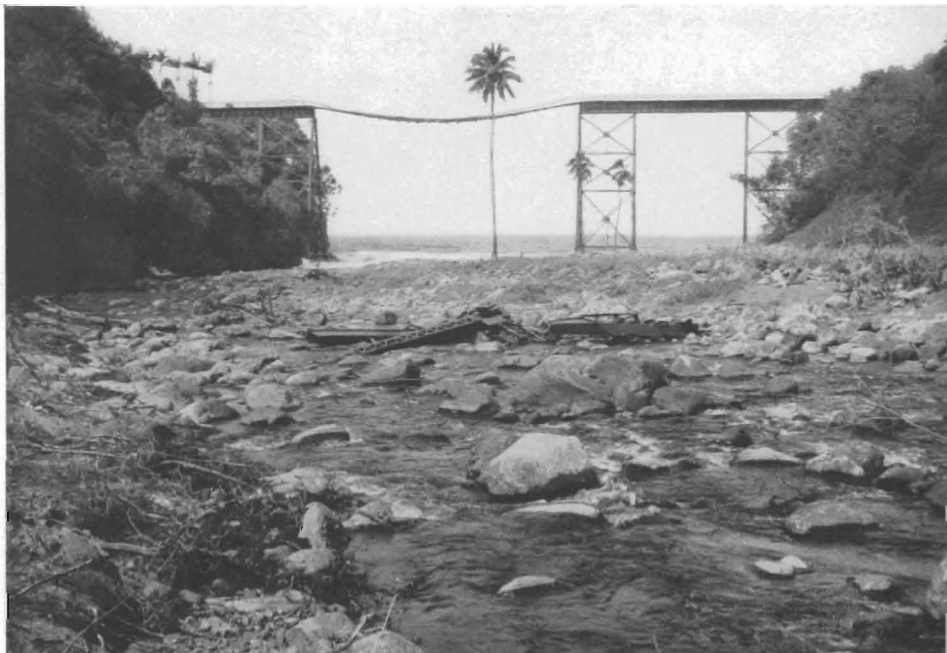
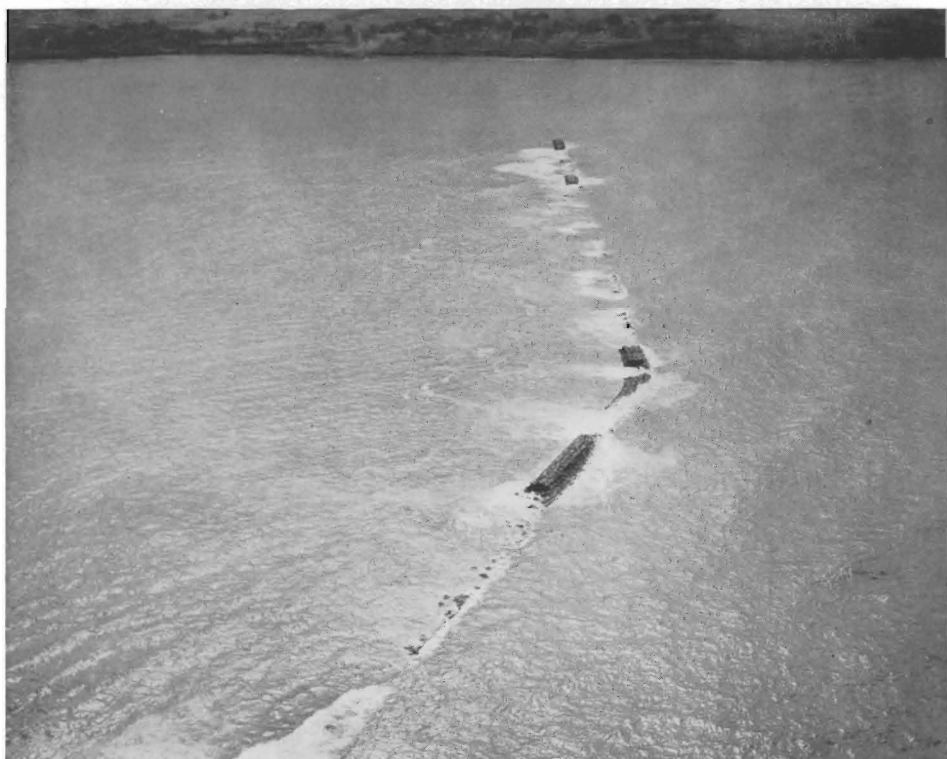
- a.* Railroad bridge at Kolekole Stream, Hawaii, showing the girders of the trestle thrown 500 feet inland by the tsunami, and the bridge deck left hanging by the rails. Photo by G. A. Macdonald.
- b.* Breakwater at Hilo, Hawaii, severely damaged by the tsunami. The rocks were removed to an average depth of 3 feet below sea level. Photo by U. S. Navy.

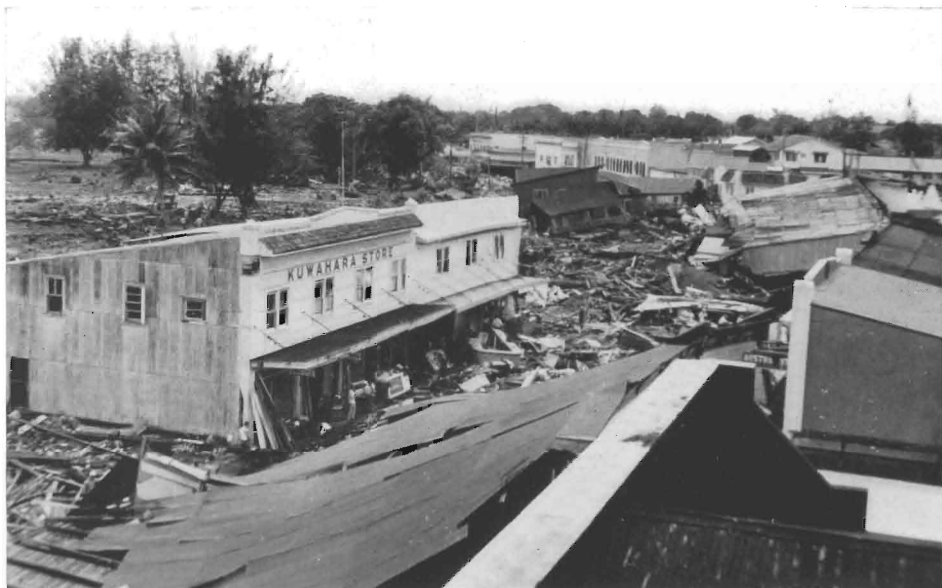
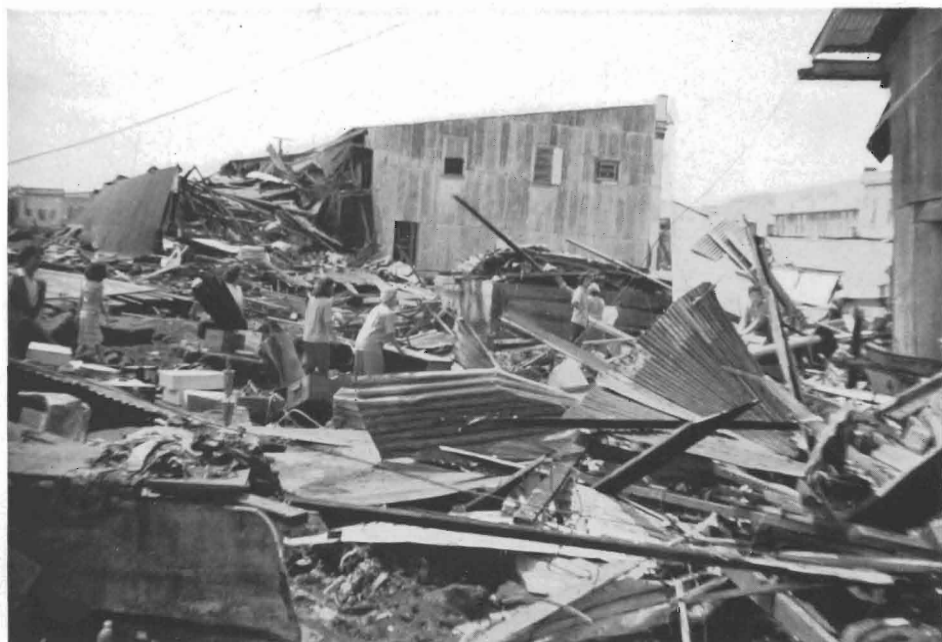
PLATE 28

Wreckage left by the tsunami along Kamehameha Avenue, Hilo. Photos by Francis Lyman.
