The Tsunami of April 1, 1946

F. P. SHEPARD, G. A. MACDONALD, AND D. C. COX

BULLETIN OF THE SCRIPPS INSTITUTION OF OCEANOGRAPHY
OF THE UNIVERSITY OF CALIFORNIA
LA JOLLA, CALIFORNIA

Volume 5, No. 6, pp. 391-528, plates 6-33, 21 figures in text

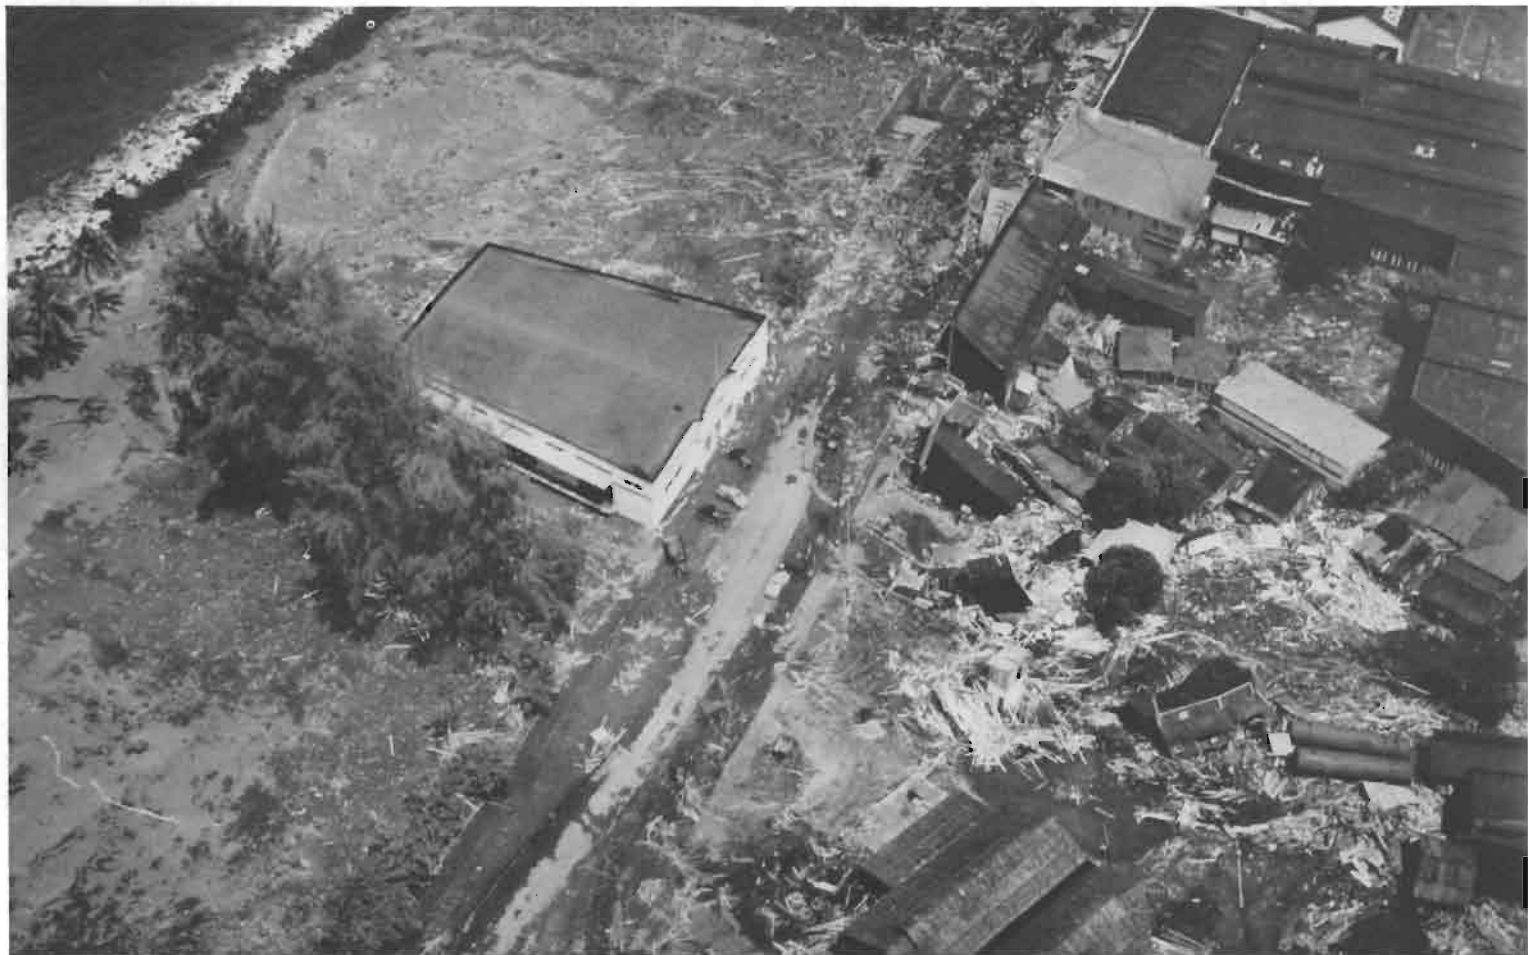
PLATE 30

Water front at Hilo, Hawaii, swept almost bare by the tsunami. Photo by U. S. Navy.

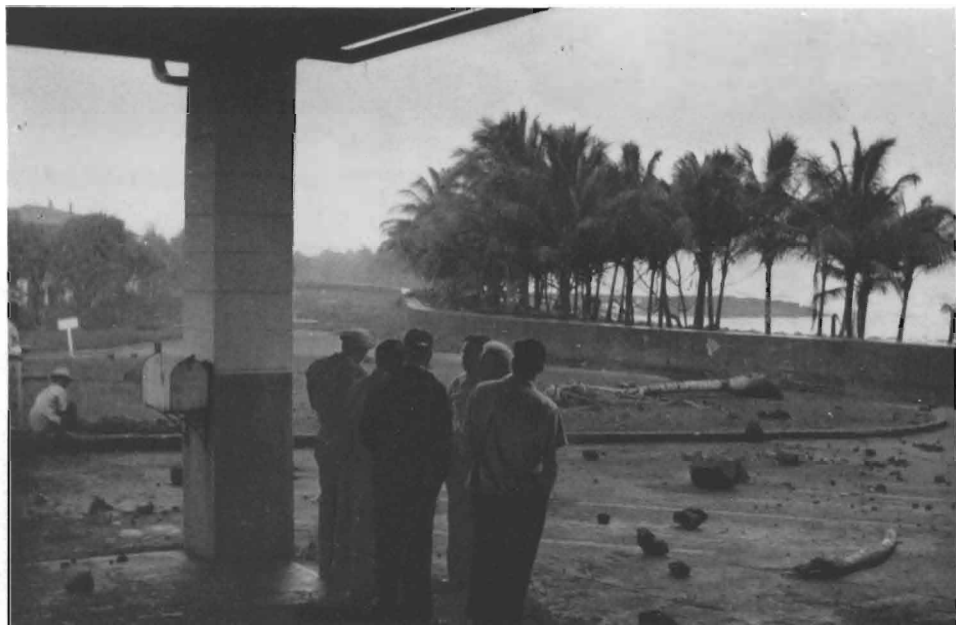
a

- a.* The sea wall at the Puu Maile Hospital at Hilo after the tsunami. See also plate 12, *a*. Photo by Mrs. Pearl Welsh.
- b.* The same sea wall partly collapsed after the huge wind waves of January, 1947, which produced more damage than the tsunami at this locality. Photo by F. P. Shepard.

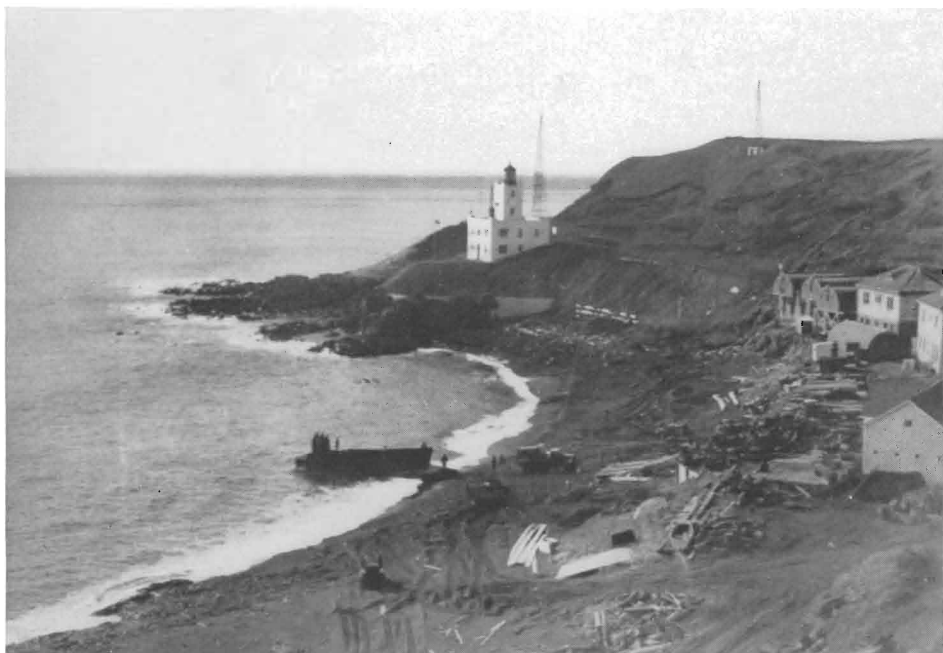
a

- a* Scotch Cap Lighthouse, Unimak Island of the Aleutians, taken before the tsunami. The foundation of the lighthouse is at an elevation of 45 feet, the upper radio mast 103 feet, and the upper plateau 115 feet.
- b*. The same place after the tsunami. Note that the lighthouse and the radio masts have gone, the slopes are heavily washed almost to the plateau level, and debris has been deposited on the plateau. Note also the exposure of stratification on the slopes, revealed by removal of the overburden. The radio masts around the upper building are still standing, and, since the waves hit the locality about four hours before Hawaii, it may be supposed that warning of the imminence of disastrous waves could have been transmitted to Hawaii well in advance of their arrival. Photos by courtesy of 17th Coast Guard.

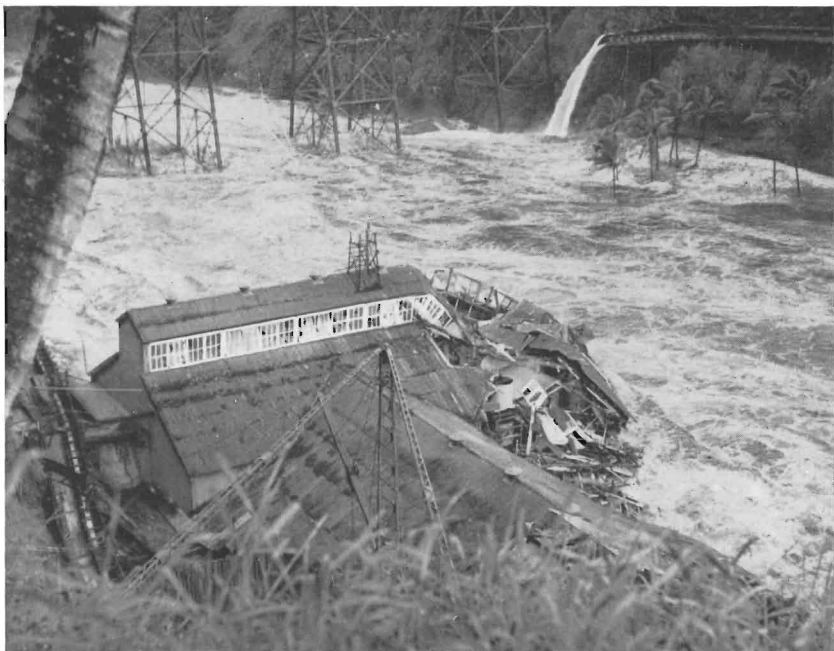
a

- a.* One of the early waves of the series sweeping by the Hakalau sugar mill, Hawaii. The wreckage of the mill can be seen. Photo by Shigeharu Furusho.
- b.* Building at Hilo, Hawaii, of which the lower story collapsed, allowing the second story to drop to the ground level. Photo by Francis Lyman.

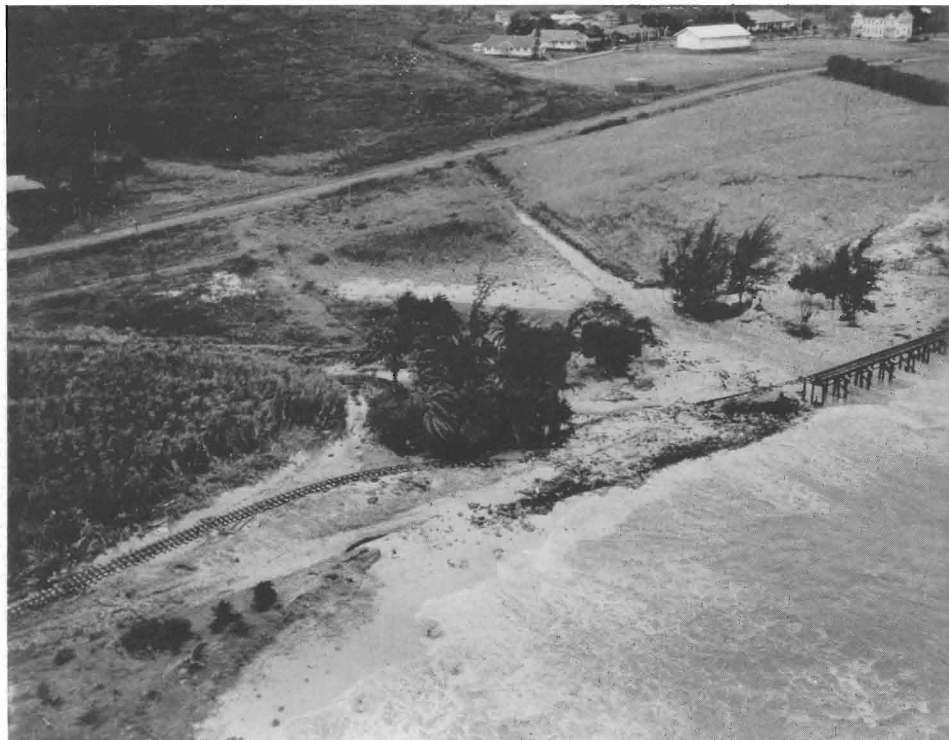
a

- a. Railroad swept inland from its bed, at Waialeale, Oahu. Photo by U. S. Navy.
- b. A fish (*Myripristis* sp., probably *M. prasinus* Cuvier) washed inland and left by the retreating waves. Photo by John Isaacs, University of California.
