Seismic Performance Limitation of Slender Reinforced Concrete Structural Walls

Seismic Performance Limitations of Slender Reinforced Concrete Structural Walls

A dissertation submitted in partial satisfaction of the requirements for the degree Doctor of
Philosophy in Civil Engineering

Christopher Lee Segura

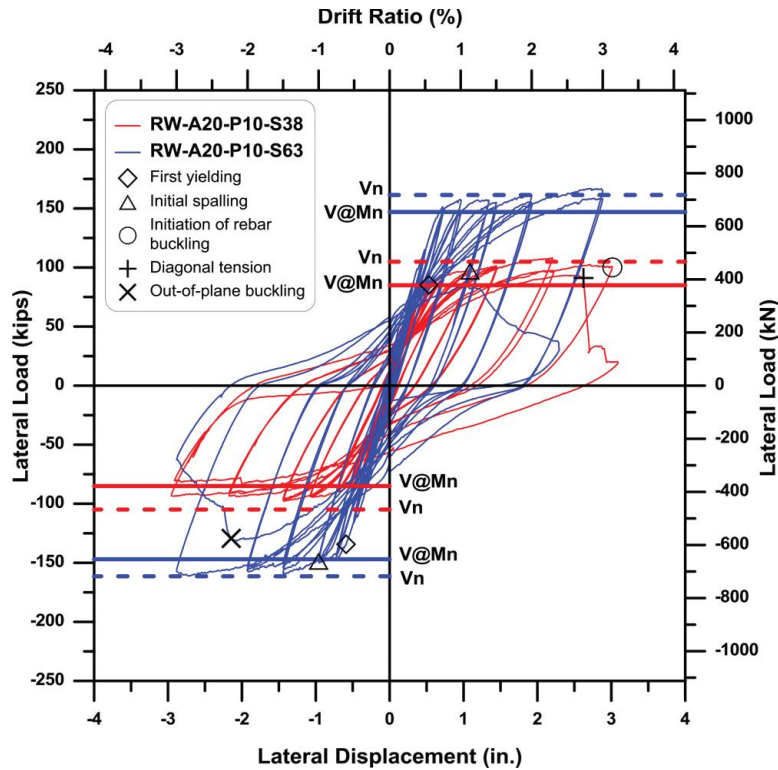
Figure 2-43: Tran (2012) lateral load vs. drift

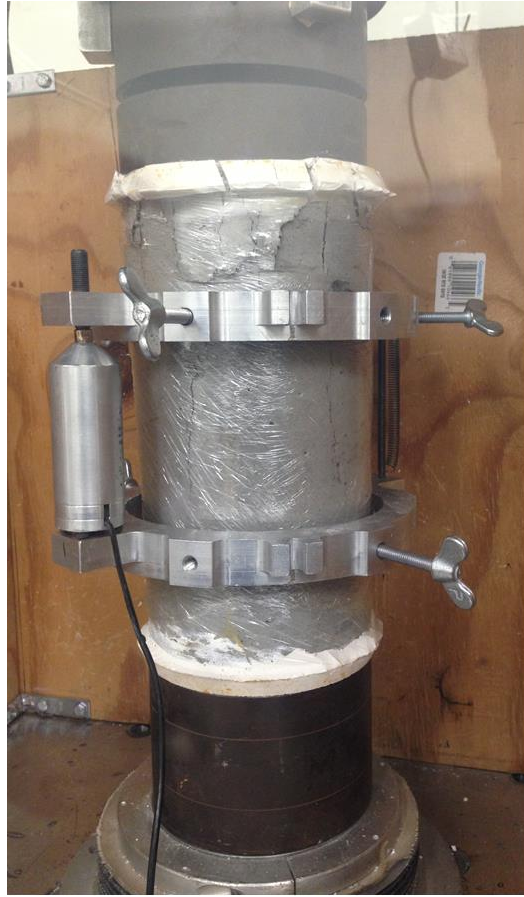
Figure 4-1: Concrete cylinder test setup

a single compressometer with a 5 in. (127 mm) gage length (Figure 4-1). Values of $f'_{c,test}$ and $\epsilon_{co,test}$ are compared in Figure 4-3 for all cylinders tested and grouped according to test specimens.

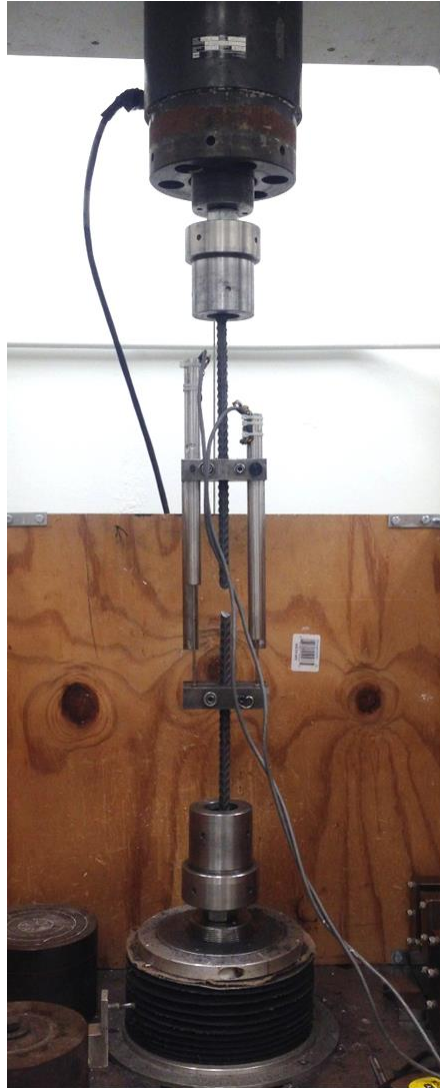
Figure 4-4: Steel reinforcement tension test setup

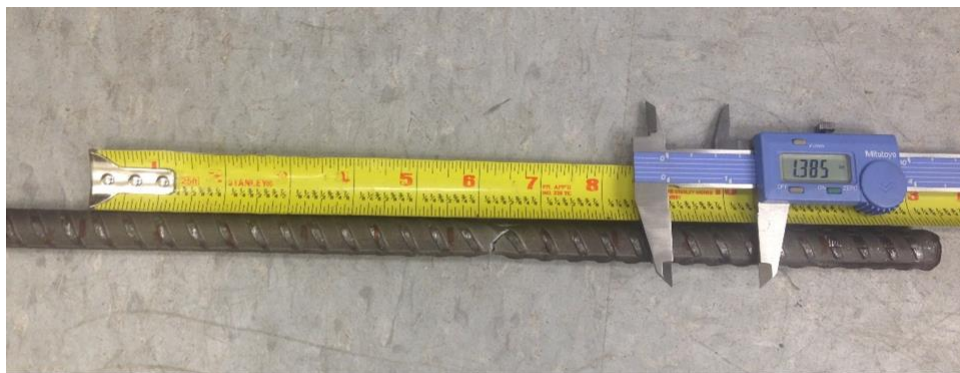
Figure 4-5: Rupture strain measurement outside gage length

by Twining prior to the UCLA tests. The tensile stress-strain result for each bar tested at UCLA is shown in Figure 4-7 for specimens WP1-4 and in and Figure 4-8 for specimens WP5-7. The stress-strain curve for 5/16" wire for specimens WP1-WP4 was inferred from Twining strength test results because no additional samples were available for testing at UCLA. Strain measurements were determined using linear variable differential transducers (LVDTs) with an 8 in. (203 mm) gage length (Figure 4-4). The stress-strain at which rupture occurred is indicated by an "x" in Figure 4-7 and Figure 4-8. The reported rupture strain was determined from LVDT results for tests in which rupture occurred within the gage length. For each bar, marks were placed on the bar at 1 in. (25 mm) intervals prior to the test. For tests in which rupture occurred outside of the gage length, reported rupture strain was determined using these marks over an 8 in. (203 mm) length in which rupture occurred (Figure 4-5). For tests in which rupture occurred outside the gage length, a dashed line is shown in Figure 4-7 and Figure 4-8 to indicate the strains measured in the ruptured zone.

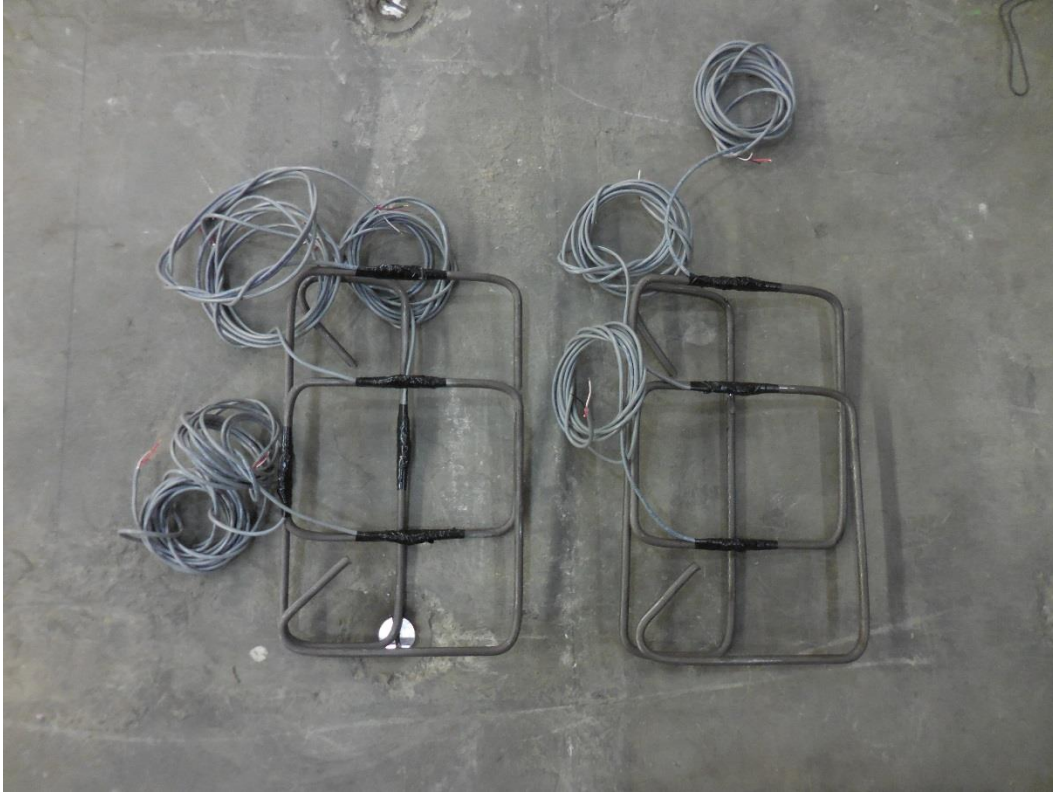
Figure 4-27: Reinforcement with strain gages installed and lead wires attached

1. Reinforcement cut and bent at Gerdau's shop and delivered to UCLA laboratory
2. Strain gages installed on reinforcing bars (Figure 4-27)
3. Formwork assembled for footings (Figure 4-32)
4. Footing and boundary region reinforcing cages assembled (Figure 4-28 - Figure 4-30)
5. Footing reinforcement placed in formwork (Figure 4-32)
6. Boundary reinforcing cages and wall web reinforcement placed (Figure 4-32)
7. Concrete poured to top of footing (Figure 4-32)
8. Formwork and shoring assembled for wall panel specimen and top cap (Figure 4-37)
9. Top cap reinforcing cage assembled and placed in formwork
10. Concrete poured to top of specimen top cap (Figure 4-38)

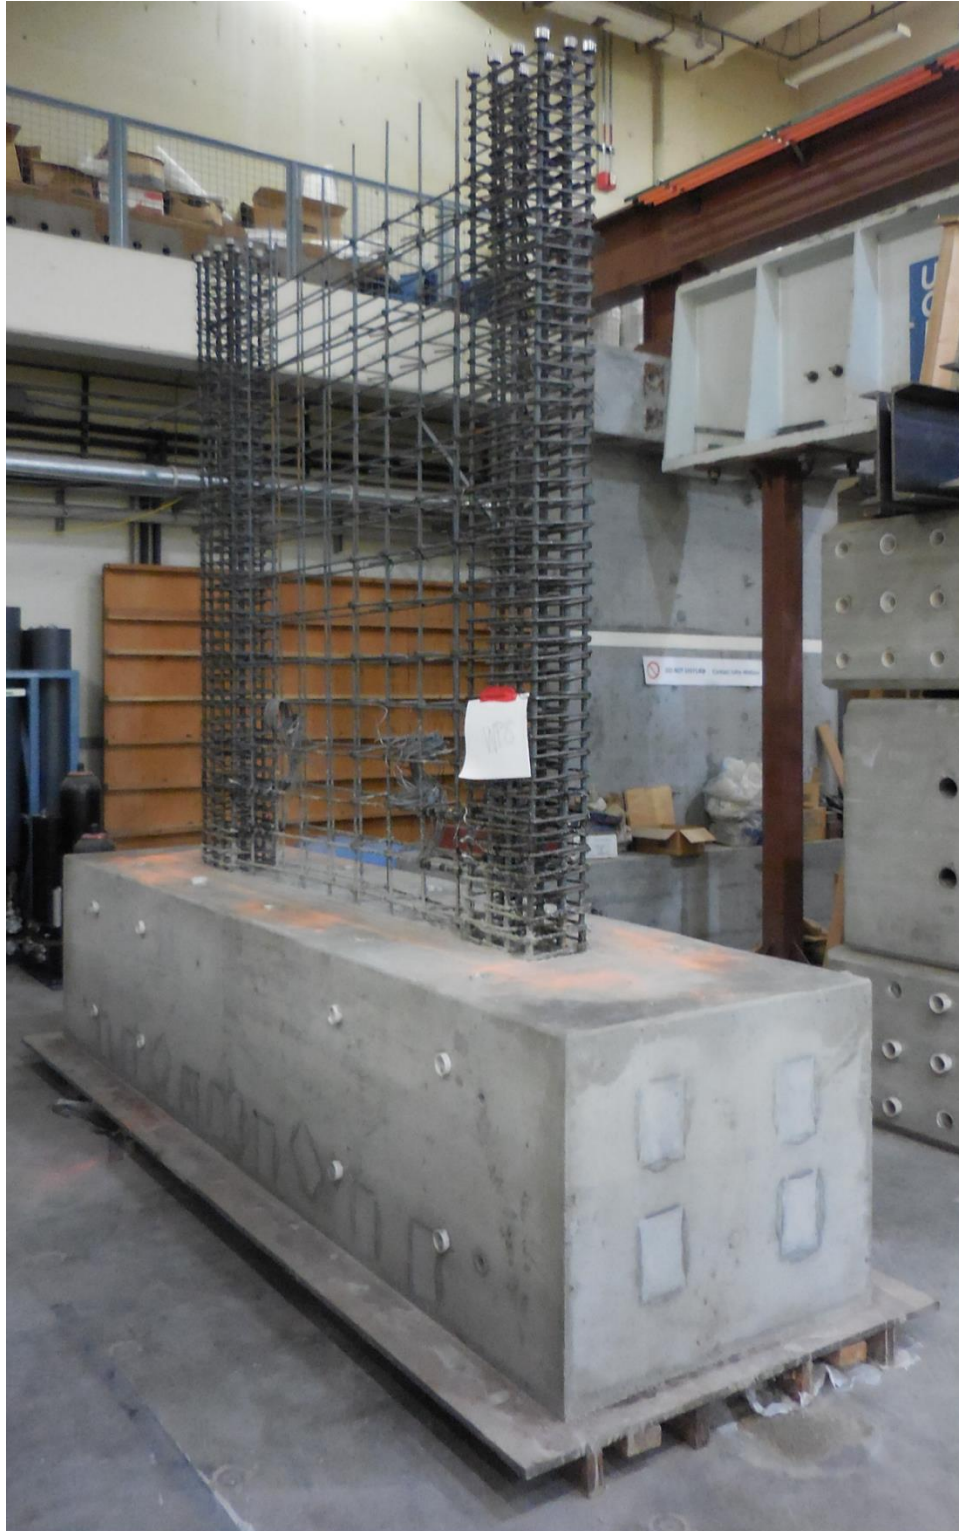
Figure 4-32: Concrete footing with wall reinforcement

Construction photos are shown in Figure 4-27 through Figure 4-38. All specimens were cast in an upright position. Each specimen was constructed in two concrete pours, resulting in a construction joint at the wall-footing interface (Figure 4-32). Strain gages were applied to reinforcing bars at various locations within the wall panel test region (Figure 4-27). The strain gages were installed at UCLA upon delivery of reinforcement to the UCLA laboratory. The construction sequence for a typical specimen was as follows:

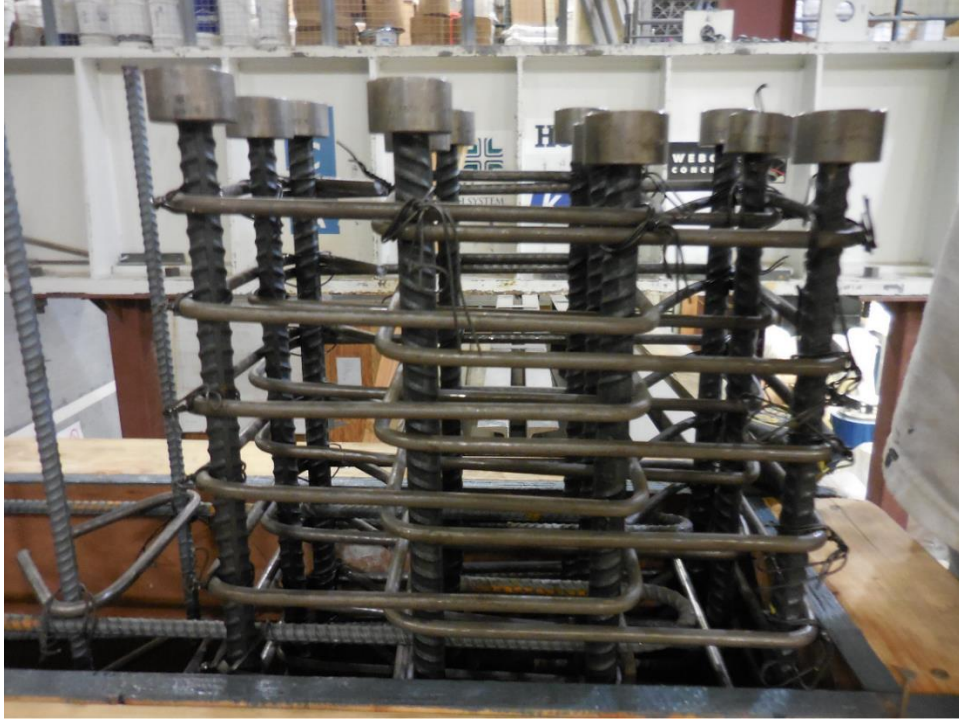
Figure 4-34: Boundary reinforcement cage extension into specimen top cap

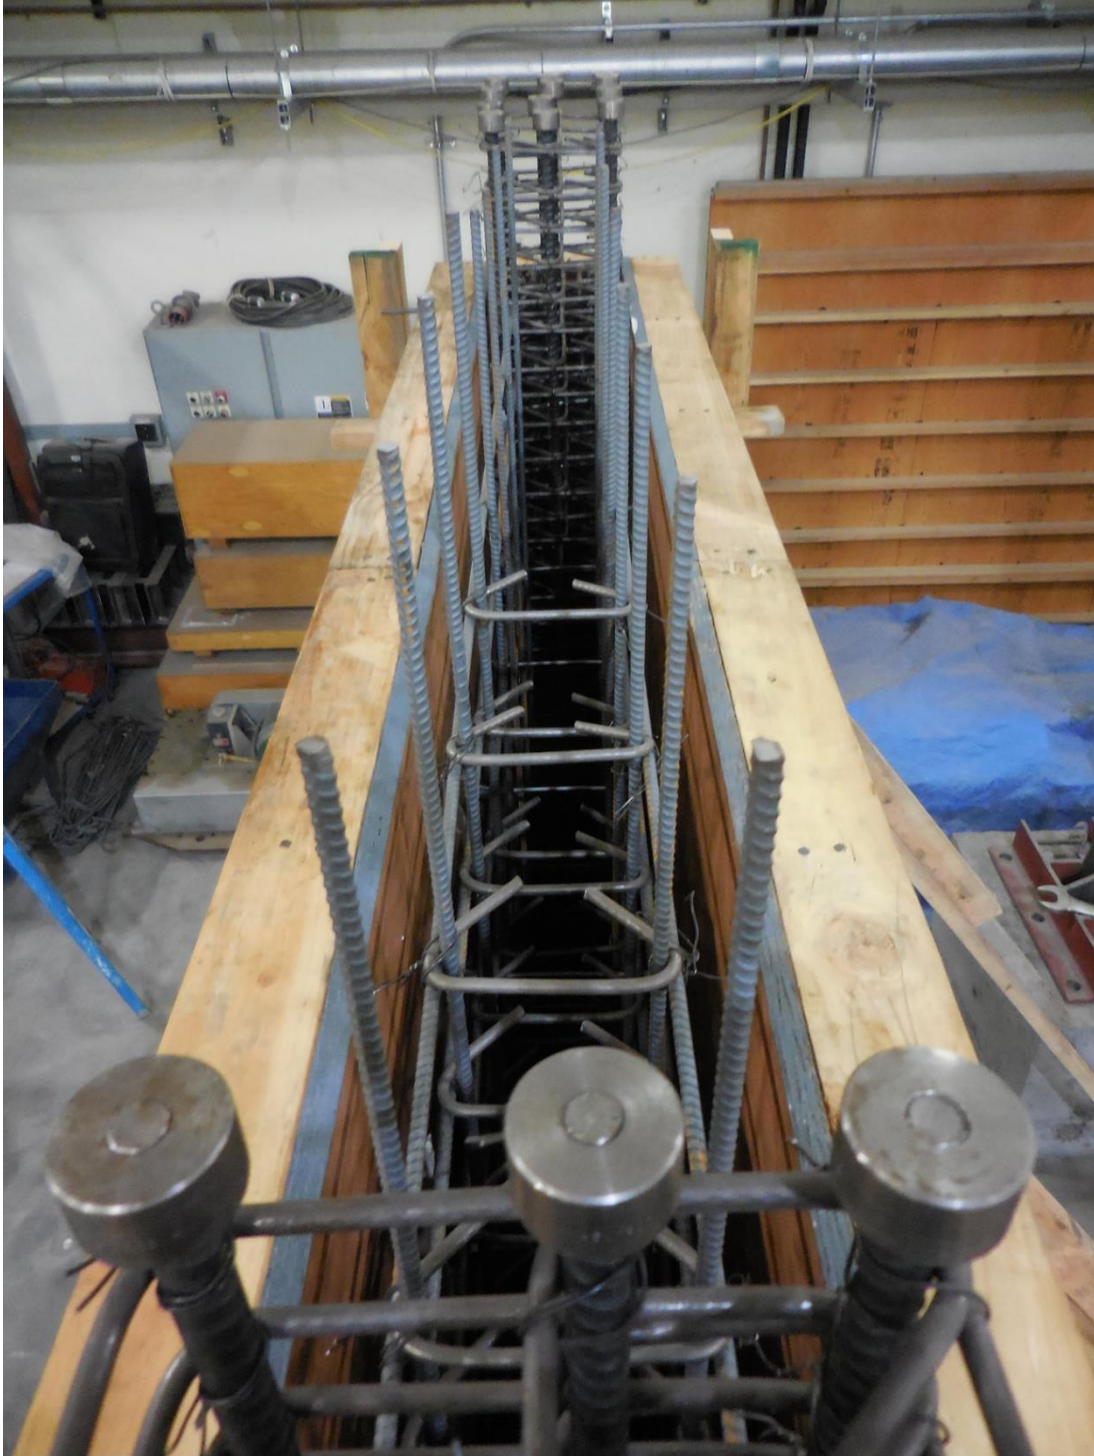
Figure 4-36: Wall web reinforcement – cross-ties supporting longitudinal bars on one side only

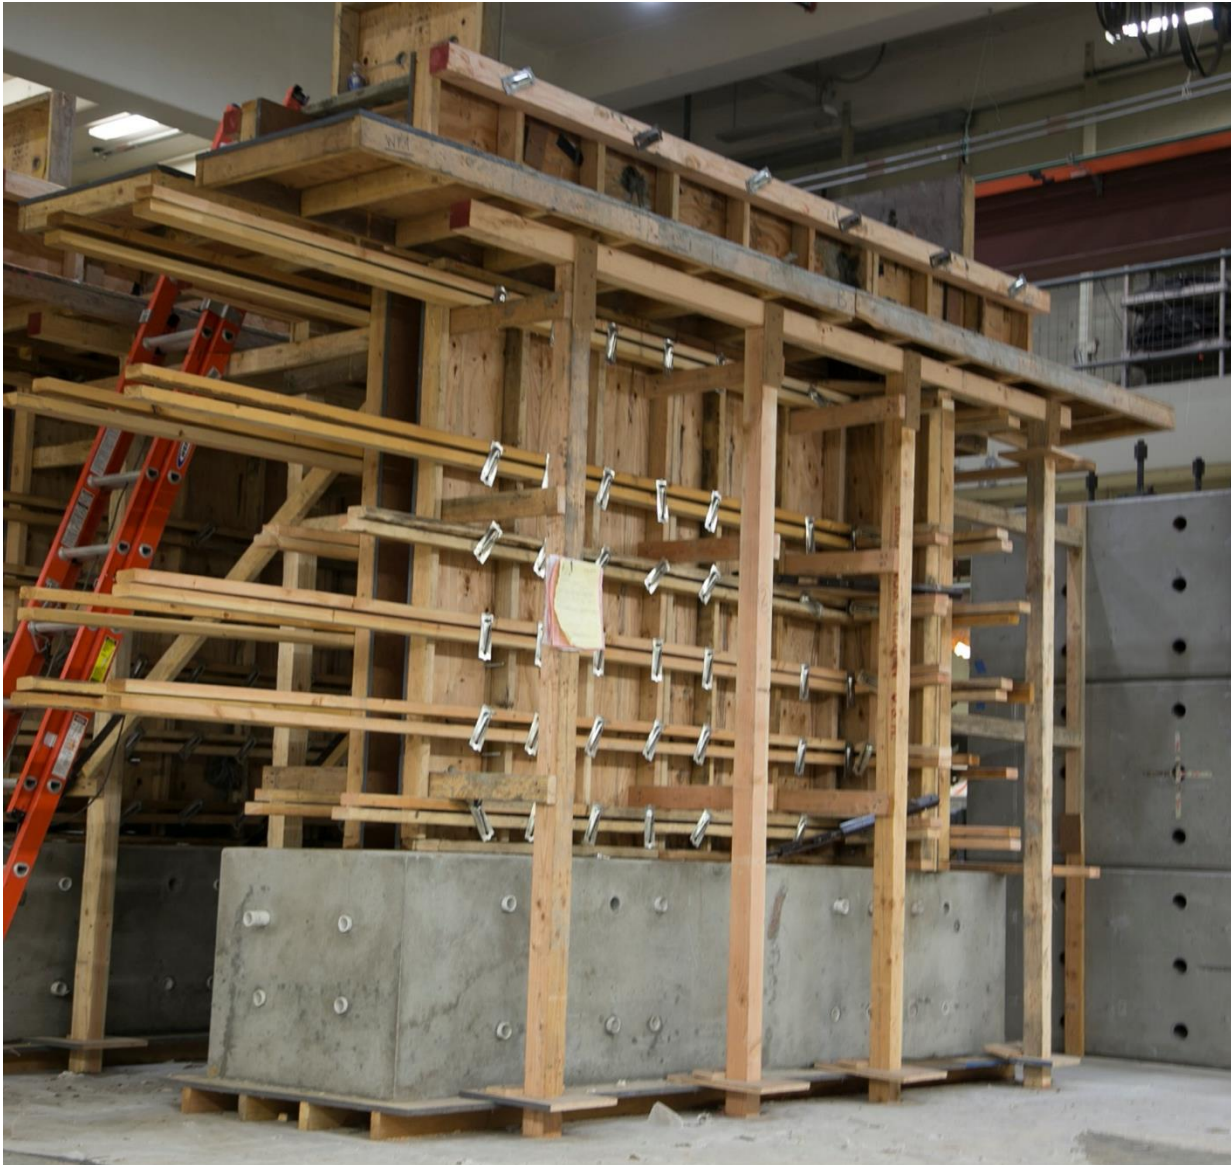
Figure 4-37: Typical wall and top cap formwork and shoring

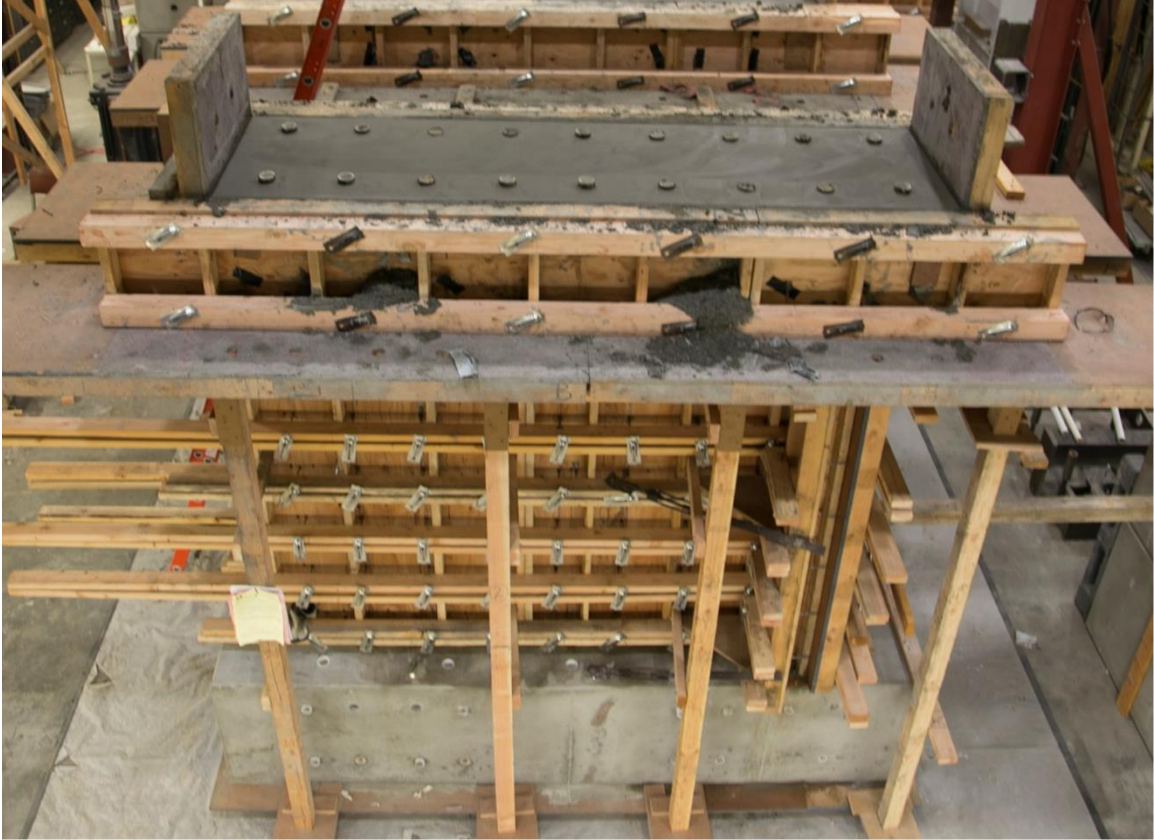
Figure 4-38: Specimen concrete curing

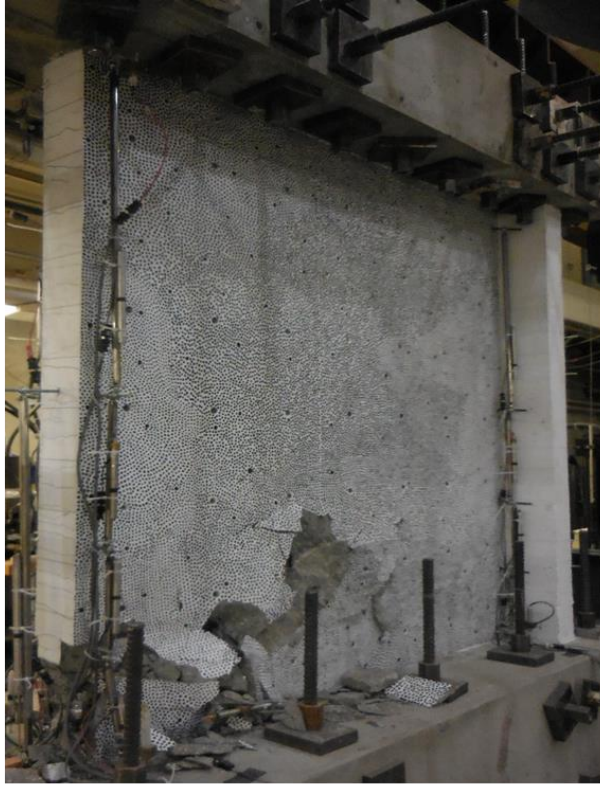
Figure 5-11: Specimen WP4 damage – a) Boundary/web crushing, b) Out-of-plane displacement of web boundary, c) Flange after the test; and d) Minor crushing of cover concrete at flange boundary

During the first loading cycle to +1.5% rotation, at a rotation of +1.32%, an abrupt compression failure (concrete crushing and reinforcement buckling) was observed at the west (web) boundary, and the lateral load-carrying capacity dropped to approximately 15% of the peak lateral strength. Damage extended horizontally from the west edge of the wall nearly two-thirds the length of the wall (58 in. [147 cm]). When loose concrete was removed, it was observed that several No. 3 web longitudinal bars buckled over a height of approximately 15 in. (381 mm), or about $40d_b$ (Figure 5-11a). Prior to the failure, no visible signs of lateral (out-of-plane) deformation were evident;

however, as crushing occurred, the compression zone deformed out-of-plane (Figure 5-11b). A maximum out-of-plane displacement of 2.25 in. (57.2 mm) was measured approximately 8 in. (20.3 cm) above the wall footing.

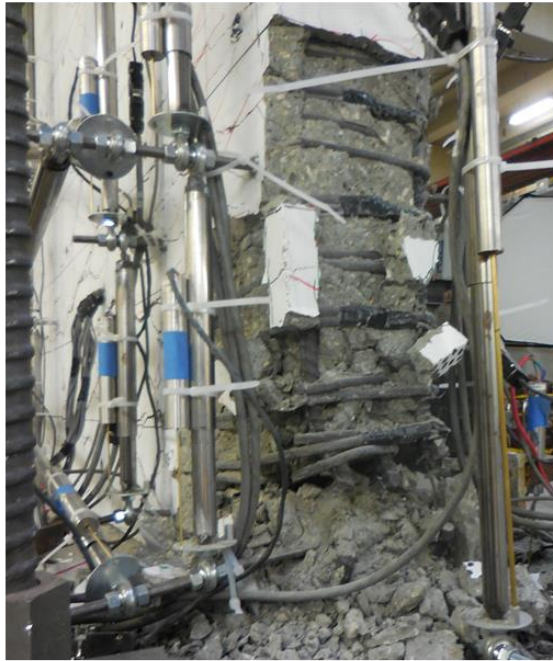
Figure 5-17: Specimen WP6 damage progression at west boundary – a) Buckling of longitudinal reinforcement (+2 % rotation, cycle 2); b) Fracture of longitudinal bar at southwest corner of wall (-2% rotation, cycle 2); c) Fracture of all boundary longitudinal reinforcement (-3% rotation); and d) Out-of-plane sliding of west boundary and web

Two complete cycles were completed to +/-2% rotation prior to significant strength loss. The peak lateral strength measured in the negative loading direction ($1.20M_n$) occurred at -2% rotation (cycle 1). A small reduction in strength was observed at +2% rotation (cycle 2), at which time buckling of longitudinal reinforcement at the west edge of the wall was observed between hoops located 3 in. (76 mm) and 5 in. (127 mm) above the footing (Figure 5-17a). While loading to -2% rotation in the following half load cycle, the bar at the southwest corner fractured at approximately -0.25% rotation (Figure 5-17b). At -2% rotation, the measured load was approximately 95% of the peak strength from previous cycles, and visible damage at the east boundary consisted only of crushing/spalling of cover concrete when loading was reversed at -2% rotation. While unloading from -2% rotation (cycle 2), out-of-plane movement of the west boundary was observed while horizontal flexural cracks were still open. The movement was in the north direction, towards the rear face of the wall, and maximum out-of-plane displacements appeared to occur above a height of approximately 15 in. (381 mm) above the footing. Buckling of the two non-fractured bars at the

west edge of the wall was observed at approximately +0.5% rotation, and out-of-plane displacement of the west boundary became more apparent as buckling became more severe. The wall appeared to realign vertically at larger rotations, and the maximum measured lateral strength in the positive loading direction ($1.22M_n$) was measured at +3% rotation. While loading in the negative direction to -3% rotation, several more longitudinal bars fractured in tension (Figure 5-17c). When loading was reversed at -3% rotation, the measured lateral strength was 71% of the peak capacity. While attempting to reload to +3% rotation (cycle 2), out-of-plane movement of the west boundary occurred near the base of the wall. Similar to what was observed for specimen WP5, the out-of-plane movement appeared to occur due to lateral sliding along a flexural crack at the height where longitudinal reinforcement previously fractured in tension. Crushing of the wall web and buckling of web longitudinal bars were observed over more than half the length of the wall (Figure 5-17d).

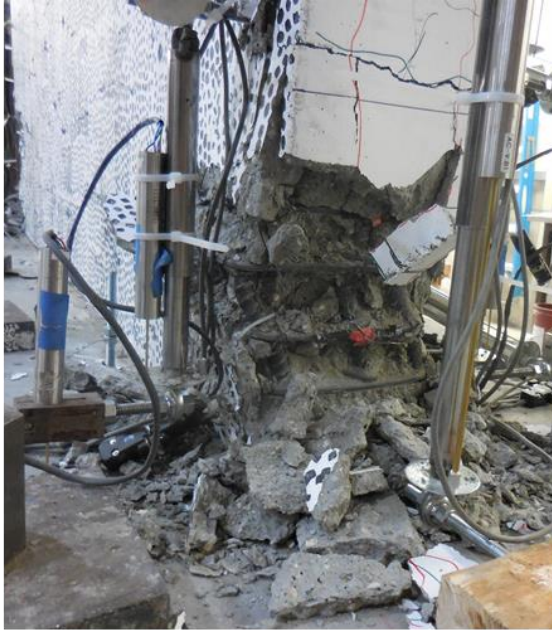
Figure 5-18: Specimen WP6 damage at east boundary – a) Concrete crushing and buckling of longitudinal reinforcement (-3% rotation, cycle 1), b) Damage state at end of test

At the east boundary of WP6, out-of-plane movement of the compression zone was observed while unloading from +3% rotation during the first cycle. The out-of-plane movement occurred while horizontal flexural cracks were open and maximum out-of-plane displacements occurred near midheight of the wall panel, approximately 40 in. (1016 mm) above the footing. As the horizontal cracks closed, out-of-plane movement decreased and was no longer visible. Buckling of longitudinal reinforcement and crushing of the confined boundary occurred just prior to reaching -3% rotation (cycle 1). A small, abrupt drop in strength occurred, and at least four longitudinal bars buckled (Figure 5-18a). While loading to +3% rotation (cycle 2), the three outer bars fractured in tension. During the second cycle to -3% rotation, the remaining longitudinal bars at the east boundary buckled, and crushing of the confined core occurred. Figure 5-18b shows the state of the
