Vernacular Architecture: Pre-Columbian Households of the Middle Chamelecon Drainage, Northwest Honduras

Vernacular Architecture:
Pre-Columbian Households of the Middle Chamelecón Drainage,
Northwest Honduras

A Dissertation submitted in partial satisfaction
of the requirements for the degree of

Anthropology

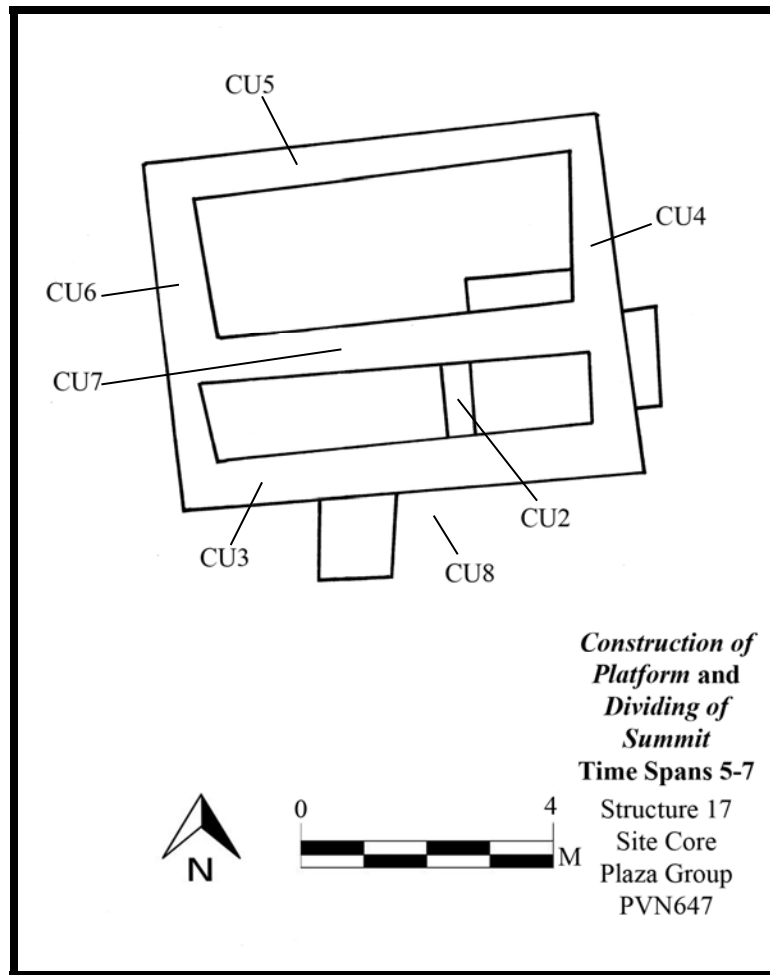
Figure 5.9: Plan-view of excavations of Structure 17 – *Construction of Platform and Dividing of Summit*.

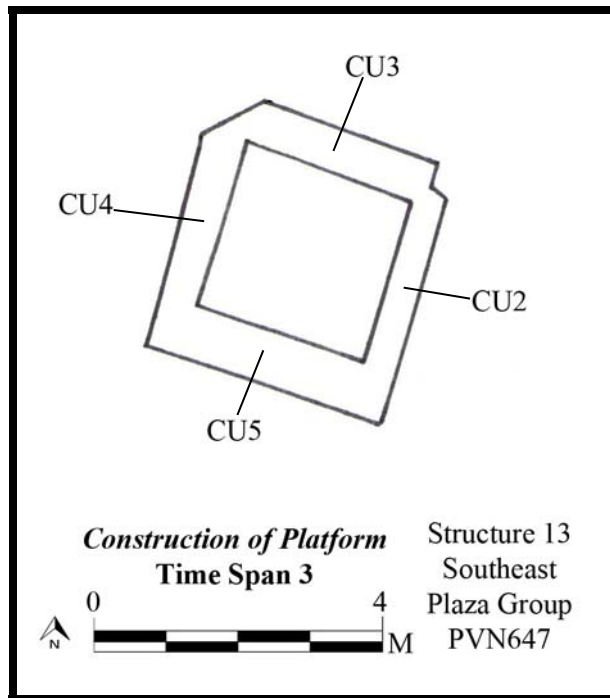
Figure 5.22: Plan-view of excavations of Structure 13 –
Construction of Platform

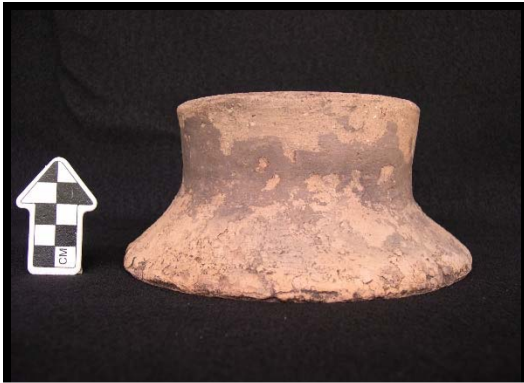
Figure 6.2: Intentionally modeled potstand from PVN598. This example does not have an everted upper-rim but possesses a clear break to the body/base of the stand. Evidence of clay drippings are present near the base of the object (photo courtesy of Ellison).

Potstands are hypothesized to be manufactured in two ways: intentionally or as recycled objects from broken jar vessels (**Figure 6.1**). Intentionally modeled potstands exhibit nearly vertical necks and are defined by a large everted rim and a break to the body/base of the stand. Furthermore, potstands purposely made as stands are observed to be devoid of evidence indicating that either the lower or upper rims were deliberately chipped, grinded, or smoothed flat (**Figure 6.2**). Potstands recycled from broken jar vessels are described as having either a continuous curvature with no break to the body/base of the stand or having a break between the neck and the shoulder/body (**Figure 6.3**). Additionally, potstands fashioned from broken jars contain evidence of modified edges to create a smooth, flat upper rim where objects would have rested and an even, balanced, and continuous surface at the base in order to not wobble as the object was being shaped.

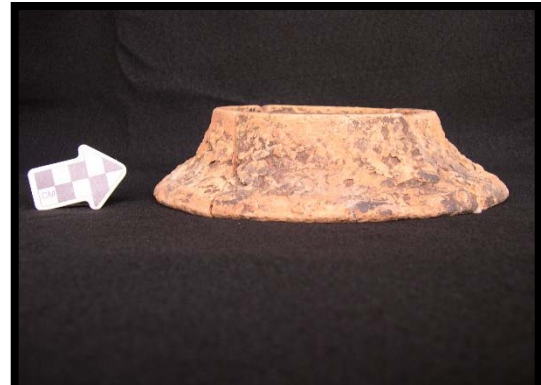
Figure 6.3: Recycled potstand from jar vessel from Las Canoas (PVN202). This example exhibits a continuous shape, without a break to the body/base of the stand. Evidence of clay drippings and discoloration due to reheating are present all over the object (photo courtesy of Urban and Schortman).

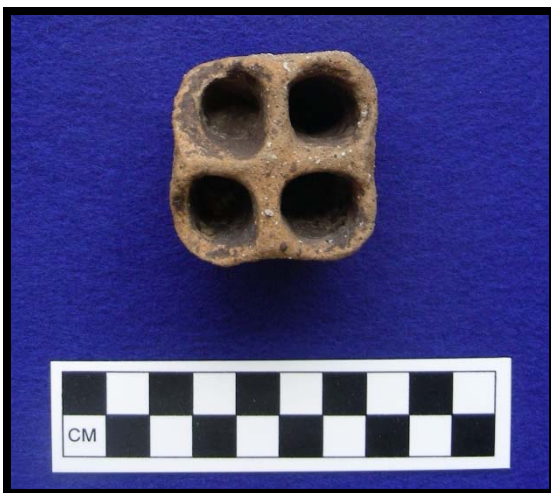
Figure 6.4: Plan-view image of a four-chambered, square-shaped candelero from Structure 17 at PVN647.

Candeleros are akin in appearance to a candleholder or candelabra; however, a definitive function is less obvious. Candeleros are fairly under-studied in northwest Honduras, though quite common in the Naco and Cacaupala Valleys during the Late and Terminal Classic (Urban, personal communication 2014). The shape of candeleros can vary from rounded or squared and consist of cylindrical chambers or wells, where the material to be burned is positioned. The number of chambers can vary from being a single well to as many as six individual burning chambers. Trace remains from burning or sooting can be evident both along the exterior or interior of the chambers. Typically, each chamber will include a small hole along the exterior of the chamber to serve as a vent, indicating burning at the base of the chamber. Candeleros can vary stylistically as well and may include supports or feet on the base to elevate the object (**Figures 6.4 and**

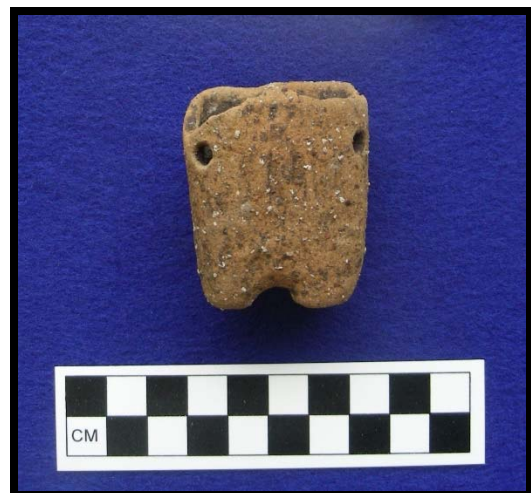
Figure 6.5: Profile image of same four-chambered, square-shaped candelero from Structure 17 at PVN647. Vent holes and supports are visible.

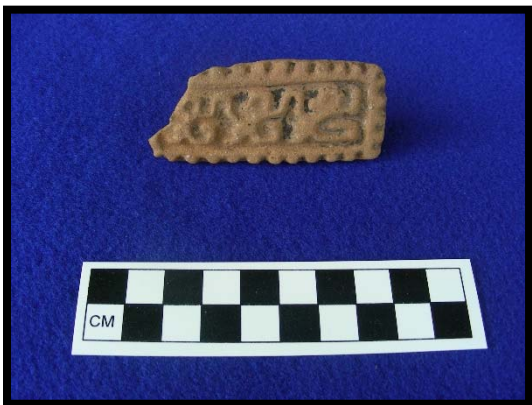
Figure 6.6: Rectangular-shaped stamp from Structure 16 at PVN647. The decorative portion is of three monkeys in profile, holding hands.

Ceramic stamps predominantly consist of the flat-facing form with a handle or nub on the back with which to grasp the object and press down to make an imprint (**Figures 6.6 and 6.7**). Rarely are roller or in-the-round ceramic stamps recovered from this region of Honduras. However, the shape of flat-facing stamps can vary from being square, rectangular, or circular. The decorative portion of the stamp can also vary greatly from including anthropomorphic or zoomorphic imagery to stylistic designs, motifs, or patterns. Stamps appear to be mostly individually formed, yet could be initially mold-made and then embellished before hardened. Occasionally, dye remnants are present and objects are found as nearly complete, as stamps are solid ceramic objects. Stamps were likely used on textiles or bark-based paper materials. It is unclear if the decoration or imagery of a stamp related to the identity of the owner or manufacturer of an object.

more utilitarian objects, such as pot stands, worked sherds, stamps and used sherds, provide more variation to the types of activities occurring within and around Structure 16. Of all of these artifact classes, the stamps (N=2) are of the most notable as they are both nearly complete, yet different in shape and design. Both stamps are flat-facings, yet one is rectangular in shape and the other is circular. The rectangular stamp contains the incised image of three monkeys in profile, holding hands (see **Figures 6.6 and 6.7**). The circular stamp contains a more abstract, deeply incised pattern of lines.

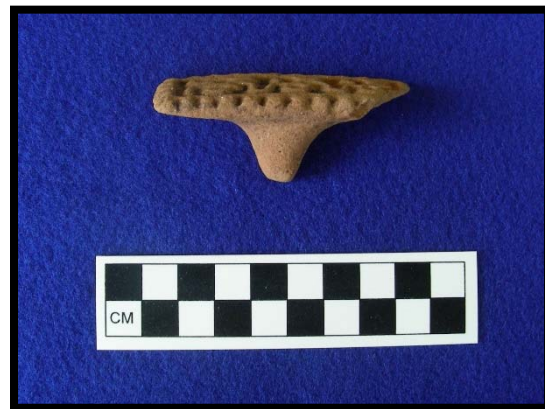
Figure 6.7: Rectangular-shaped stamp from Structure 16 at PVN647. This image shows the handle on the back of the object.

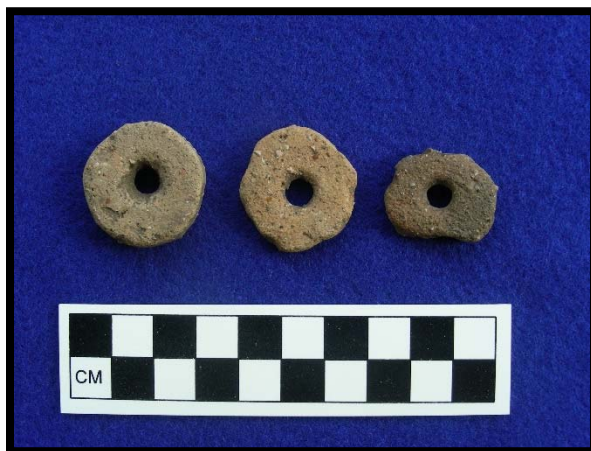
Figure 6.8: Sherd disks from PVN647. The objects on the left and center are from Structure 6 from the Southeast Plaza Group. The object on the right is from Structure 12 from the Site Core Plaza Group.

pierced hole, large enough to be threaded and worn as a necklace. Earspools are common Mesoamerican ear jewelry and are small, tube-shaped objects that are inserted into a pierced earlobe. Sherd disks are described as circular and flat ceramic objects with a circular hole in the center (**Figure 6.8**). The shape of the object is typically the result of grinding and then smoothing to round the edge and average approximately 2.6cm in diameter. The center hole is fashioned by grinding a pointed object in the center from both sides to achieve a piercing and then further grinding to produce a hole with a diameter approximately 0.7cm. Sherd disks appear to be shaped from discarded ceramic fragments. The functional intent of sherd disks is unclear and have been hypothesized to range in purpose from light weights to ornamental objects for jewelry. All miscellaneous ceramic artifacts are issued a catalog number and analyzed separately, taking note of dimensions, manufacturing or use-related markers, and any other specific characteristics or features that are germane to the particular object type.

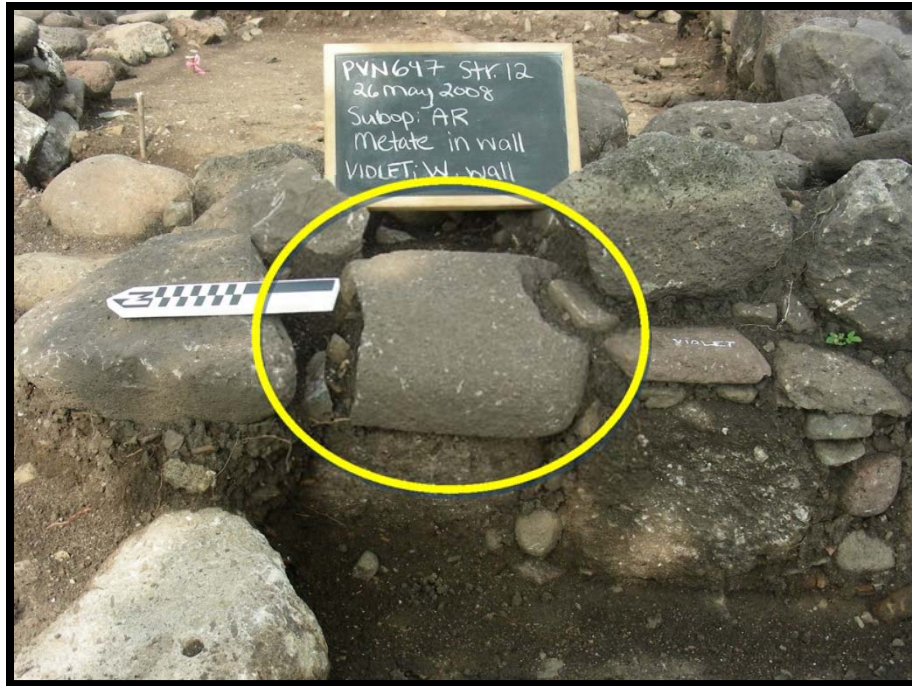
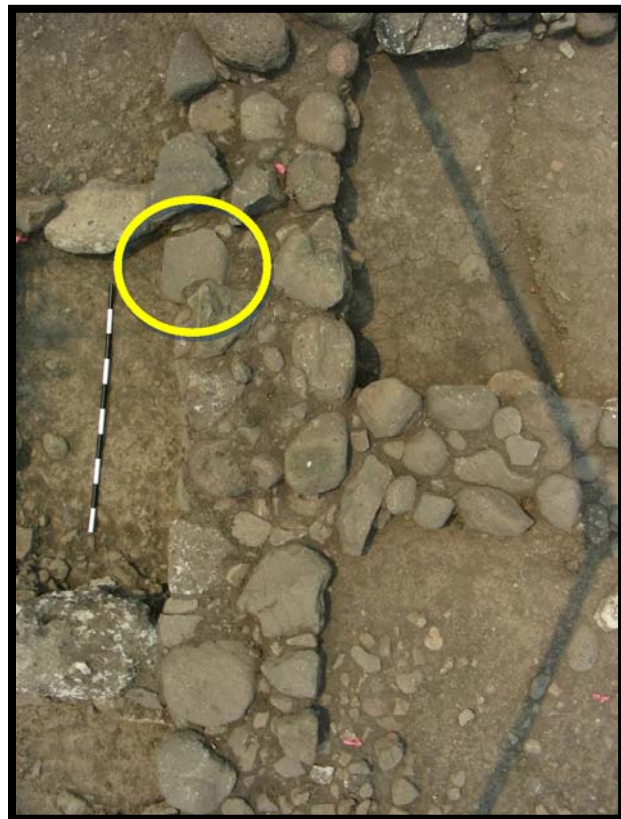
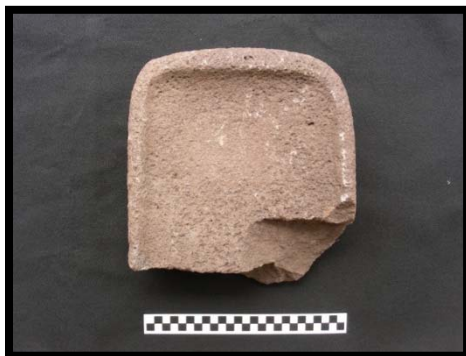
Figure 6.9: Above: Side-view of inverted metate fragment in west basal wall, Structure 12.

Figure 6.10: Left: Plan-view of inverted metate fragment in west basal wall, Structure 12.

Figure 6.11: Below: Working surface of metate fragment from west basal wall, Structure 12

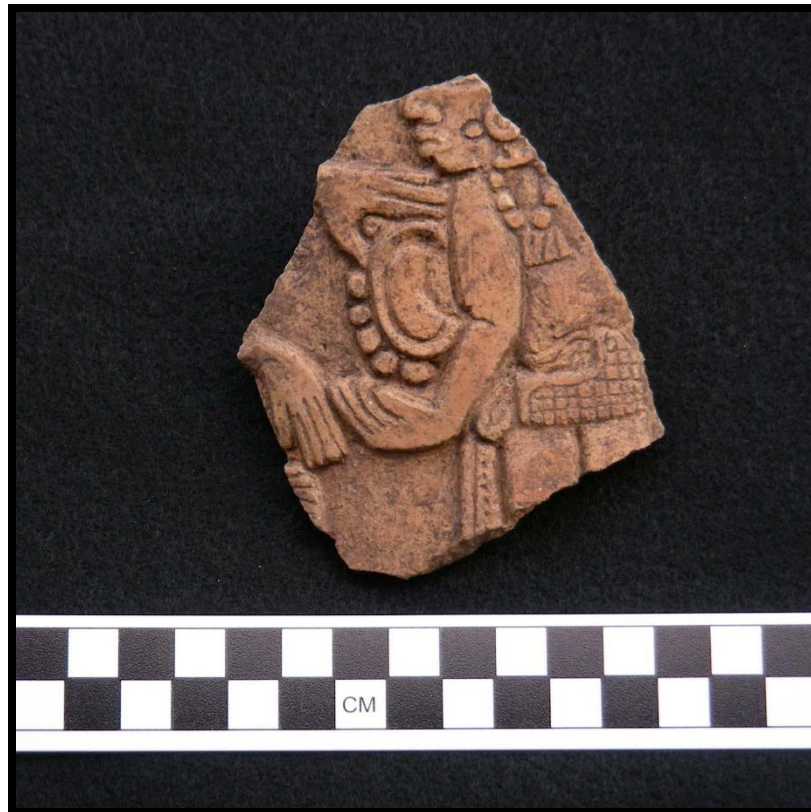
Figure 6.12: Ceramic fragment from Structure 18 within the Site Core Plaza Group, PVN647.

The recovery of one particularly unique ceramic fragment has the potential to complicate the purpose of Structure 18 and the social positioning of its occupants. The sole ceramic fragment that accounts for the high density of “other” artifacts from the building is that of a body portion of a straight-sided jar vessel (**Figure 6.12**). The complete object was likely not utilitarian in purpose, and though identified to be from a jar vessel, is not deemed to be diagnostic pottery. This ceramic item is observed to be highly distinctive, as it has preserved an incised image of a human figure engaging in some form of a social interaction. The imagery partially portrays a human figure in profile, clothed in a patterned tunic with a hanging belt, and adorned with a necklace and

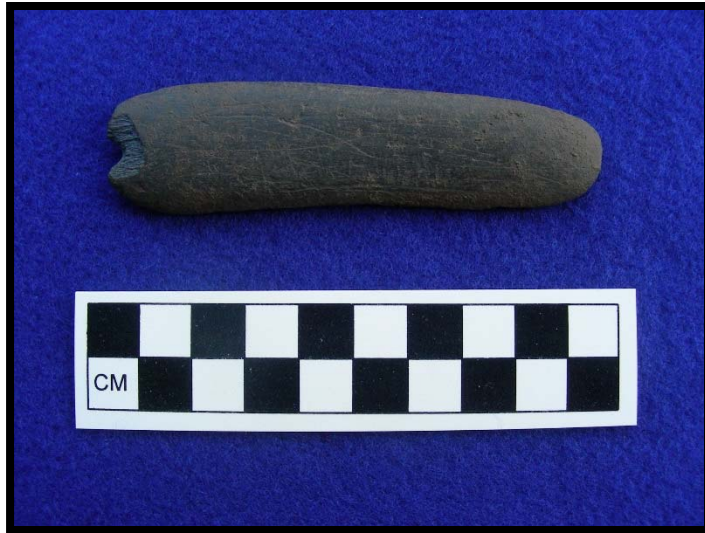
Figure 6.15: Image of stone pendant fragment from Structure 33 within the Site Core Plaza Group, PVN647.

Unlike the earspool, the recovered pendant object is not complete, yet a pierced hole to thread a string through is partially preserved. The object is made from an unknown stone material and rectangular in shape, with rounded edges (**Figure 6.15**). The best preserved facing is observed to have been highly polished, yet is preserved to be moderately eroded and contains various scratch markings. The pendant fragment is not observed to be associated with the burial context and was recovered along the western exterior of the building. Regardless, the presence of the burial remains and all associated artifacts located within the summit interior of Structure 33 are consistent with household ancestor internment practices.

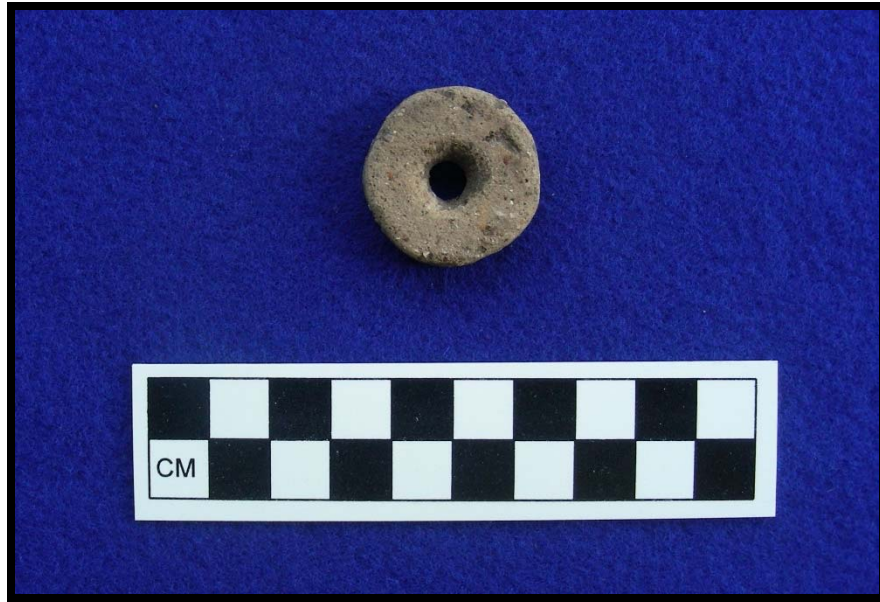
Figure 6.16: One of the two sherd disks from Structure 6 of the Southeast Plaza Group at PVN647. Also see **Figure 6.8**.

Of the more all-purpose non-pottery ceramics, Structure 6 is recorded to have the greatest density of potstands and sherd disks (**Figure 6.16**). Potstands have been most greatly associated with ceramic production activities, yet could also purpose as supports for round-bottomed ceramic vessels, specifically those associated with storage or possibly food cooking intentions. As only one comal fragment is identified from Structure 6, it is possible that potstands were utilized as stabilizers for other vessels for cooking. A solid functional purpose for sherd disks is not well known, however, the largest quantity (N=2) from all of PVN647 and the only such objects occurring within the Southeast Plaza Group are located at Structure 6. Sherd disks are quite rare and unclear as to serving as light weights for weaving, ornamental jewelry, or simply opportunistic objects, which are fashioned indiscriminately.

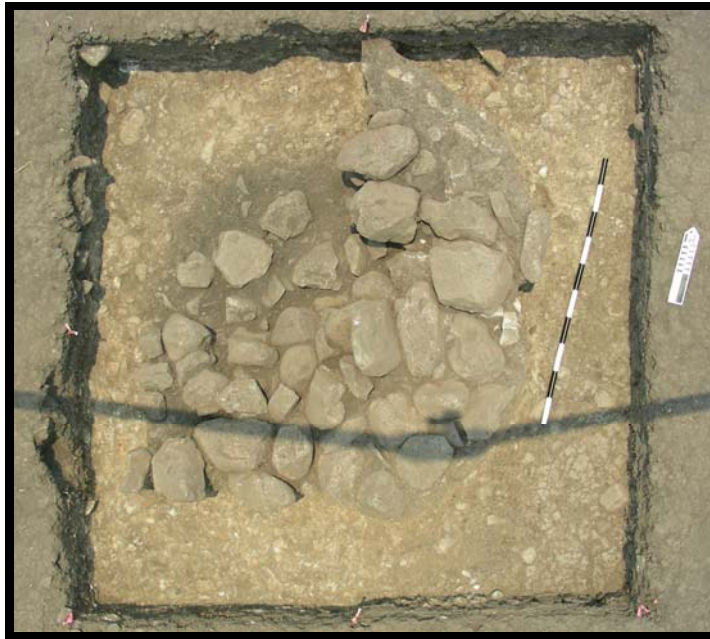
Figure C.7: Plan-view photograph of cobble feature in Test Pit 5 from PVN647.

The cobble feature is described as a circular assemblage composed of medium-to-large unmodified river cobbles with evidence of burning in select locations (**Figure C.6-C.8**). It measures roughly 1.4 north-south and 1.3m east-west, and ranges 0.2-0.25m in height. The northwest region of the cobble feature does not contain cobbles and the soil in the area indicates that burning occurred immediately in and around the feature. Hardened bajareque is present in a curved formation in the northeast exterior of the cobble feature. It is unclear if the preservation of this bajareque indicates that the feature was faced all around the exterior with bajareque. Results from processed artifacts indicate moderate densities of ceramic sherd fragments and obsidian; though the significance of these calculations remain unknown (**Table C.5**).

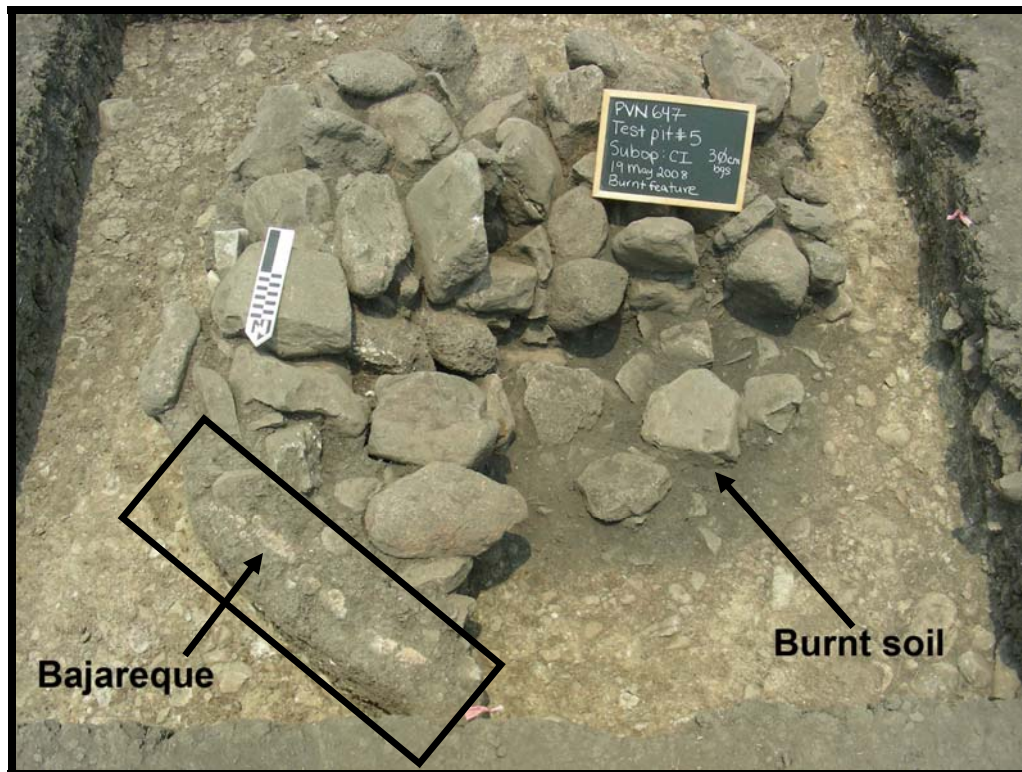
Figure C.8: Photograph of cobble feature in Test Pit 5 from PVN647 with bajareque and burnt soil.
