Seismic Performance of Buildings Subjected to Soil Liquefaction

Joshua David Zupan

Doctor of Philosophy

University of California, Berkeley

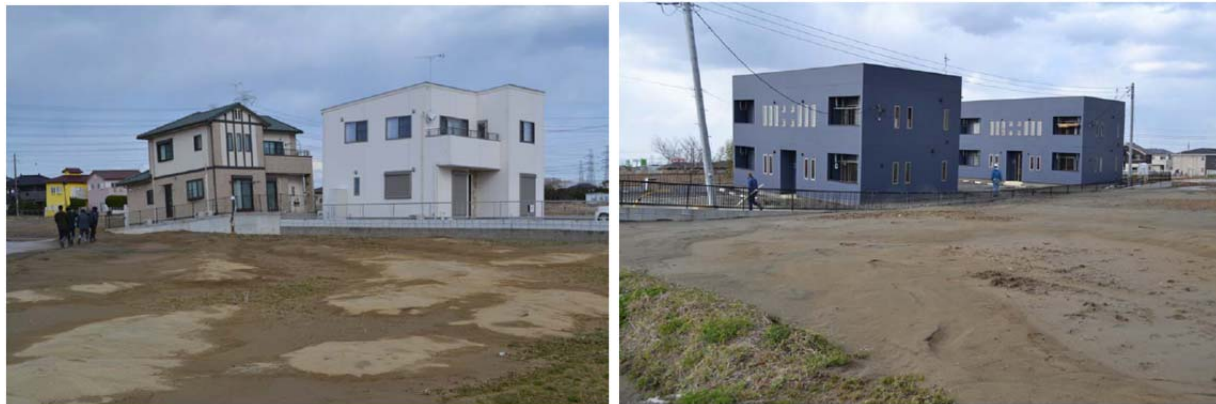
**Figure 2.2.3.** Settlement and tilting of residences in Kamisu City (N35.917, E140.642). Photographs from GEER Association Report No. GEER-025a (Ashford et al., 2011).

Liquefaction-induced damage to the built environment in the Kanto Plain region, which includes the Tokyo Bay and Tone River areas, following the 2011  $M_w$  9.0 Tohoku, Japan earthquake was observed by GEER researchers (Ashford et al., 2011). Light residential and light commercial structures often settled and tilted significantly (Fig. 2.2.3). However, there was often little damage, if any, to the superstructures of buildings supported on mat foundations. Localized settlement depressions were observed around buildings, in addition to broader uneven ground settlements.

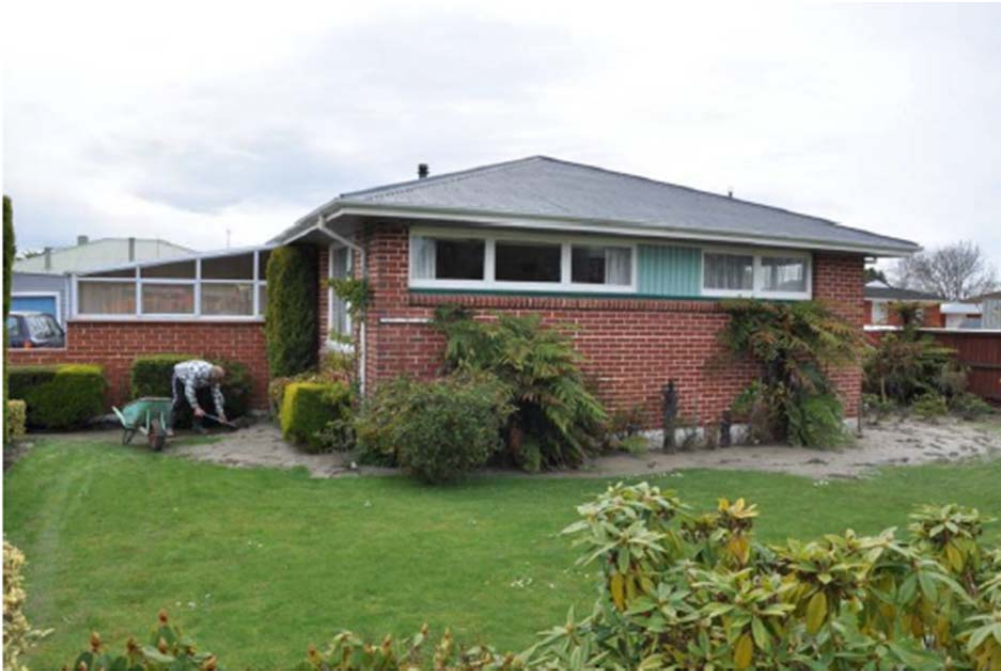
**Figure 2.2.6.** Example of residence in Kaiapoi subjected to liquefaction-induced ground movement during the September 4, 2010  $M_w$  7.1 Darfield earthquake. Note the liquefaction-induced sediment ejecta around the perimeter of the foundation. This house experienced approximately 40 cm of settlement along the north side (from Green et al., 2010).

GEER researchers (Green et al., 2010) observed significant damage to houses, light commercial buildings, and school and church buildings due to ground failure following the Darfield earthquake. Buildings settled, tilted, and were subjected to lateral ground movements causing structural components to separate (Fig. 2.2.6). Lateral movements and settlements due to lateral spreading and liquefaction damaged many buildings in Kaiapoi in the vicinity of Kaiapoi River and in the Dallington area in the vicinity of the Avon River. Similar types of liquefaction- and lateral spread-induced damage were observed in the Bexley and Brooklands residential areas.

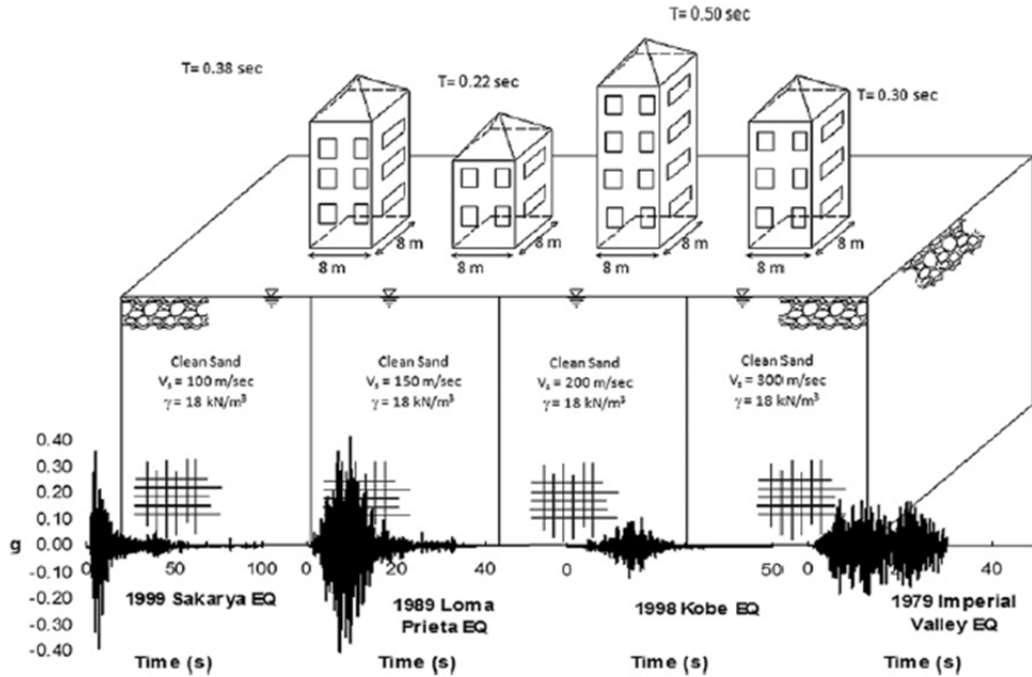
**Figure 2.3.3.** Schematic summary of soil profiles, structures, and earthquake motions modeled by Cetin et al. (2012) (from Cetin et al., 2012).

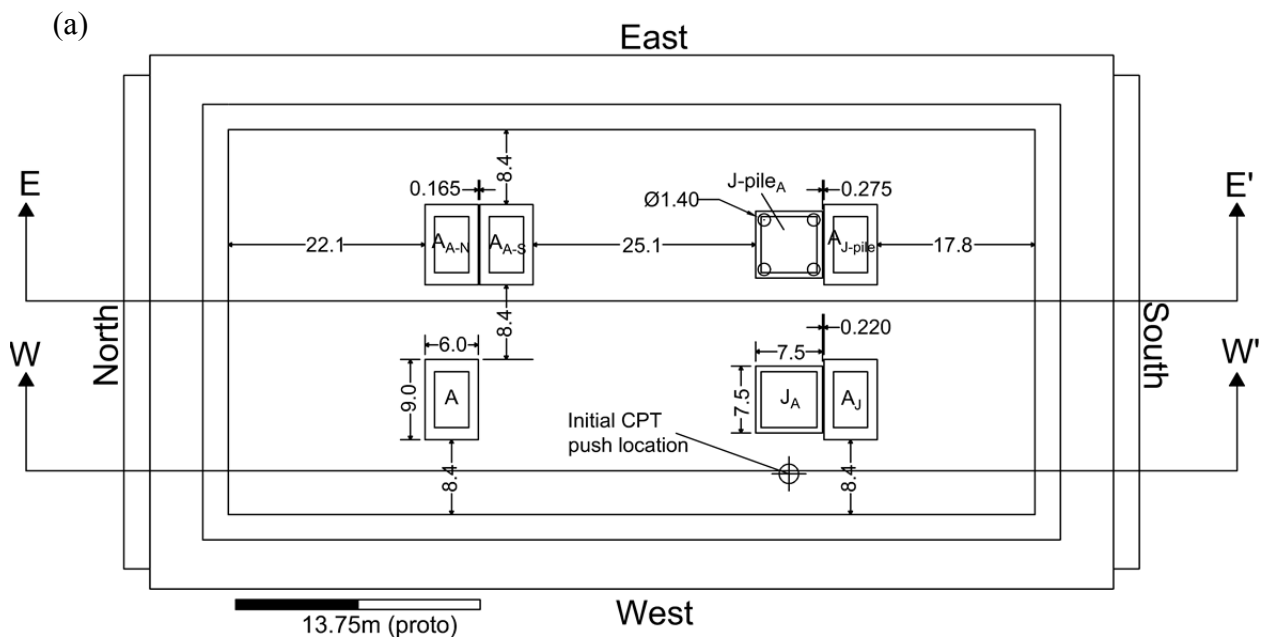
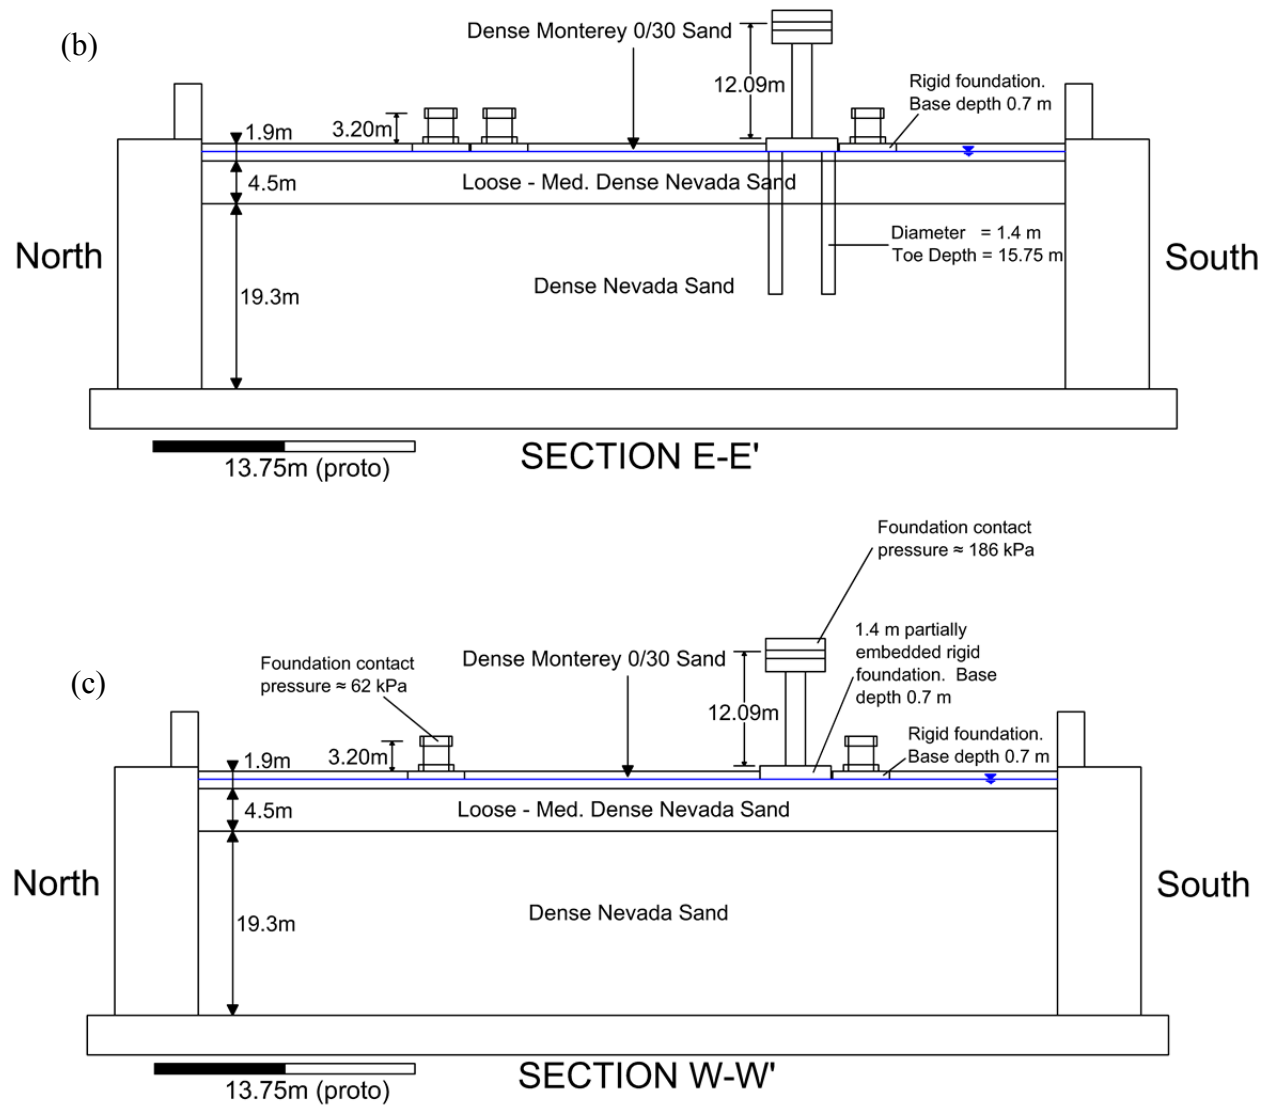
**Figure 3.2.3.** (a) Plan view, (b) elevation view along E-E', and (c) elevation view along W-W' of the Test-5 configuration. Indicated dimensions are prototype scale. As will be described subsequently, the groundwater depth, indicated by the blue line in this figure, was approximately 0.37 m during the PRI\_small event, 0.50 m during the PRI\_mod event and 0.87 m during the TCU\_mod and PRI\_large events, respectively.

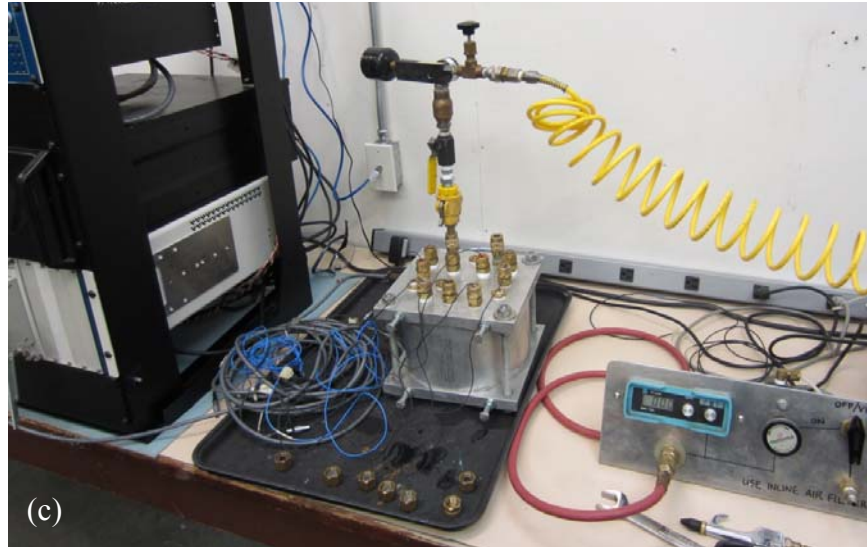
**Figure 3.2.7.** (a) Waterproofing ICP accelerometer with synthetic rubber. (b) View of the LP calibration station. (c) View of the PPT calibration station.

2. The instrumentation was prepared for installation: ICP accelerometers were checked to make sure they were functioning properly and then waterproofed using a coat of primer followed by one to three coats of synthetic rubber (Plasti Dip). Calibration values for the linear potentiometers (LPs) and pore water pressure transducers (PPTs) were determined by following calibration procedures under the guidance of NEES@UCD staff (Figure 3.2.7). PPTs were dried prior to installation in the model.

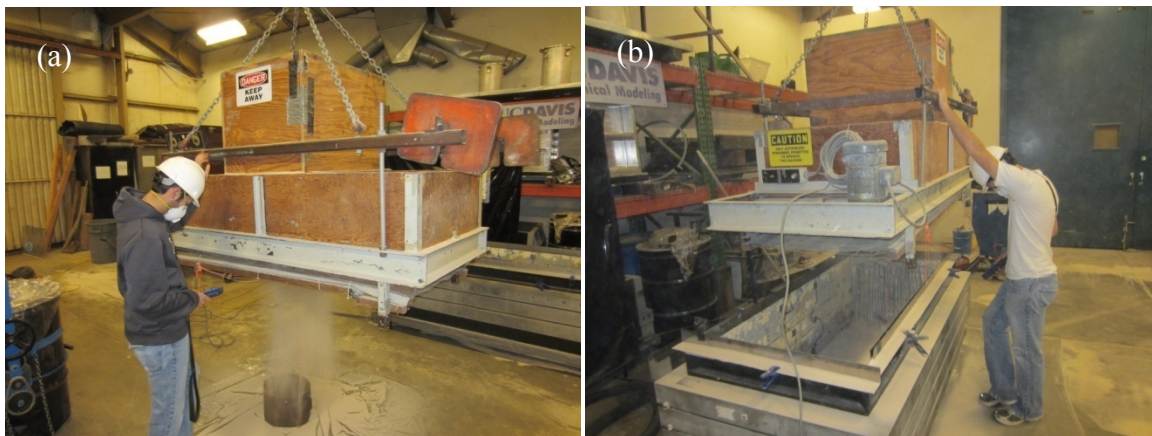
**Figure 3.2.11.** (a) Calibration of large pluviator. (b) Placing dense Nevada Sand using large pluviator. (c) Calibrating the pluviator for loose to medium-dense Nevada Sand. (d) Placing loose to medium-dense Nevada Sand. (e) Placing dense Monterey Sand.

7. The container weight was measured.
8. Nevada Sand and Monterey 0/30 Sand were pluviated in lifts of varying thickness (Figure 3.2.11). Lift thicknesses were controlled by the instrumentation location plan and the structural location plan. All sand was placed by dry pluviation into the model container. Three pluviators were used to place the respective layers of dense Nevada Sand, loose to medium-dense Nevada Sand, and dense Monterey Sand. Each of the three pluviators was calibrated to place material at the desired dry density using a calibration chamber of known volume. The calibration process consisted of adjusting the drop height and flow rate of the sand until the correct weight of sand was measured for the known volume of the calibration chamber.

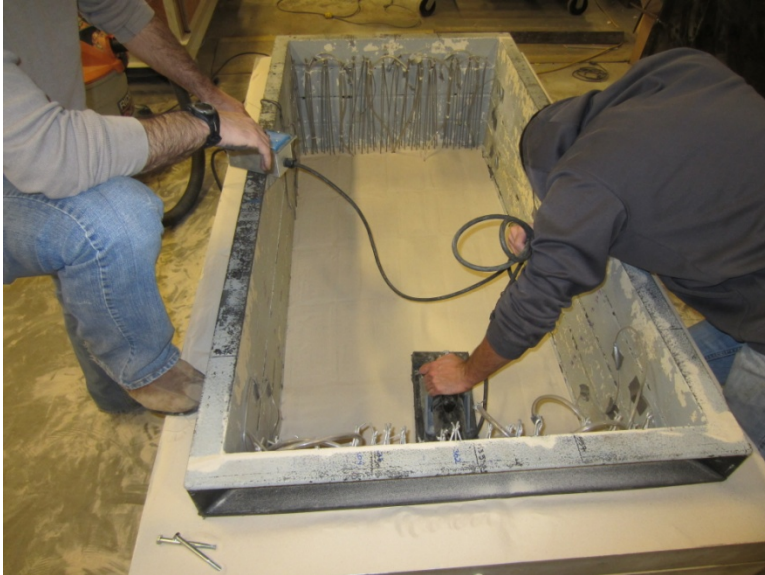
**Figure 3.2.12.** Vibration of dense Nevada Sand

9. Each lift of dense Nevada Sand was also vibrated using an electric vibratory plate, as shown in Figure 3.2.12. While the objective was to make the dense Nevada Sand as dense as possible, care was also taken to apply an equal amount of vibration to each lift of dense Nevada Sand to minimize variability in the density within and between each lift.

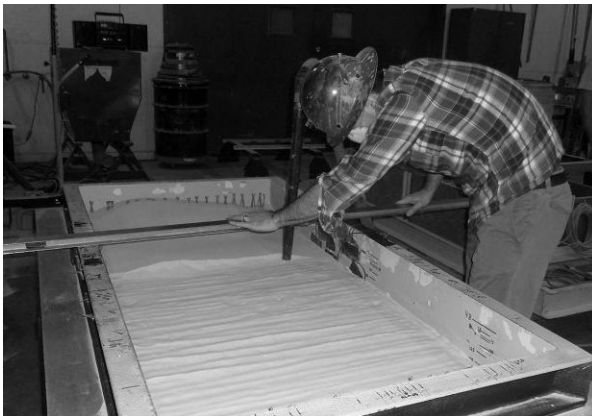
**Figure 3.2.13.** Vacuum soil lift to desired elevation.

10. After each lift was pluviated, the surface of the soil was groomed to the desired elevation using a vacuum cleaner (Figure 3.2.13). The vacuum cleaner filter was blown out with compressed air before it was used each time. Additionally, the hoses were kept clear of sand during the grooming process. These steps were necessary to ensure a constant suction height during grooming so that a correct final elevation could be achieved. After the lifts were finished to the correct elevation, the weight of the model was measured to get an estimate of the average relative density of the lift. Model weight measurements were performed until the model weight exceeded the capacity of the crane.

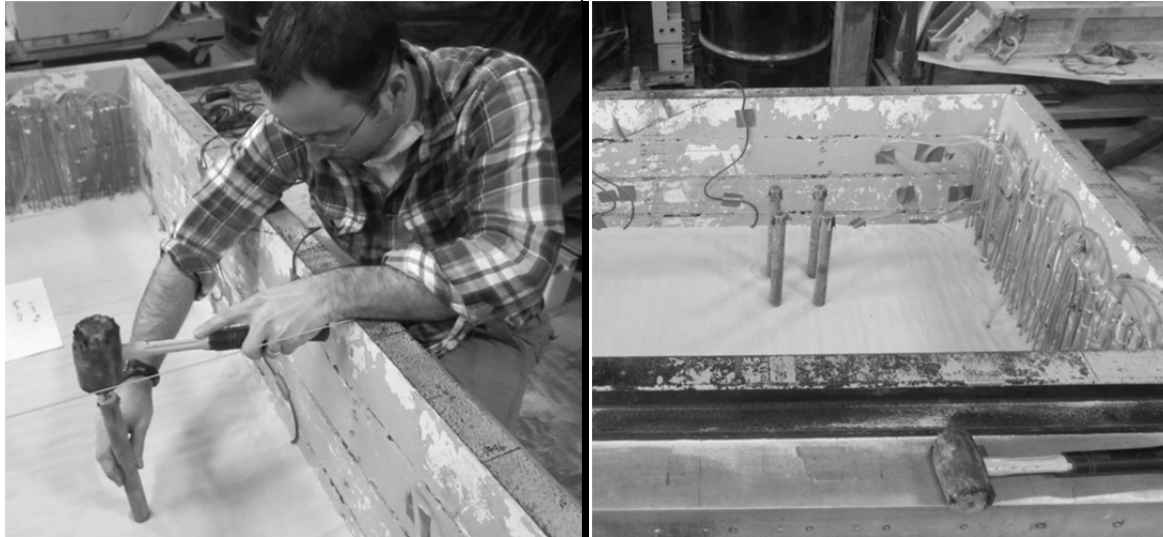
**Figure 3.2.14.** Installation of model piles.

11. The desired location of each instrument was marked on the surface of each lift and the instruments were carefully placed. Instrumentation cables were routed along the side walls of the model container and secured with duct tape.
12. When the surface of the soil was finished at a depth corresponding to approximately 50 mm above the toe depth of the piles, the piles were installed at the appropriate locations by driving the piles into the dense Nevada Sand using a rubber mallet (Figure 3.2.14).

The piles were then checked with a bullseye bubble level and a small carpenter's level to ensure they were plumb.

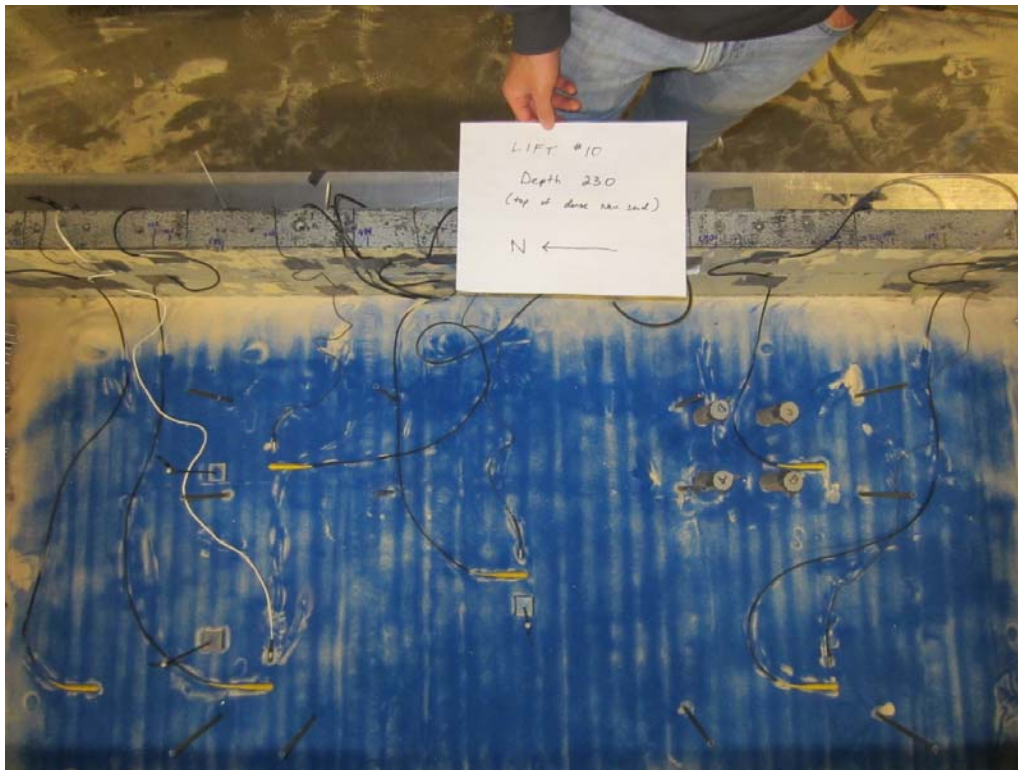
**Figure 3.2.15.** Thin layer of colored sand at top of dense Nevada Sand layer.

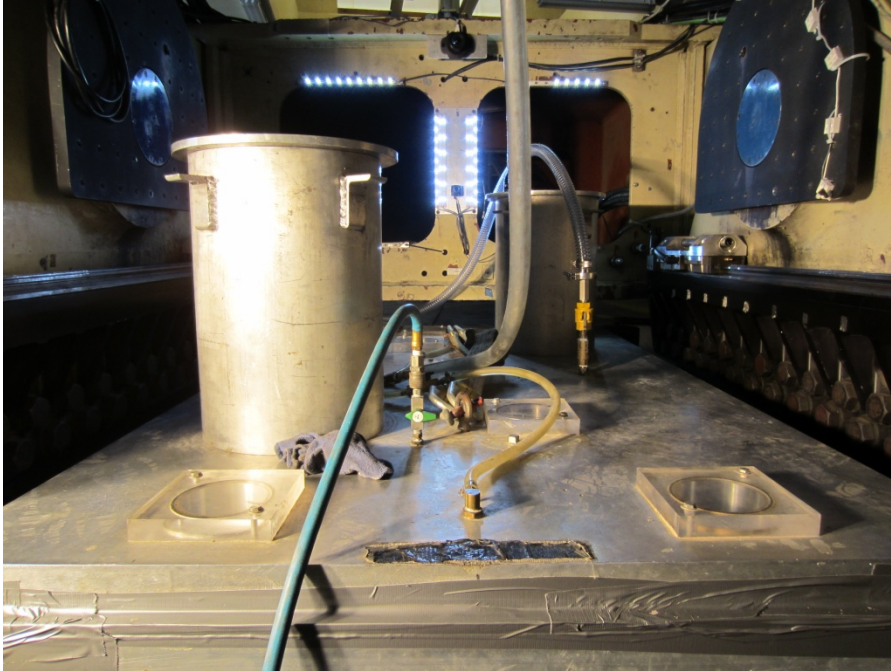
**Figure 3.2.16.** Saturation Set-up

17. The model was transported from the model preparation shop to the centrifuge and mounted on the centrifuge arm.
18. The model was saturated with the HPMC and water pore fluid solution described previously. Saturation consisted of covering and sealing the model with an air tight lid, applying a vacuum to remove air from the pores, slowly releasing the vacuum and filling the pore space with carbon dioxide, and then re-applying the vacuum (Figure 3.2.16). While the model was under vacuum, the de-aired pore fluid solution was dripped into the saturation troughs and, through the large tubes connected to the saturation troughs, into the soil. Valves were used to control the flow rate of de-aired pore fluid into the saturation troughs.

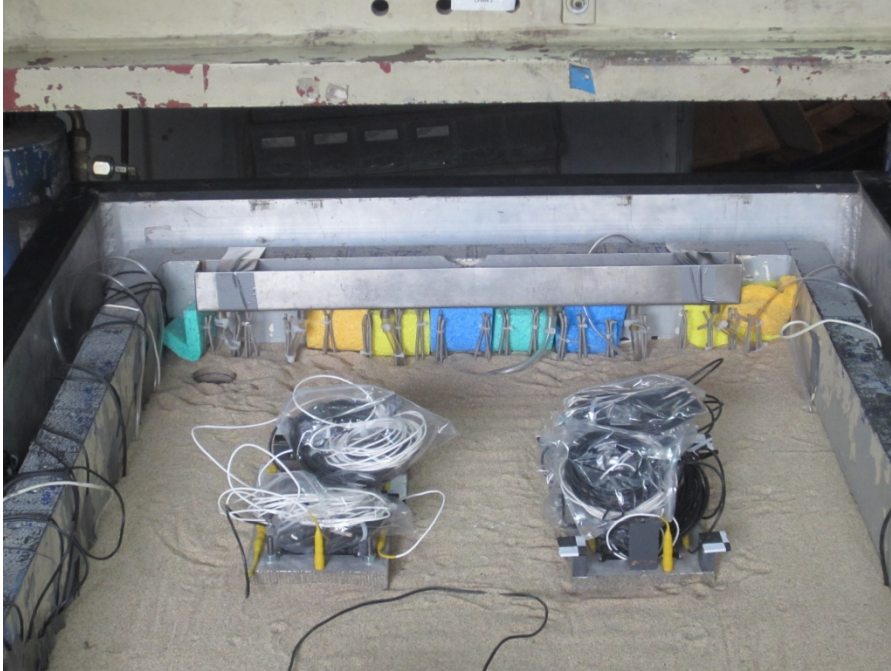
**Figure 3.2.17.** Sponges underneath saturation trough.

19. After approximately 95 hours of model saturation, the model had taken approximately 60% of the theoretical required amount of pore fluid. At this point the pore fluid was allowed to overflow the metal saturation troughs and drip through several sponges into narrow saturation trenches on the soil surface to speed up the rate of progress (Figure 3.2.17). The idea with this procedure was to allow for the pore fluid to fill the soil pore space from both the bottom of the container (i.e., through the tubes connected to the saturation troughs) and through the surface of the container along the northern and southern edges of the container. Care was taken so as to not overflow the surface trenches. Pore fluid was introduced into the model up to the point where it was ponded across the surface of the entire model. The vacuum pressure was then released and the saturation lid was removed.

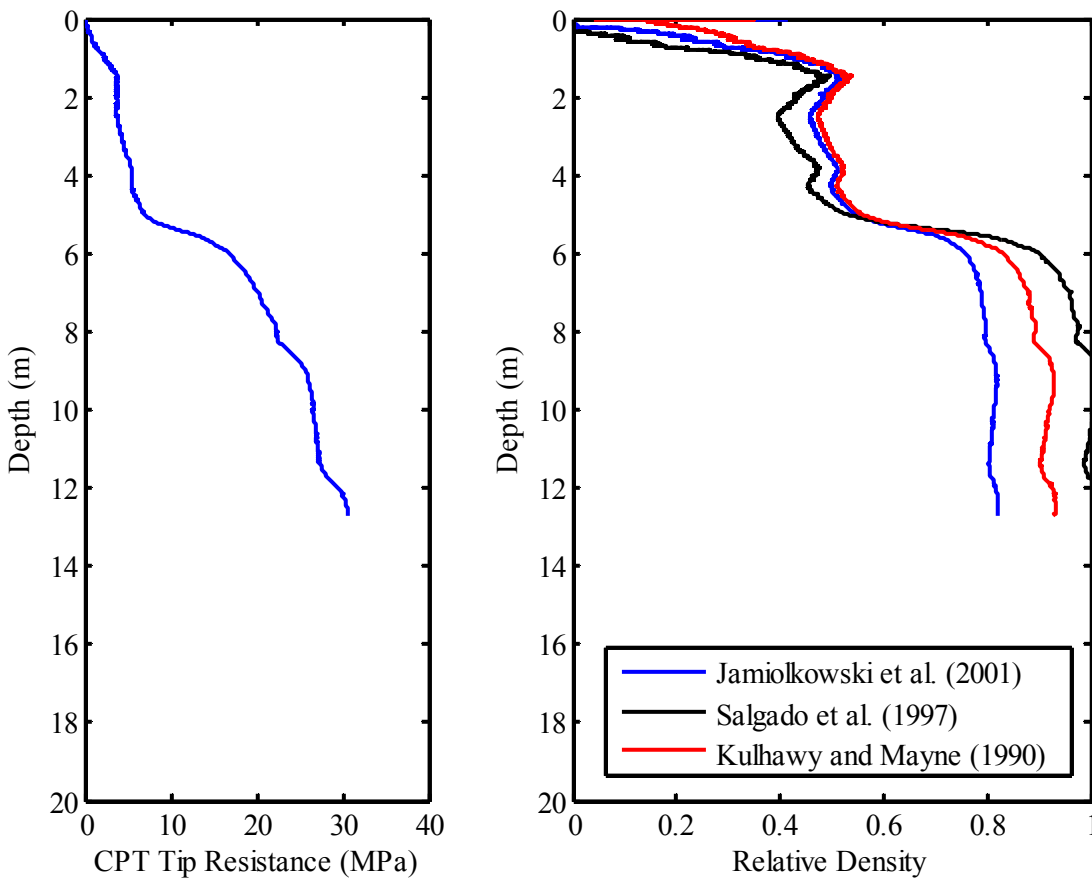
**Figure 3.3.2.** (a) Raw CPT tip resistance profile and (b) the relative density profiles as correlated from CPT tip resistance using formulas suggested by Kulhawy and Mayne (1990), Salgado et al. (1997), and Jamiolkowski et al. (2001).

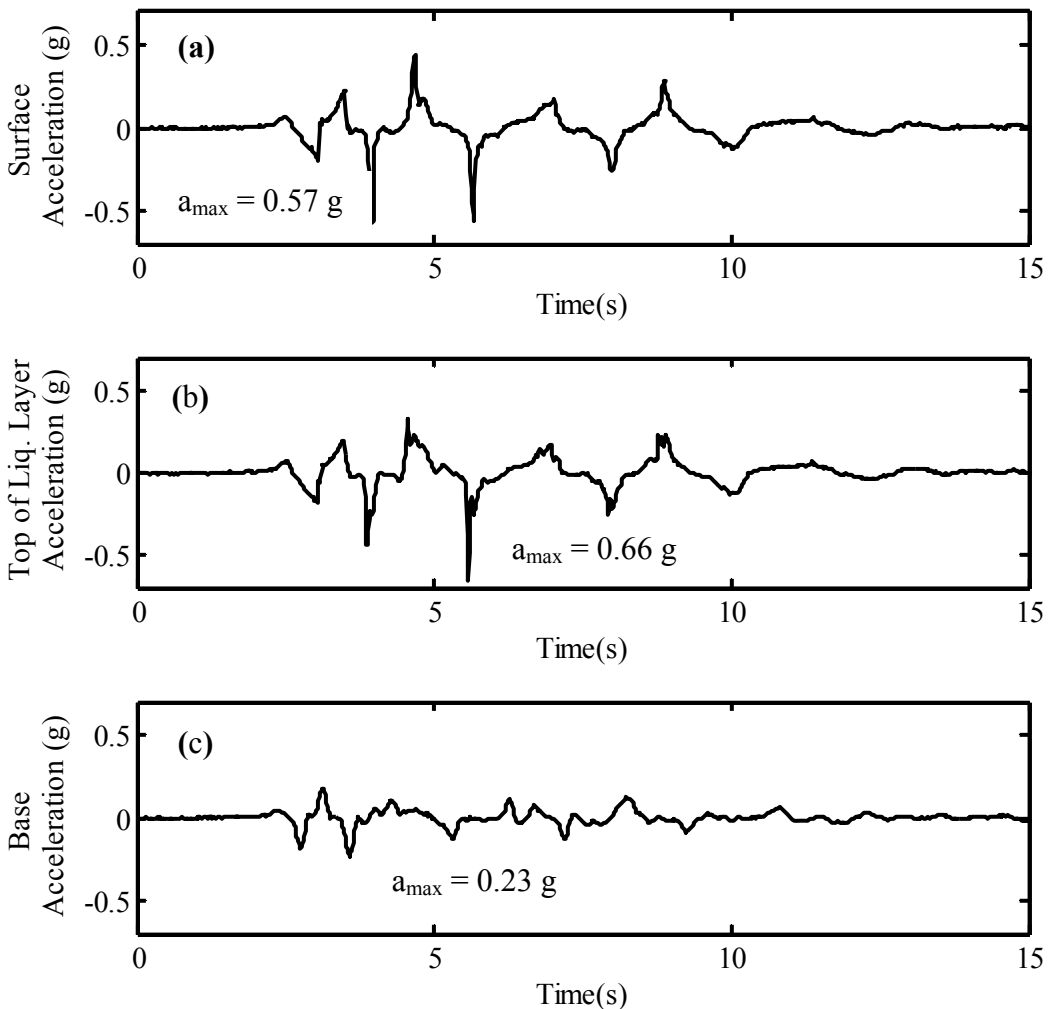
**Figure 3.3.3.** Free-field acceleration-time histories at (a) the soil surface, (b) the top of the loose to medium-dense Nevada Sand, and (c) the base of the model container during the PRI<sub>mod</sub> motion.

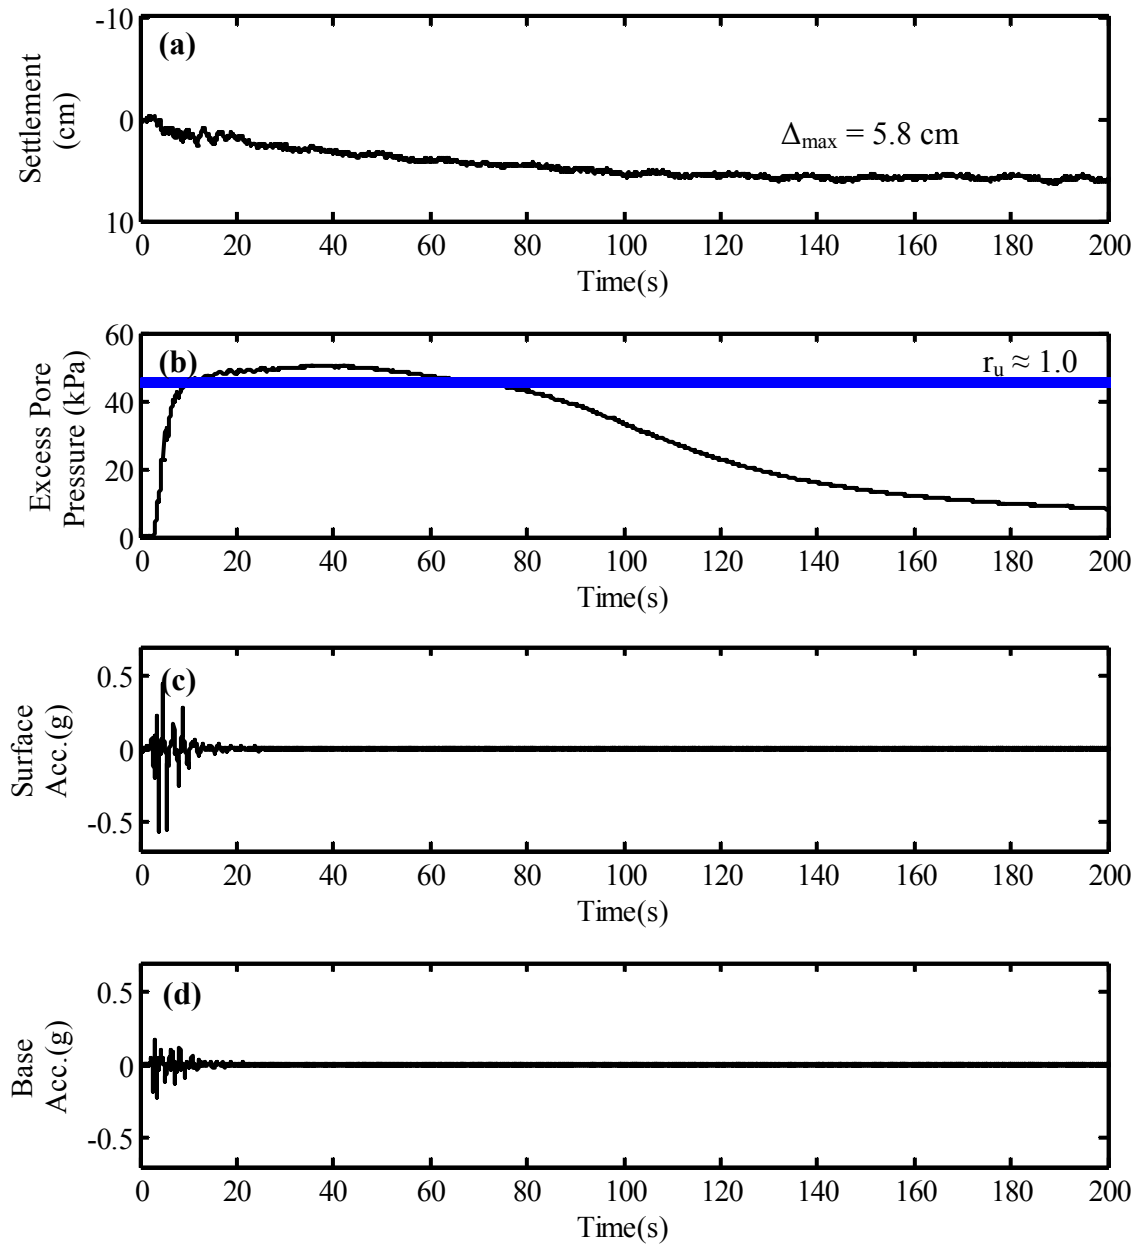
**Figure 3.3.4.** The free-field (a) settlement-time history at the soil surface, (b) excess pore water pressure-time history in the middle of the loose to medium-dense Nevada Sand layer, (c) the acceleration-time history at the surface, and (d) the acceleration-time history at the base of the model container.

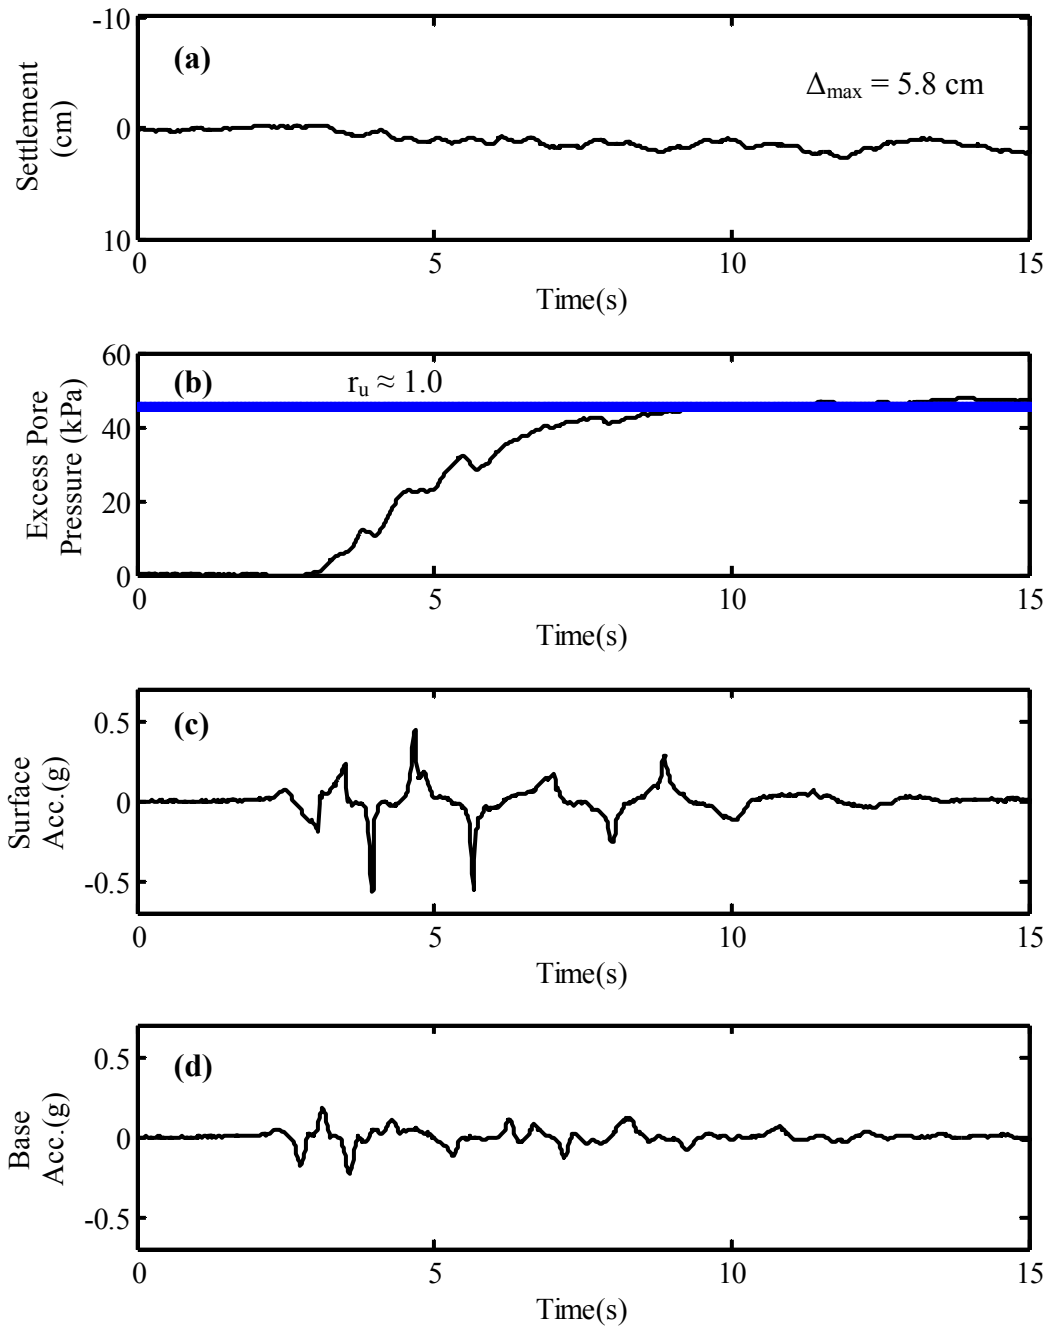
**Figure 3.3.5.** The zoomed-in free-field (a) settlement-time history at the soil surface, (b) excess pore water pressure-time history in the middle of the loose to medium-dense Nevada Sand layer, (c) the acceleration-time history at the surface, and (d) the acceleration-time history at the base of the model container.

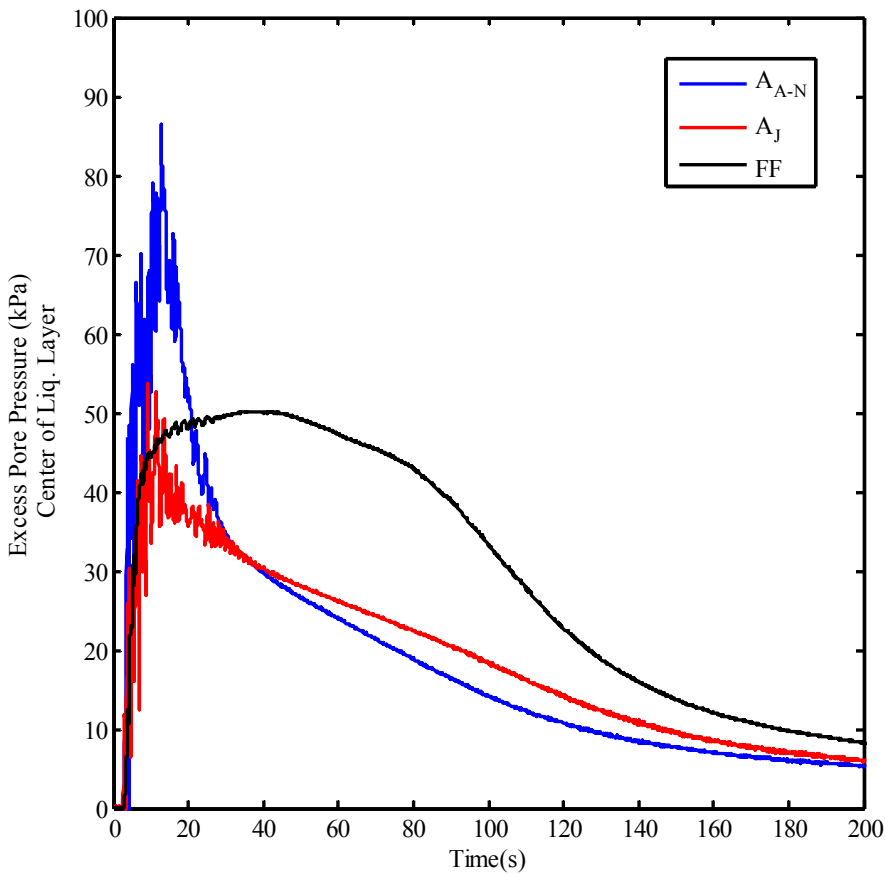
**Figure 3.3.9.** Excess pore water pressure-time histories at the center of the liquefiable layer beneath the center of  $A_{A-N}$ , the center of  $A_J$ , and the free-field.

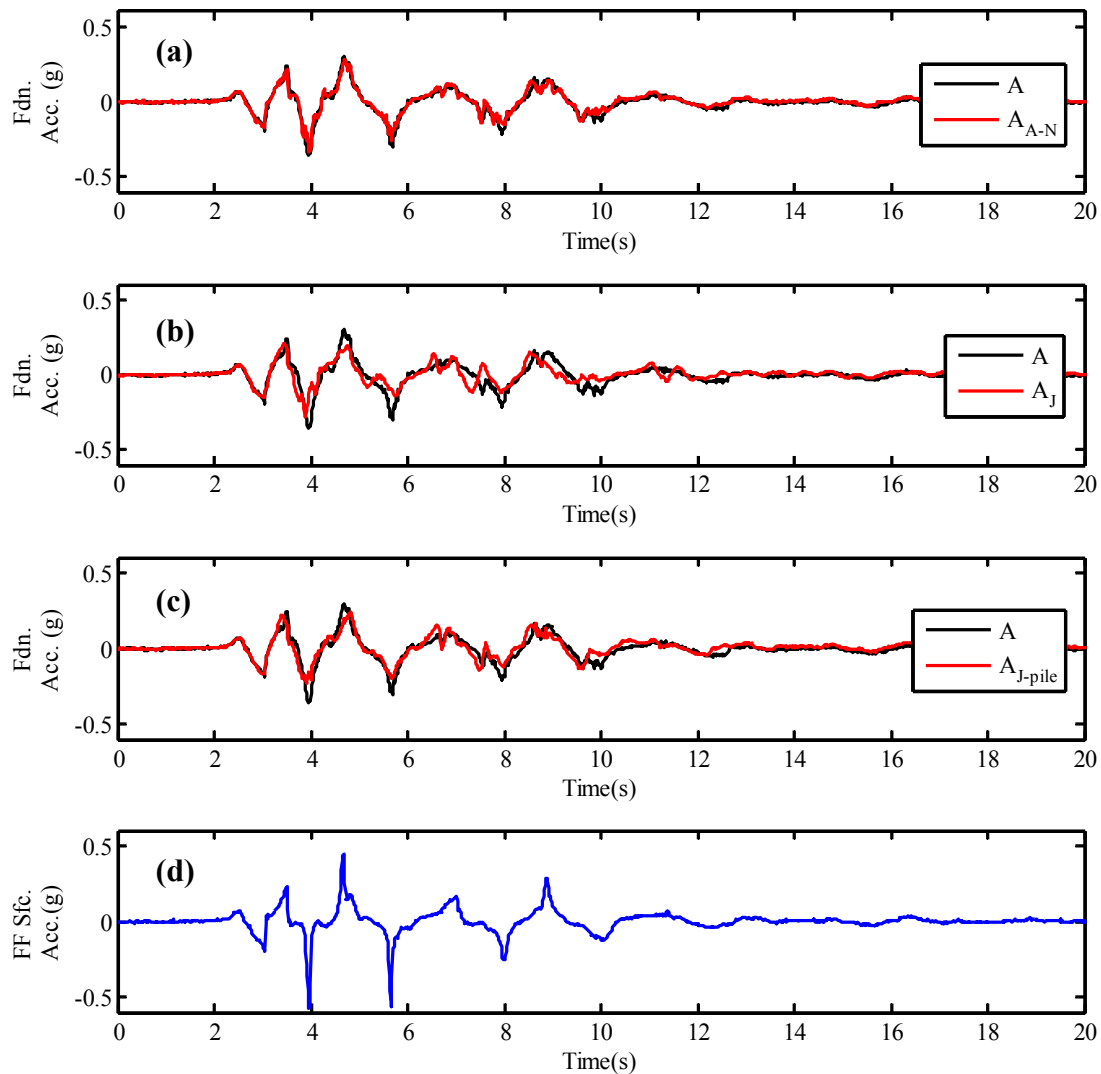
**Figure 3.3.10.** Foundation level acceleration-time histories at (a)  $A_{A-N}$ , (b)  $A_J$ , and (c)  $A_{J\text{-pile}}$ . The foundation level acceleration-time history of A is shown on each plot for the purposes of comparison. (d) Free-field surface acceleration-time history.

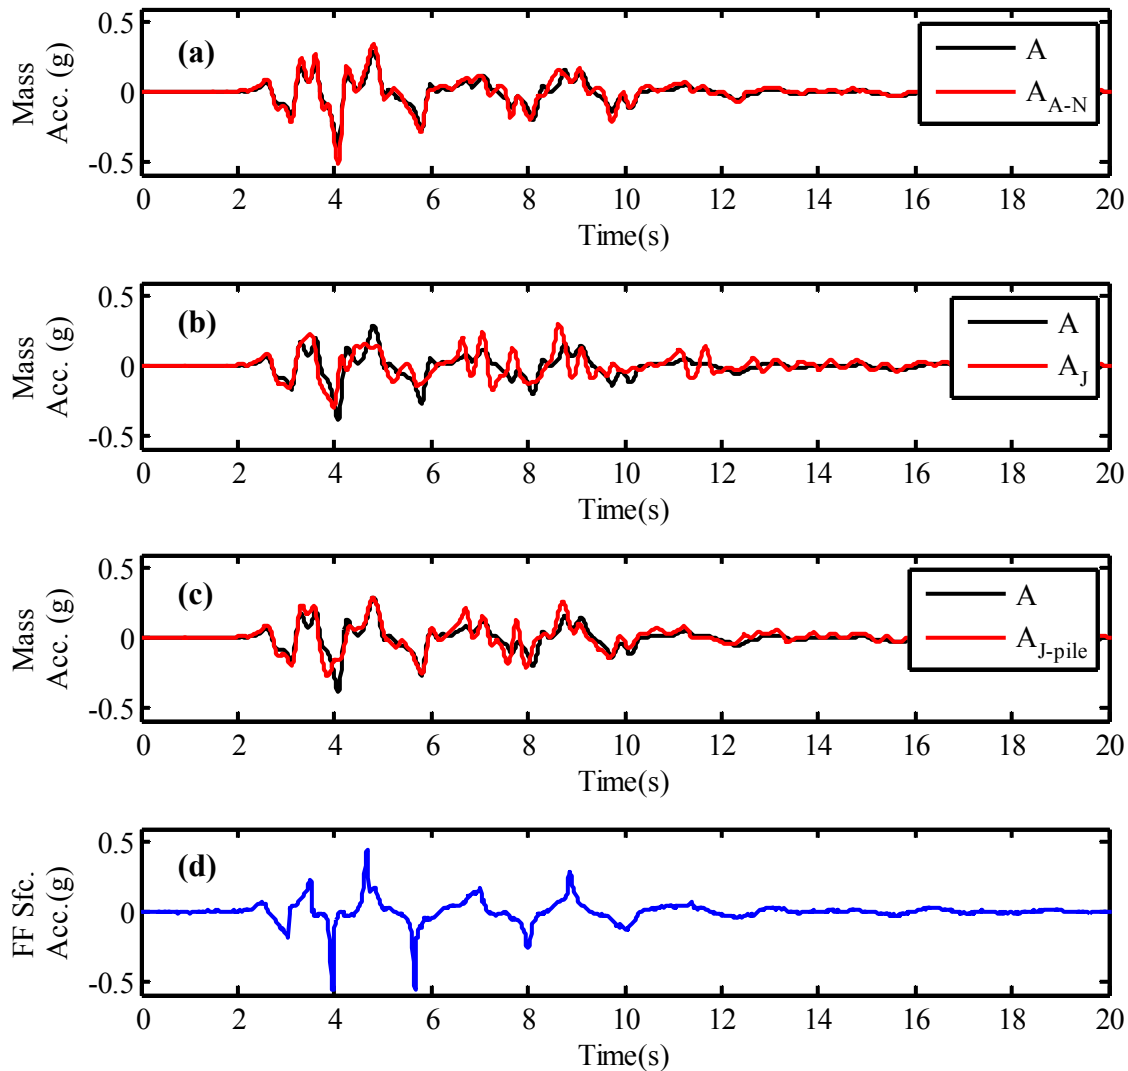
**Figure 3.3.11.** Lumped mass-level acceleration-time histories at (a)  $A_{A-N}$ , (b)  $A_J$ , and (c)  $A_{J-pile}$ . The lumped mass-level acceleration-time history of A is shown on each plot for the purposes of comparison. (d) Free-field surface acceleration-time history.

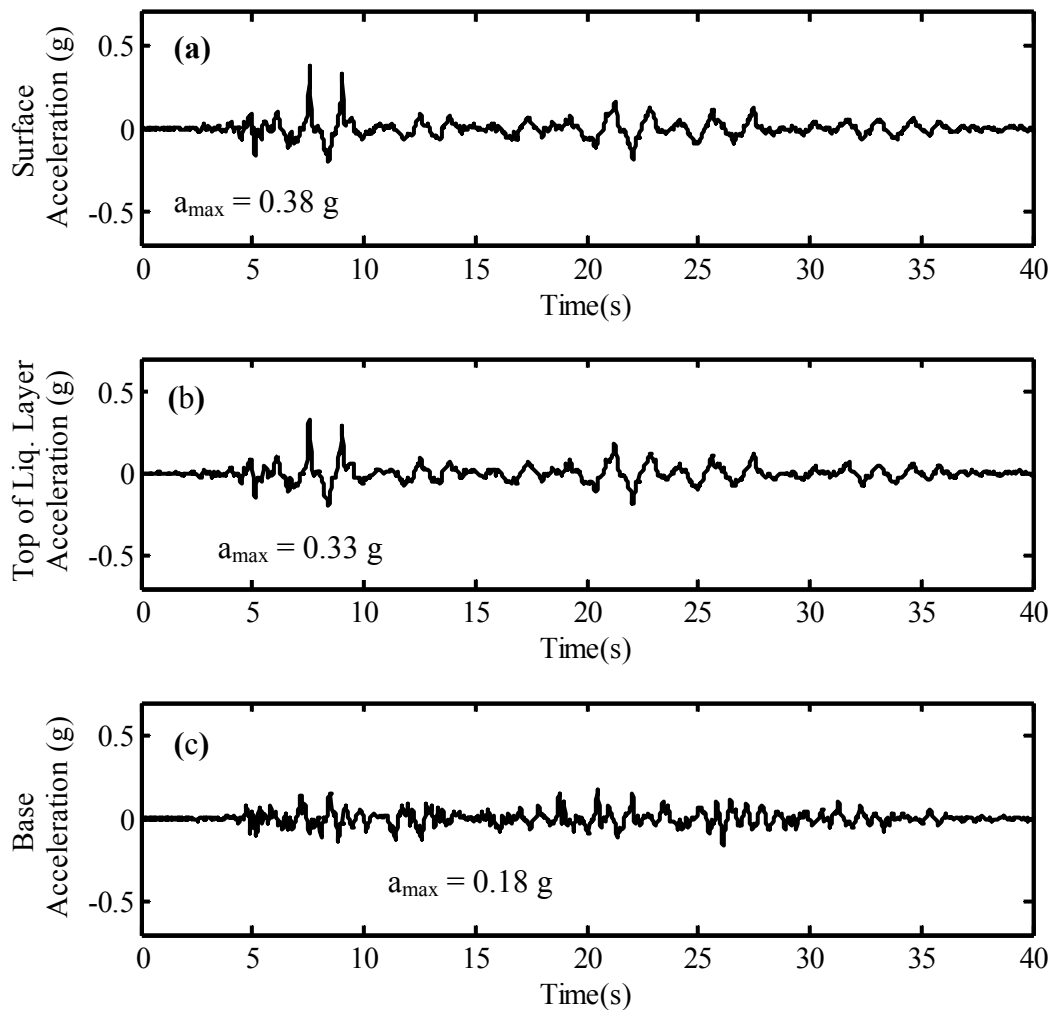
**Figure 3.3.14.** Free-field acceleration-time histories at (a) the soil surface, (b) the top of the loose to medium-dense Nevada Sand, and (c) the base of the model container during the TCU\_mod motion.

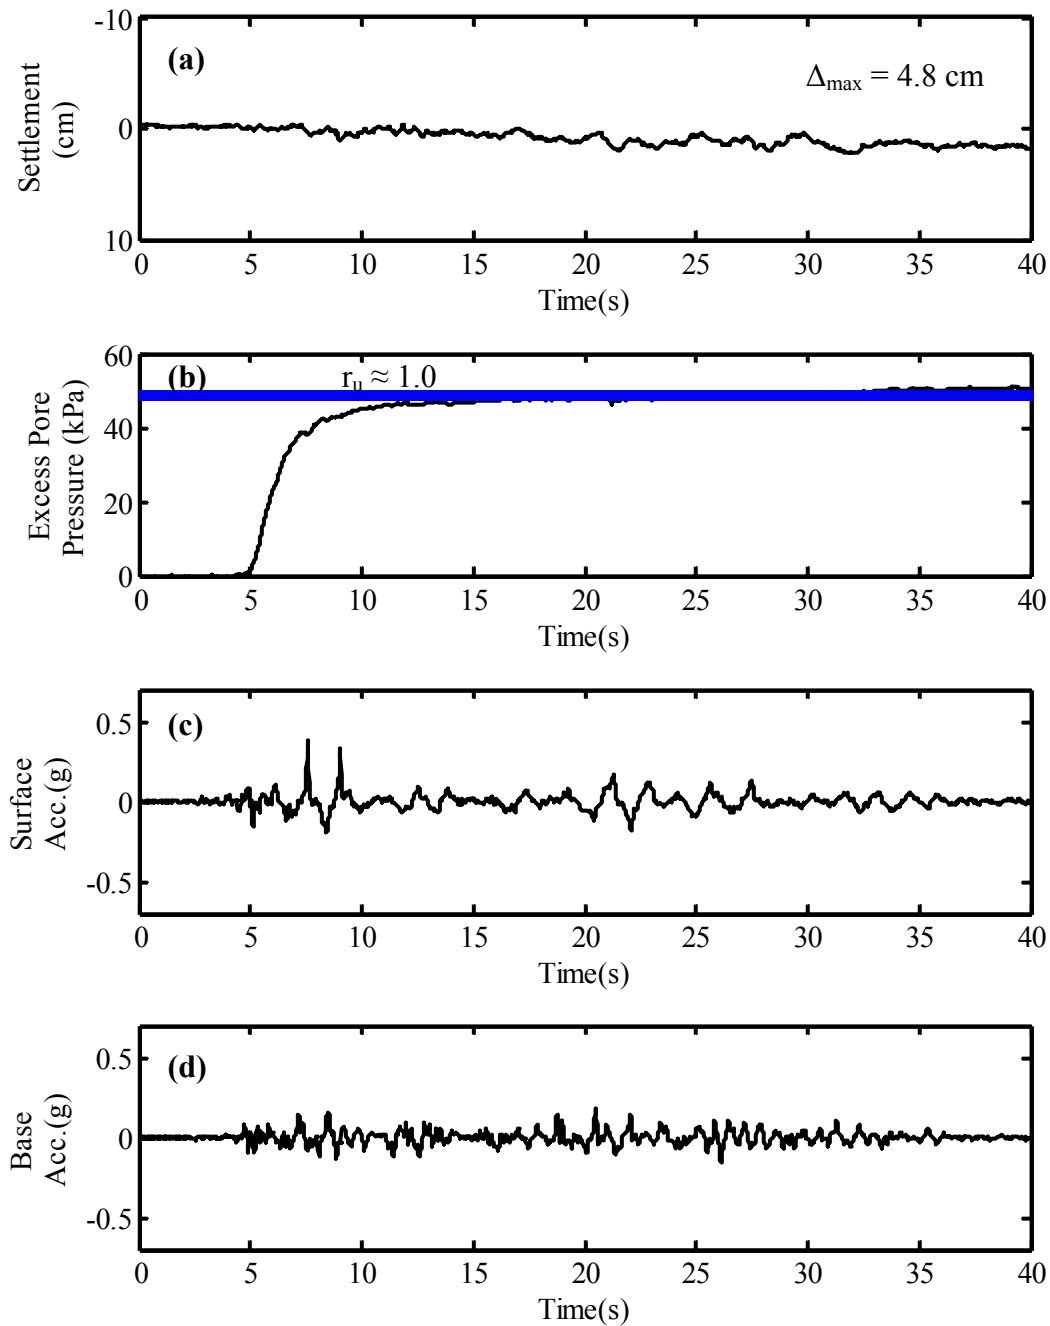
**Figure 3.3.16.** The zoomed-in free-field (a) settlement-time history at the soil surface, (b) excess pore water pressure-time history in the middle of the loose to medium-dense Nevada Sand layer, (c) the acceleration-time history at the surface, and (d) the acceleration-time history at the base of the model container.

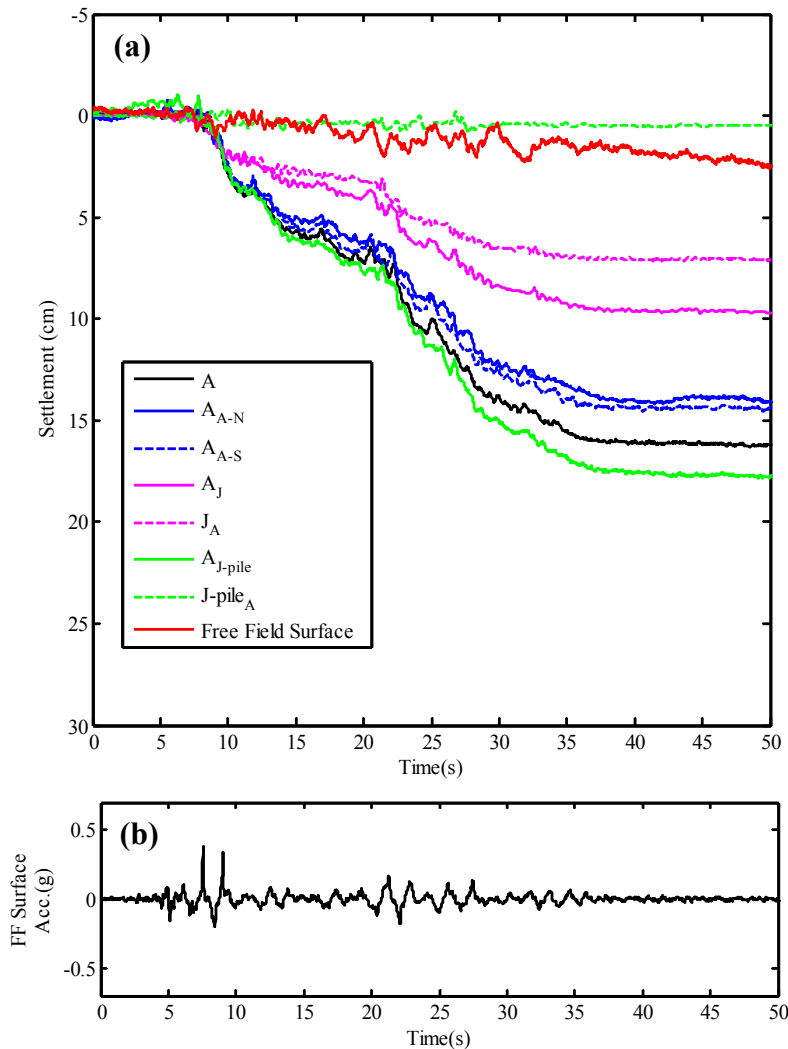
**Figure 3.3.17.** (a) Settlement-time histories at the centers of the A, A<sub>A-N</sub>, A<sub>A-S</sub>, A<sub>J</sub>, and J<sub>A</sub> buildings. Average settlement of the A<sub>J-pile</sub> building, and the settlement of the southwest corner of the J-pile building. Free-field surface settlements are shown for reference. (b) Free-field surface acceleration-time history.
