Seismic Performance of Buildings Subjected to Soil Liquefaction

Joshua David Zupan

Doctor of Philosophy

University of California, Berkeley

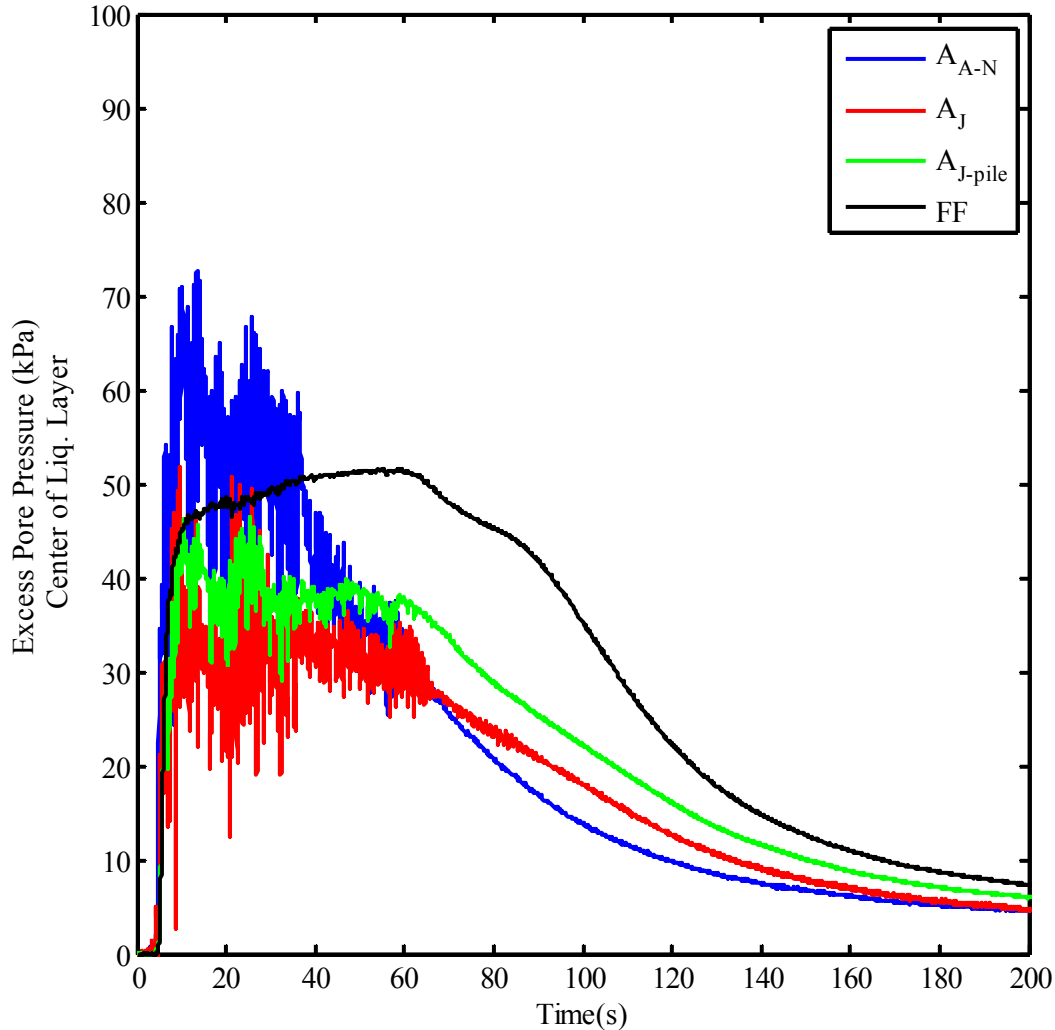
**Figure 3.3.20.** Excess pore water pressure-time histories at the center of the liquefiable layer beneath the center of  $A_{A-N}$ , the center of  $A_J$ , the center of  $A_{J-pile}$ , and the free-field.

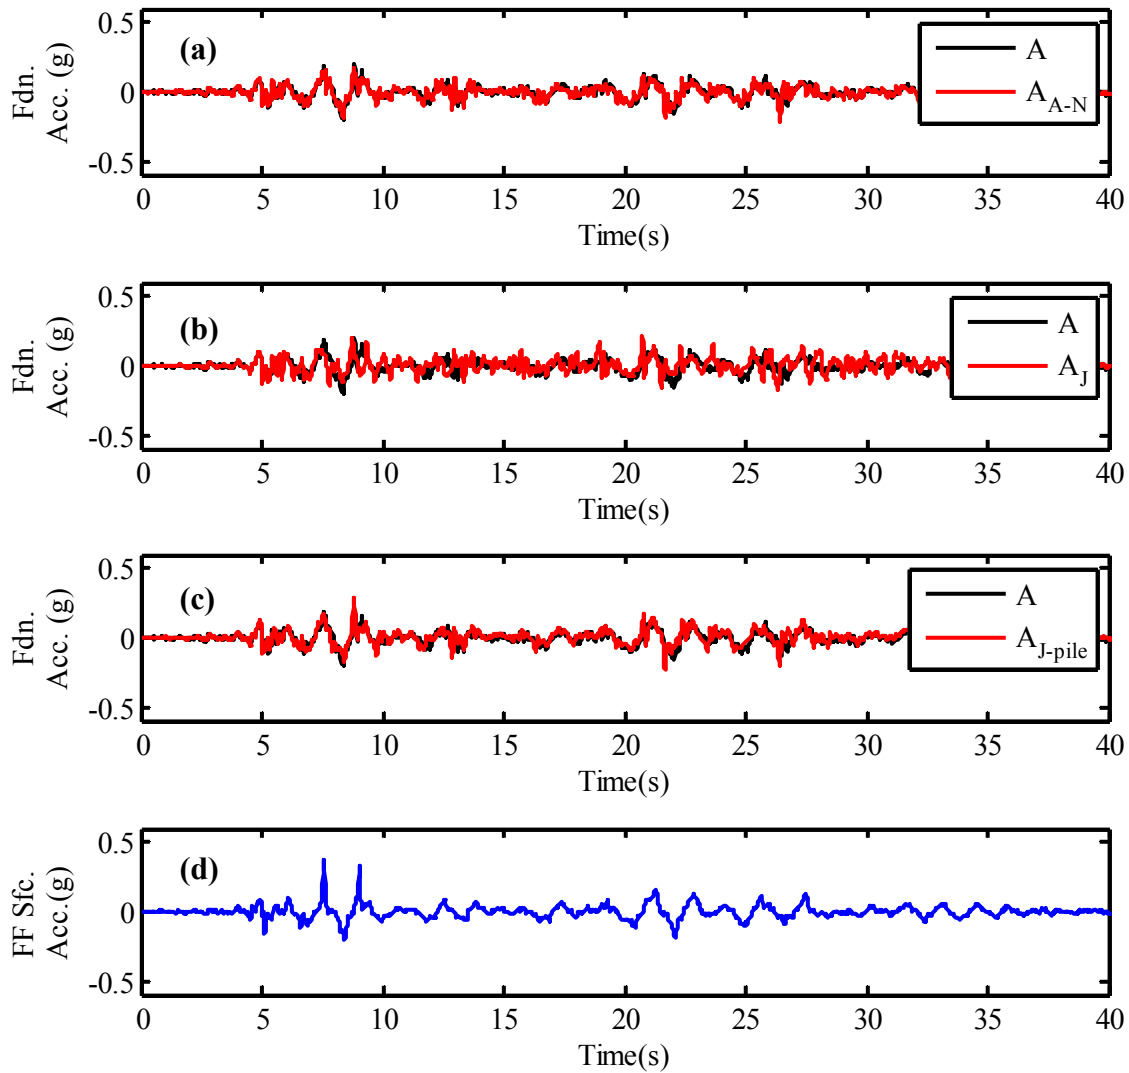
**Figure 3.3.21.** Foundation level acceleration-time histories at (a)  $A_{A-N}$ , (b)  $A_J$ , and (c)  $A_{J-pile}$ . The foundation level acceleration-time history of  $A$  is shown on each plot for the purposes of comparison. (d) Free-field surface acceleration-time history.

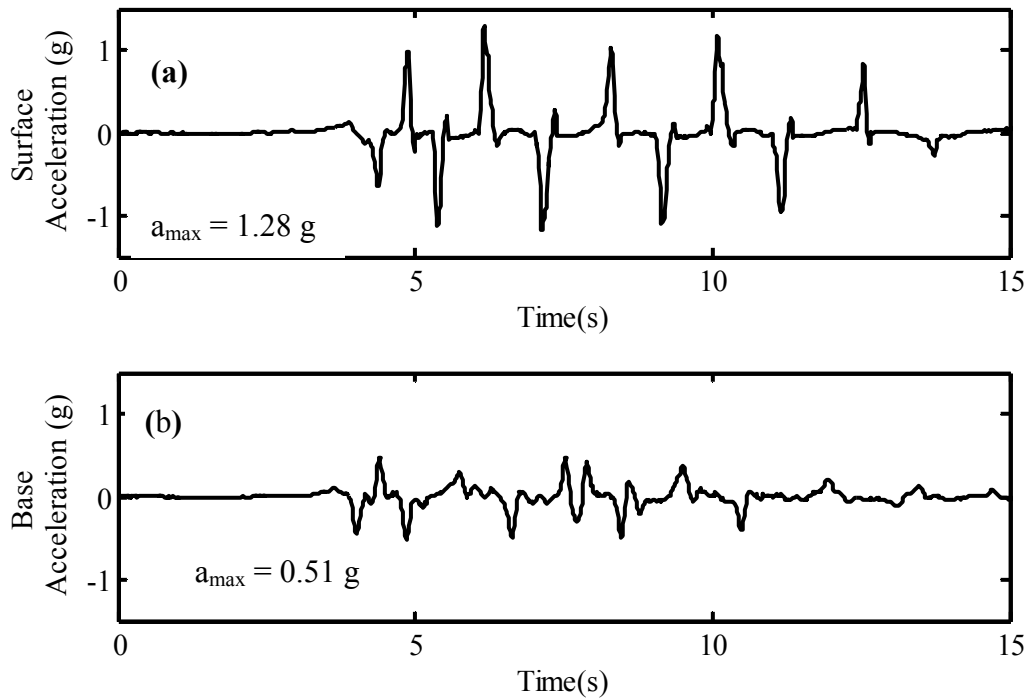
**Figure 3.3.25.** Free-field acceleration-time histories at (a) the soil surface and (b) the base of the model container during the PRI\_large motion.

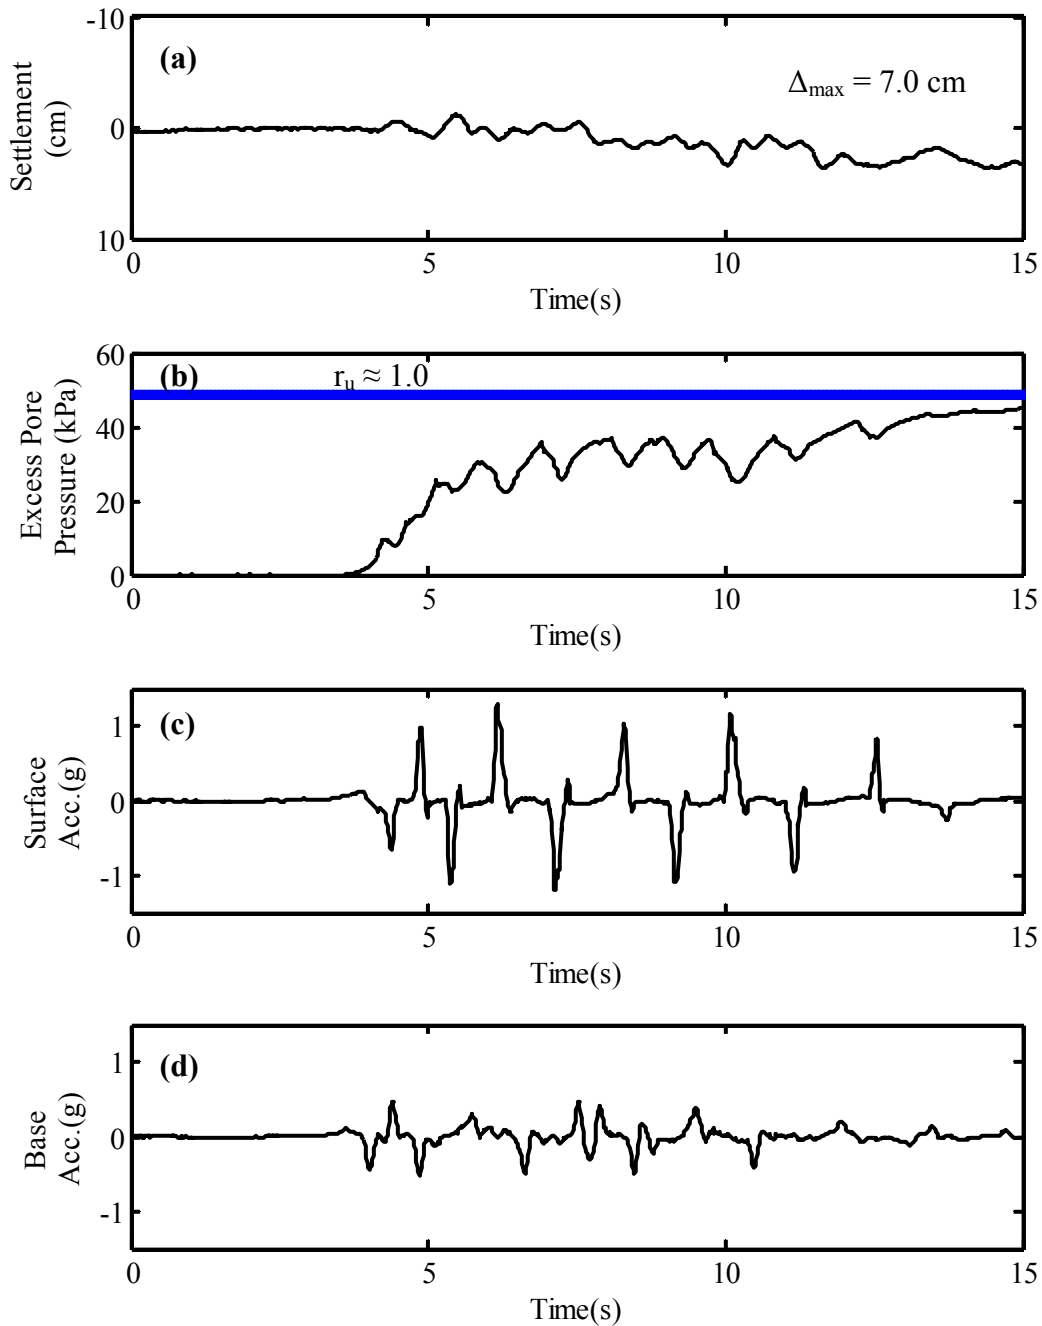
**Figure 3.3.27.** The zoomed-in free-field (a) settlement-time history at the soil surface, (b) excess pore water pressure-time history in the middle of the loose to medium-dense Nevada Sand layer, (c) the acceleration-time history at the surface, and (d) the acceleration-time history at the base of the model container.

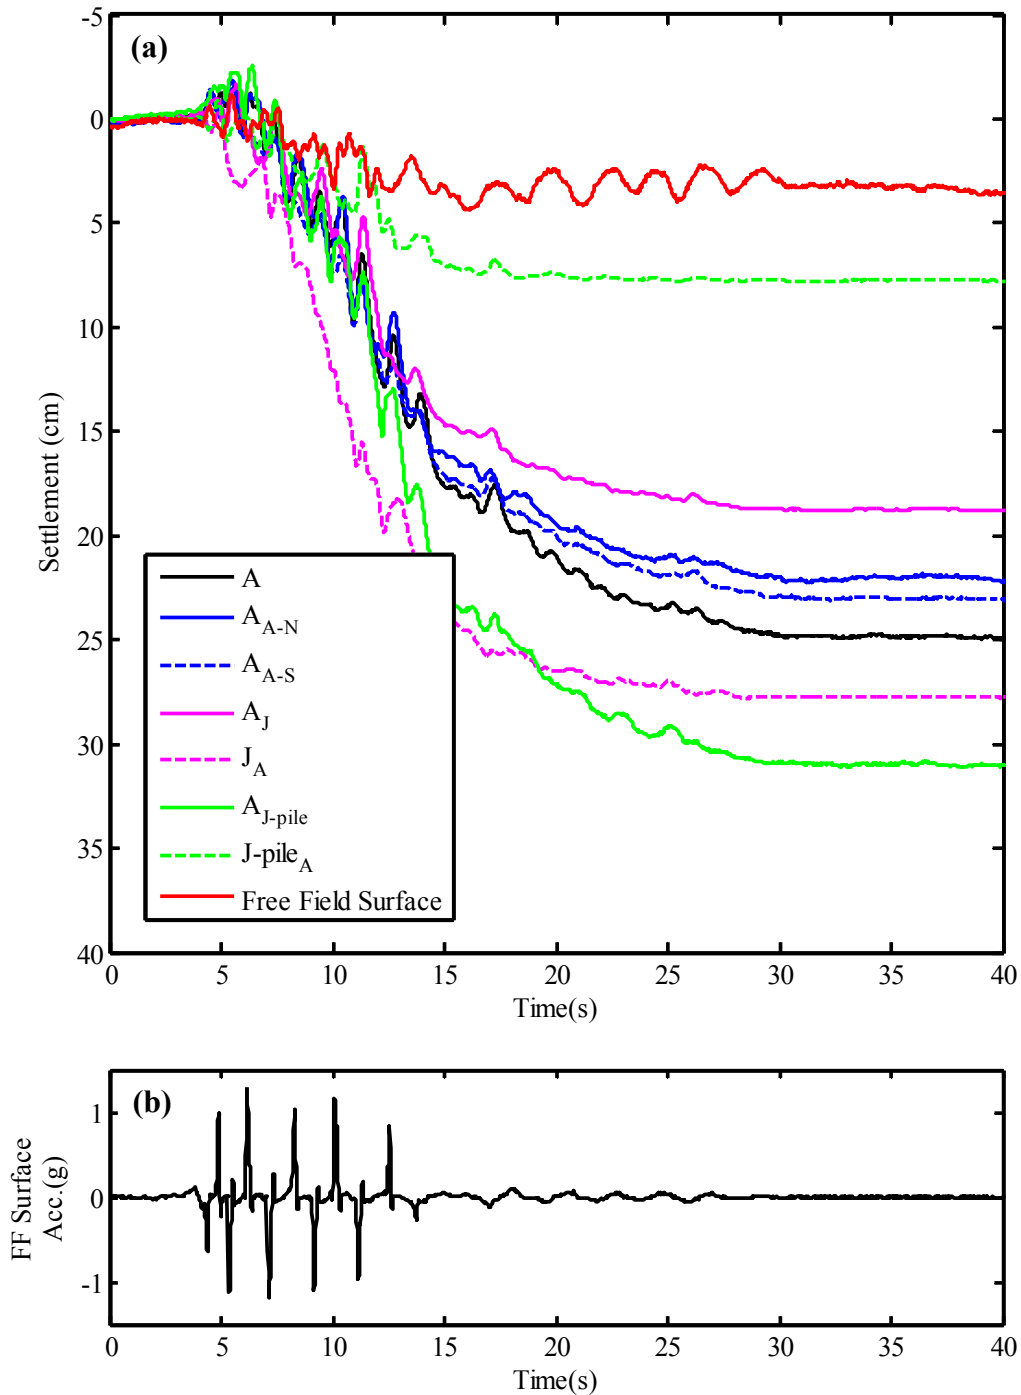
**Figure 3.3.28.** (a) Settlement-time histories at the centers of the A,  $A_{A-N}$ ,  $A_{A-S}$ ,  $A_J$ , and  $J_A$  buildings. Average settlement of the  $A_{J-pile}$  building, and the settlement of the southwest corner of the J-pile building. Free-field surface settlements are shown for reference. (b) Free-field surface acceleration-time history.

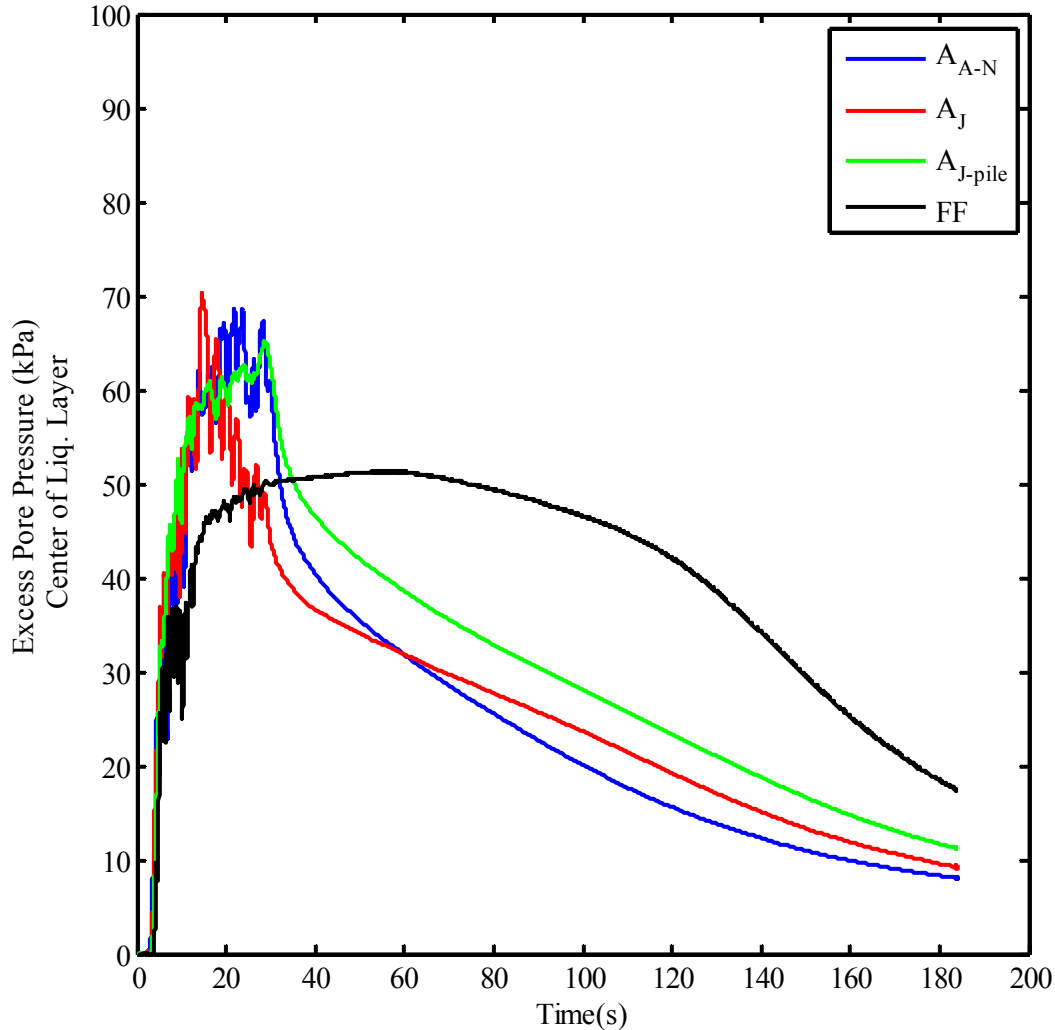
**Figure 3.3.31.** Excess pore water pressure-time histories at the center of the liquefiable layer beneath the center of  $A_{A-N}$ , the center of  $A_J$ , the center of  $A_{J-pile}$ , and the free-field.

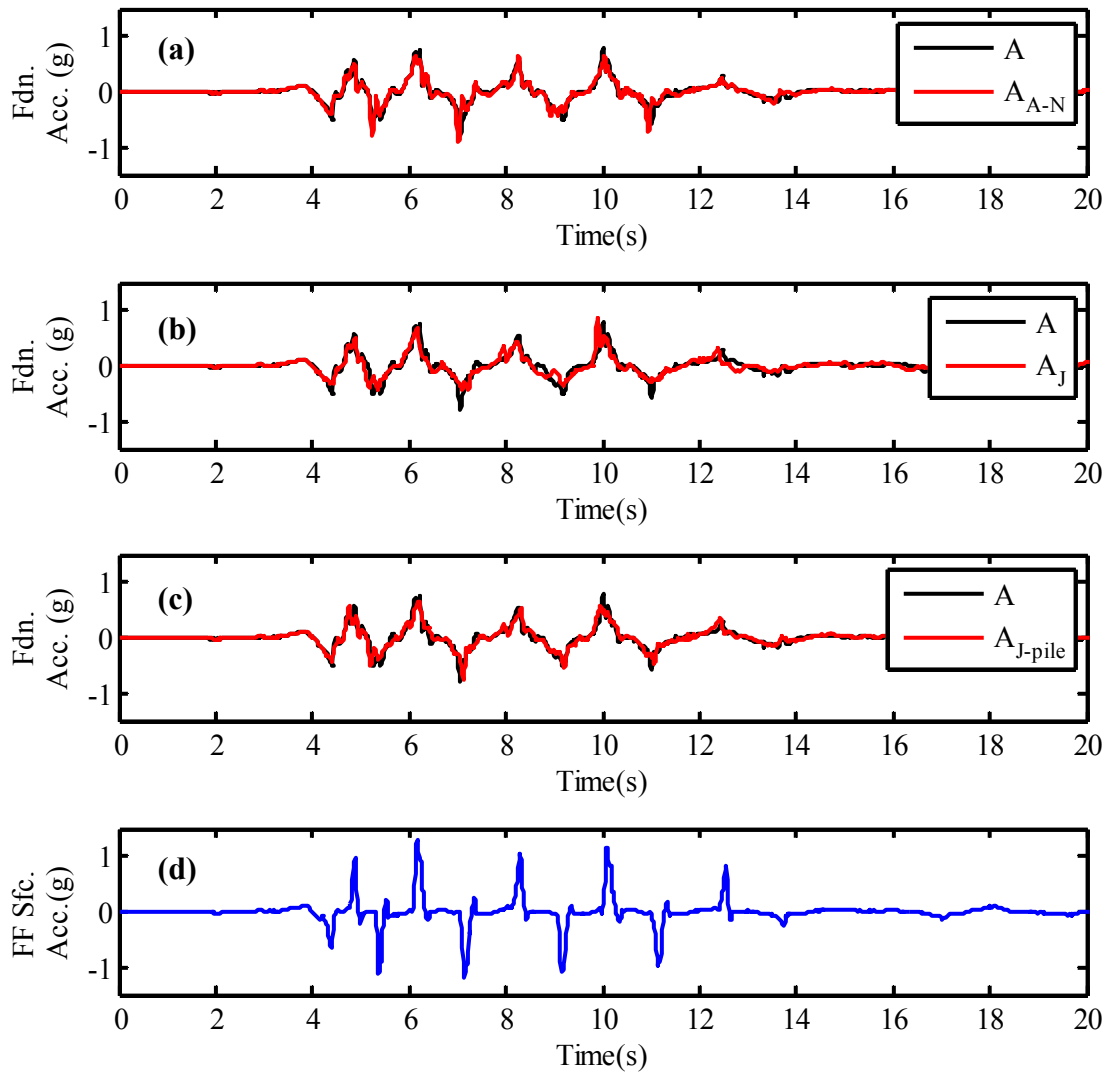
**Figure 3.3.32.** Foundation-level acceleration-time histories at (a)  $A_{A-N}$ , (b)  $A_J$ , and (c)  $A_{J-pile}$ . The foundation level acceleration-time history of A is shown on each plot for the purposes of comparison. (d) Free-field surface acceleration-time history.

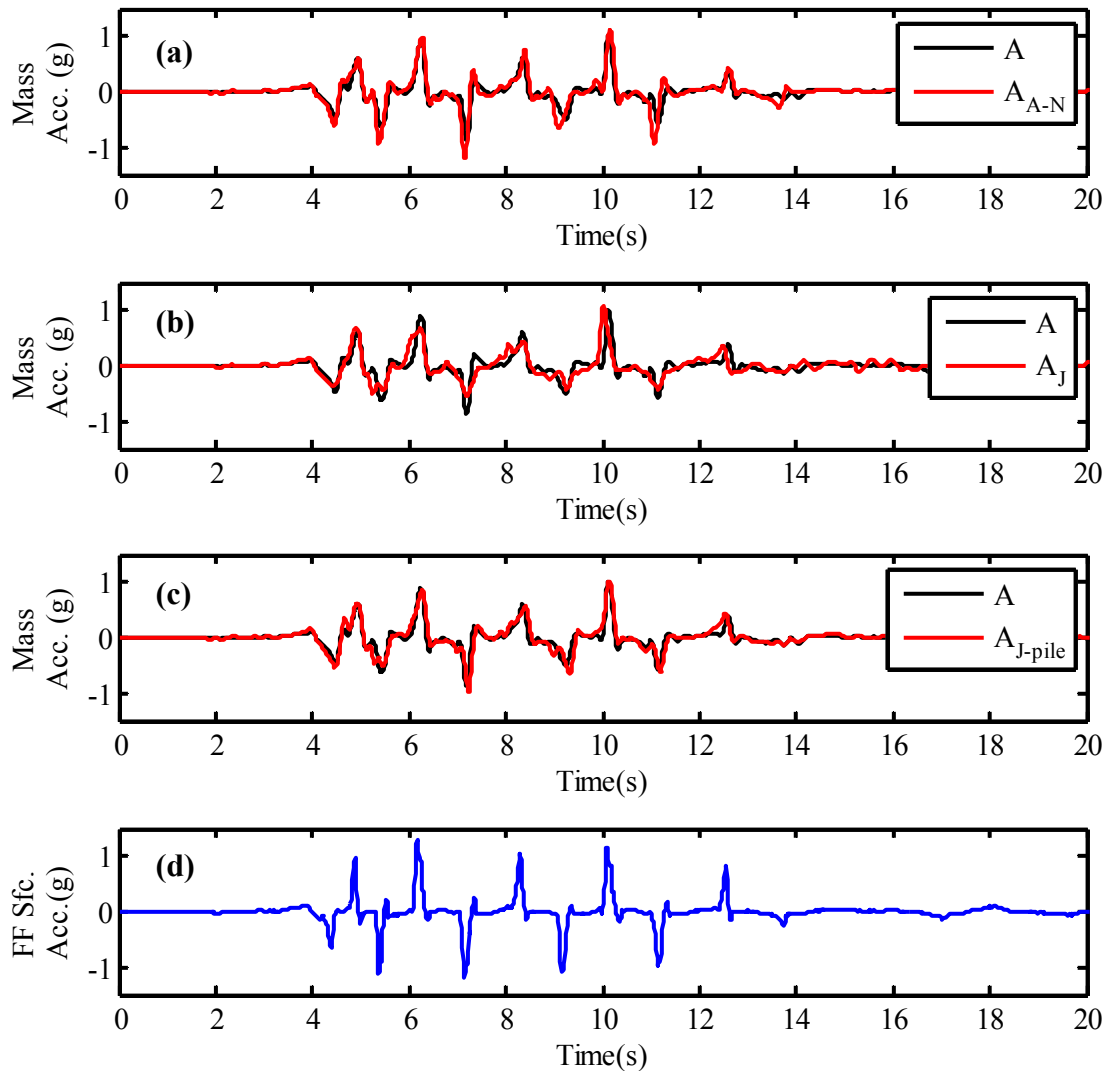
**Figure 3.3.33.** Lumped mass-level acceleration-time histories at (a)  $A_{A-N}$ , (b)  $A_J$ , and (c)  $A_{J-pile}$ . The lumped mass-level acceleration-time history of A is shown on each plot for the purposes of comparison. (d) Free-field surface acceleration-time history.

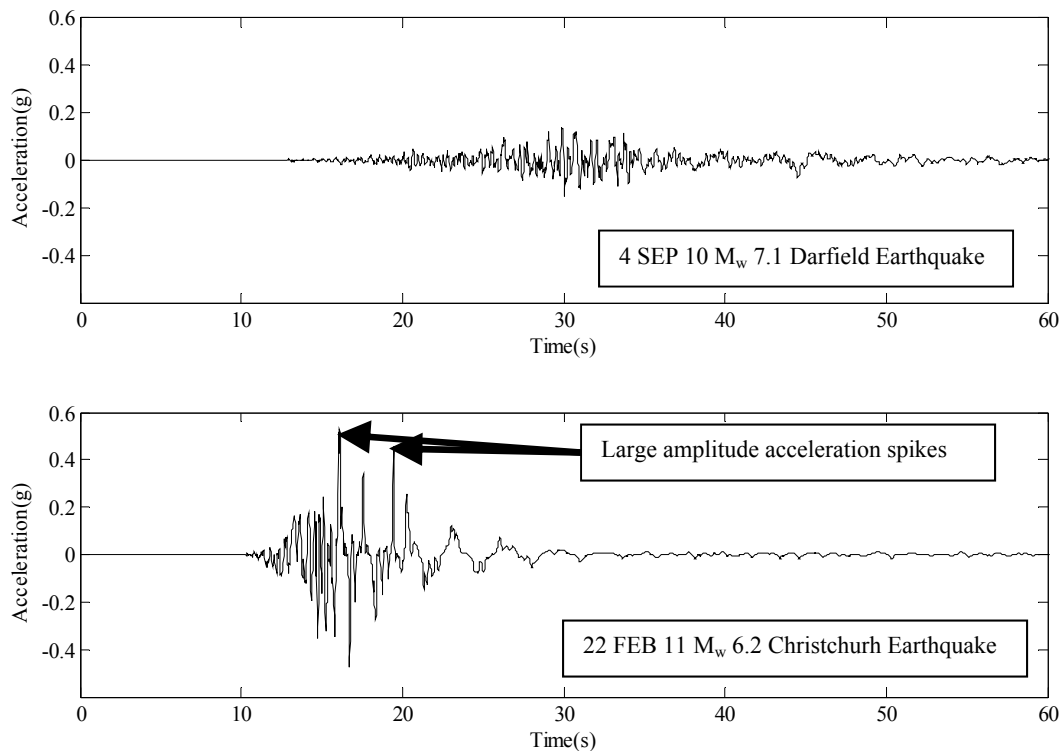
**Figure 4.1.7.** Acceleration-time histories recorded at station CBGS along azimuth 271 during the 4 SEP 10 and 22 FEB 11 events. Qualitative evidence of soil liquefaction is observed during the 22 FEB 11 event but not during the 4 SEP 10 event.

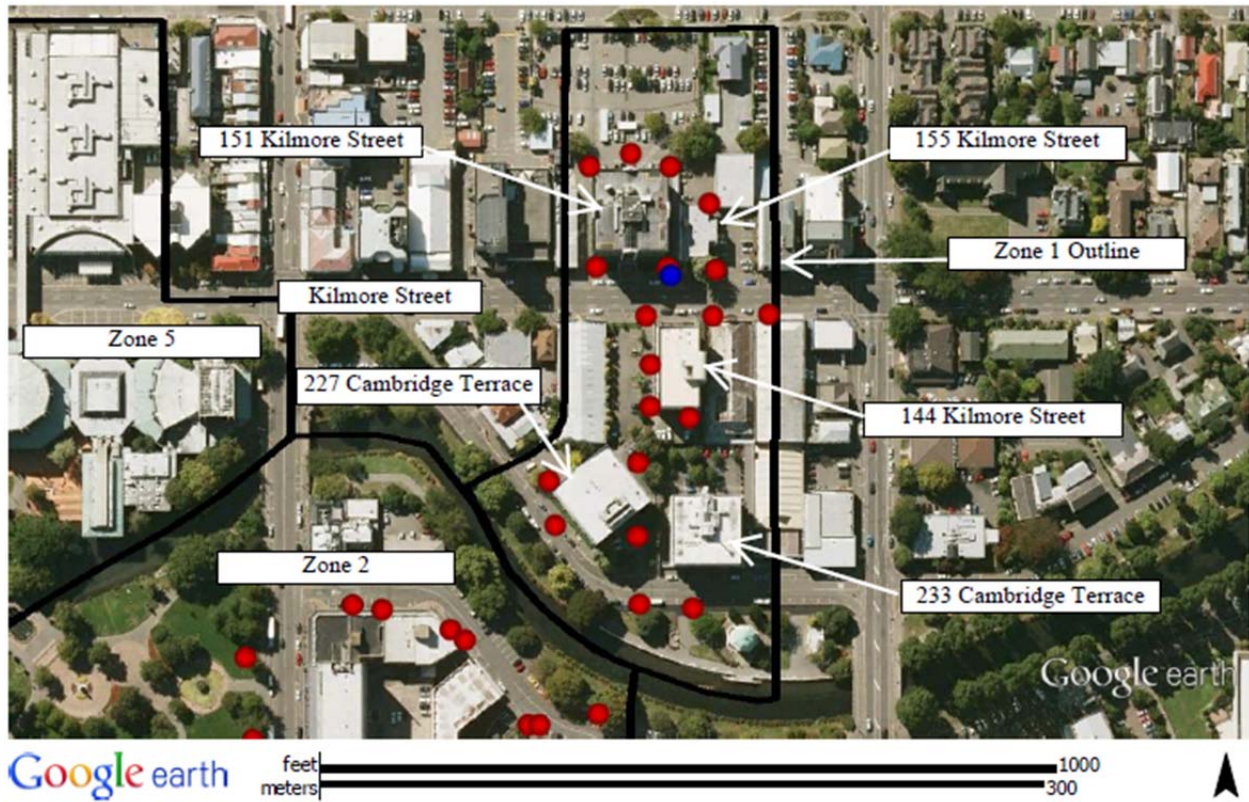
**Figure 4.1.9.** Zone 1 overview with structures of interest indicated. CPT locations are indicated in red. University of Canterbury borehole location indicated in blue.

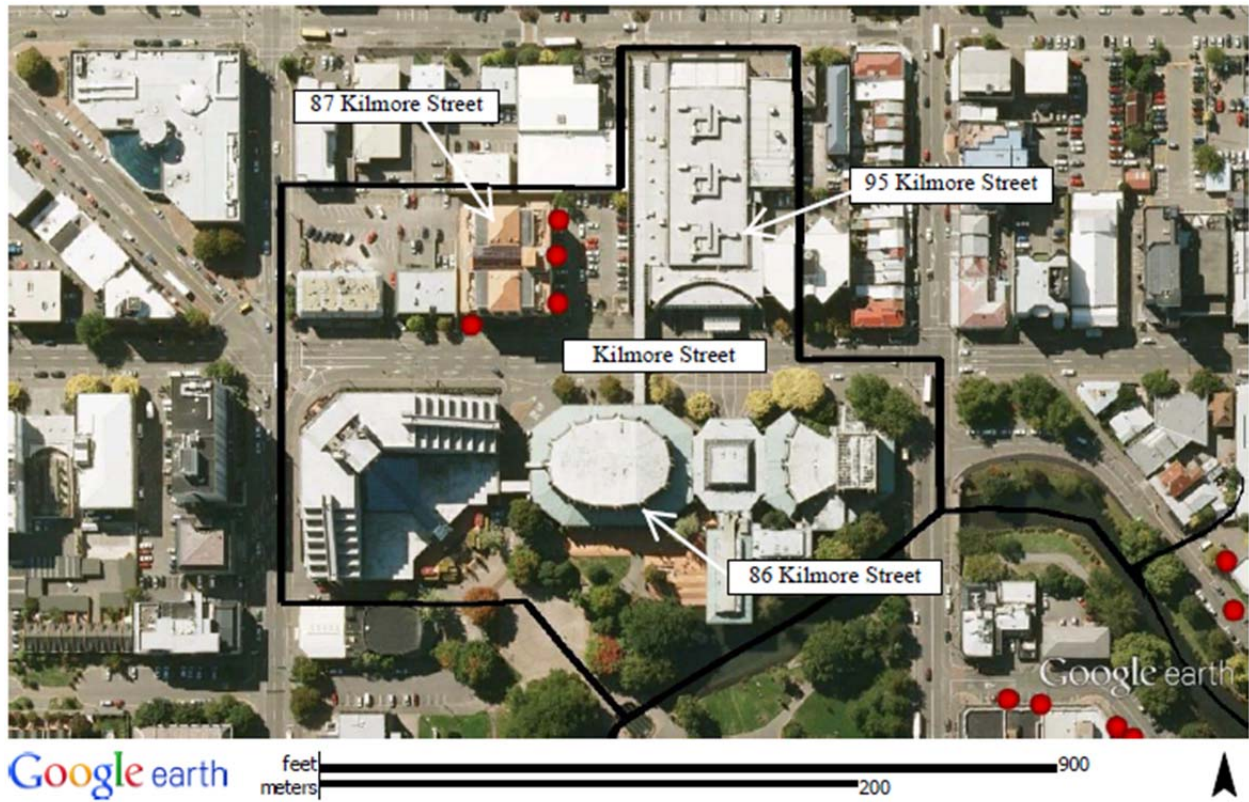
**Figure 4.1.12.** Zone 5 overview with structures of interest indicated. CPT locations are indicated in red.

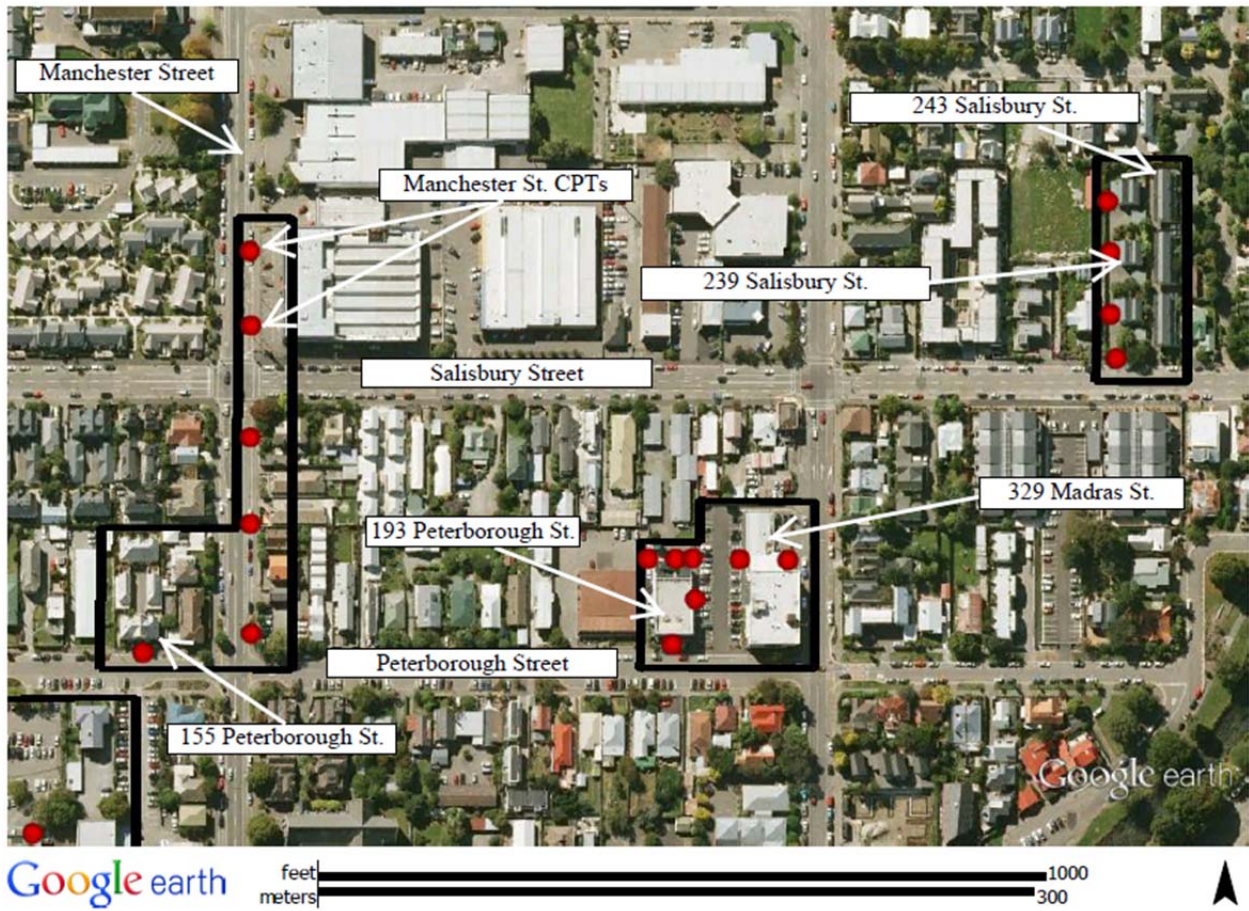
**Figure 4.1.13.** Zone 8 overview with structures of interest indicated. CPT locations are indicated in red.

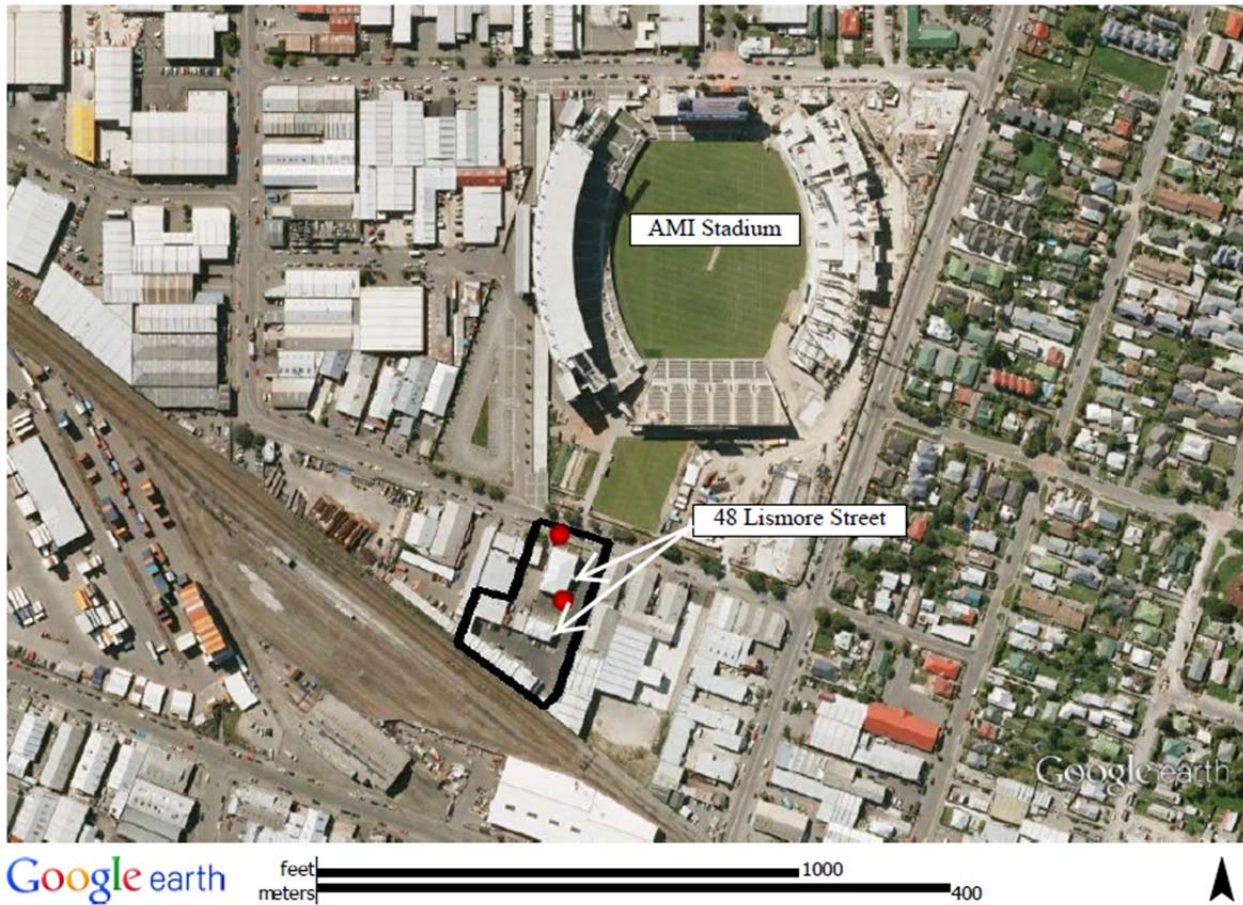
**Figure 4.1.14.** Zone 9 overview with structures of interest indicated. CPT locations are indicated in red.

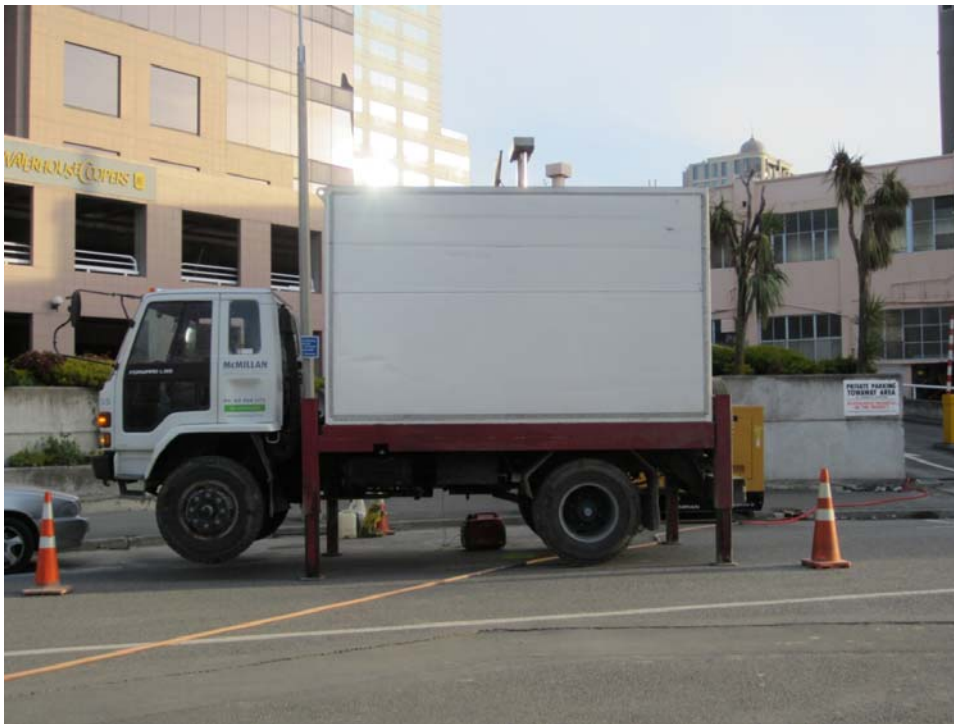
**Figure 4.1.15.** McMillan Drilling Services 14 Tonne CPT Truck

Eighty-four of the 107 CPTs performed for this study were performed by McMillan Drilling Services (henceforth McMillan) of Southbridge, Canterbury, New Zealand, and the remaining 23 CPTs were performed by Fugro Geotechnical NZ (henceforth Fugro) of Christchurch, New Zealand. The CPTs were generally performed in accordance with the procedures described in ASTM D5778-07. This included pushing a 10 cm<sup>2</sup> or 15 cm<sup>2</sup> cone penetrometer into the ground at a rate of approximately 2 cm/s and measuring the resistance at the tip and along the sleeve of the probe, the push rate, and inclination at every 1 or 2 cm depth increment during the test. Figures 4.1.15 through 4.1.17 are photographs of the CPT trucks used by McMillan and Fugro for this work.

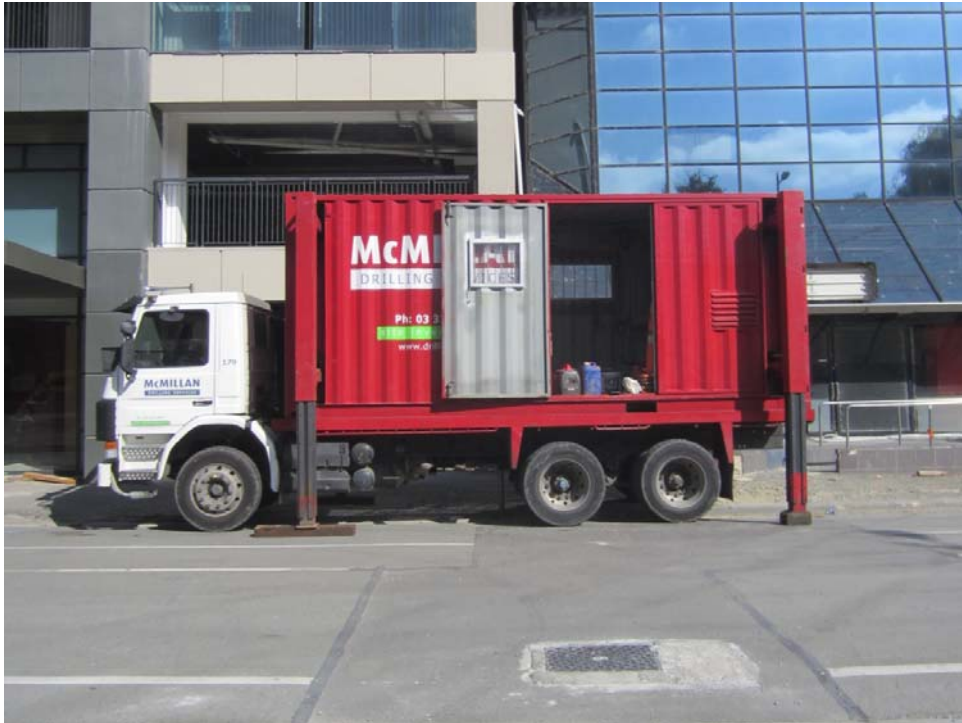
**Figure 4.1.16.** McMillan Drilling Services 22 Tonne CPT Truck

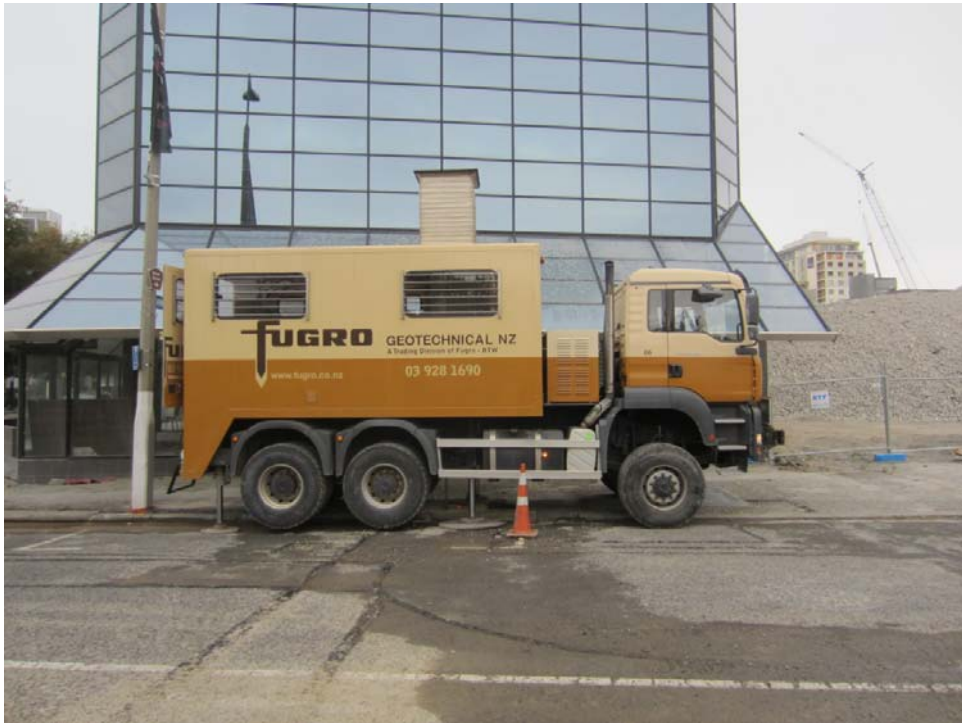
**Figure 4.1.17.** Fugro Geotechnical NZ 20 tonne CPT Truck.

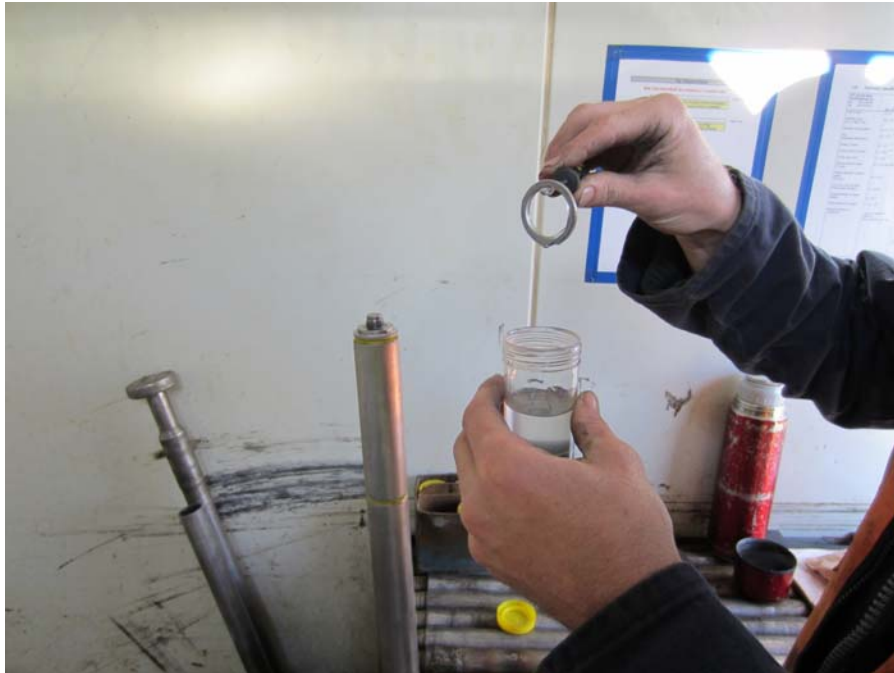
**Figure 4.1.18.** Stainless steel filter element being removed from silicone oil bath prior to installation.

The filter element for CPTu tests was located in the standard shoulder position just above the base of the cone. This is typically described in the literature as the u2 position and is the most common position for filter elements in modern electric cone penetrometers. McMillan filter elements consisted of greased stainless steel and the pore pressure fluid was silicone oil. Fugro filter elements were made of HDPE and the pore pressure fluid was glycerol. The filter elements were replaced prior to each CPTu. The pore pressure fluid ports were also flushed prior to each CPTu. Figure 4.1.18 illustrates a filter element prior to installation by McMillan on the penetrometer. Figure 4.1.19 shows the Fugro filter element installation and final assembly prior to push.

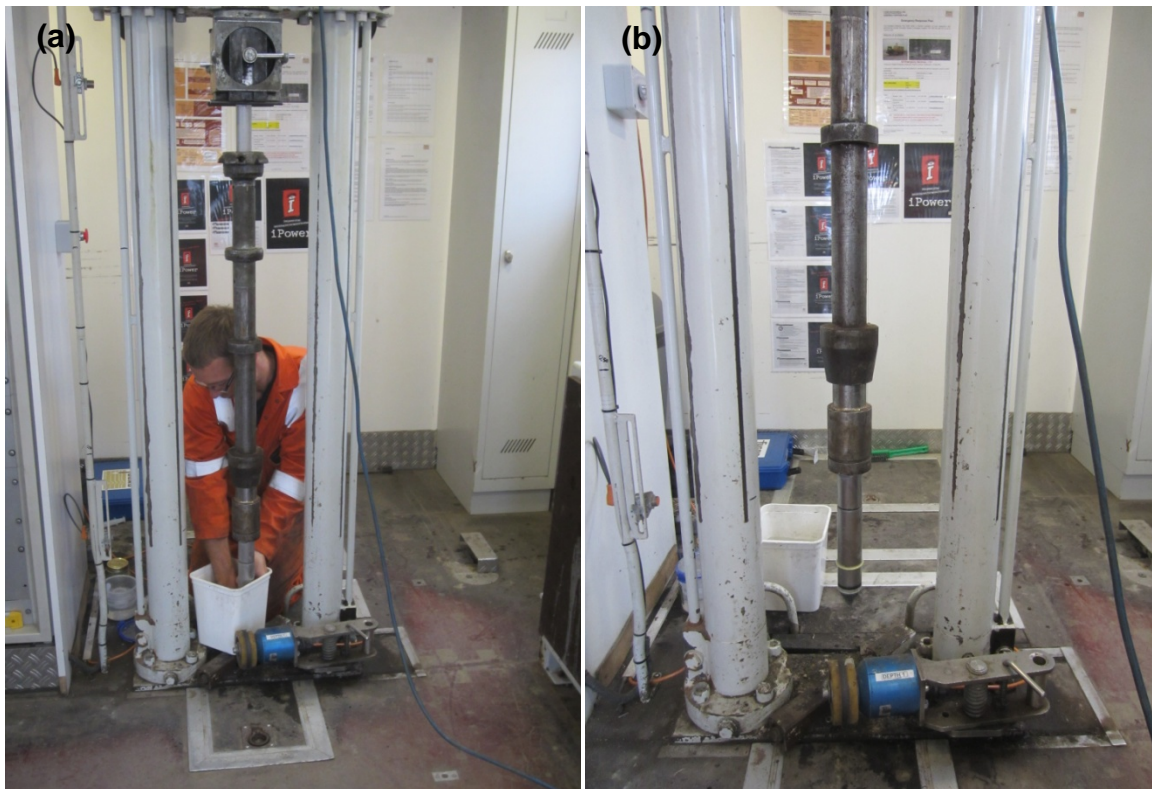
**Figure 4.1.19.** (a) Fugro filter element installation and (b) final assembly prior to CPTu.

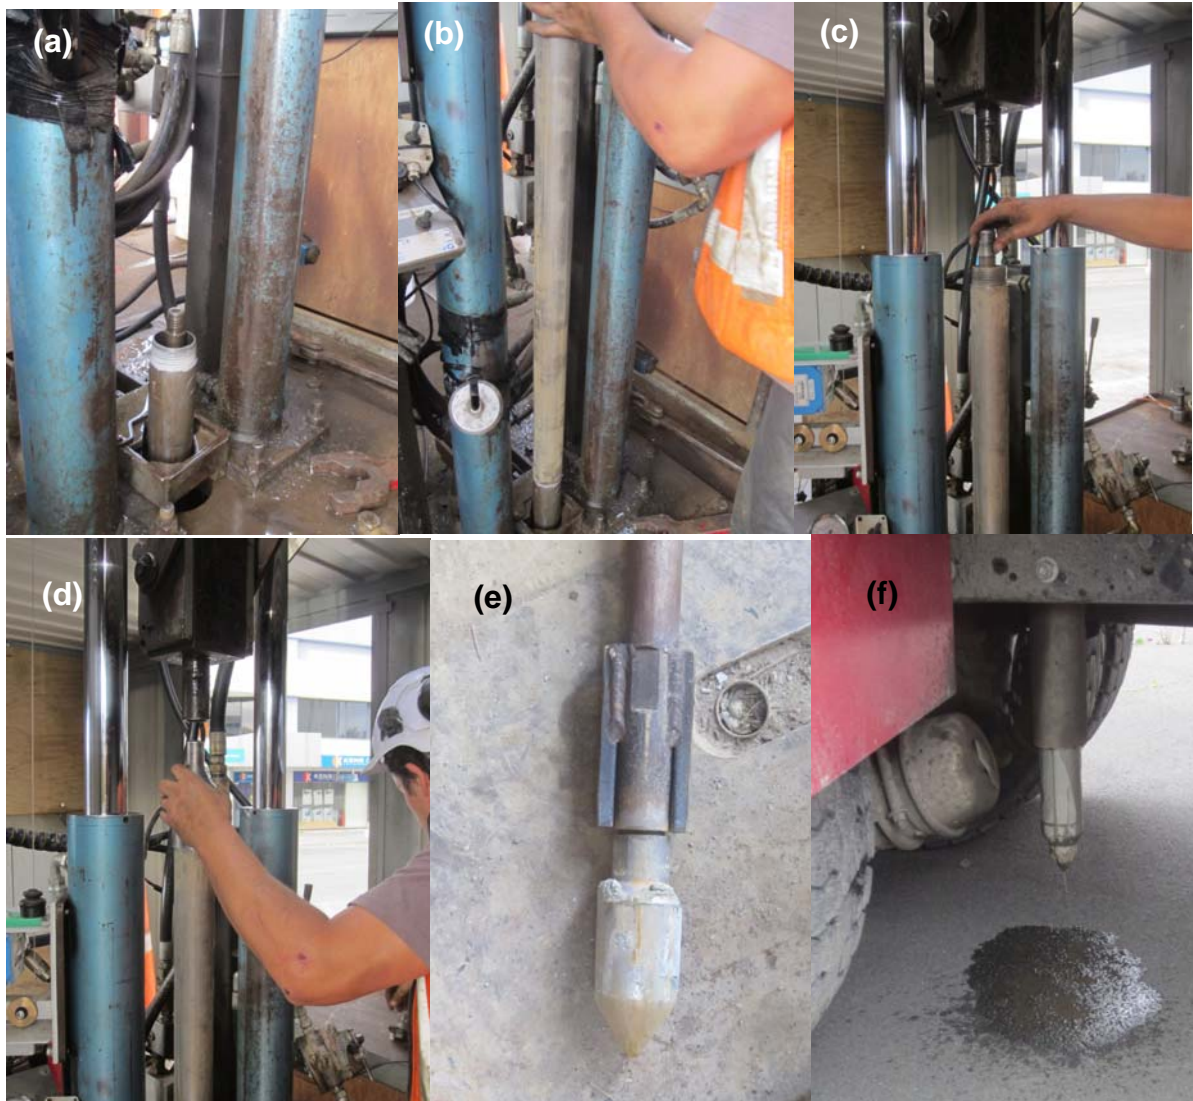
**Figure 4.1.20.** (a) View of dual tube casing system. (b) Connecting additional casing rods. (c) View of casing rods prior to driving cap placement. (d) View of casing rods following driving cap placement. (e) View of inner rod tip. (f) View of tip of casing assembly through the CPT truck sleeve prior to shallow driving.

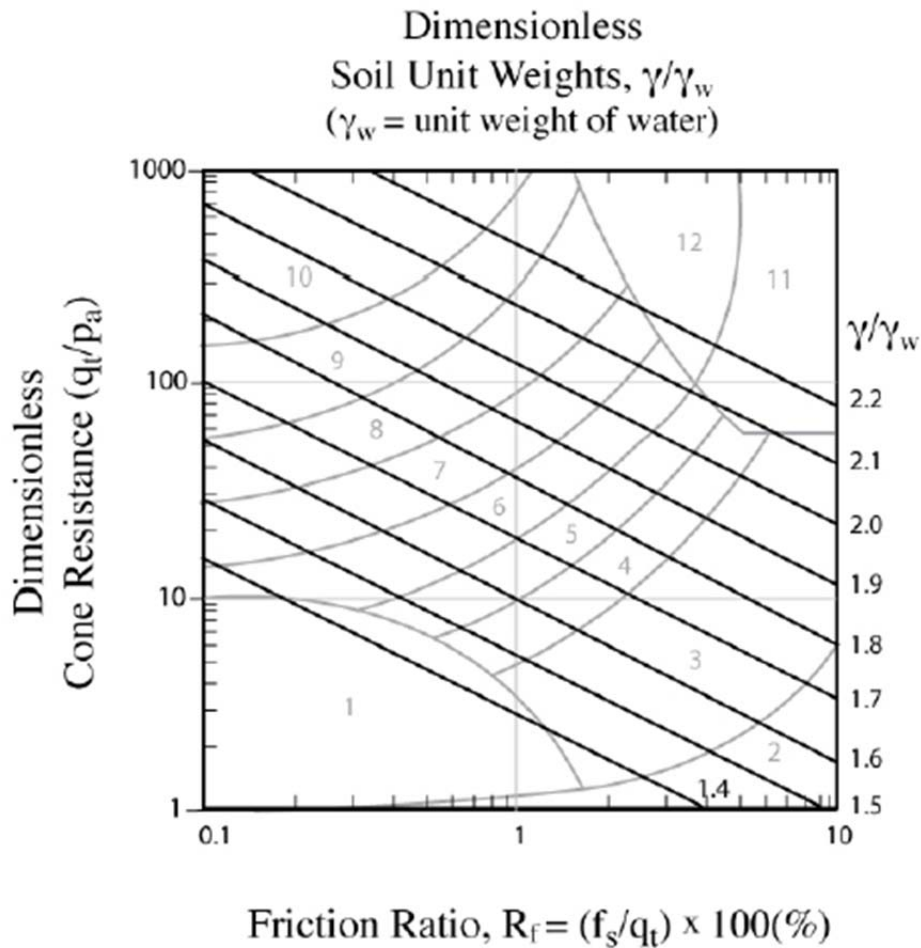
**Figure 4.1.22.** Relationship between specific gravity and corrected cone tip resistance and friction ratio (from Robertson and Cabal, 2010)

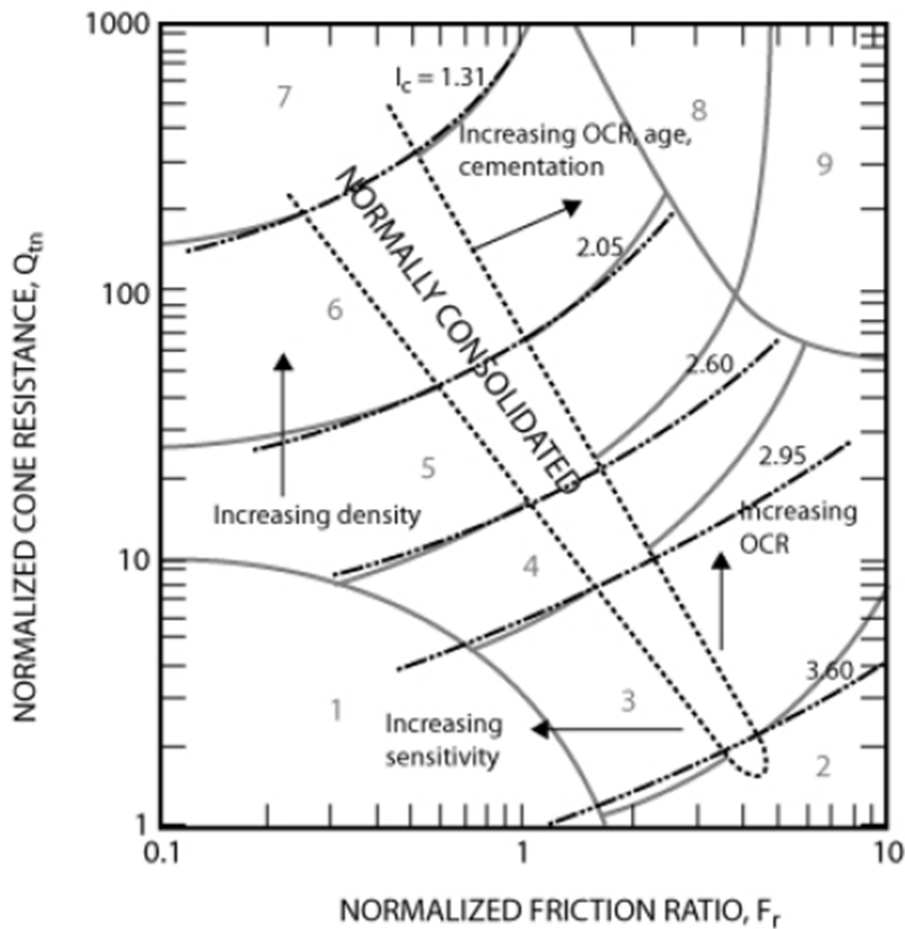
**Figure 4.1.23.** Normalized CPT soil behavior type (SBT) chart (from Robertson and Cabal, 2010)
