Seismic Performance of Buildings Subjected to Soil Liquefaction

Joshua David Zupan

Doctor of Philosophy

University of California, Berkeley

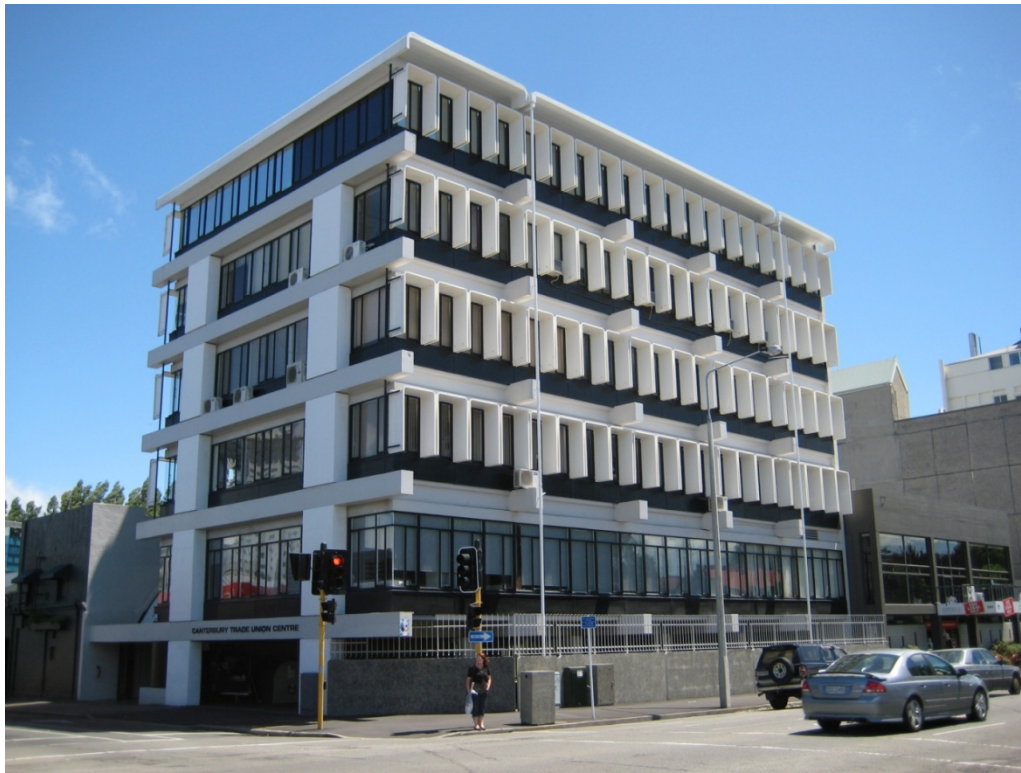
**Figure 4.3.1.** Photo of the CTUC building taken prior to Canterbury earthquake sequence (photo courtesy of L. Wotherspoon)

The CTUC building, located at 199 Armagh Street in Christchurch, New Zealand (Lat - 43.52855, Lon 172.64247), was a six-story, reinforced concrete (RC) frame structure, with a complex shallow foundation (Figures 4.3.1 and 4.3.2). The building was located only 20 m west of the Armagh and Madras parking lot discussed previously. Large differential settlements

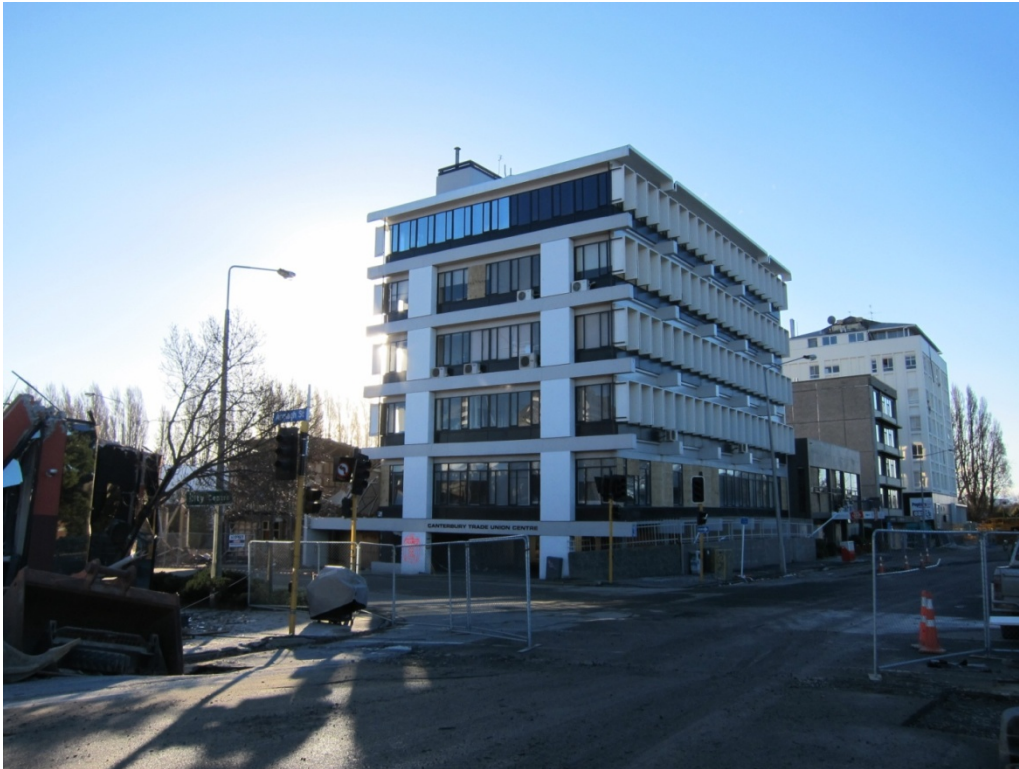
**Figure 4.3.2.** Photo of the CTUC building taken in July 2011, following several damaging earthquake events (photo courtesy of M. Taylor).

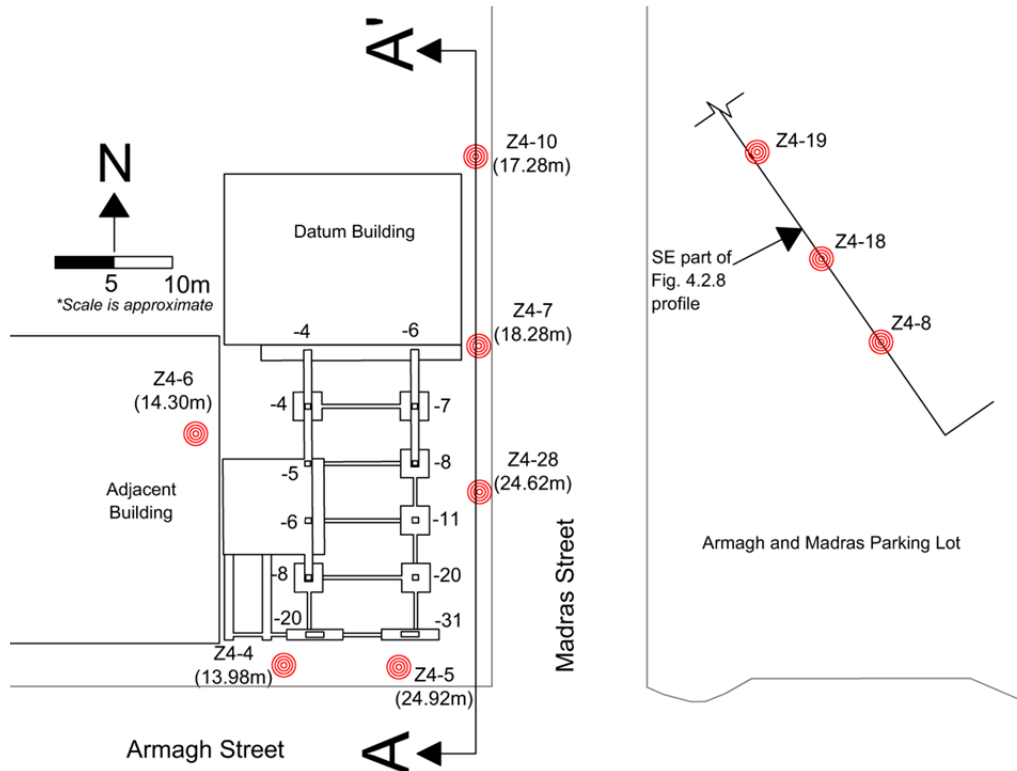
**Figure 4.3.3.** CTUC building site with its foundation system and CPT locations (with depths). Footing settlements at column locations relative to the datum building are provided in cm. The location of the subsurface profile in Figure 4.2.8 is shown for reference.

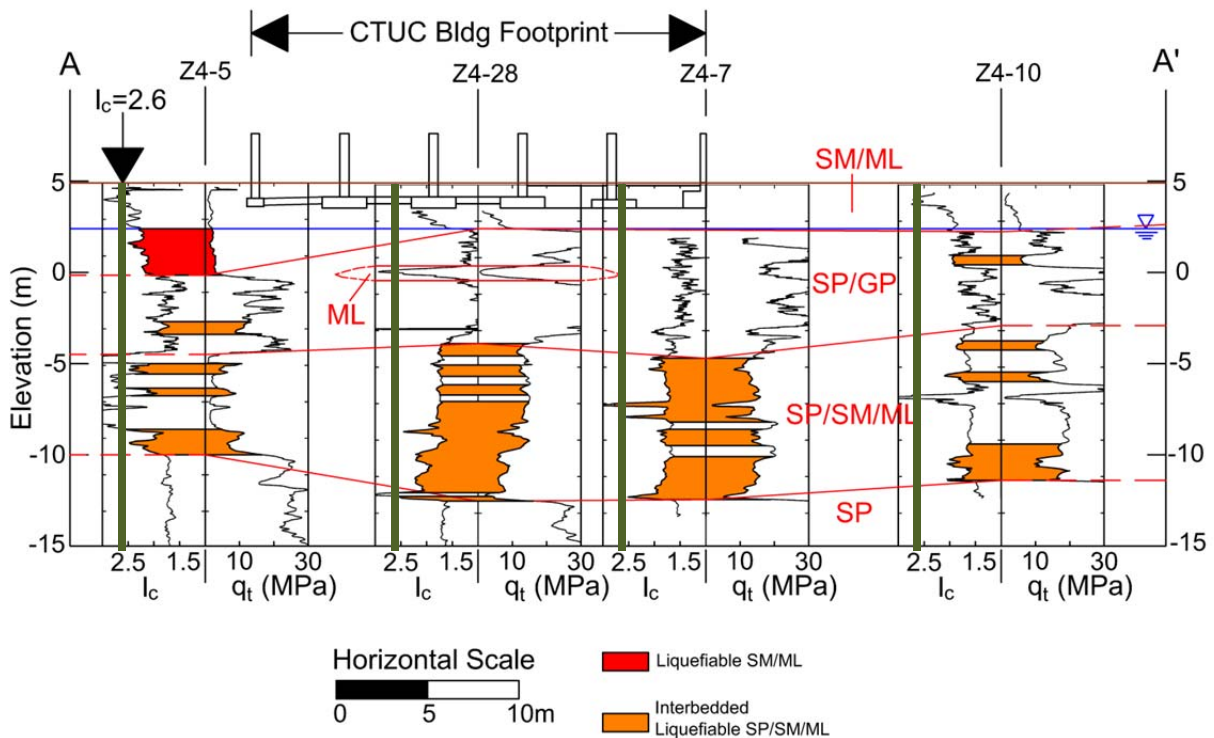
**Figure 4.3.4.** Subsurface conditions at the CTUC building site showing zones of materials with  $FS_1 < 1.0$  based on the RW98 procedure using  $PGA_{50}$  from Bradley and Hughes (2012) for the 22 FEB 11 earthquake.

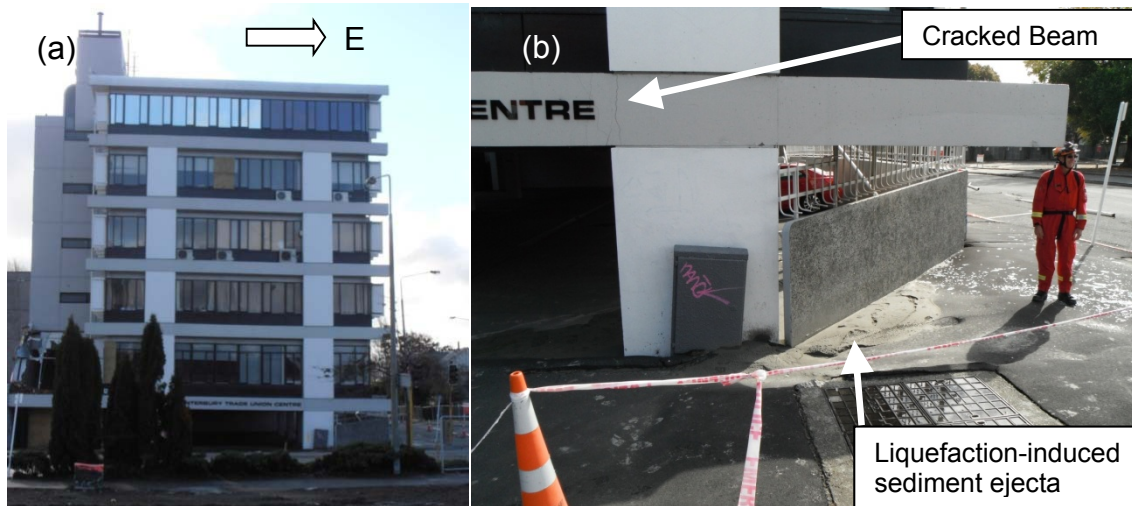
**Figure 4.3.5.** (a) South end of CTUC Building showing tilt to the east (taken July 2011) and (b) Close-up photograph of the SE corner of the building (taken March 2011).

While damage to the CTUC building was negligible during the 4 SEP 10 and 13 JUN 11 events, severe liquefaction of the foundation soils during the 22 FEB 11 earthquake induced significant total and differential settlements of the building, leading to structural distortions and cracking (Cubrinovski et al. 2011a). The building tilted to the east 0.4 – 0.5 degrees (Figure 4.3.5a). Differential settlement of the SE corner of the building produced most of the structural damage. Several of the exposed beams on the south side of the building were cracked near the beam-column connections (Figure 4.3.5b). Building settlement measurements were performed using the building located just to the north of the CTUC building as the datum, as it did not appear to displace relative to the surrounding ground. The settlement measurements are indicated on Figure 4.3.3. The building settled more on its south side than on its north side and more on its east side than its west side. Approximately 20 of the 25 cm of differential building settlement along the eastern side of the building was measured across its two southernmost spans (angular distortion  $\approx 1/50$ ). Thus, cracking of structural beams in this area is not surprising.

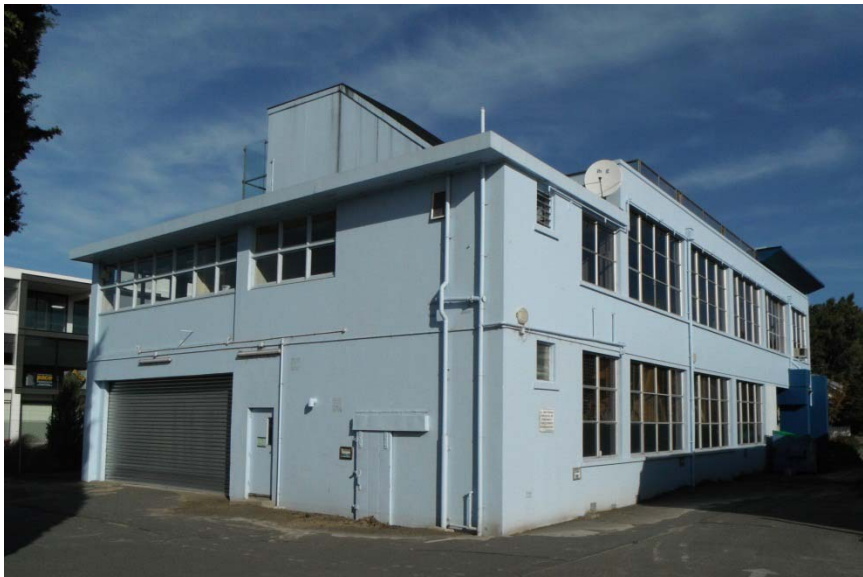
**Figure 4.4.1.** Photo of the SA building taken in March, 2011. Photo was taken from the NW and is viewing SE.

The SA building, located at 193 Peterborough Street in Christchurch, New Zealand (S43.5252 E172.6419), was a two-story RC frame structure with concrete infilled walls, interior timber-framed walls, and timber flooring that was 15 m by 30 m in plan with two bays in the E-W direction and six bays in the N-S direction (Figure 4.4.1). The building was remodeled in 1997-98, during which time the two southernmost first floor bay frames were removed to create an exterior parking area and replaced with a more robust RC frame. In addition, several of the pre-existing frames were retrofitted with steel K-bracing. It appears that the original building was founded on a grid of shallow strip footings that were approximately 0.5 m wide and 0.6 m deep. The new shallow square footings within the southernmost two bays were either 1.5 m by 1.5 m or 3.3 m by 3.3 m and were 0.6 m thick. The footings were cast in place under the pre-existing foundation tie beams at a depth of approximately 1.4 m below the ground surface.

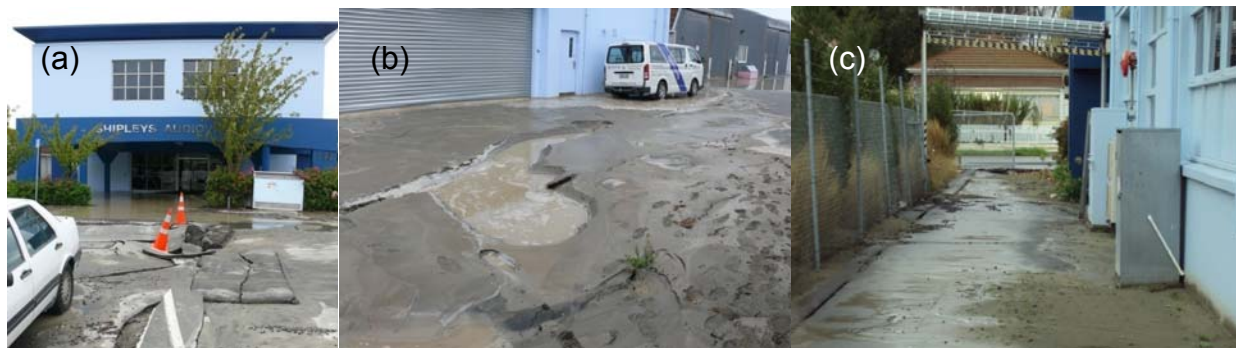
**Figure 4.4.4.** (a) Views of the south end and (b) north end of SA building taken approximately 2 hours after the Christchurch earthquake. (c) Photo of the east side of the building taken June 5th, 2011. (Photos courtesy of Shipleys Audiovisual Ltd.)

Liquefaction was far more severe and damaging during the Christchurch earthquake. Figure 4.4.4 illustrates severe ground cracking in the road south of the building and the extent of the ejected groundwater pond near the entrance of the building, which was reported to be 0.5 m deep, as well as the extent of liquefaction just north of the building. The building was surveyed by UCB-UC researchers in March 2011 and again in July 2011. During the March 2011 survey, Cubrinovski et al. (2011a) observed nearly continuous sediment ejecta around the perimeter of the building and evidence of its foundation displacing downward into the surrounding ground with the ground floor at the south entrance of the building uplifted and blistered. The building settled approximately 25 cm relative to the surrounding ground at its SE corner and approximately 10-20 cm at its NW corner. The locations of these settlements are indicated on Figure 4.4.2. Due to this damage, the building was demolished in 2012.

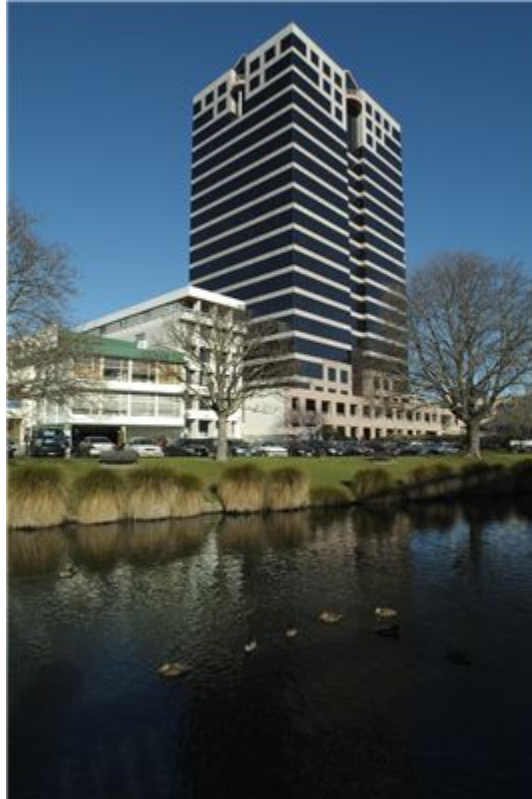
**Figure 4.6.1.** Photo of the PWC Building Prior to the Canterbury Earthquake Sequence (from Colliers International New Zealand Ltd., 2009)

The PWC building, located at 119 Armagh Street in Christchurch, New Zealand (Lat - 43.52850, Lon 172.63788), was a 21-story, RC frame structure, with a one-story basement (Figure 4.6.1). Liquefaction-induced sediment ejecta was observed on both the north and south sides of the building following the Christchurch earthquake, and the tops of accessible structural columns were generally tilted slightly to the south. In addition, ground settlements of at least 30 cm were measured near the street on the north side of the building and areas of localized ground settlement of up to 10 - 15 cm were measured on the south side of the building. General ground settlements on the south side appeared to be less than approximately 10 cm. There was some lateral spreading of the ground north of the building toward the Avon River which could have contributed to the vertical ground displacements in this area. Prior to its demolition in 2012, the

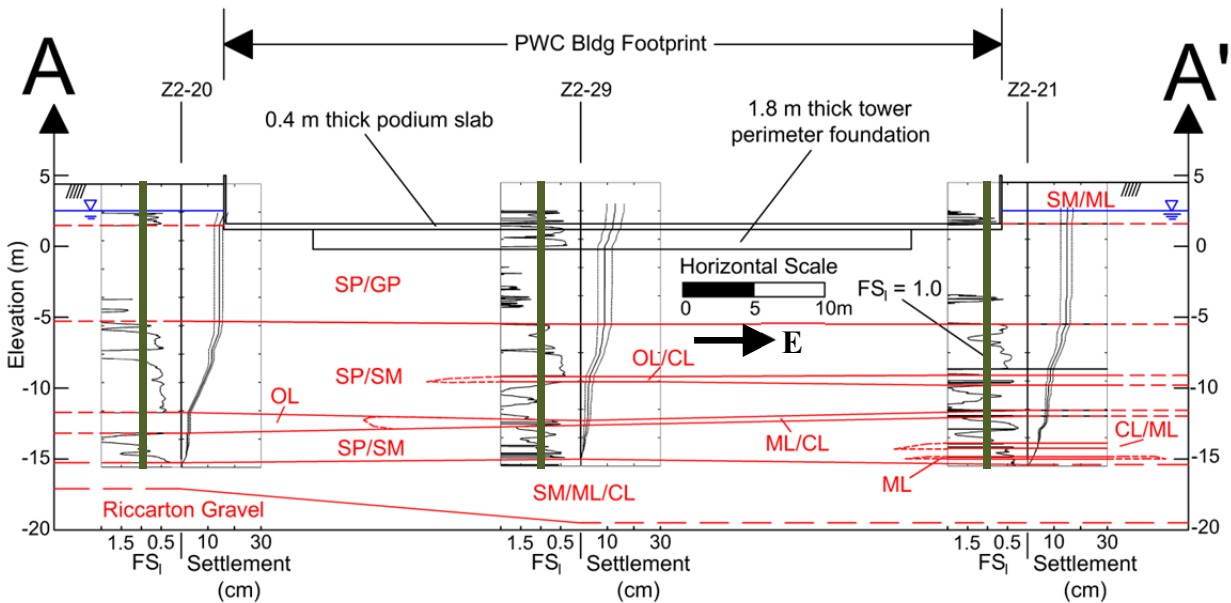
**Figure 4.6.8.** Factor of safety against liquefaction triggering ( $FS_1$ ) profiles, calculated in accordance with RW98 for the  $PGA_{50}$  during the 22 FEB 11 event, and liquefaction induced settlement profiles, calculated in accordance with ZR02-RW98 for the  $PGA_{16}$ ,  $PGA_{50}$ , and  $PGA_{84}$  during the 22 FEB 11 event, at CPT locations along cross section A-A'. Settlements are due to post-liquefaction volumetric strains in the top 20 m.

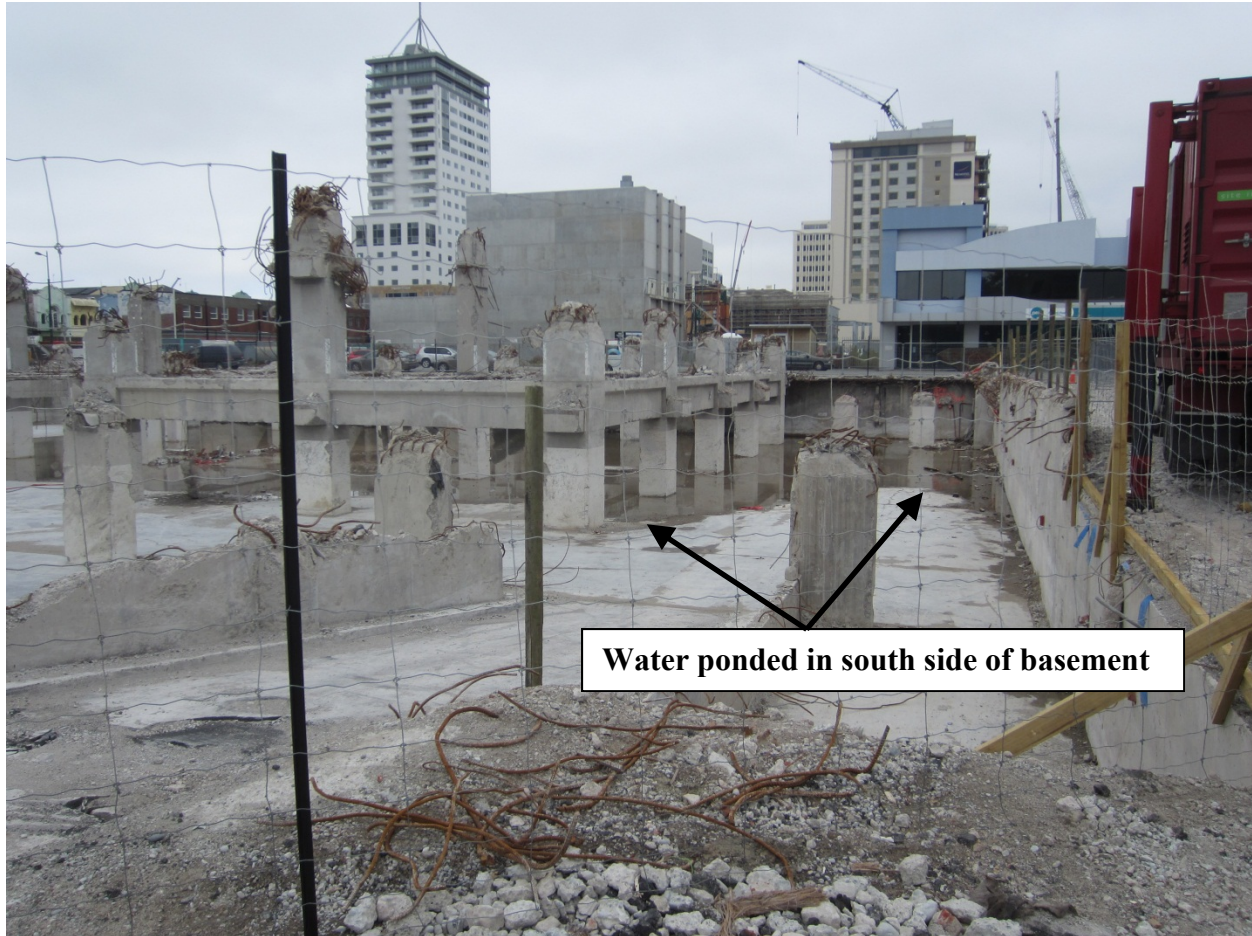
**Figure 4.6.14.** Photograph of the exposed basement of the PWC building from the north viewing south-southeast, taken in March 2013.

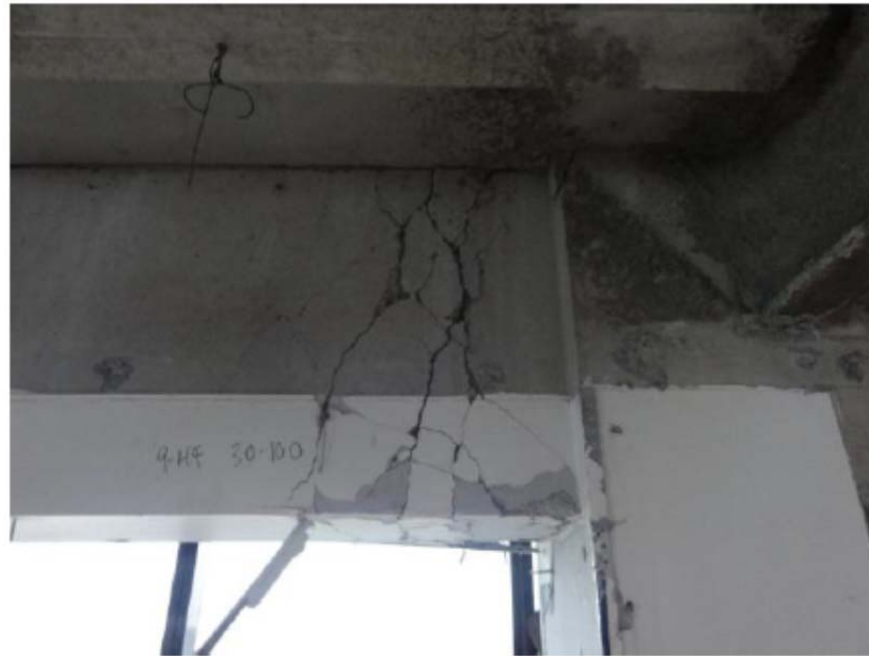
**Figure 4.6.15.** Photograph of beam plastic hinge (from Pampanin, 2012).

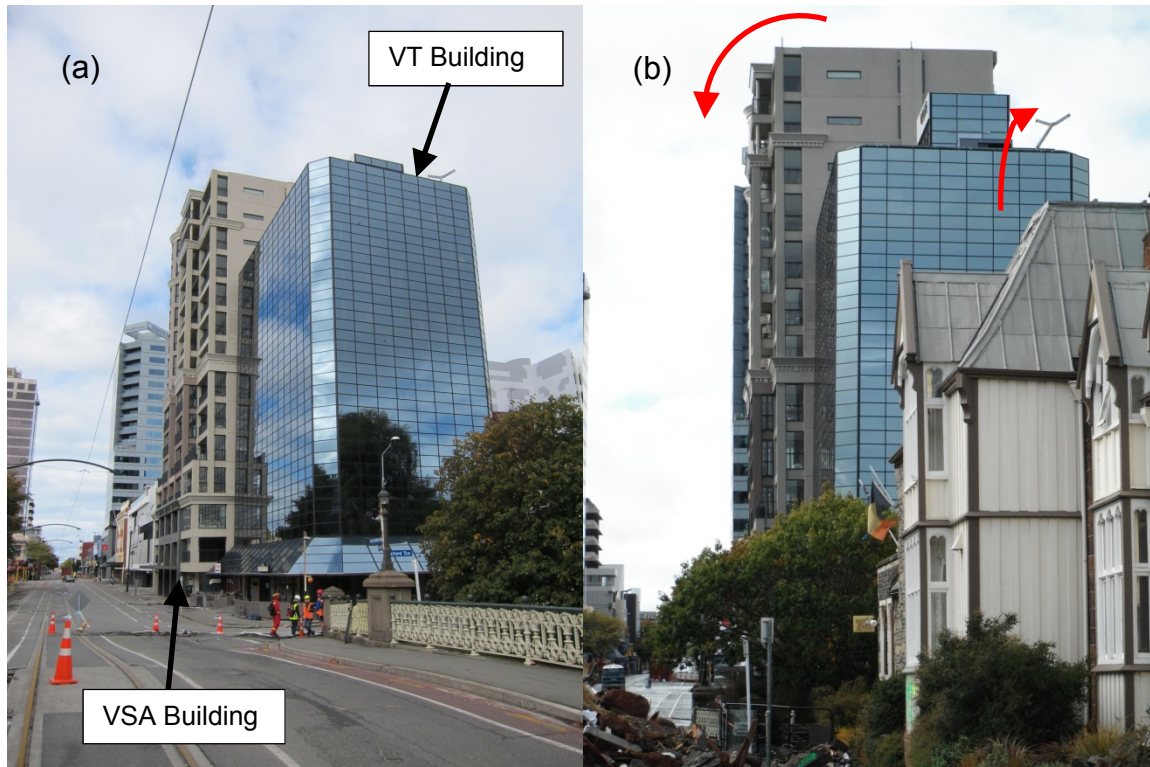
**Figure 4.7.1.** Photos of the VT building at 90 Armagh Street and the VSA building at 100 Armagh Street as viewed from the (a) northwest and (b) west taken in March 2011. Red arrows indicate the primary direction of tilt of the buildings (i.e., the VSA building top tilted to the north and the VT building top tilted to the southeast).

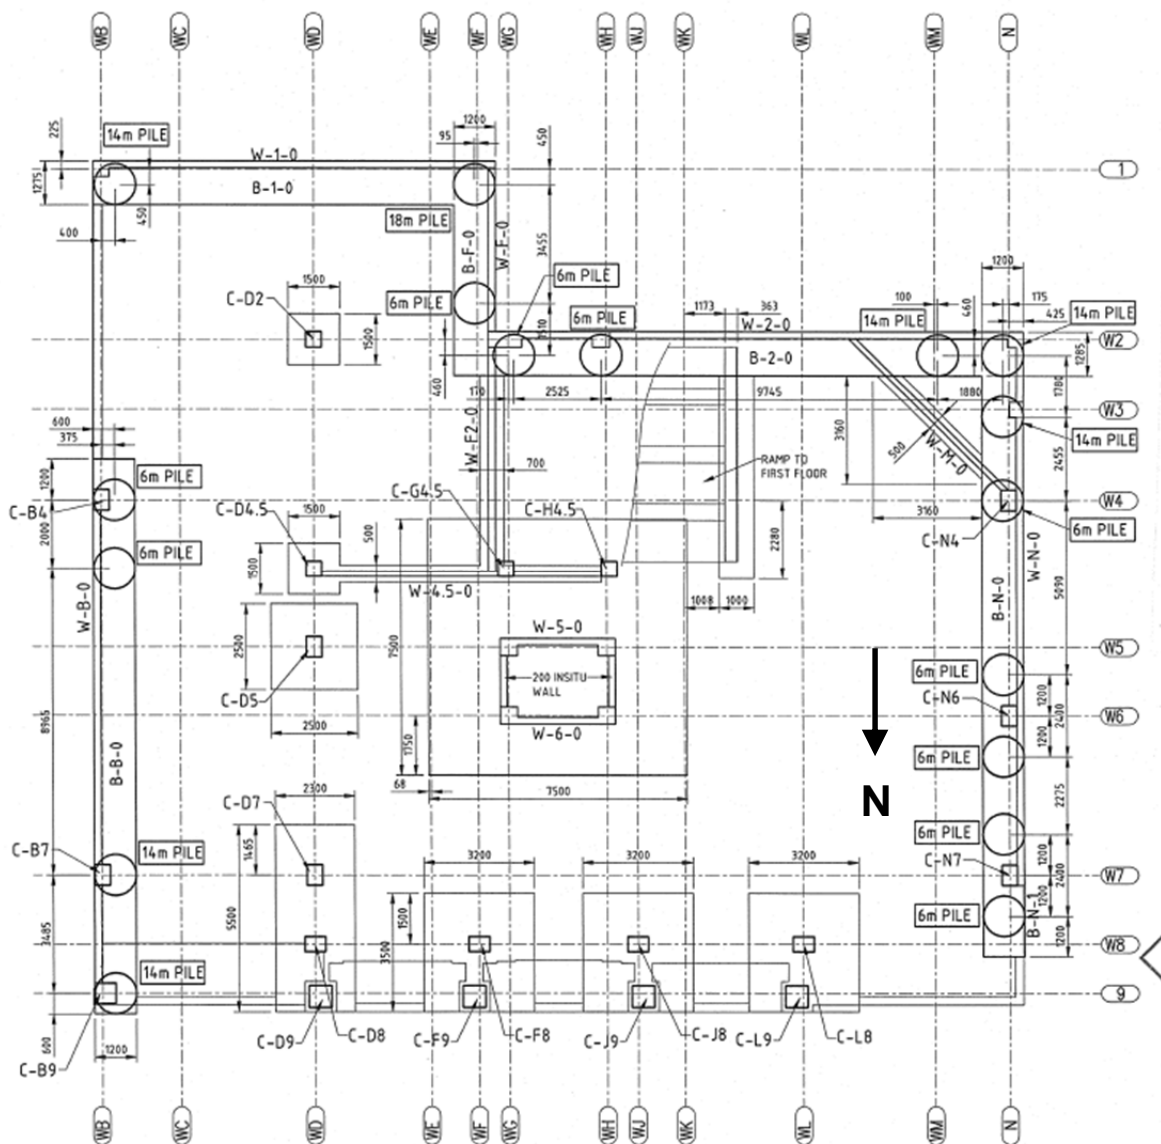
**Figure 4.7.5.** Foundation plan for the VSA building (from the structural design drawings; Connell Mott MacDonald, 2004). Note that north is oriented downward in this figure.

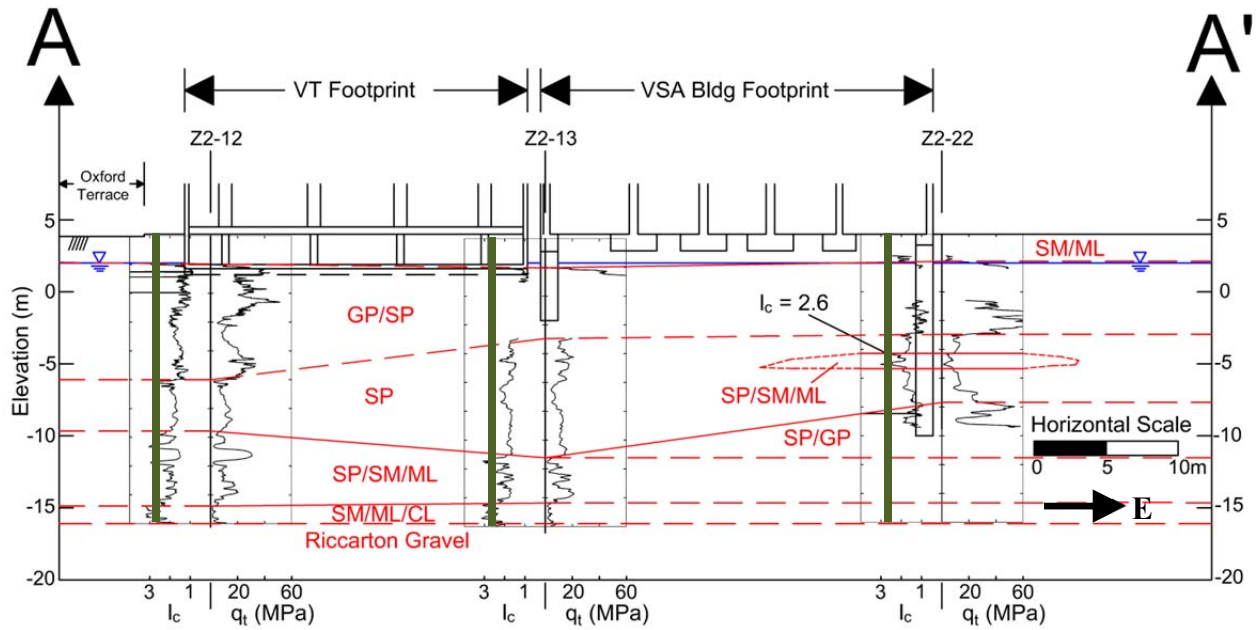
**Figure 4.7.7.** CPT tip resistance and normalized soil behavior type index profiles along cross section A-A'.

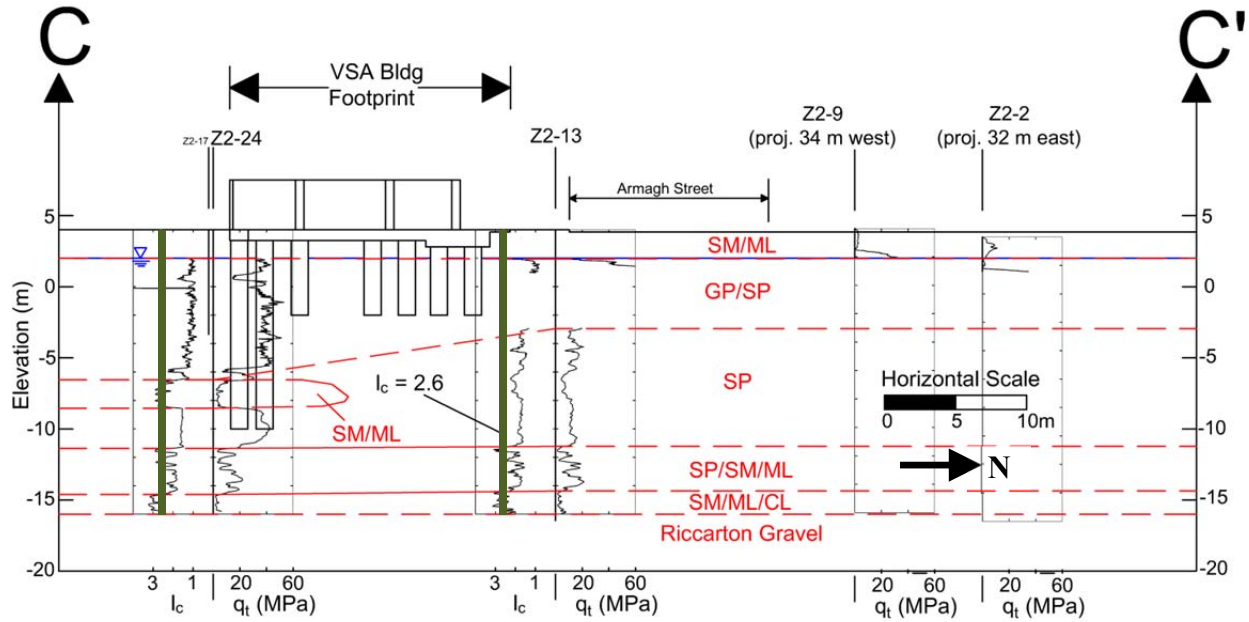
**Figure 4.7.9.** CPT tip resistance and normalized soil behavior type index profiles along cross section C-C' with VSA building foundation shown for reference.

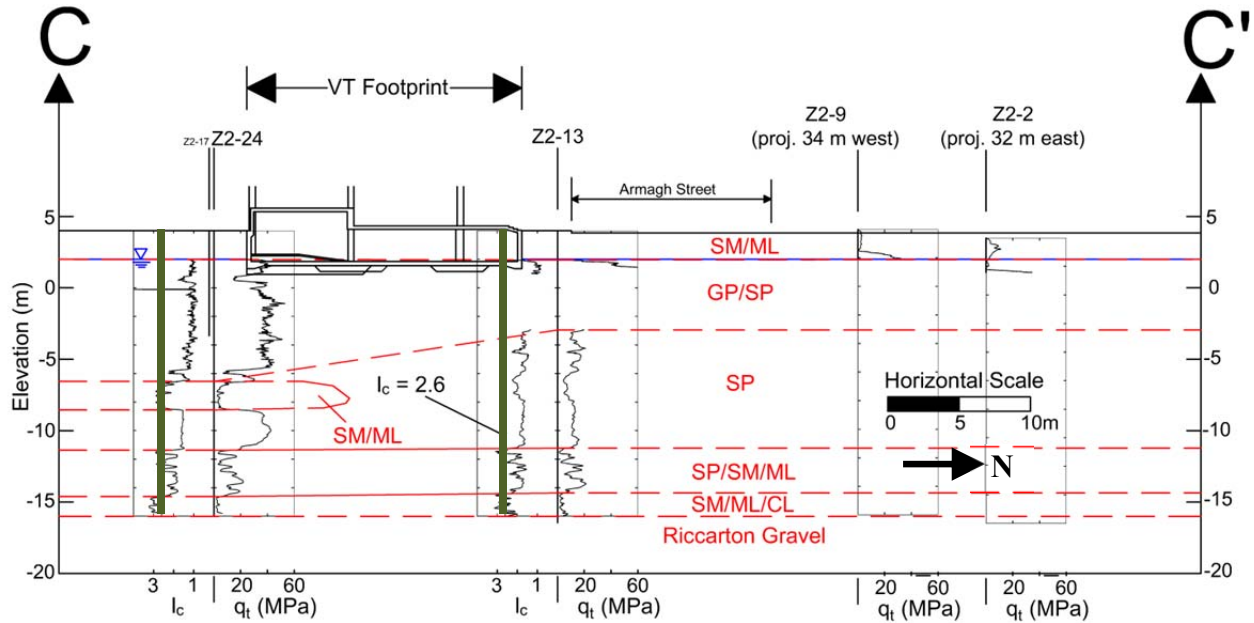
**Figure 4.7.10.** CPT tip resistance and normalized soil behavior type index profiles along cross section C-C' with VT building foundation shown for reference.

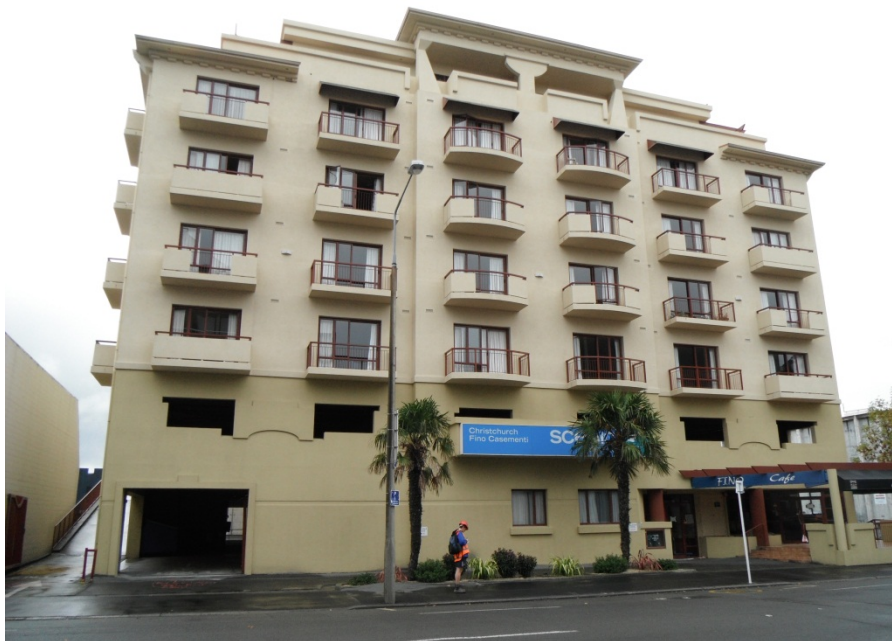
**Figure 4.8.1.** Photo of the SCH Building from March 2011.

The SCH building, located at 87-89 Kilmore Street in Christchurch, New Zealand (Lat - 43.52628, Lon 172.63470), was a seven-story, reinforced concrete frame structure (Figure 4.8.1) on a drilled shaft foundation. The building was located on the same street and approximately 270

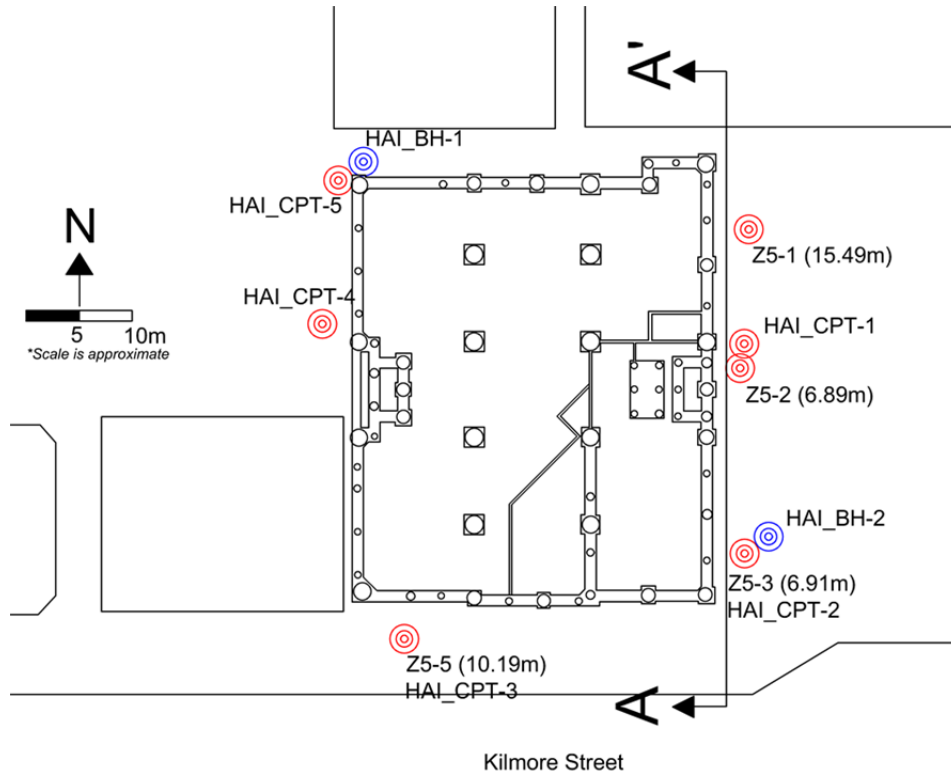
**Figure 4.8.2.** SCH Building site with foundation elements and CPT locations (with depths).

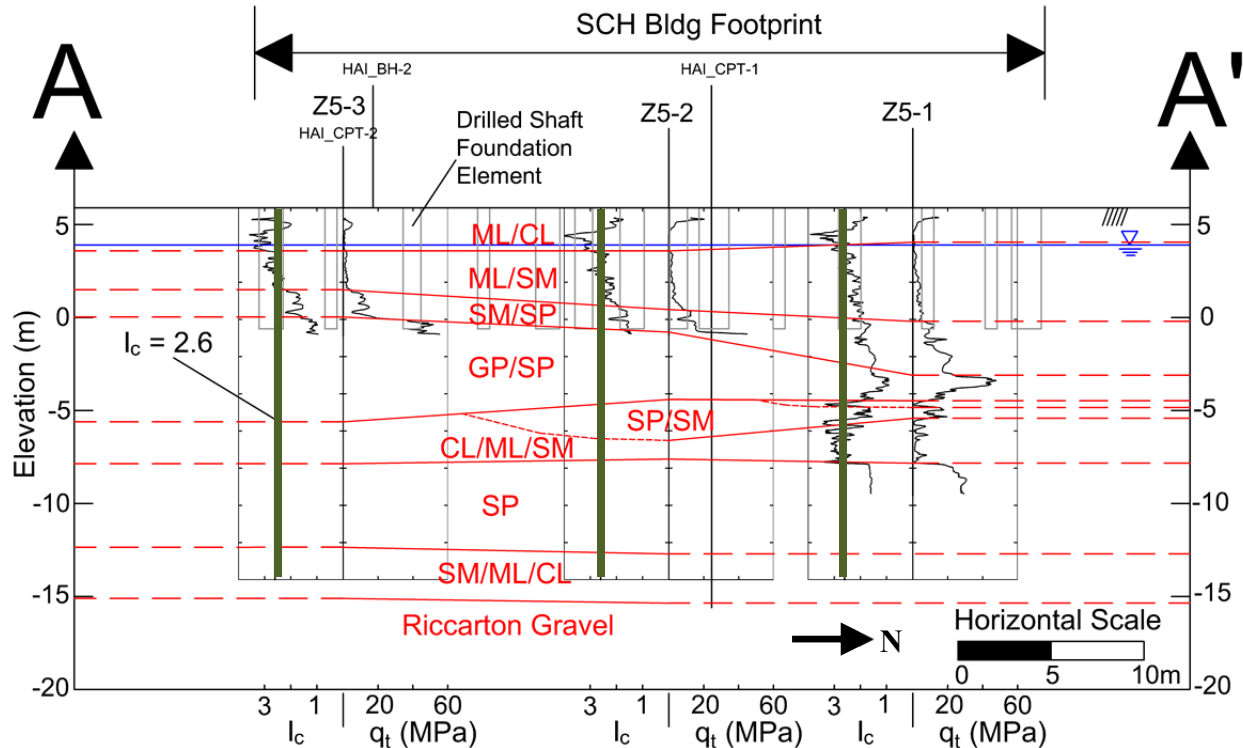
**Figure 4.8.3.** CPT tip resistance and normalized soil behavior type index profiles along cross section A-A'. Drilled shaft depths and diameters are approximate. Pile base enlargements are not shown. HAI\_CPT-1 and HAI\_CPT-2 provided additional subsurface information at the locations indicated and were considered during the development of the subsurface profile.

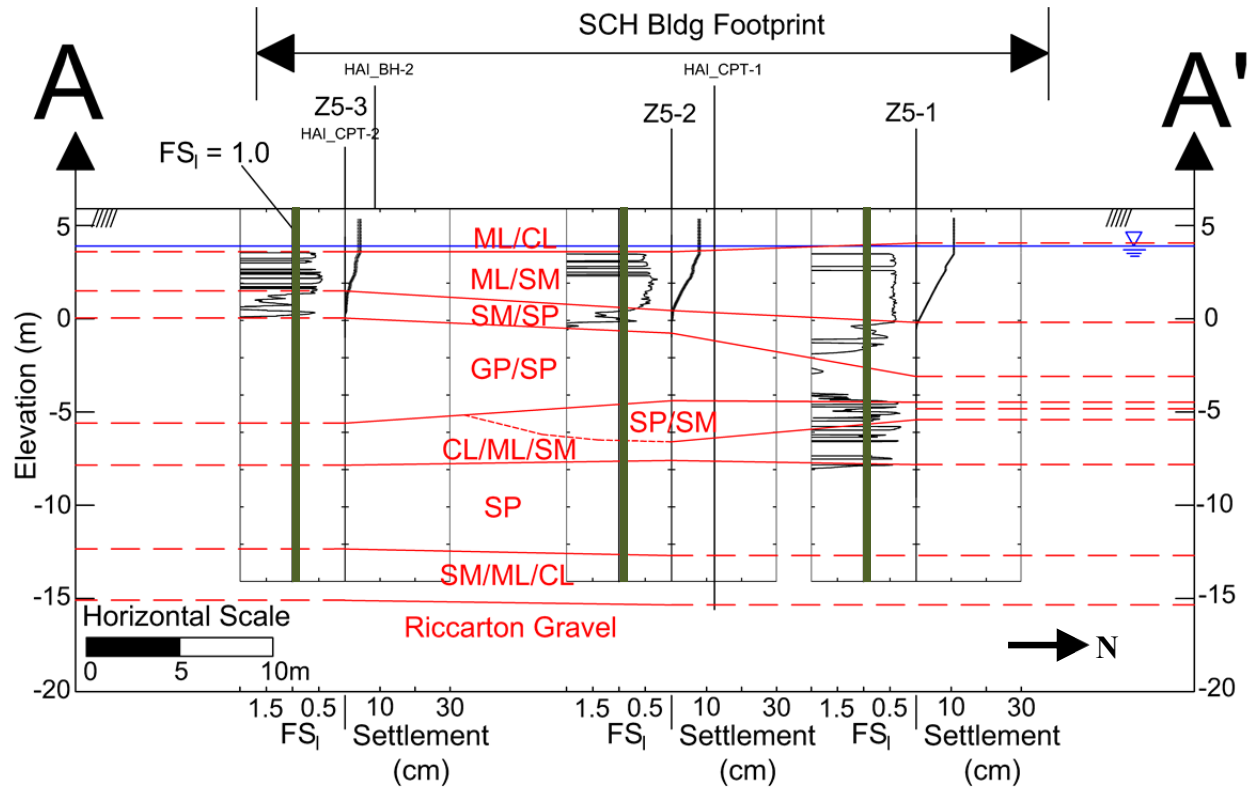
**Figure 4.8.4.** Factor of safety against liquefaction triggering ( $FS_l$ ) profiles, calculated in accordance with RW98 for the  $PGA_{50}$  during the 22 FEB 11 event, and liquefaction-induced settlement profiles, calculated in accordance with ZR02-RW98, at CPT locations along cross section A-A'. Settlements are due to post-liquefaction volumetric strains in the top 6.5 m.

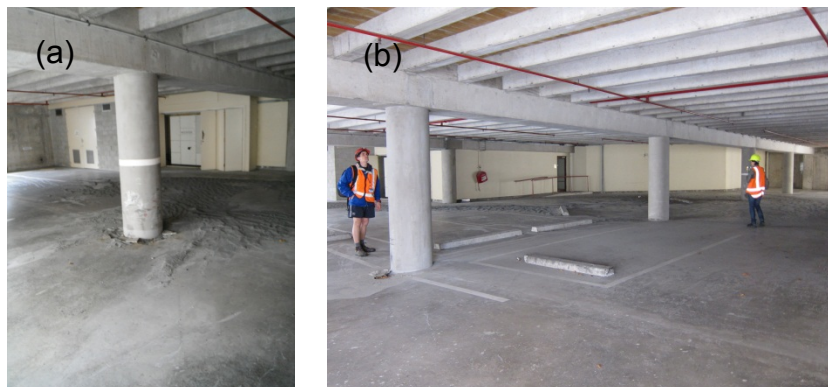
**Figure 4.8.5.** Photos of the ground floor level of the SCH building. While significant sediment ejecta was observed, there was little differential settlement.

The SCH building was evaluated by GEER researchers following the 22 FEB 11 earthquake and their initial observations were summarized by Cubrinovski et al. (2011a). While significant amounts of liquefaction-induced sediment ejecta were found in the area, the building did not appear to have punched into the ground and differential settlements between adjacent columns were often negligible and rarely up to 3.5 cm.

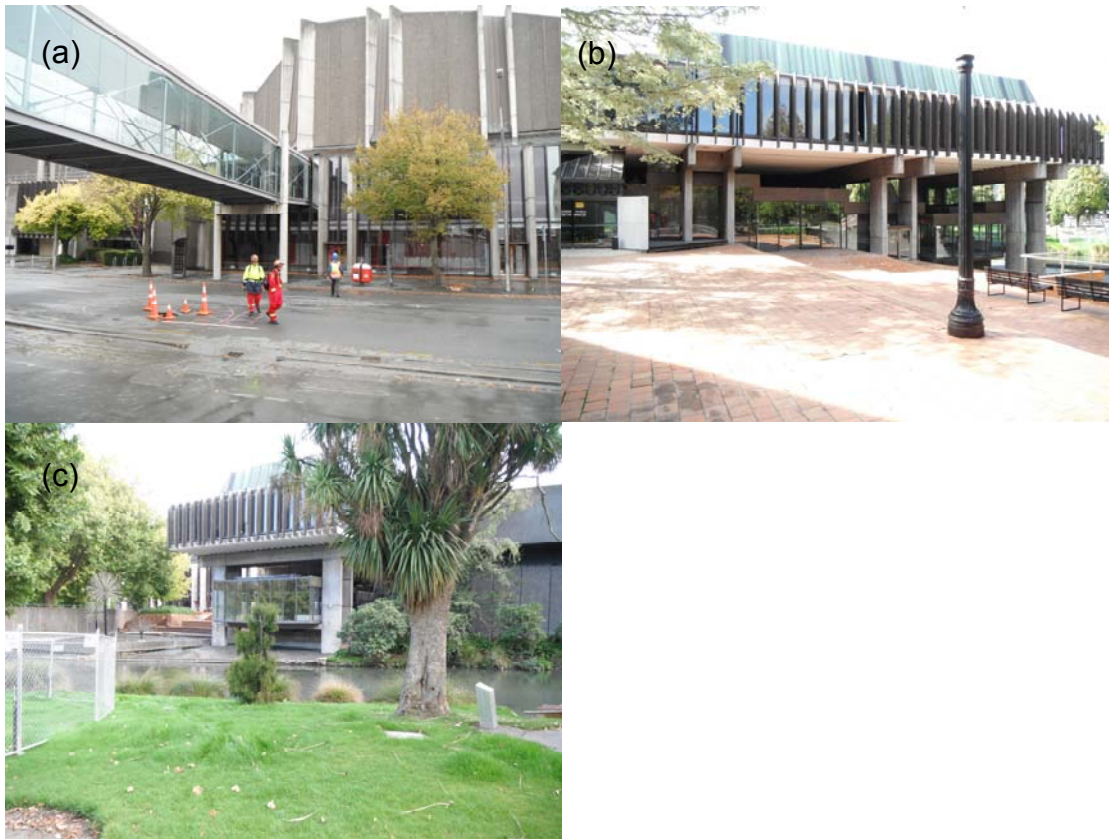
**Figure 4.9.2.** Photos of the (a) auditorium as viewed from the north, (b) the restaurant as viewed from the west, and (c) restaurant as viewed from Victoria Square Park to the south, Photos were taken March 2011.

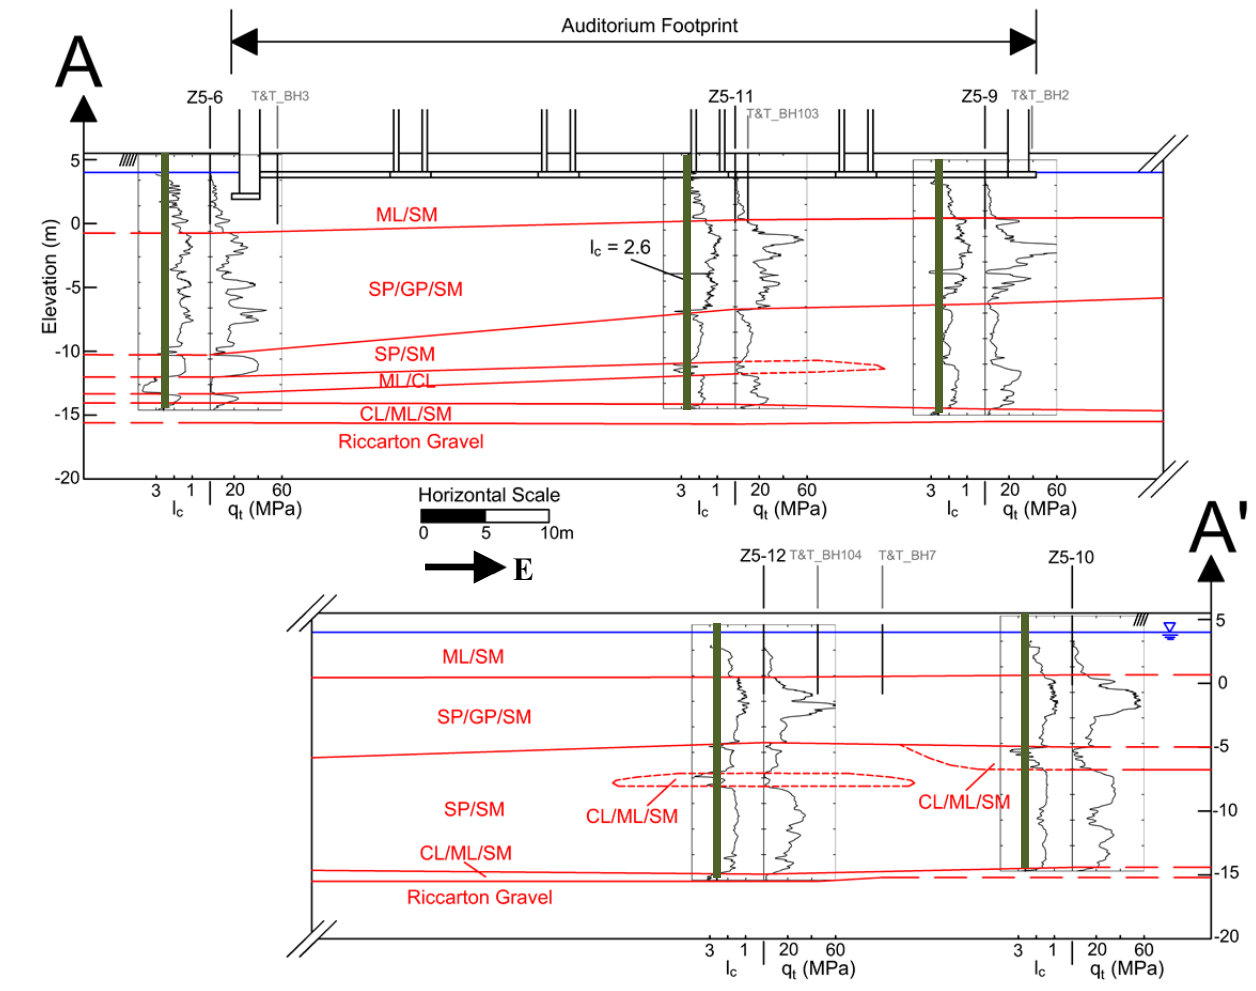
**Figure 4.9.4.** CPT tip resistance and normalized soil behavior type index profiles along cross section A-A'.

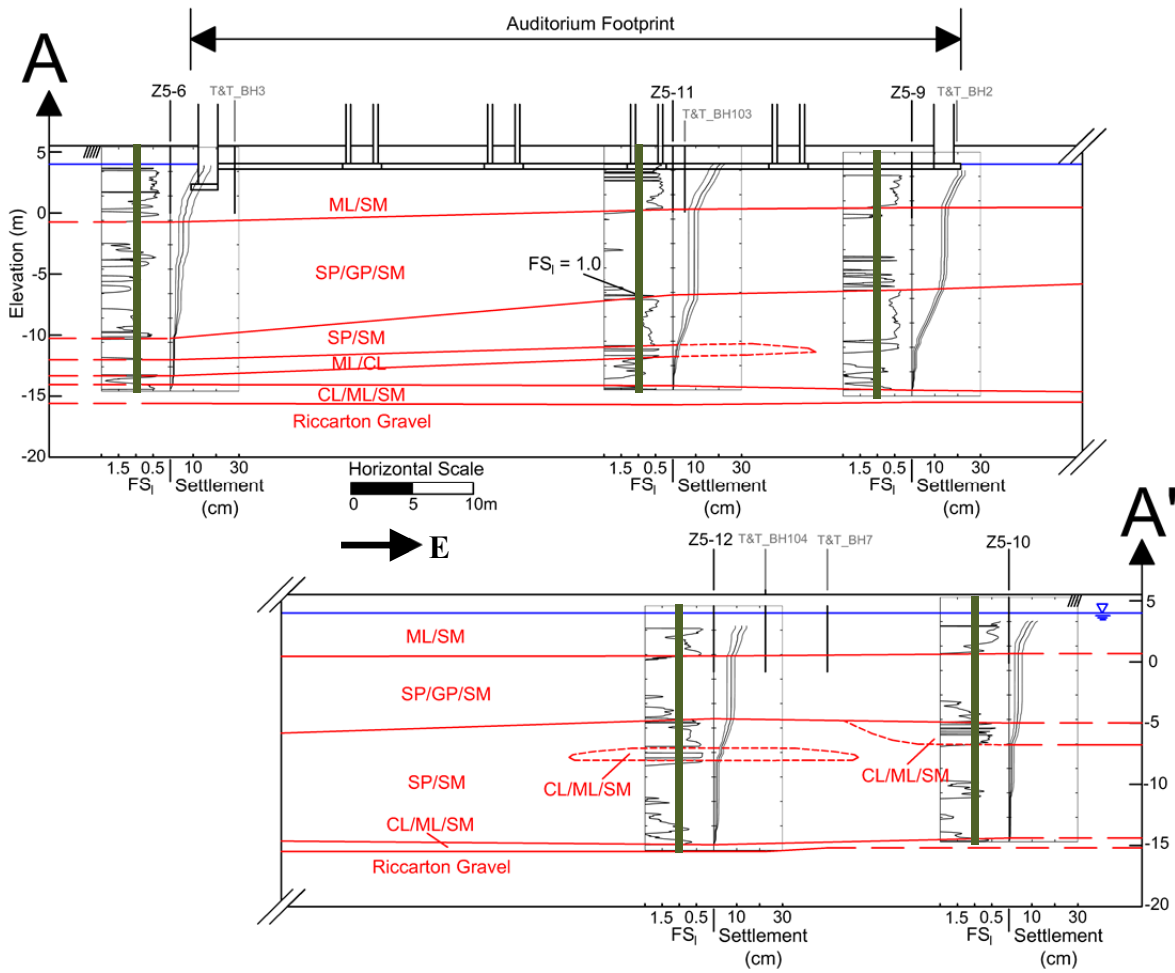
**Figure 4.9.9.** RW98  $FS_1$  and ZR02-RW98 settlement profiles for the 22 FEB 11 event as projected on cross section A-A'. Settlements are due to post-liquefaction volumetric strains in the top 20 m and based on median PGA estimates.

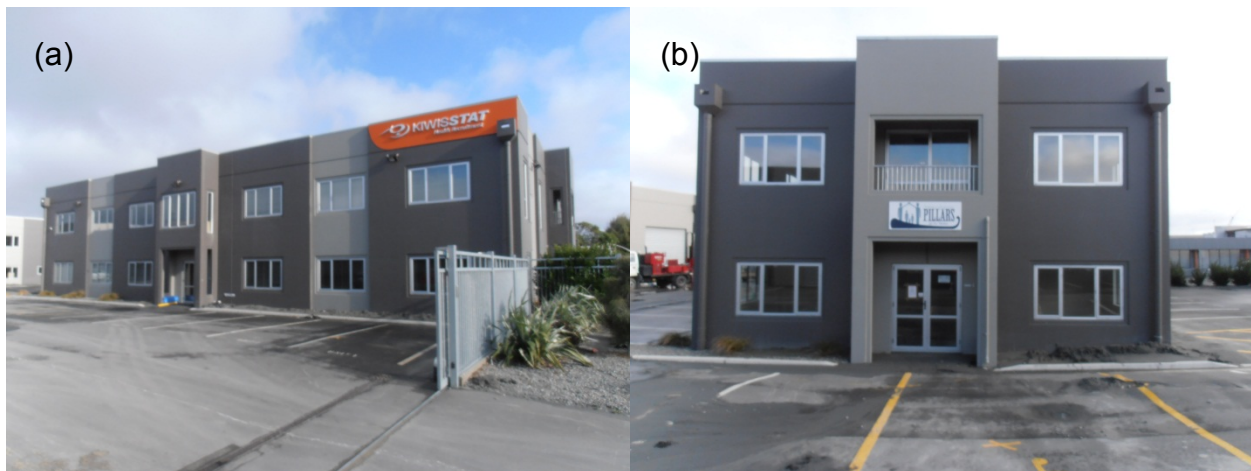
**Figure 4.10.1.** Photos of the (a) LS-I and (b) LS-II buildings taken in July of 2011

The property located at 48 Lismore Street in Christchurch, New Zealand (Lat -43.54380, Lon 172.6530) was comprised of nine units, seven of which consisted of both office space and a warehouse with at least one shared wall (Unit Three – Unit Nine), one of which consisted of office space and a warehouse and was detached (Unit Two), and another detached building consisting of only office space (Unit One). The focus of this section is on the two detached buildings, Unit One and Unit Two, herein referred to as LS-I and LS-II, as they shared many common design characteristics but displayed different engineering performance characteristics following the 22 FEB 11 and 13 JUN 11 earthquakes (Figure 4.10.1).
