Reflective Cracking Study: Initial Construction, Phase 1 HVS Testing, and Overlay Construction

M. Bejarano, D. Jones, B. Morton, and C. Scheffy

Partnered Pavement Research Program (PPRC) Contract Strategic Plan Element 4.10:  
Development of Improved Rehabilitation Designs for Reflective Cracking

University of California  
Pavement Research Center  
UC Davis, UC Berkeley

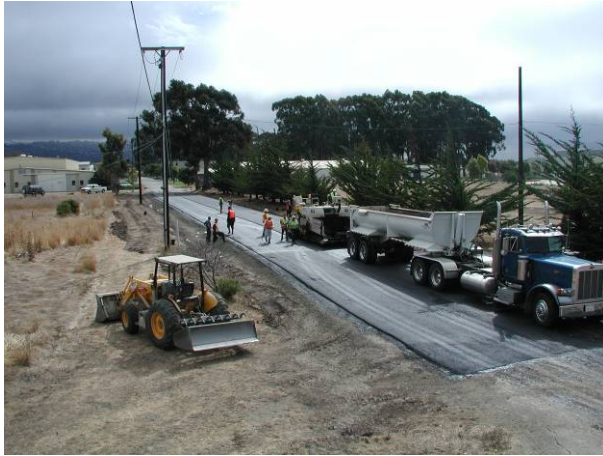
**Figure 2.13: Asphalt concrete placement**

During the paving of the first lift, asphalt concrete was removed from the skip of the paver and spread evenly in a thickness of approximately 20 mm (0.8 in) over the strain gages and tamped in place using a hand tamper. The leads of the strain gages were also covered with asphalt concrete to prevent damage by the paver.
