Stability investigation and stabilization of a heavily fractured and loosened rock slope during construction of a strategic hydropower station in China

# Stability investigation and stabilization of a heavily fractured and loosened rock slope during construction of a strategic hydropower station in China

This paper presents a case history of the 205 m high intake slope at the Huangjinping (HJP) hydropower station on the Dadu River. Deformation and cracks developed on the cut slope during excavation, and the deformation extended onto the natural slope above the cut, giving rise to serious safety concerns. Research was conducted to study the engineering geological conditions and the deformation characteristics of the slope during excavation. In situ monitoring data and possible causes of cracking were analyzed. The results show that the zone of loosened rock mass extended much deeper into the rock mass than it did at other sites in the region because of the tectonic history of the site and cutting. The empirically designed cable anchors with lengths of 40 m or 45 m were insufficient to stabilize the slope, while the remedial cable anchors as long as 100 m successfully stabilized th

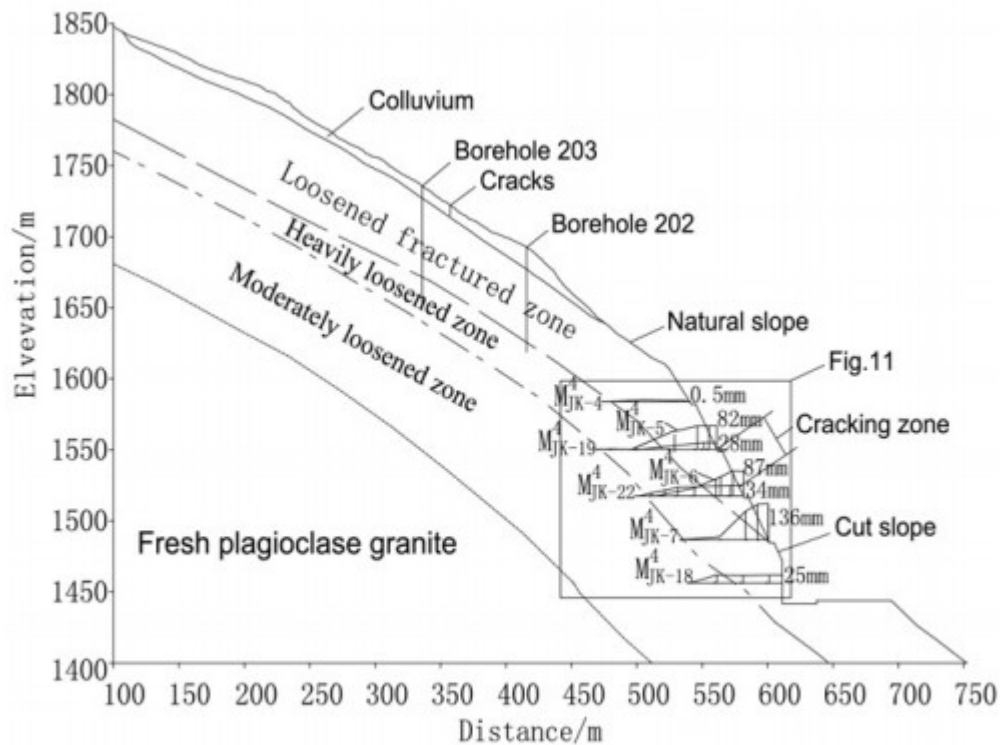
**Fig. 4.** Identification of different zones of section 2-2, with respect to the fracturing condition of the rock.

Abundant geological prospecting work was done at the site. Vertical boreholes and horizontal adits are displayed in Fig. 2. The investigation indicates that the rock mass of the intake slope has been extensively fractured and jointed. The degree of fracturing and jointing increases toward the ground surface, resulting in an increasingly loosened rock mass. As shown schematically in the cross section (in Fig. 4), the loosened fractured zone extends to a depth of about 50 m, and the entire zone of loosened rock mass reaches to approximately 150 m below the ground surface. The heavily loosened rock mass is usually mildly weathered, with a fractured surface layer. The drill core of loosened fractured zone is fragmental with tiny short column (in Fig. 5(a)), while that of heavily loosened zone is relatively intact (in Fig. 5(b)). The rock mass along slopes above the river banks is extensively fractured and highly permeable (in Fig. 6). Stable groundwater levels were not found during pre-construction investigations.

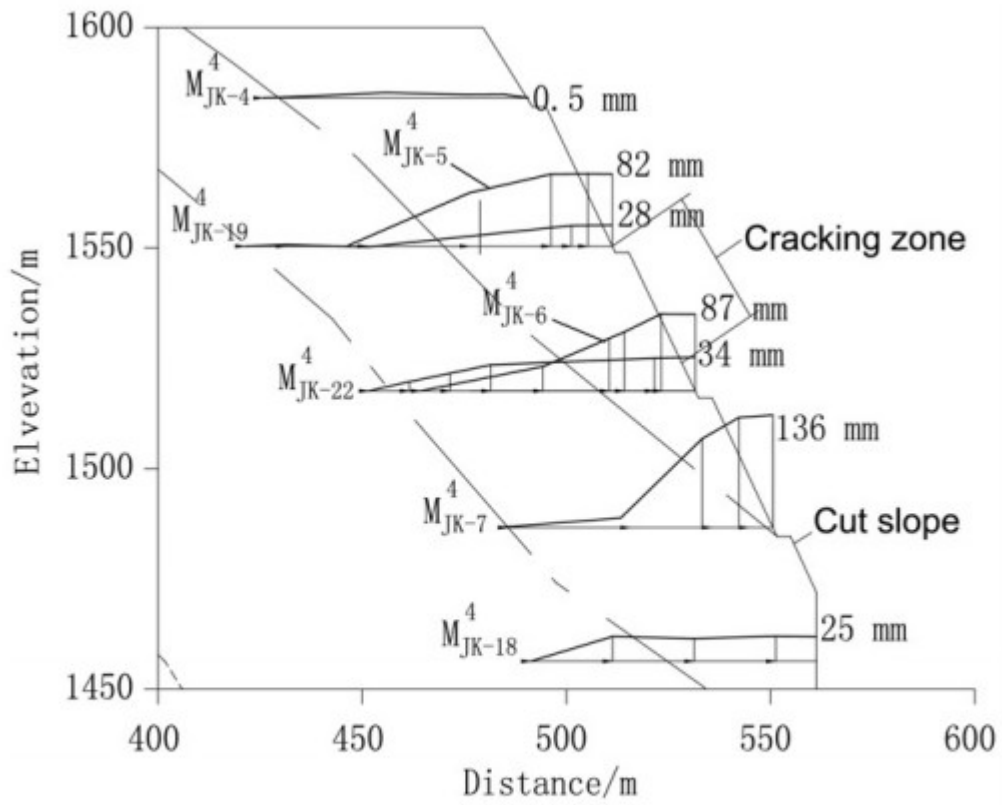
**Fig. 11.** Deformation-horizontal depth curves of section 2-2. Note: Displacement unit is mm; M<sub>JK-4</sub><sup>4</sup> is unavailable.

The deformation vectors for the entire intake slope, as plotted in Fig. 7, indicate that the whole slope was deformed to the northwest. Although the installation of multipoint extensometers lagged behind excavation, the extensometer results still indicate that the excavation had an obvious influence on the deformation. A typical curve of deformation-time is shown in Fig. 10. For  $M_{JK-7}^4$ , just during the excavation from elevation 1460 m to elevation 1415 m. Fig. 11 shows a typical curve of deformation-horizontal depth at cross section 2-2. The results indicate that the maximum depth of deformation was around 65 m, which is roughly the horizontal distance to the base of the heavily loosened zone. Fig. 11 also shows that the largest deformation occurred above elevation 1481 m, i.e. the elevation at the outcrop of the loosened fractured layer in the cut slope. Therefore, the major deformed body was the loosened fractured zone, and the depth of which was beyond the designed cable length of 60 m. As a result, the designed cable bolts had a limited capacity to control deep deformation, and the deformation of the natural slope was the result of structural adjustments of loosened fractured zone. In addition, curves of deformation - horizontal depth (in Fig. 11) indicate that the deformation characteristics of the slope were similar to those of particles. And there were no preferred structural planes, which have a significant influence on the deformation.

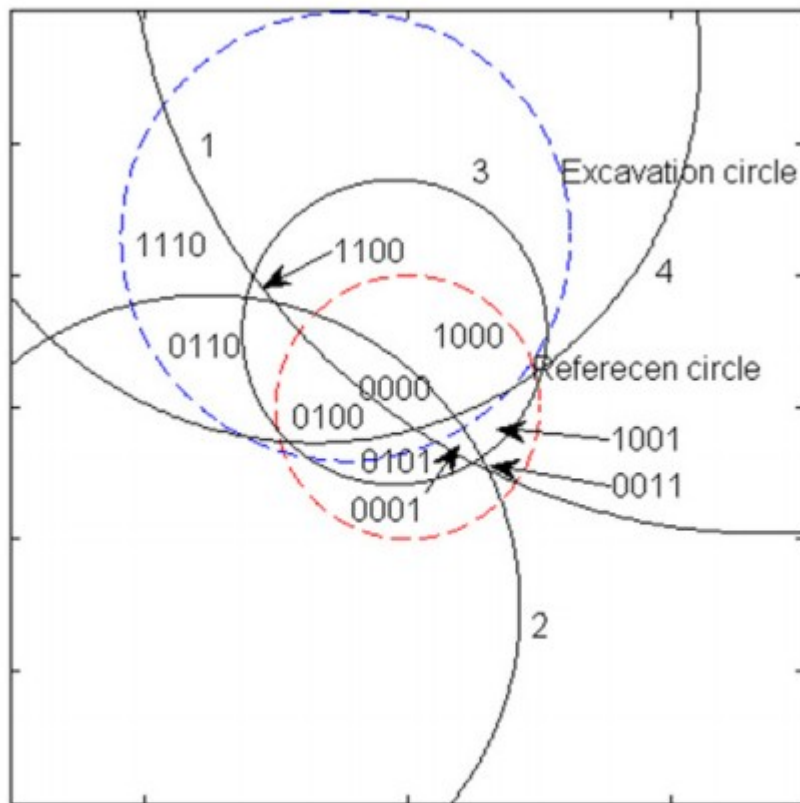
**Fig. 13.** Identification of removable blocks for cut slope cracking area using stereographic projection. Note: block 0000 and block 1100 are removable infinite blocks.

Field investigations showed a diabase vein ( $\beta\mu 6$ ) and three sets of discontinuities (L1, L2, and L3) in the cut slope cracks area. The mean orientations of those discontinuities are listed in Table 2. Block theory analysis of the joint data identified two removed infinite blocks: block 0000 and block 1100, as shown in Fig. 13. Worse still, the reinforced concrete lattice was not used in this area, because the rock mass in the zone had more widely spaced joints. Therefore, the cracking was most likely caused by the moving of the key blocks, i.e., the deformation was localized in the zone without lattice support.

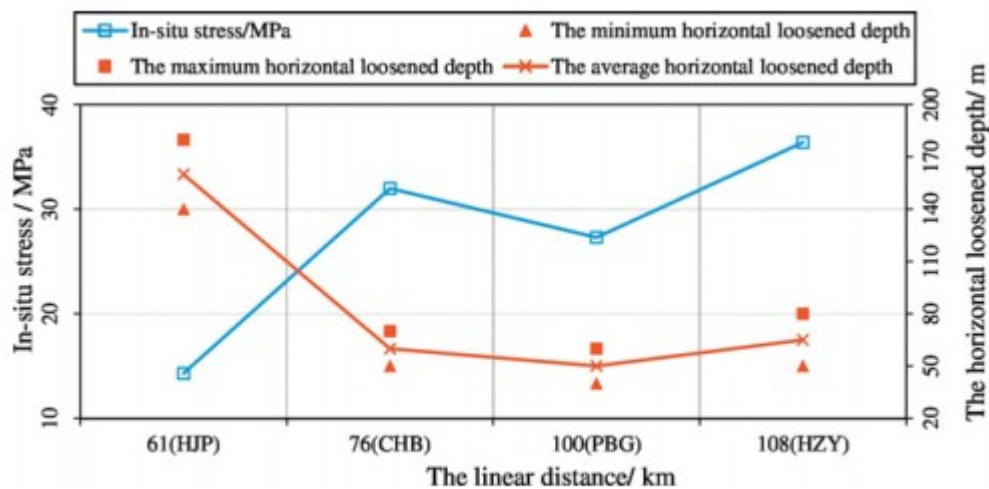
**Fig. 14.** In-situ stress and horizontal loosened depth vs linear distance from the Gongga Mountains.

In Table 3, the authors has summarized the maximum in-situ stress at the underground powerhouse, and the horizontal loosened depth of the bank slopes of four hydropower projects on the Dadu River. Then, the relationship between the above results and the distance from the Gongga Mountains (GGM) are drawn in Fig. 14. These comparisons indicate that the closer the site to the Gongga Mountains (GGM), the lower the in-situ stress magnitude and the larger the horizontal loosened depth. Among the four projects, the horizontal depth of the loosened zone is the greatest at the HJP project site, while the measured maximum in-situ stress is the lowest. Second, in order to study the influence on the rock mass structure, the authors compared the distribution of discontinuities between the left abutment intake slope of the HJP and the right abutment slope of CHB, which is somewhat far from the Gongga Mountains. For the HJP intake slope, 733 discontinuities divided into 21 sets were mapped, as shown in Fig. 15(a). For the right abutment slope of CHP, only 341 discontinuities divided into 9 sets were mapped, as shown in Fig. 15(b). These results indicate that the discontinuities on the HJP intake slope are abundant and essential; no persistent and dominating discontinuity trends were identified. In addition, the joints and fractures remained open, and did not progressively close with depth, as would be expected with increasing overburden stress (in Fig. 16).

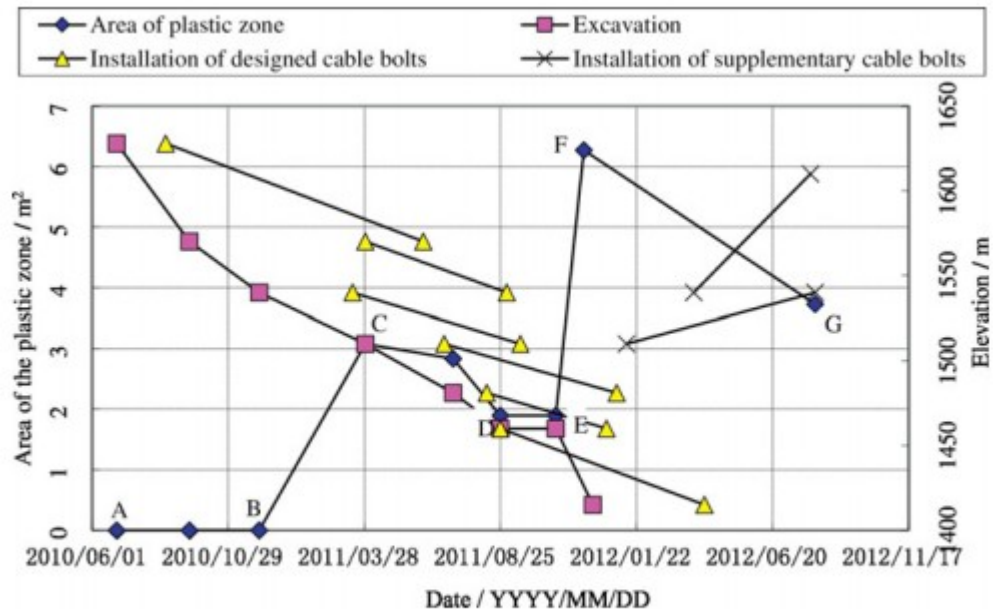
Fig. 18. The plastic zone process during excavation.

The construction process, including excavation and the installation of reinforcements, was simulated according to the actual work performed on the slope. The area of the plastic zone in key sections, such as section 2-2, was calculated using the FISH program. The process of extent of plastic zone during excavation (in Fig. 18) could be divided into six stages. In stage 1 (from point A to B in Fig. 18), because the excavation scope was small, no

plastic zone formed. In stage 2 (from point B to C in Fig. 18), the area of the plastic zone increased rapidly, because of the excavation from 1540 to 1510 m, and the delay in the installation of supporting measures. In stage 3 (from point C to D in Fig. 18) the area of the plastic zone obviously decreased, due to the installation of cable anchors from elevation 1570 m to elevation 1482 m. During stage 4 (from point D to E in Fig. 18), excavation had to be suspended because of the large deformation of the slope. In stage 5 (from point E to F in Fig. 18), because of the vertical excavation below elevation 1460 m, the plastic zone once again increased rapidly. In this stage, a persistent, armchair-shaped crack formed on the natural slope. These phenomena indicate that the numerical results are consistent with slope observations taken during excavation, and that the numerical results are therefore reliable.

As shown in Fig. 18, during stage 6 (from point E to F), the plastic zone was sharply reduced as a result of the installation of the remedial cable anchors. In addition, Fig. 19 shows a comparison of the plastic zones in section 2-2 before and after the installation of the remedial cable anchors. These results also show that the extent of the plastic zone was dramatically reduced after the installation of the remedial reinforcements. The conventionally computed static factors of safety are 1.20 and 1.09 under normal and seismic conditions, respectively. These factors of safety meet the design code requirements, in this case the 2007 Professional Standards of People's Republic of China.
