HVS Test Results on Fast-Setting Hydraulic Cement Concrete, Palmdale, California Test Sections, South Tangent

## **HVS Test Results on Fast-Setting Hydraulic Cement Concrete**

### **Palmdale, California Test Sections, South Tangent**

Research report prepared for the  
California Department of Transportation by:

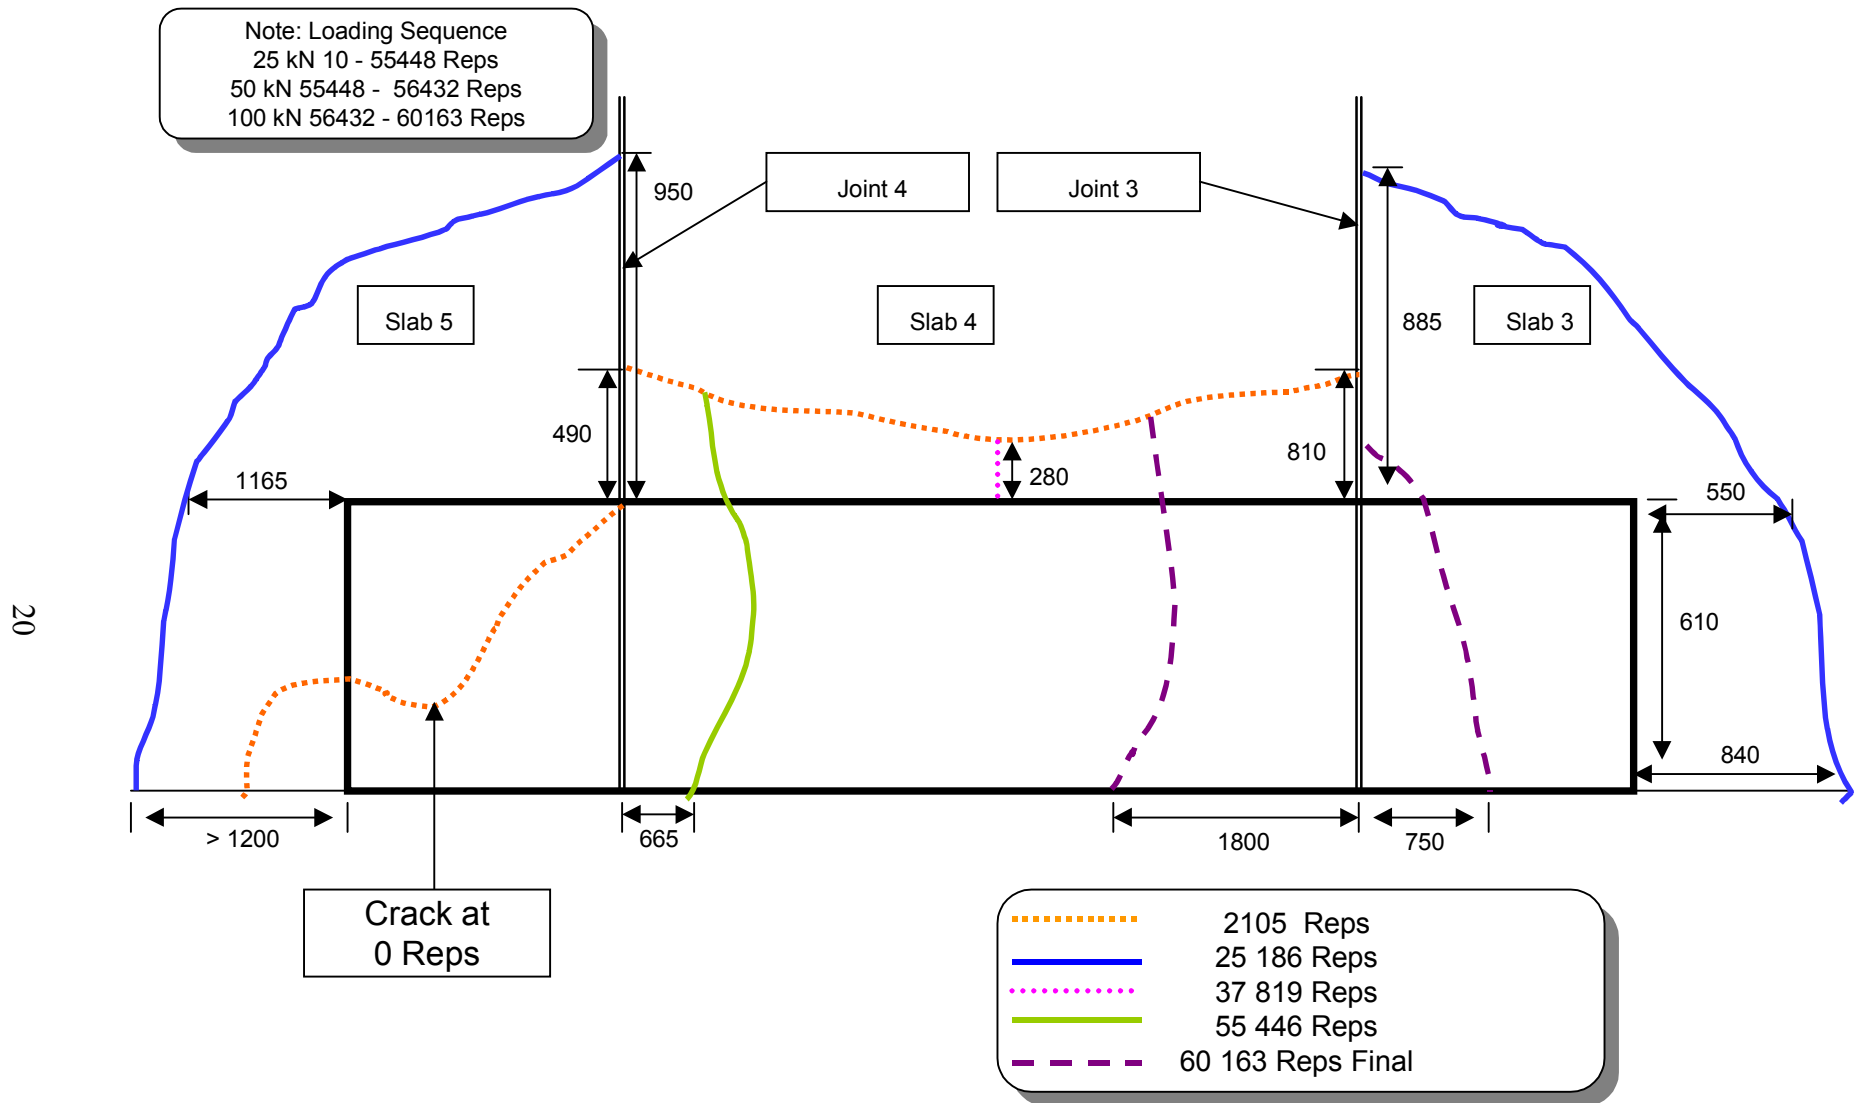
Figure 4.1. Schematic of crack development, Test Section 519FD (not to scale).

The crack pattern, as it developed with time, can be seen in Figure 4.1. Prior to the start of any loading on Section 519FD, a crack starting at joint 4 and the edge of the slab had developed, most likely from construction traffic (Photograph 4.1).

After approximately 2,000 25-kN load repetitions, a longitudinal crack developed throughout the length of the middle slab (slab 4) between both joints, about 1.4 m from the edge (Photograph 4.2). This type of crack indicates a loss of support under the slab and/or excessive slab warping causing an unsupported edge (4). This crack was followed by two corner cracks on either side of slab 4 (one in slab 3 and one in slab 5), which developed at approximately 25,000 repetitions (Photographs 4.3 and 4.4). As the test progressed, more edge and corner cracks developed. The final crack pattern is displayed in Photograph 4.5 and Figure 4.1.

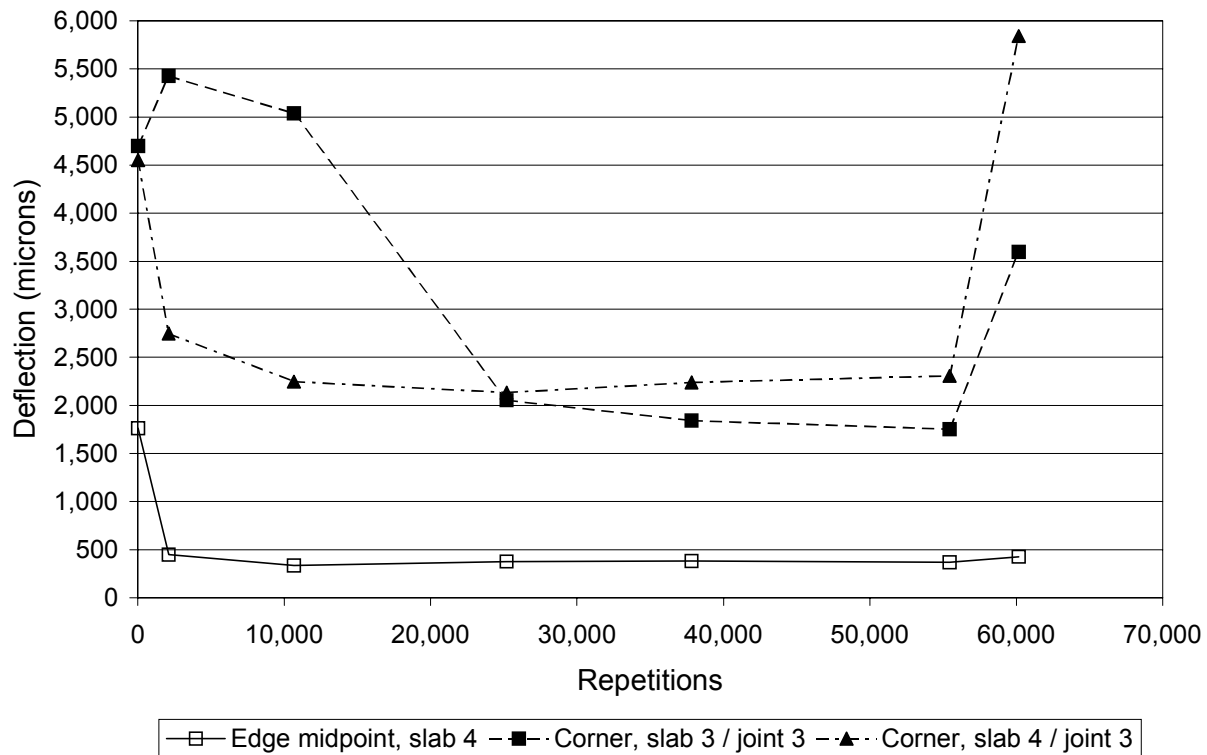
**Figure 4.2. EDMD and JDMD deflections, test load = 25 kN, Test Section 519FD.**

It is believed that a cavity under the edge of the slab caused the high initial deflections because of differential drying shrinkage in the FSHCC. This cavity, together with the applied edge loading, caused a bending moment all along the length of the slab which resulted in the longitudinal crack that developed after only 2,105 repetitions (Photograph 4.2). After this crack had developed, it was considered that the concrete slab re-seated onto the base course. This caused the cavity to close, which resulted in a significant decrease in edge deflections owing to the more effective support from the base and underlying layers. After the crack had been formed, the midpoint edge deflections decreased from 1,762 microns to 448 microns. This represents an 81 percent decrease in deflection at the midpoint. Similarly, the deflections on the slab 4 side of joint 3 experienced a 51 percent decrease in deflection.

On the slab 3 side of joint 3, the deflections stayed constant up to the point when the corner crack developed (25,186 repetitions) (see Photographs 4.3 and 4.4). At this point the deflections decreased by about 60 percent from the original N10 measurements, from 4,699 microns at the beginning of the test to 2,053 microns after 25,186 repetitions.

After the initial longitudinal crack (at 2,105 repetitions) and the corner cracks (at 25,186 repetitions), the deflections stabilized up to the point where the wheel load was increased (at 55,446 reps). A sharp increase in deflections was observed at this point as a result of the increased wheel load (Figure 4.2).

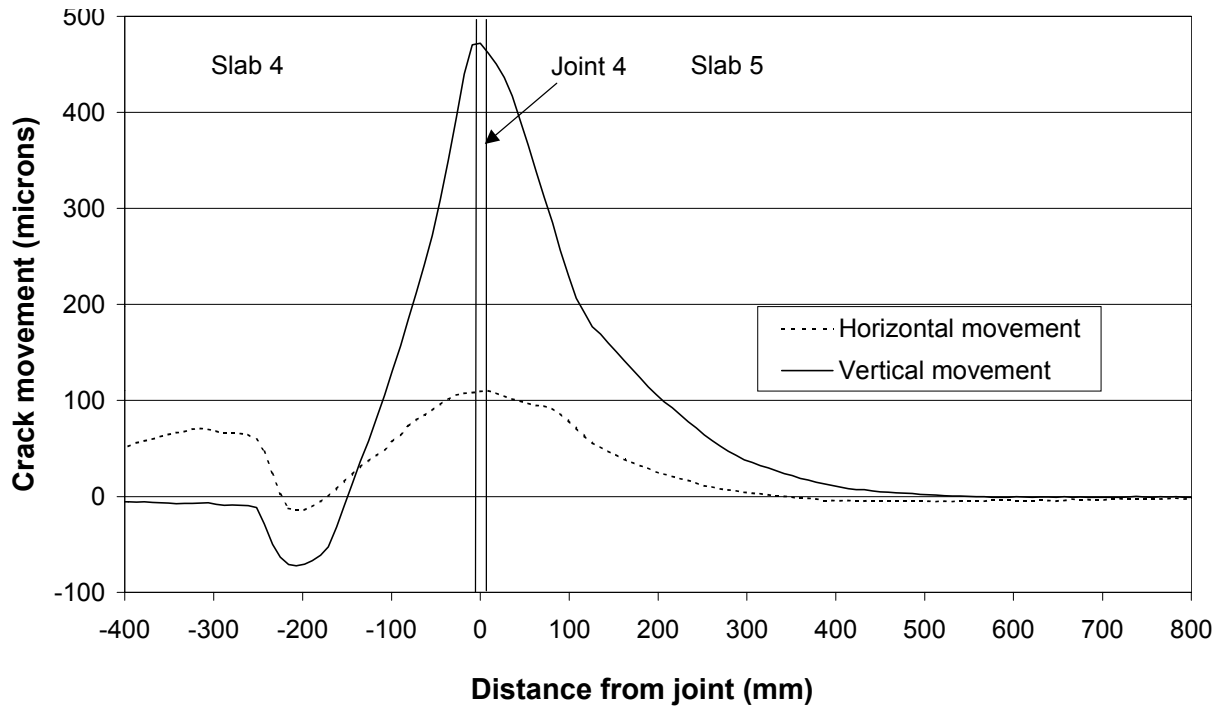
**Figure 4.3. CAM response, Test Section 519FD.**

These values are small, even after 60,000 load applications, but it is important to note that the CAM was placed over a crack, which was approximately 1 meter away from the applied load (see Photograph 4.3). The CAM results do not, therefore, reflect the crack activity under the influence of a load applied directly over the crack (as would be observed with normal traffic).

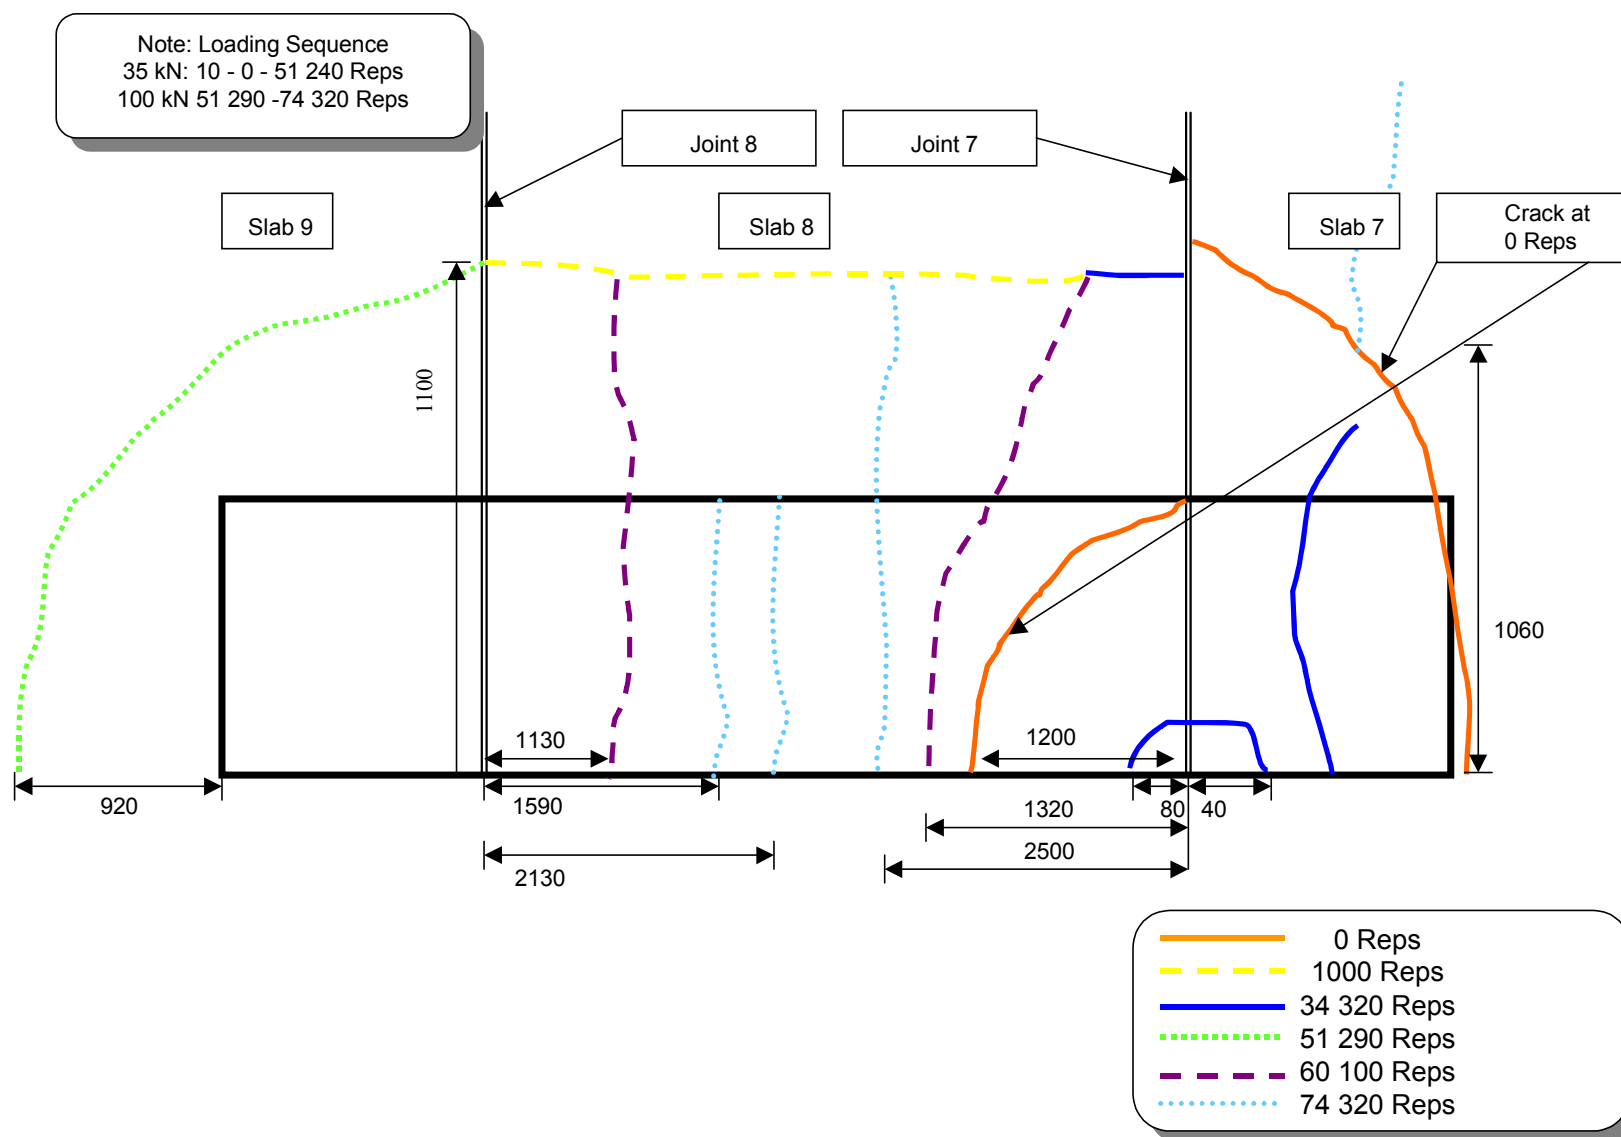
Figure 4.4. Schematic of crack development, Test Section 520FD (not to scale).

After the longitudinal crack formed (at 1,000 repetitions), a loss in load transfer took place across joint 8 (see Table 4.6). This loss in distributed load across the joint caused higher corner deflections in slab 9. These high deflections stayed constant until a large corner crack developed at approximately 50,000 load applications (see Figure 4.4), after which the deflection decreased.

Between 40,000 and 60,100 repetitions, additional transverse cracks developed (see Figure 4.4). As a result of the additional transverse cracking, the middle slab (slab 8) began to rock under the influence of the applied load, which affected the measurement of the load transfer efficiency as seen in Table 4.6.

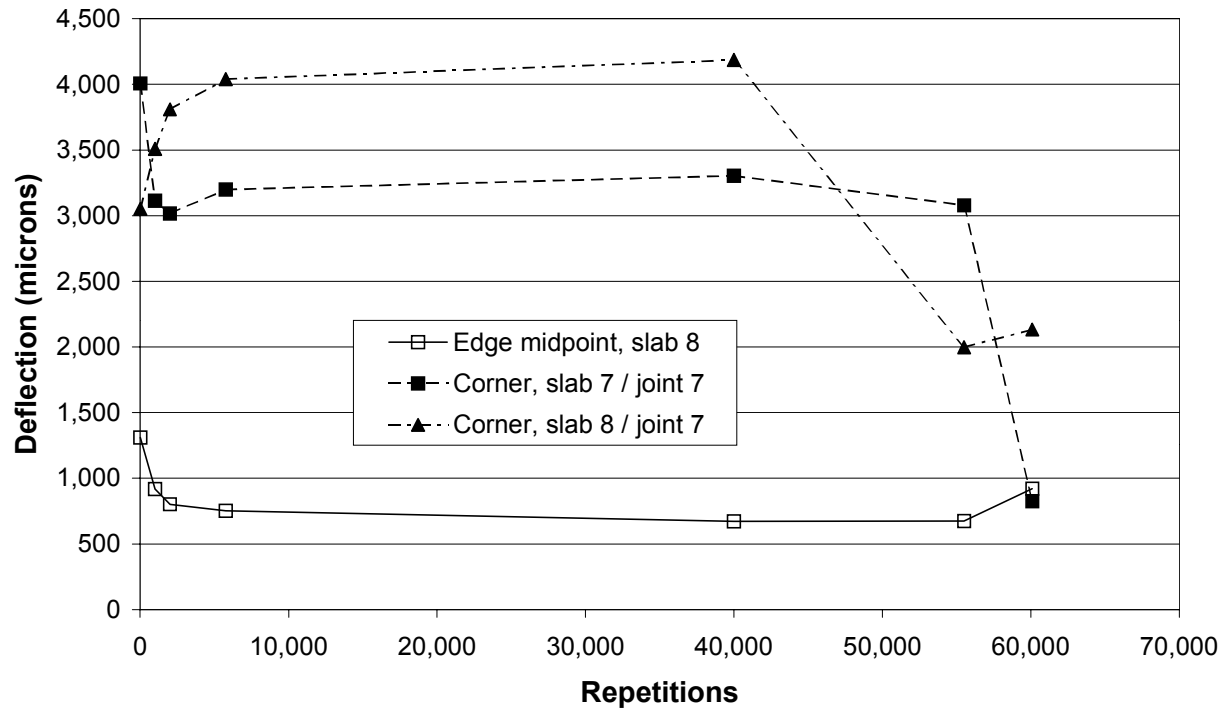
**Figure 4.5. JDMD and EDMD deflections, test load = 35 kN, Test Section 520FD.**

As soon as the longitudinal crack developed, the midpoint edge deflections dropped. This indicated that the slab came into full contact with the base and thus the deflections decreased. These initially high deflections caused by slab curling have a significant impact on the backcalculated subgrade support values. Higher deflections suggest a lower subgrade support, but this is not necessarily the case.

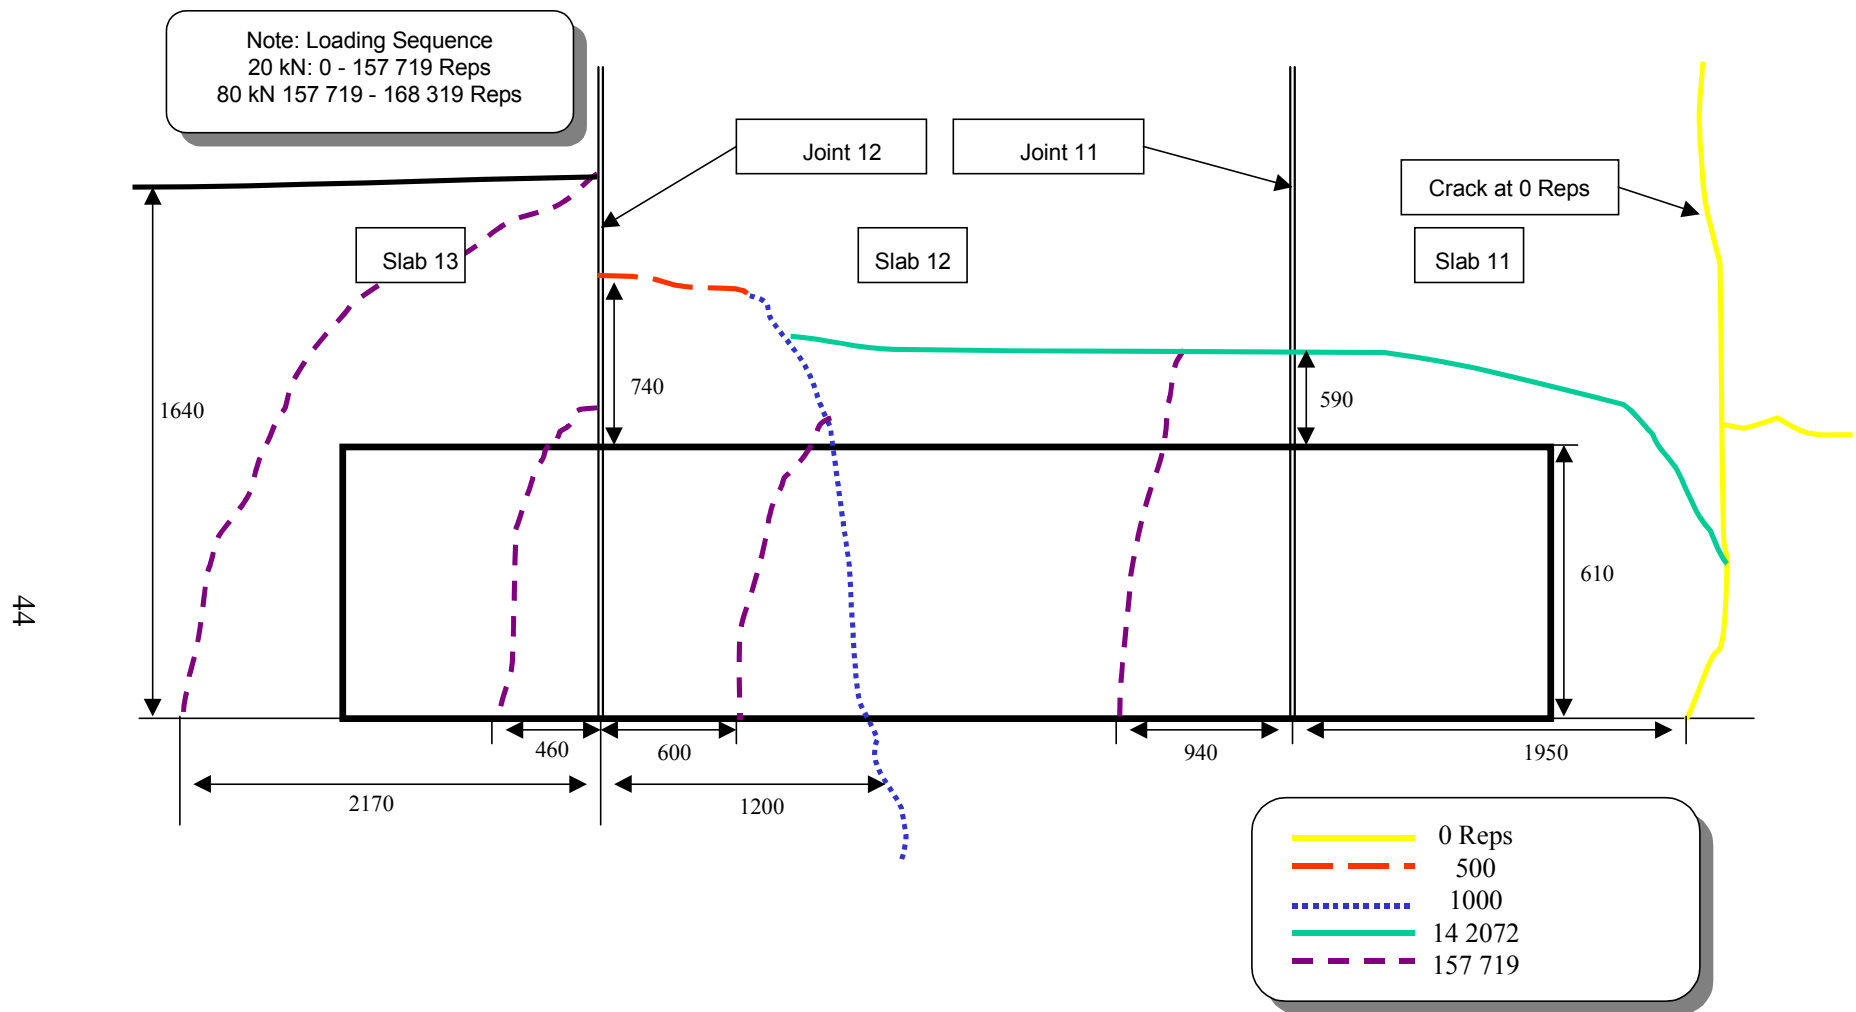
Figure 4.6. Schematic of crack development, Test Section 521 (not to scale).

An overhead photo of the entire section with cracks can be seen in Photograph 4.12; crack development is presented in Figure 4.6. Apart from a small corner crack at joint 12, the complete 8-m long test section was free of any cracks prior to the start of the test (see Photograph 4.13). The crack growth pattern for Test Section 521FD was somewhat different from those observed on Sections 519FD and 520FD (compare Figure 4.1 and 4.4 to Figure 4.6).

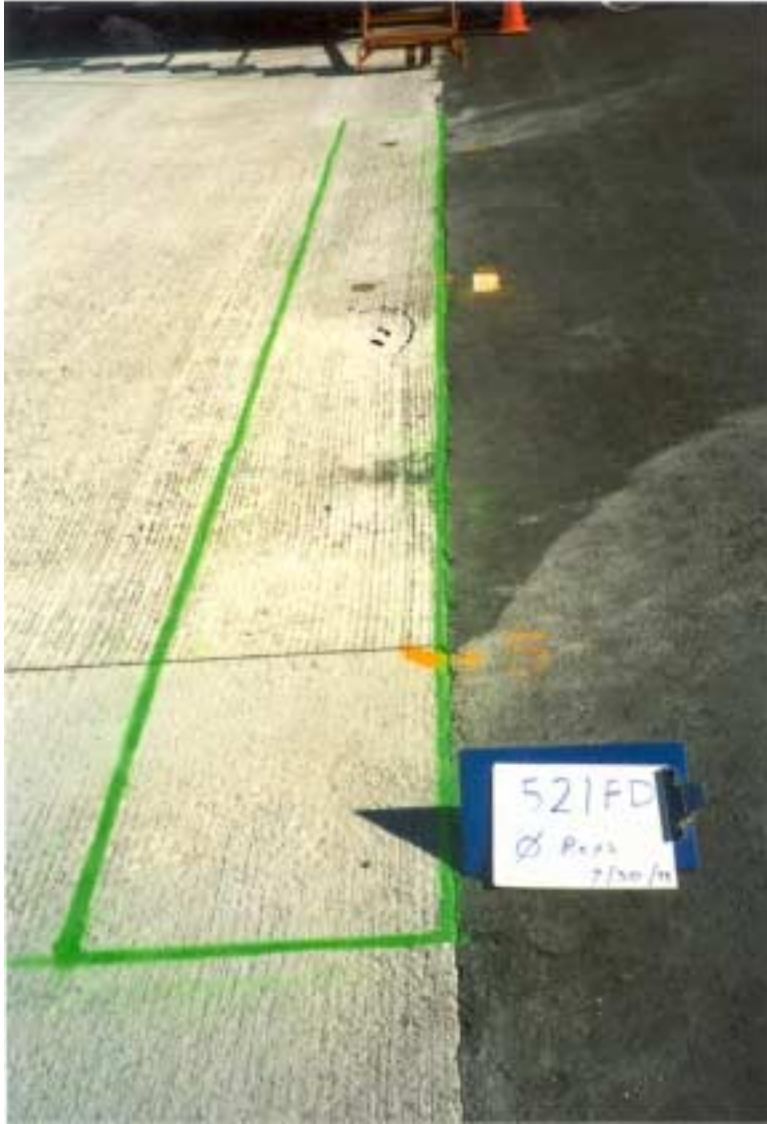
**Photograph 4.13. Section at beginning of test, Test Section 521FD.**

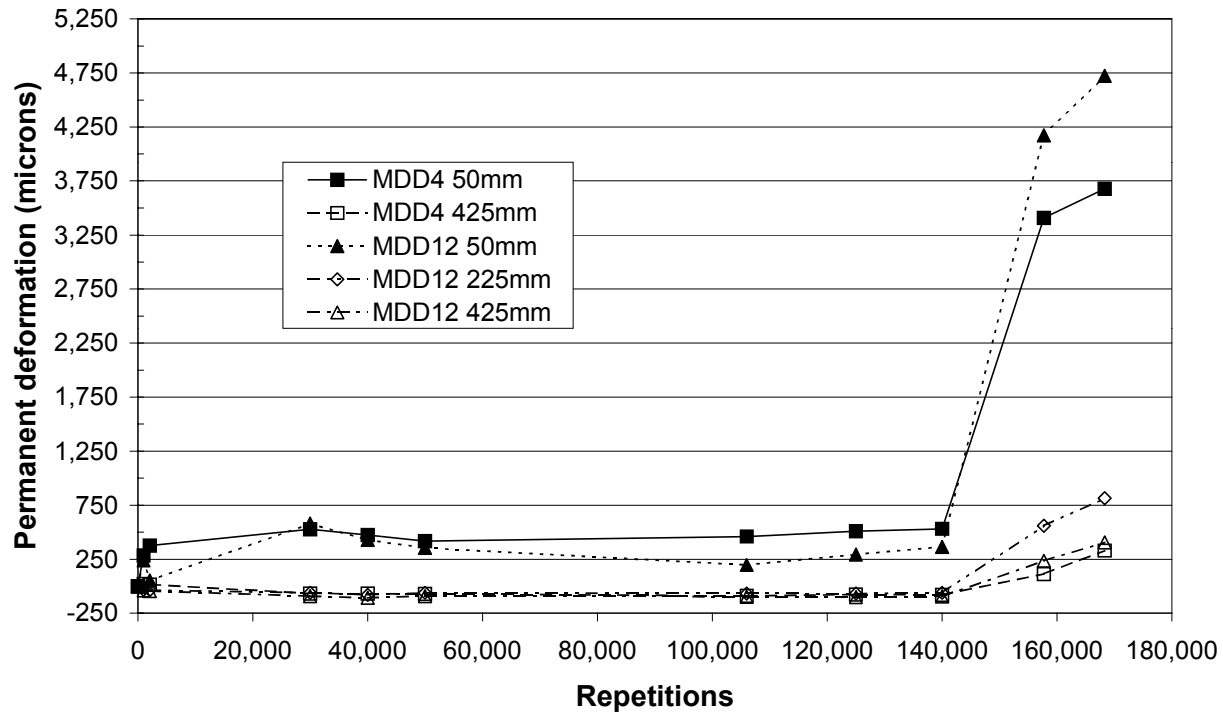
**Figure 4.9. MDD permanent deformation, Test Section 521FD.**

Figure 4.9 shows that the deeper MDDs have a slight negative deformation before going into positive values around 140,000 repetitions. This is probably due to small errors in the measurements (values are very small).

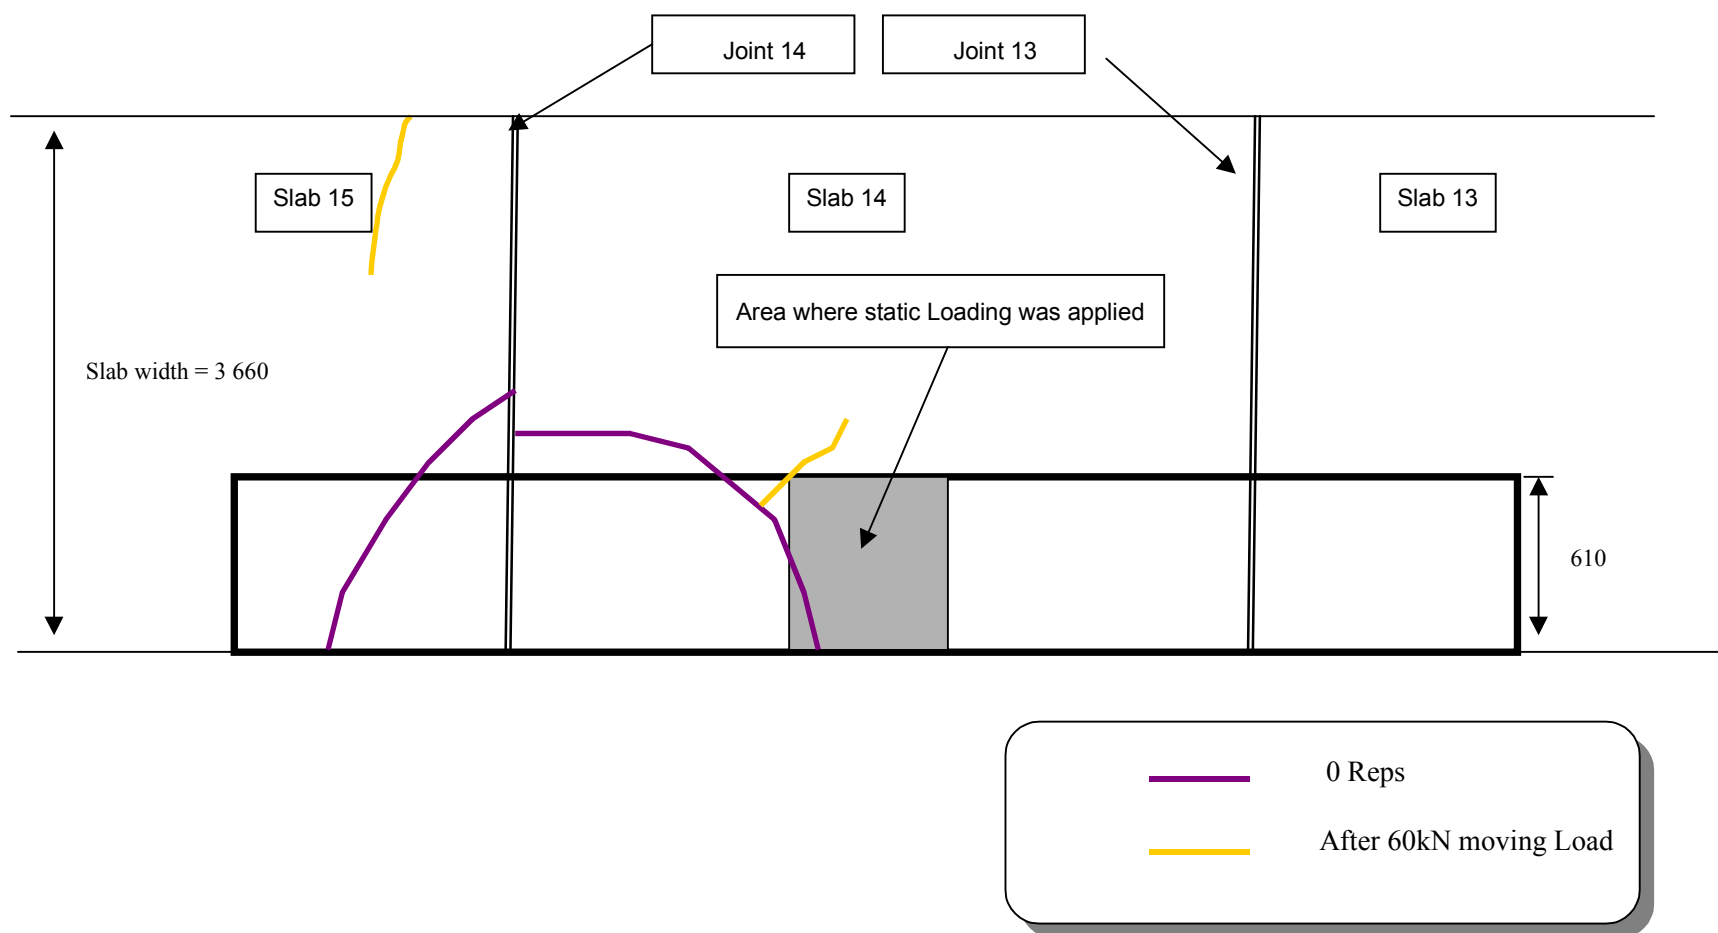
**Figure 4.10. Schematic of crack development, Test Section 522FD (not to scale).**

The test was conducted in these two phases because during phase one, no additional cracks developed on the section even after the dual wheel load was increased to 100 kN. It was thought that the moving wheel load might assist in the establishment of the maximum flexural slab strength.

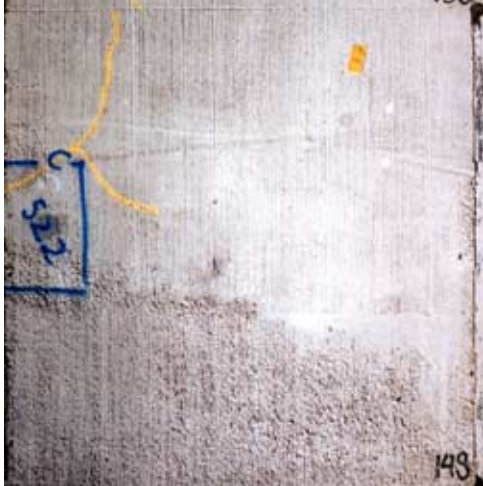
**Photograph 4.18. Photograph of final crack pattern, Test Section 522FD.**

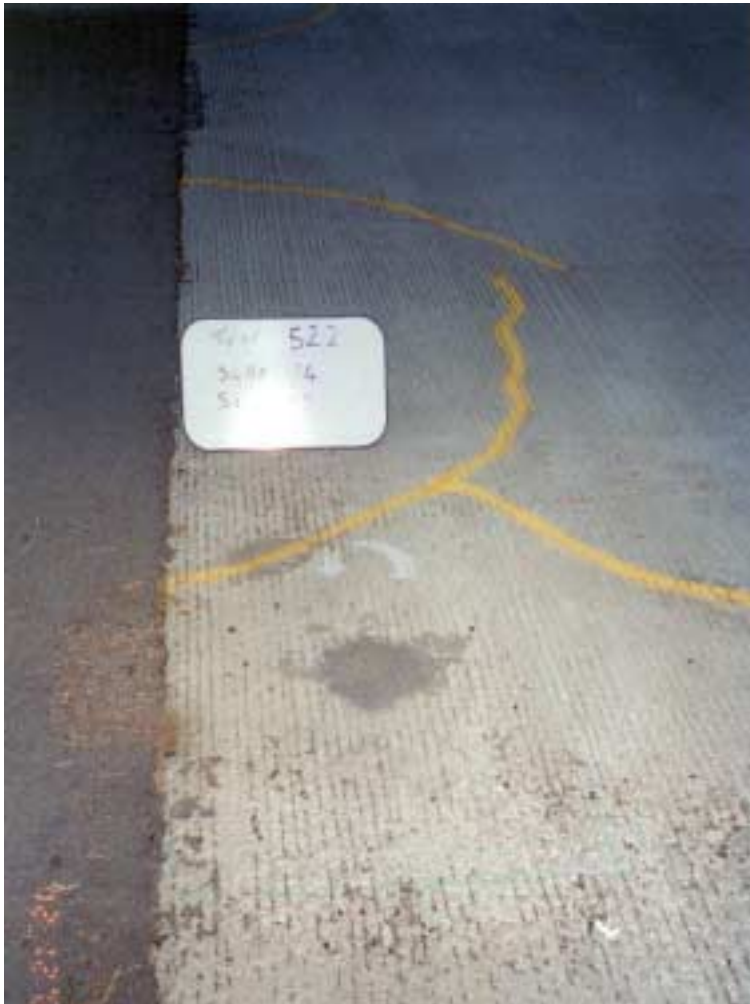
**Photograph 4.19. Crack pattern prior to HVS testing, Test Section 522FD.**

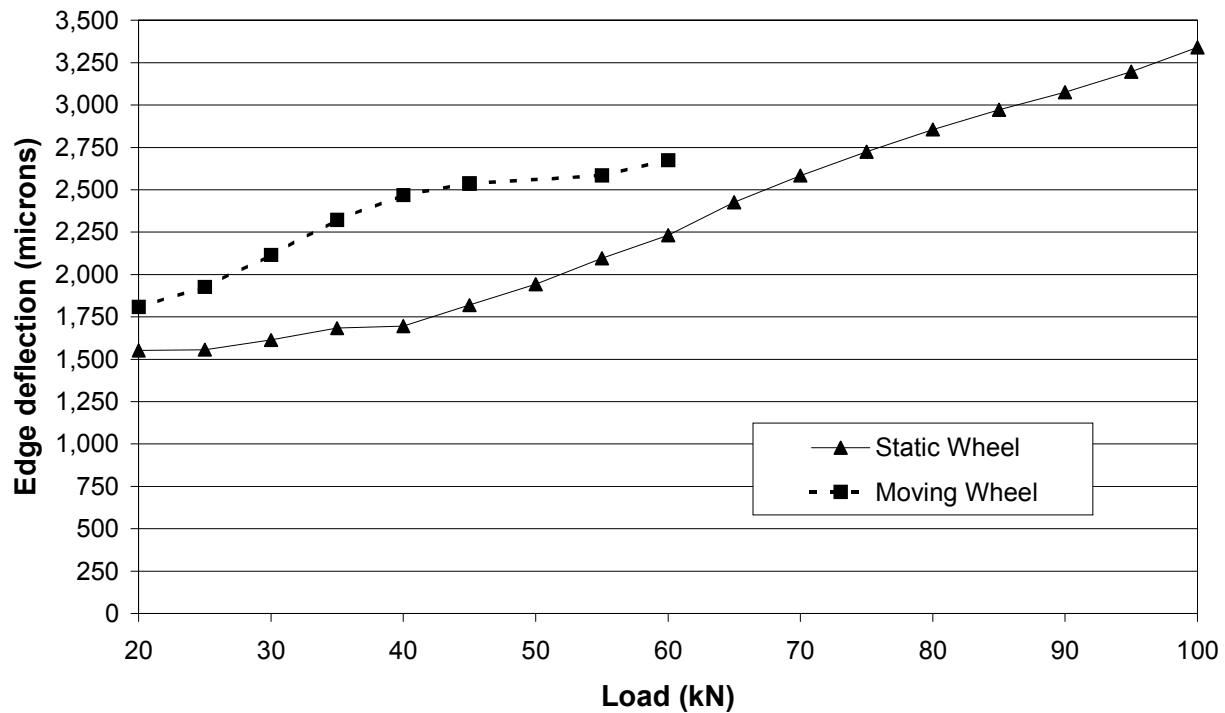
**Figure 4.11. Elastic deflections at slab edge, Test Section 522FD.**

One EDMD was used to record the elastic deflections at the edge caused by the various load cases (Photograph 4.20) and the results are presented in Table 4.14 and Figure 4.11. The moving wheel test was only conducted to a maximum load of 60 kN.

This field test revealed a significantly higher load could be supported without the slab cracking, which indicates that the bending stress in the slab was substantially reduced due to the support from the underlying layers.

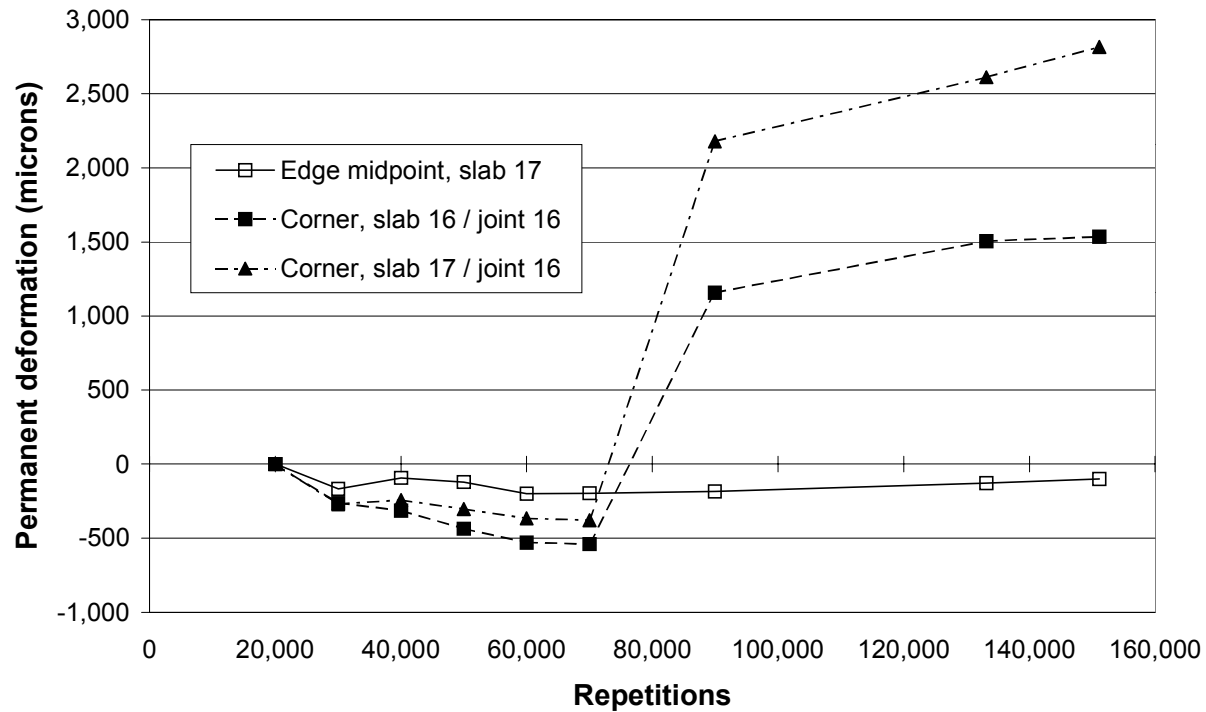
**Figure 4.14. JDMD permanent deformation, Test Section 523FD.**

A chart showing permanent deformation at joint 16 and the slab midpoint edge versus HVS wheel repetitions is shown in Figure 4.14. There was minimal permanent deformation at the corner and slab edge midpoint until around 75,000 repetitions at which point corner permanent deformation in the pavement system started accumulating. This permanent deformation most likely began due to a loss in local stiffness of the slab, which in turn slightly increased the elastic deflection and the pressure on the base and subgrade.

After the first cracking at 90,000 repetitions, there was not a significant increase in permanent deformation at the corner or edge of the slab. This can be expected since the elastic deflections at the corner of the slab decreased between 40 and 50 percent after cracking. In Figure 4.14, there is a slight negative trend in the permanent deformation of the slab system in the beginning of the test. Because the base and subgrade cannot expand under wheel loading, the only explanation for this behavior is a different zero load position caused by either the rocking of the slab or the ambient temperature outside the box. The latter explanation (temperature effect) is probably the most likely answer.

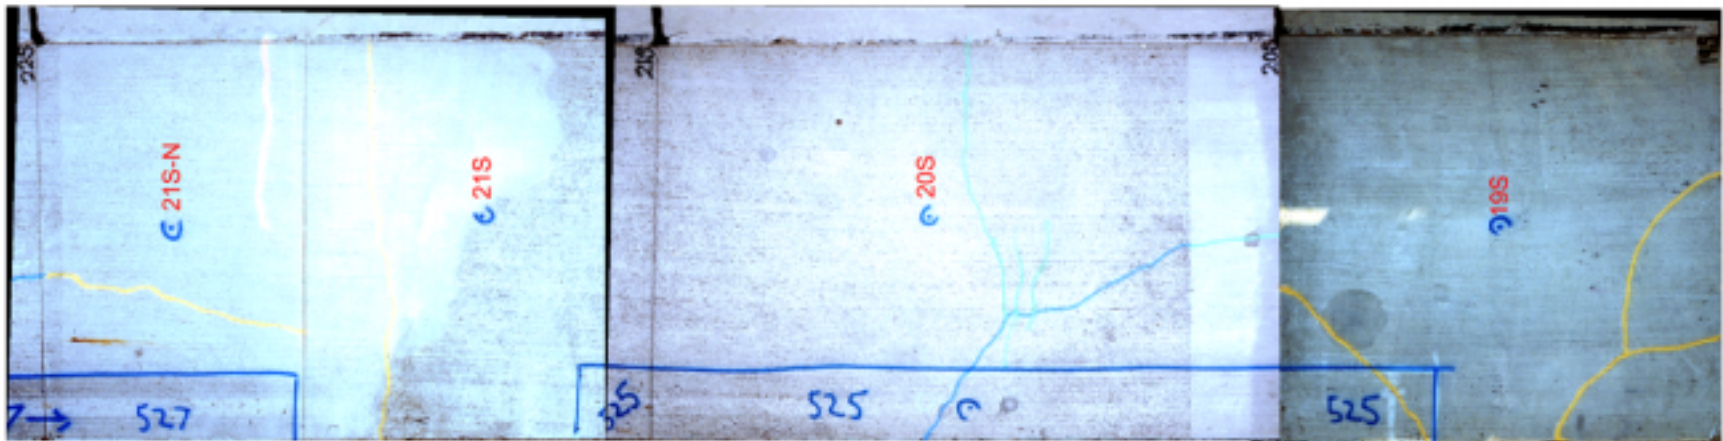
**Photograph 4.24. Composite photograph of final crack pattern, Test Section 524FD.**

*Note: The paint indicating Section 525FD in this photograph is incorrect; test section is actually 524FD.*

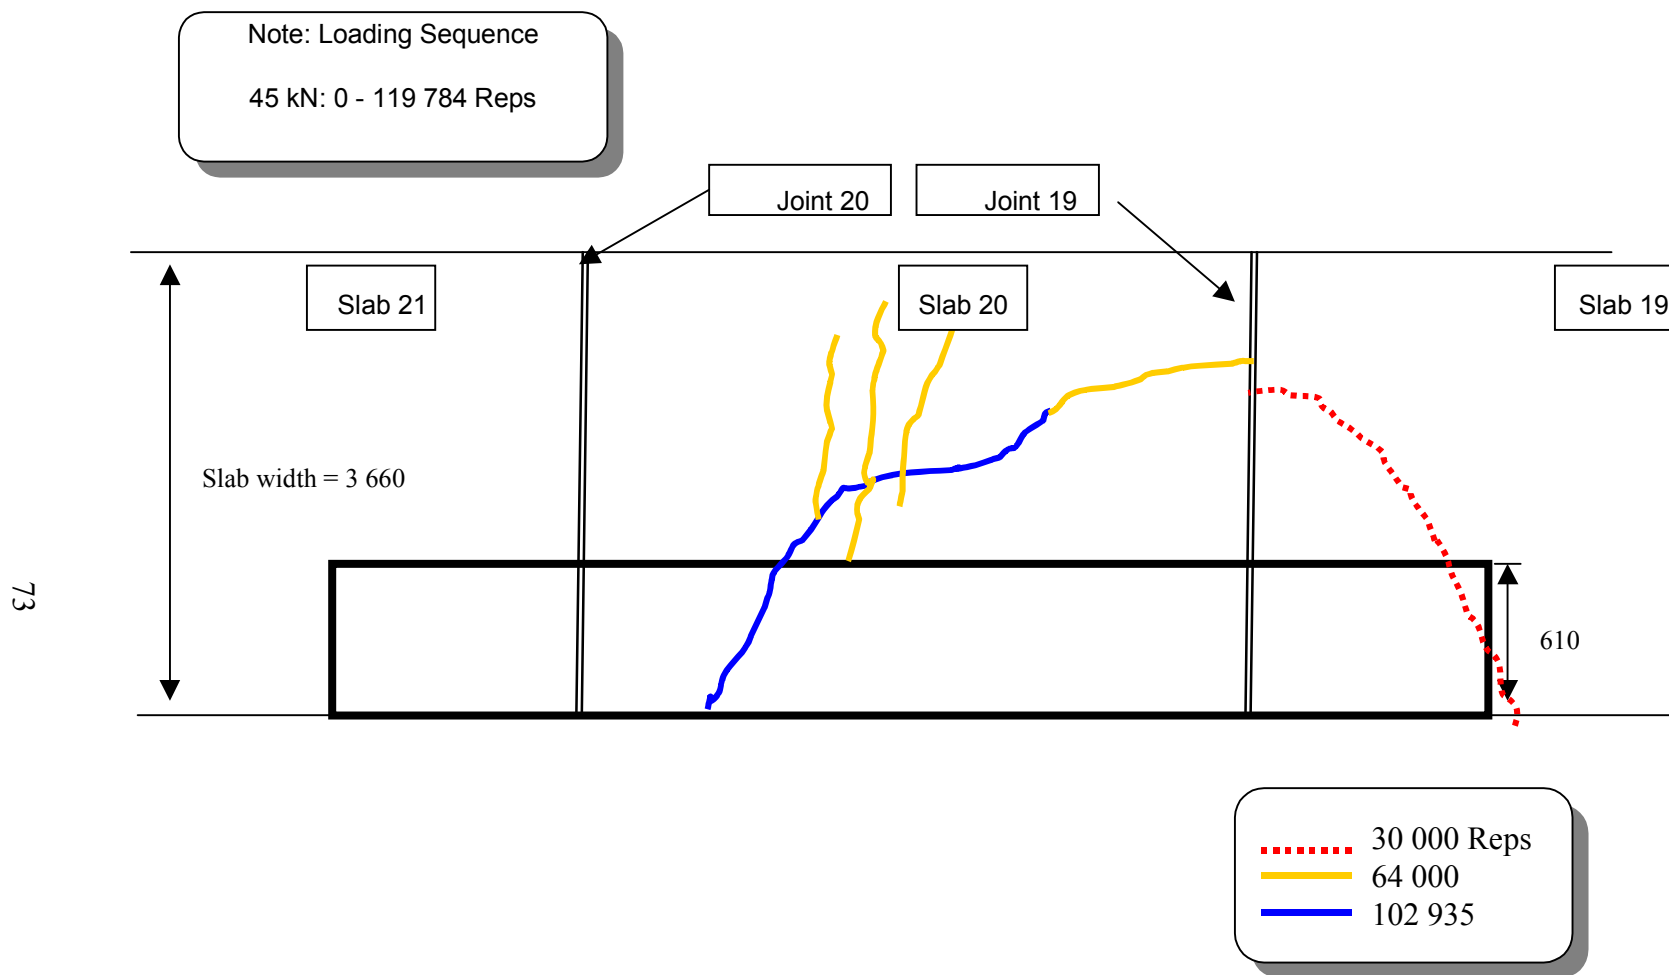
**Figure 4.15. Schematic of crack development, Test Section 524FD (not to scale).**

Figure 4.18 shows that the maximum strains parallel to the wheel are approximately constant until the large corner crack that began at joint 19 intersected the edge of the pavement (see Figure 4.15). At 30,000 repetitions, the corner crack on slab 19 was having no effect on the strain outputs at the slab midpoint edge. However, at 103,000 repetitions, all of the measured strain values at the slab midpoint edge dropped to almost zero strain. This can be attributed to

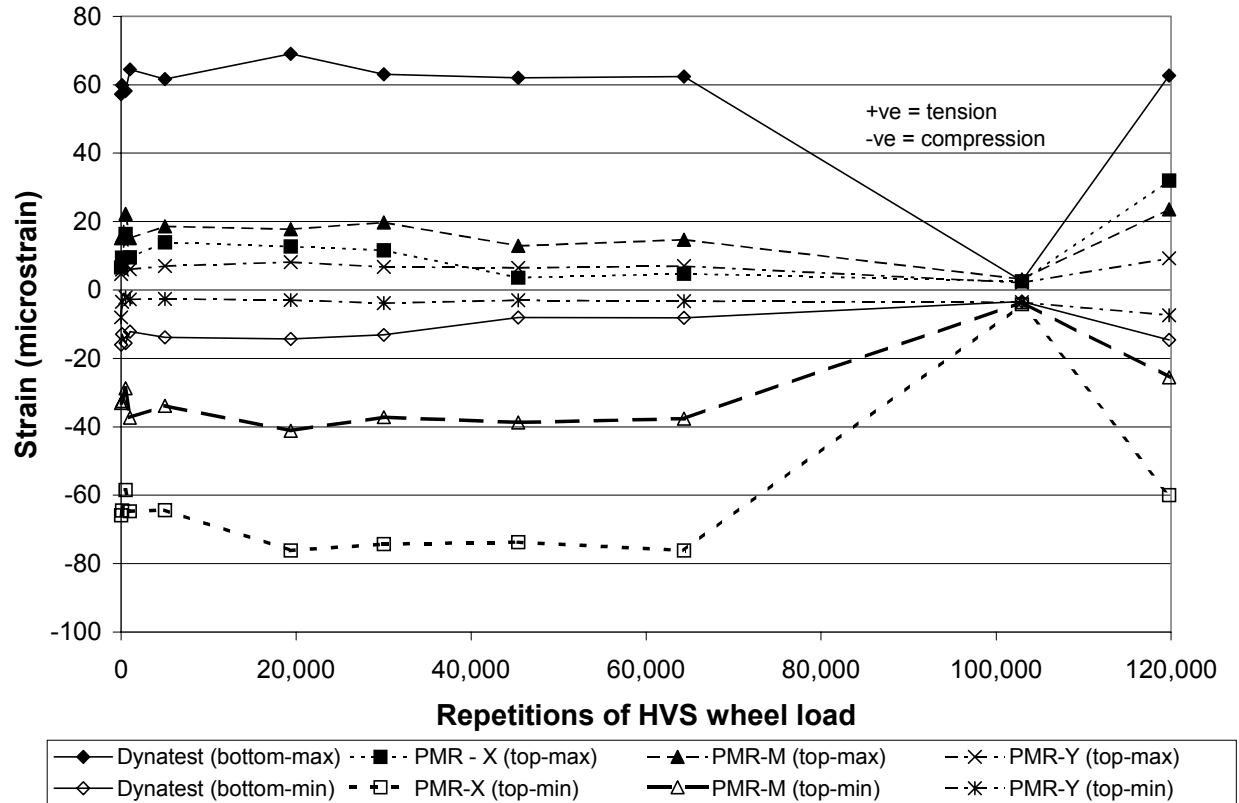
**Figure 4.18. Dynamic strain response at edge midpoint, slab 20, Test Section 524FD.**

Figure 4.18 shows that the maximum tensile stress occurred with the Dynatest strain at the bottom of the slab while the maximum compressive stress was measured with the PMR-X gauge. Both of these gauges are oriented parallel to the direction of wheel travel. Table 4.28 shows the PMR-X indicated slightly higher strains throughout the test but any deviation in strain gauge depth or slab thickness will cause these two gauges to provide different values. The PMR-M gauges should have the second highest compressive strain since they are oriented 45 degrees to the direction of travel. Finally, because the PMR-Y is oriented perpendicular to the slab edge, it should have a close to zero strain reading.

the unloading of the slab due to the relative proximity of the gauges to the newly formed crack. After approximately 20,000 more repetitions (119,784), the elastic strain reading had increased again. This could be a result of more damage accumulating in the vicinity of the gauges.

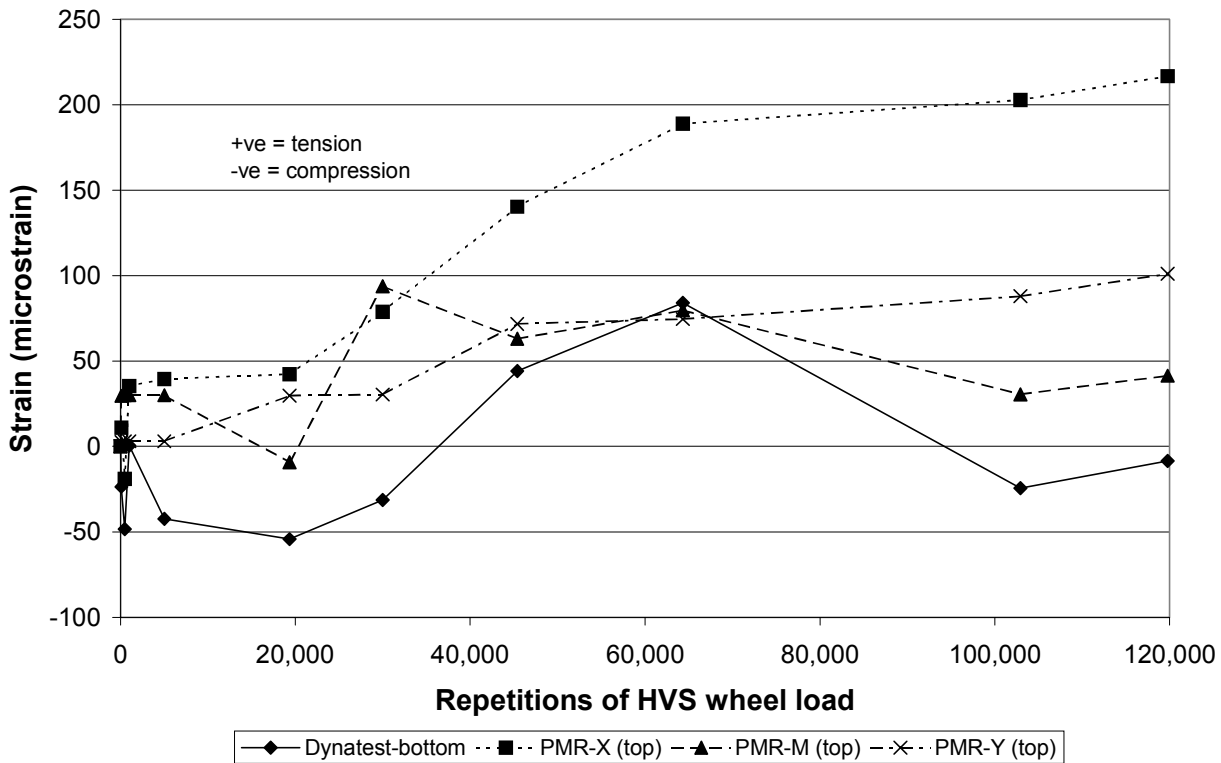
Figure 4.20. Static strain response near joint 19, Test Section 524FD.

responses recorded at joint 19. The permanent strain values from the edge midpoint showed no consistent trend, which indicates that there was no significant permanent strain or micro-cracking near the gauge.
