HVS Test Results on Fast-Setting Hydraulic Cement Concrete, Palmdale, California Test Sections, South Tangent

## **HVS Test Results on Fast-Setting Hydraulic Cement Concrete**

### **Palmdale, California Test Sections, South Tangent**

Research report prepared for the  
California Department of Transportation by:

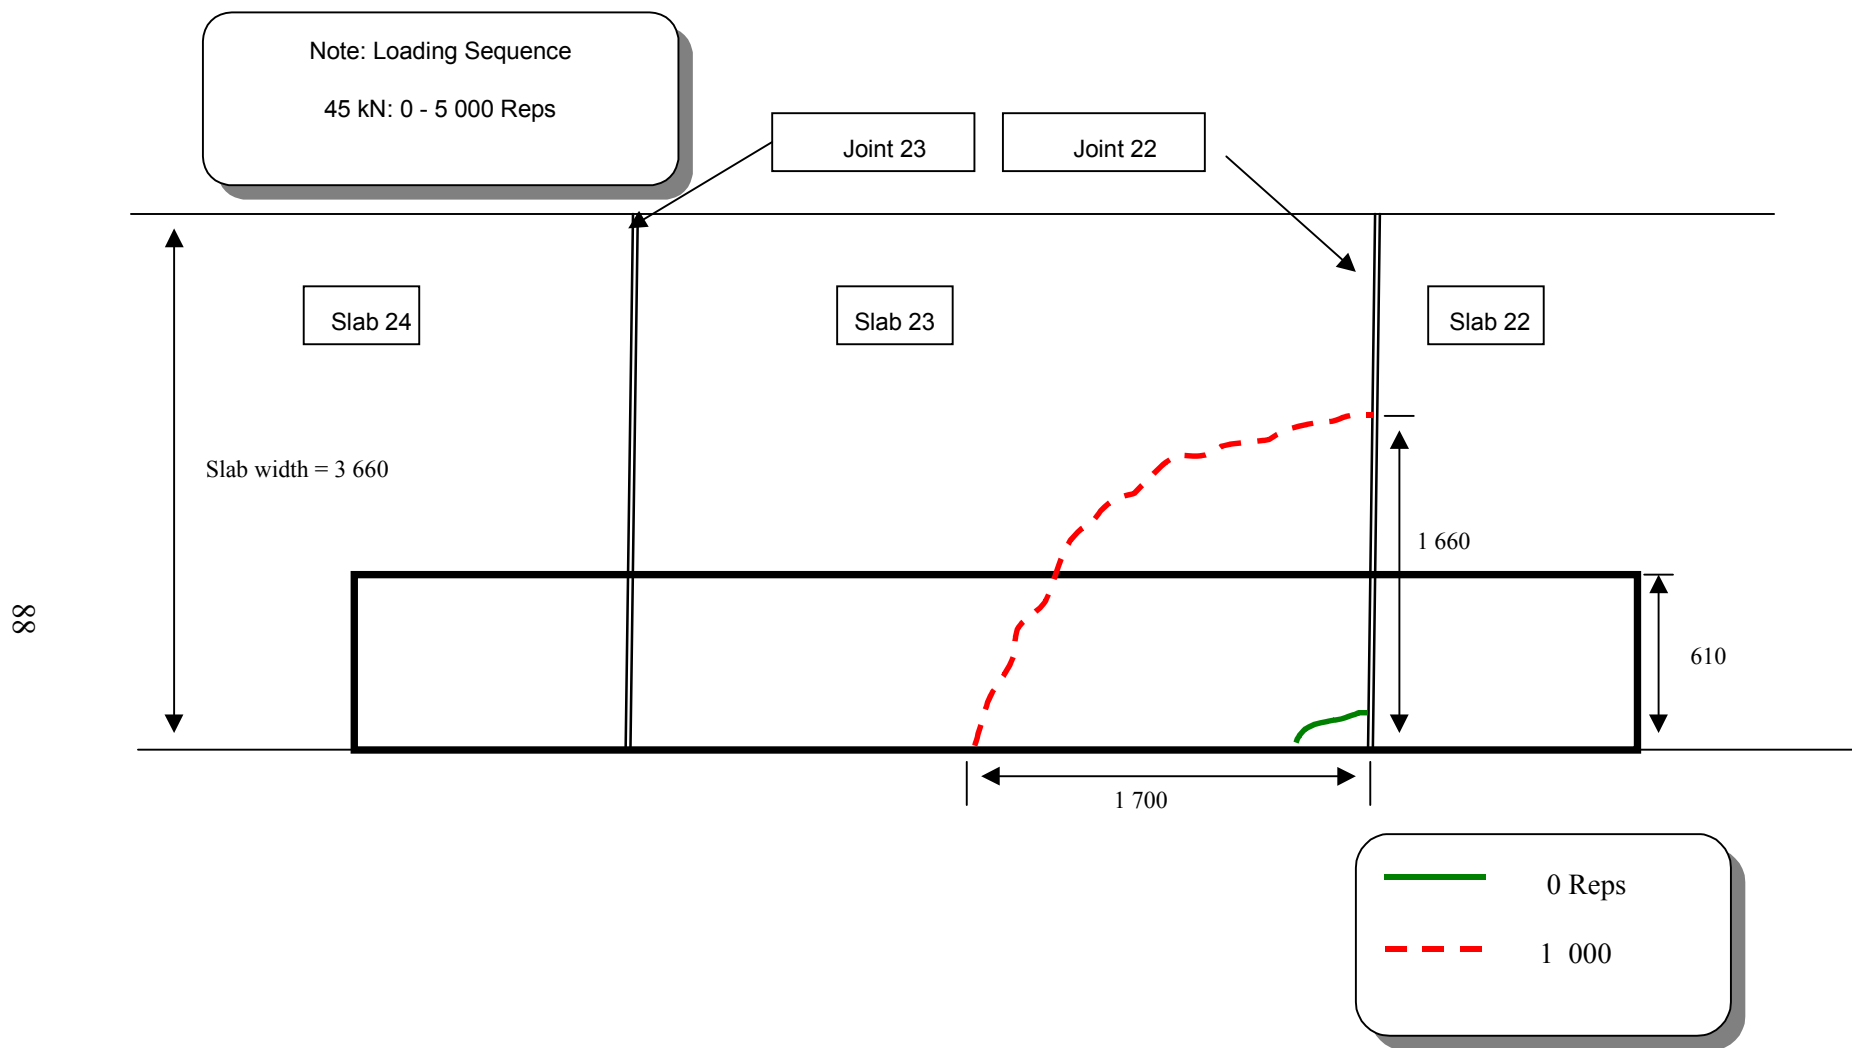
**Figure 4.21. Schematic of crack development, Test Section 525FD (not to scale).**

The first crack appeared on the middle slab (slab 23) by 1,000 repetitions. As seen in Photograph 4.26, the HVS produced a corner crack at joint 22 that was approximately symmetrical (1.7 by 1.66 m). This crack was similar to failure modes experienced on the other

The maximum permanent deformation (5 mm) occurred on the slab 23 side of joint 22 (refer to Figure 4.21 and Photograph 4.26 for the location). At the right side of the joint (slab 22), the permanent deformation was 1 mm. The 4-mm differential permanent vertical displacement between slabs at joint 22 shows that a significant faulting effect occurred. As can

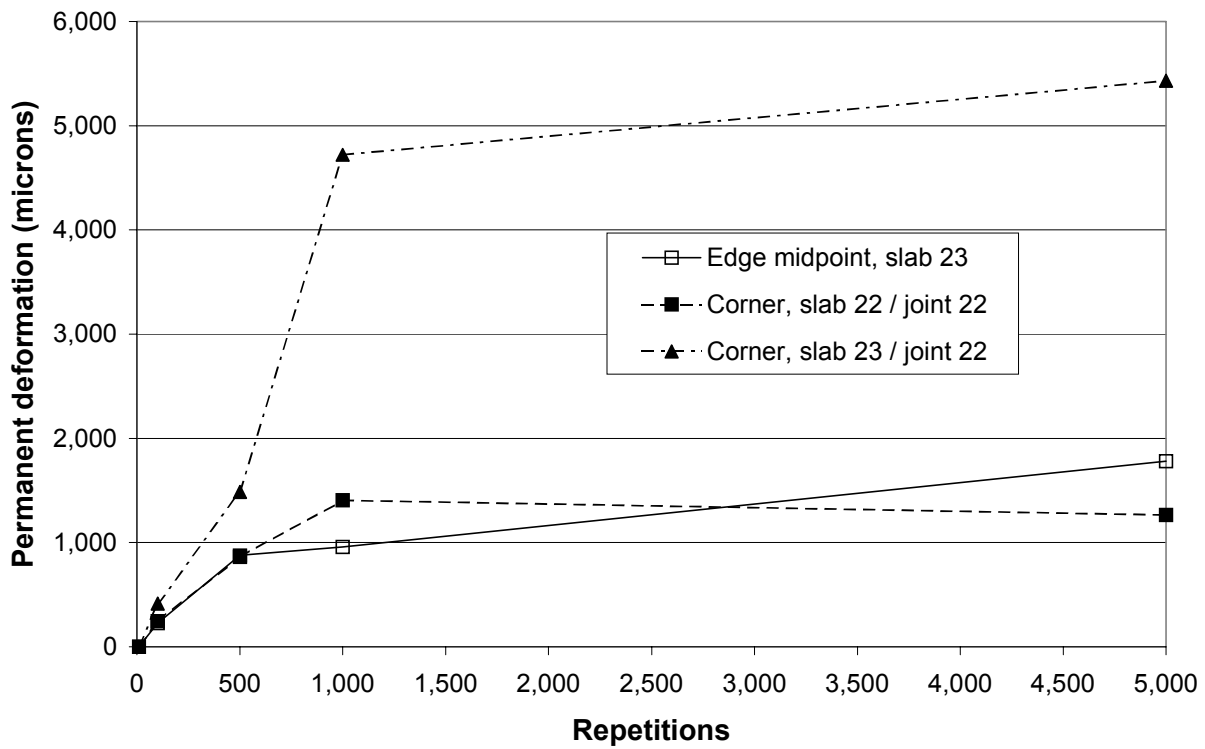
Figure 4.23. JDMD and EDMD permanent deformation, Test Section 525FD.

After 1,000 repetitions, the development of the corner crack induced a steep increase in the permanent deformation (about 63 percent) and a sudden decrease of deflection (about 56 percent). These observations lead again to the assumption that the slab was curled upward prior to the start of the test and until the corner crack developed. The unsupported condition at the corner caused the formation of a corner crack and consequent slab failure.

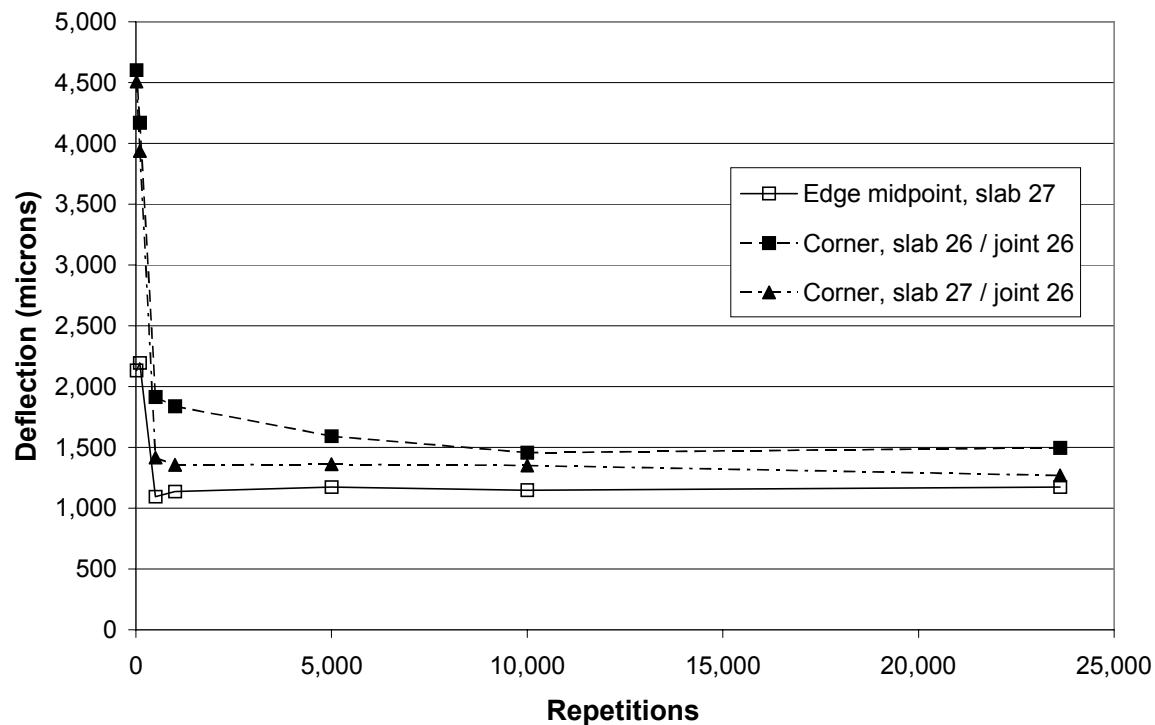
**Figure 4.25. EDMD and JDMD deflections, Test Section 526FD.**

This is probably an indication that the slab seated on the base course once the corner and transverse cracks developed, and because the seated slab received from more effective support from the base and underlying layers, the deflections decreased. No important variation in the deflection values was observed after 500 repetitions.

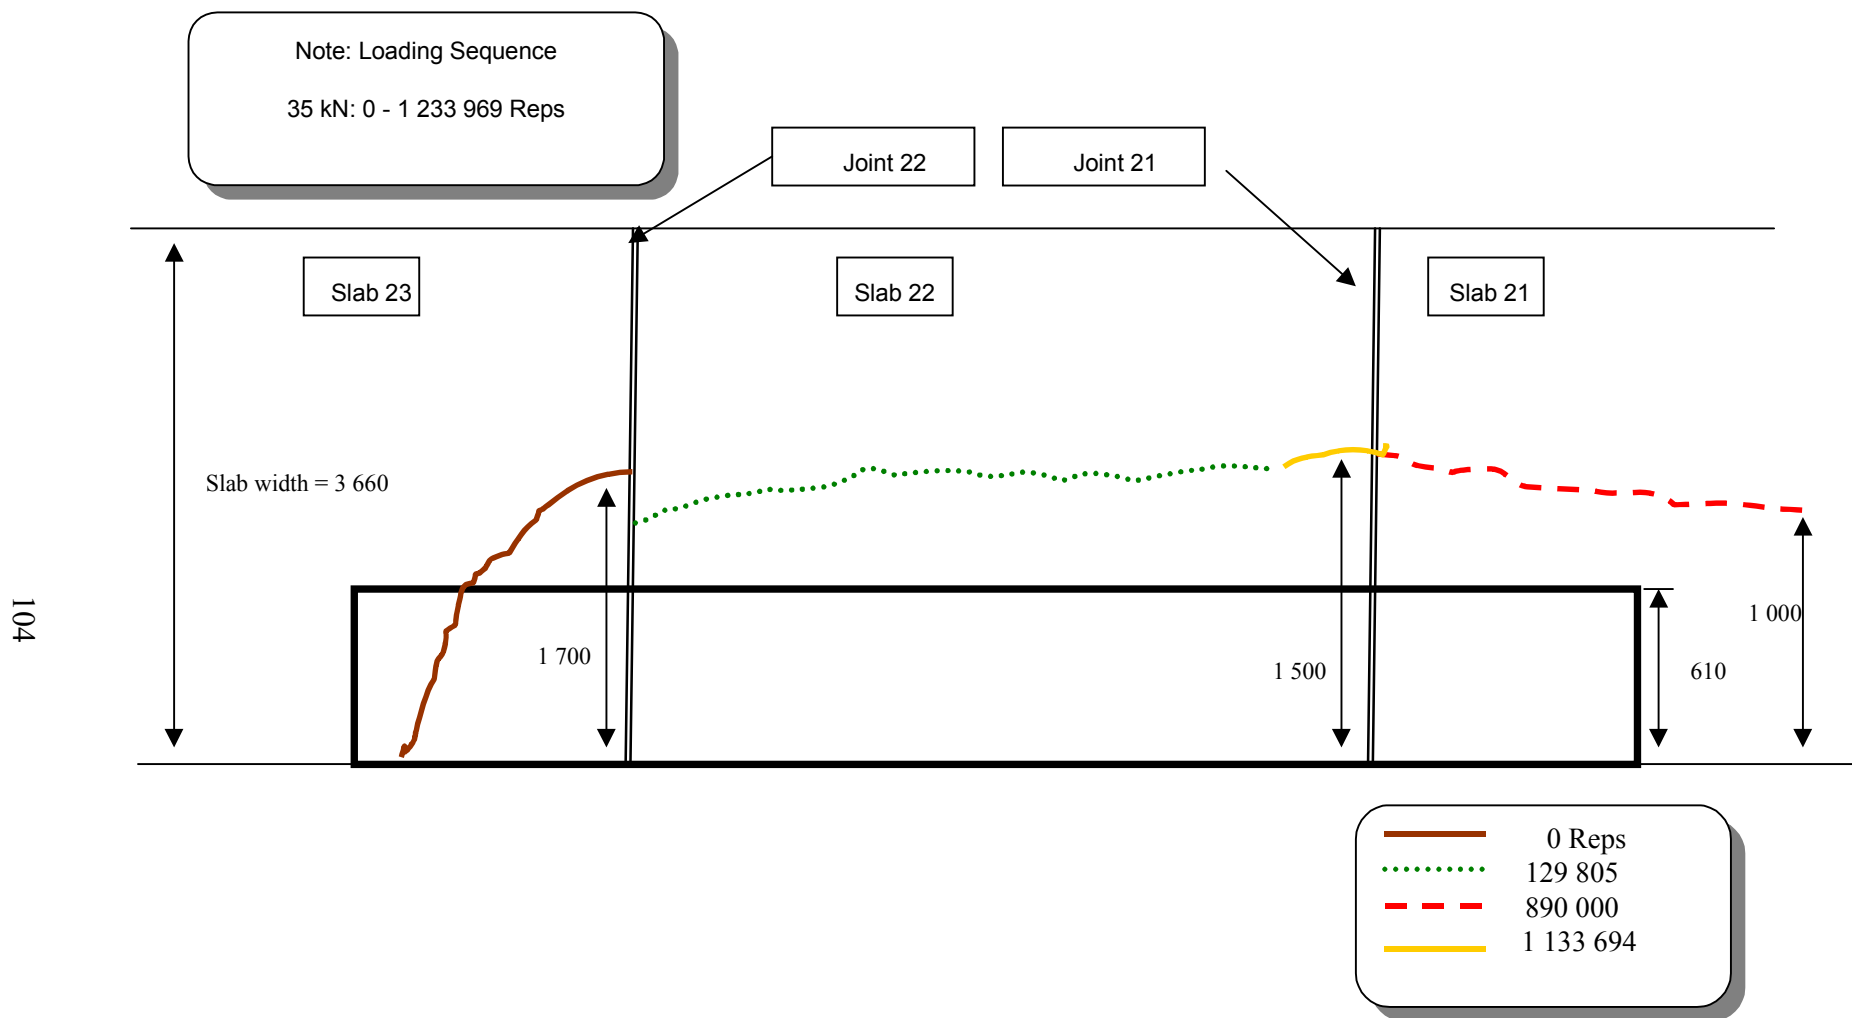
Figure 4.27. Schematic of crack development, Test Section 527FD (not to scale).

Test Section 527FD included slabs 21, 22, and 23. A photograph of the full test section with cracks at the end of HVS trafficking is presented in Photograph 4.31; crack development is presented in Figure 4.27.

As seen in Photograph 4.31, slab 23 had a corner crack from the outset, about 1.7 m from the edge. After 129,805 repetitions, a new longitudinal crack at about 1.5 m from the edge of the tested slab (slab 22) formed. Shortly after the load was increased to 40 kN (after 890,000 repetitions), a longitudinal crack formed on slab 21. This new crack developed through the entire width of the slab, also about 1.5 m from the edge.

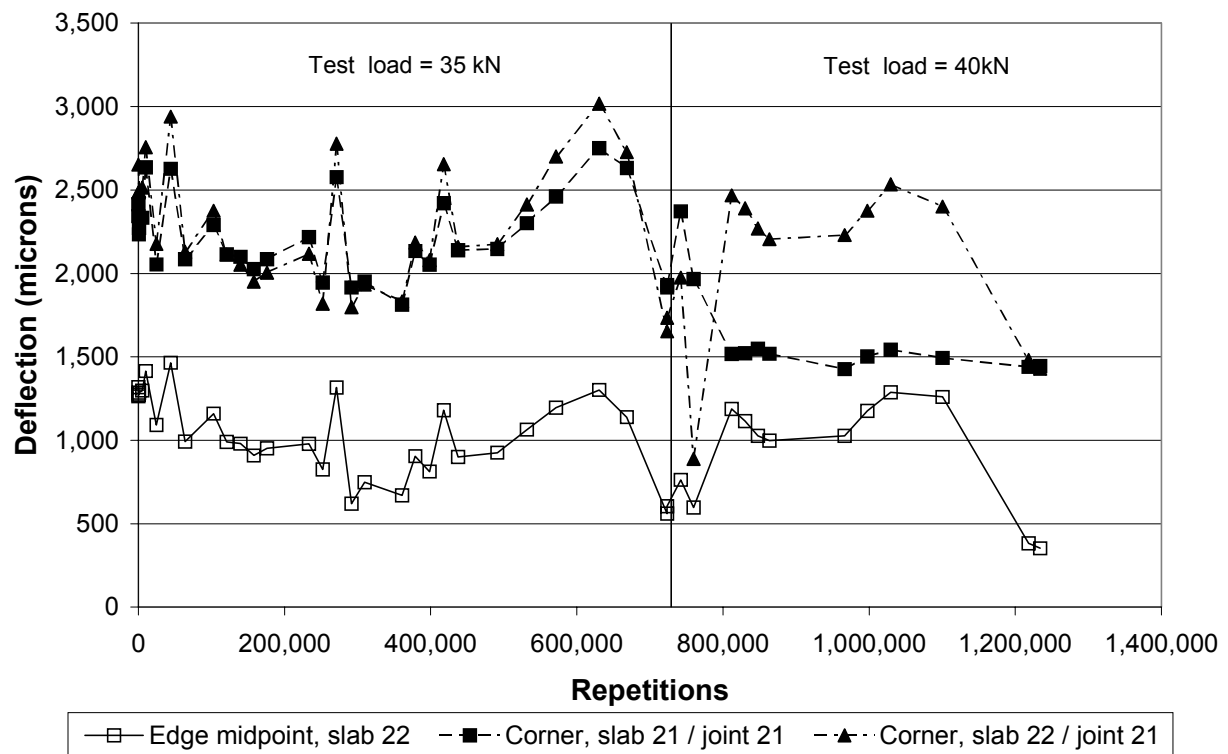
**Figure 4.28. EDMD and JDMD deflections, test load = 35 and 40 kN, Test Section 527FD.**

Deflections on both sides of joint 21 were broadly similar for the first part of the test (wheel load of 35 kN up to 723,438 repetitions) and in the order of 1,000 microns on the edge and 2,000 to 2,500 microns at the joint (Figure 4.28). This suggests that there was no significant deterioration under the trafficking load, with good slab support and aggregate interlock at the joint being maintained.

When the wheel load was increased to 40 kN, however, the joint deflections dropped noticeably (see Figure 4.28). In addition, deflections measured on each side of the joint differed until the end of the test: those on the slab 22 side (main trafficked slab) were generally higher than those on the slab 21 side.

At the end of the test, deflections on each side of the joint were approximately 1,500 microns. Deflection at the midpoint edge of slab 21 dropped to 350 microns. This may have been due to the cracks that formed on slab 21 at 890,000 repetitions and on slab 22 at 1,133,694 repetitions, which caused the slab to seat and come into full contact with the base layers similar to conditions observed in other tests.

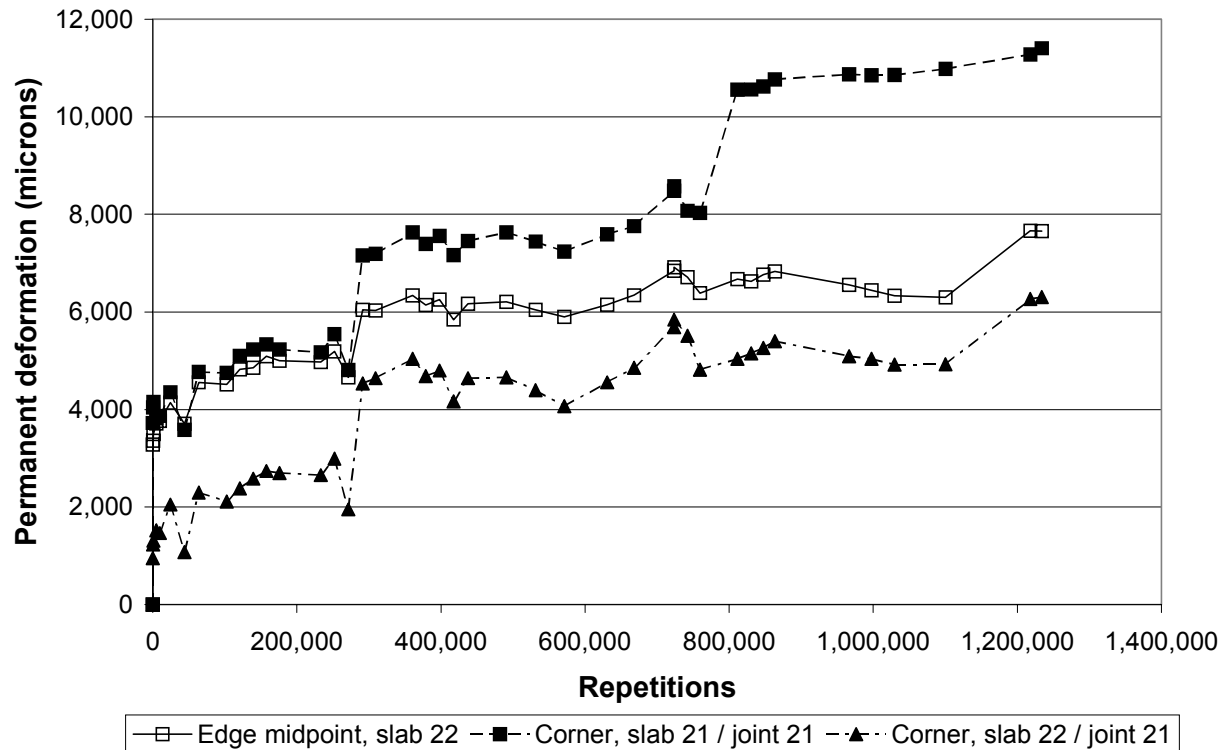
**Photograph 4.32. Corner crack at start of test, Test Section 527FD.**

The accumulation of permanent deformation at the joint is shown in Figure 4.29. The trend is similar to that of the elastic deflections. A steady increase in the permanent movement of the slab at all three recorded positions (midpoint slab edge and each side of joint 21) occurred

during the 35-kN loading phase. After the load was increased to 40 kN, an increased rate of permanent deformation was observed. The slab 21 side of joint 21 recorded the most movement, with over 11 mm at the end of the test, compared with the slab 22 side having 6.3 mm.

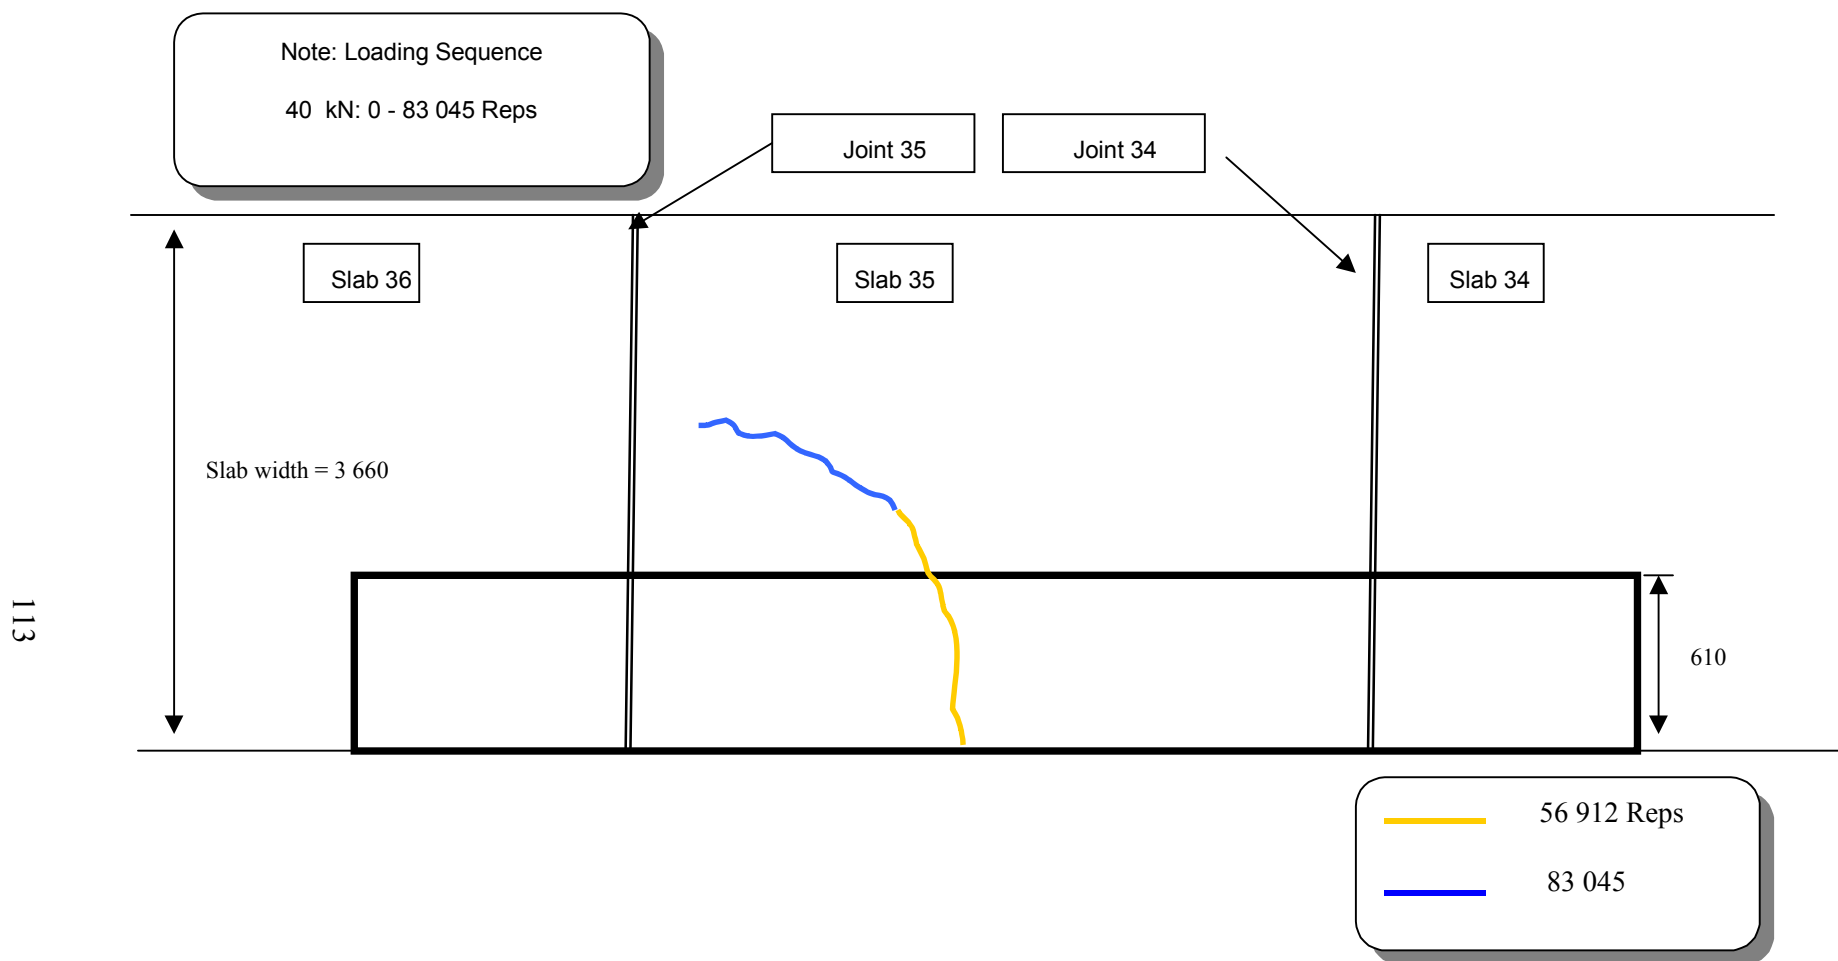
**Figure 4.30. Schematic of crack development, Test Section 528FD (not to scale).**

Prior to the start of the HVS test on Section 528FD, no cracks were visible on the test section. After approximately 56,912 load repetitions, a transverse crack developed in the middle slab (slab 35) between both joints (see Photograph 4.34). This crack pattern suggests that the slab failed due to fatigue and if time permitted, the crack may have developed into a corner

break. This crack extended with time and the final crack pattern can be seen in Figure 4.30 and Photograph 4.35.

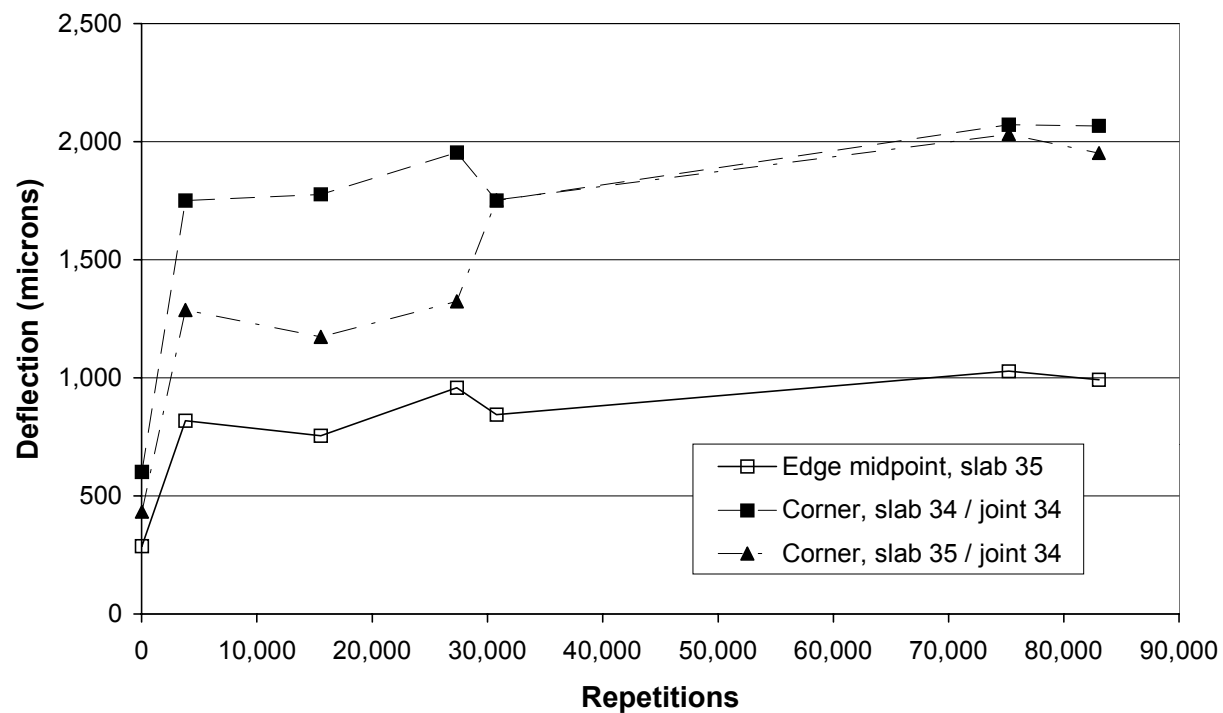
**Figure 4.31. EDMD and JDMD deflections, test load = 40 kN, Test Section 528FD.**

A significant increase in all deflections was recorded between the first and second set of readings (nominally 10 and 3,807 repetitions respectively). Broadly, all deflections tripled during this trafficking period. This is in marked contrast to previously observed behavior where deflections tended to decrease, attributable to better seating of the slab with trafficking and crack formation, and therefore suggests that the HVS trafficking disturbed the original slab seating and support without cracking the slab. It is possible that the short center slab was cracking.

After the transverse crack developed at approximately 57,000 repetitions, the midpoint edge deflections increased from 844 microns to 1,028 microns. This represents a 21 percent increase in the deflection at the midpoint edge. Similarly, the deflections on each side of joint 34 increased 15 to 18 percent.

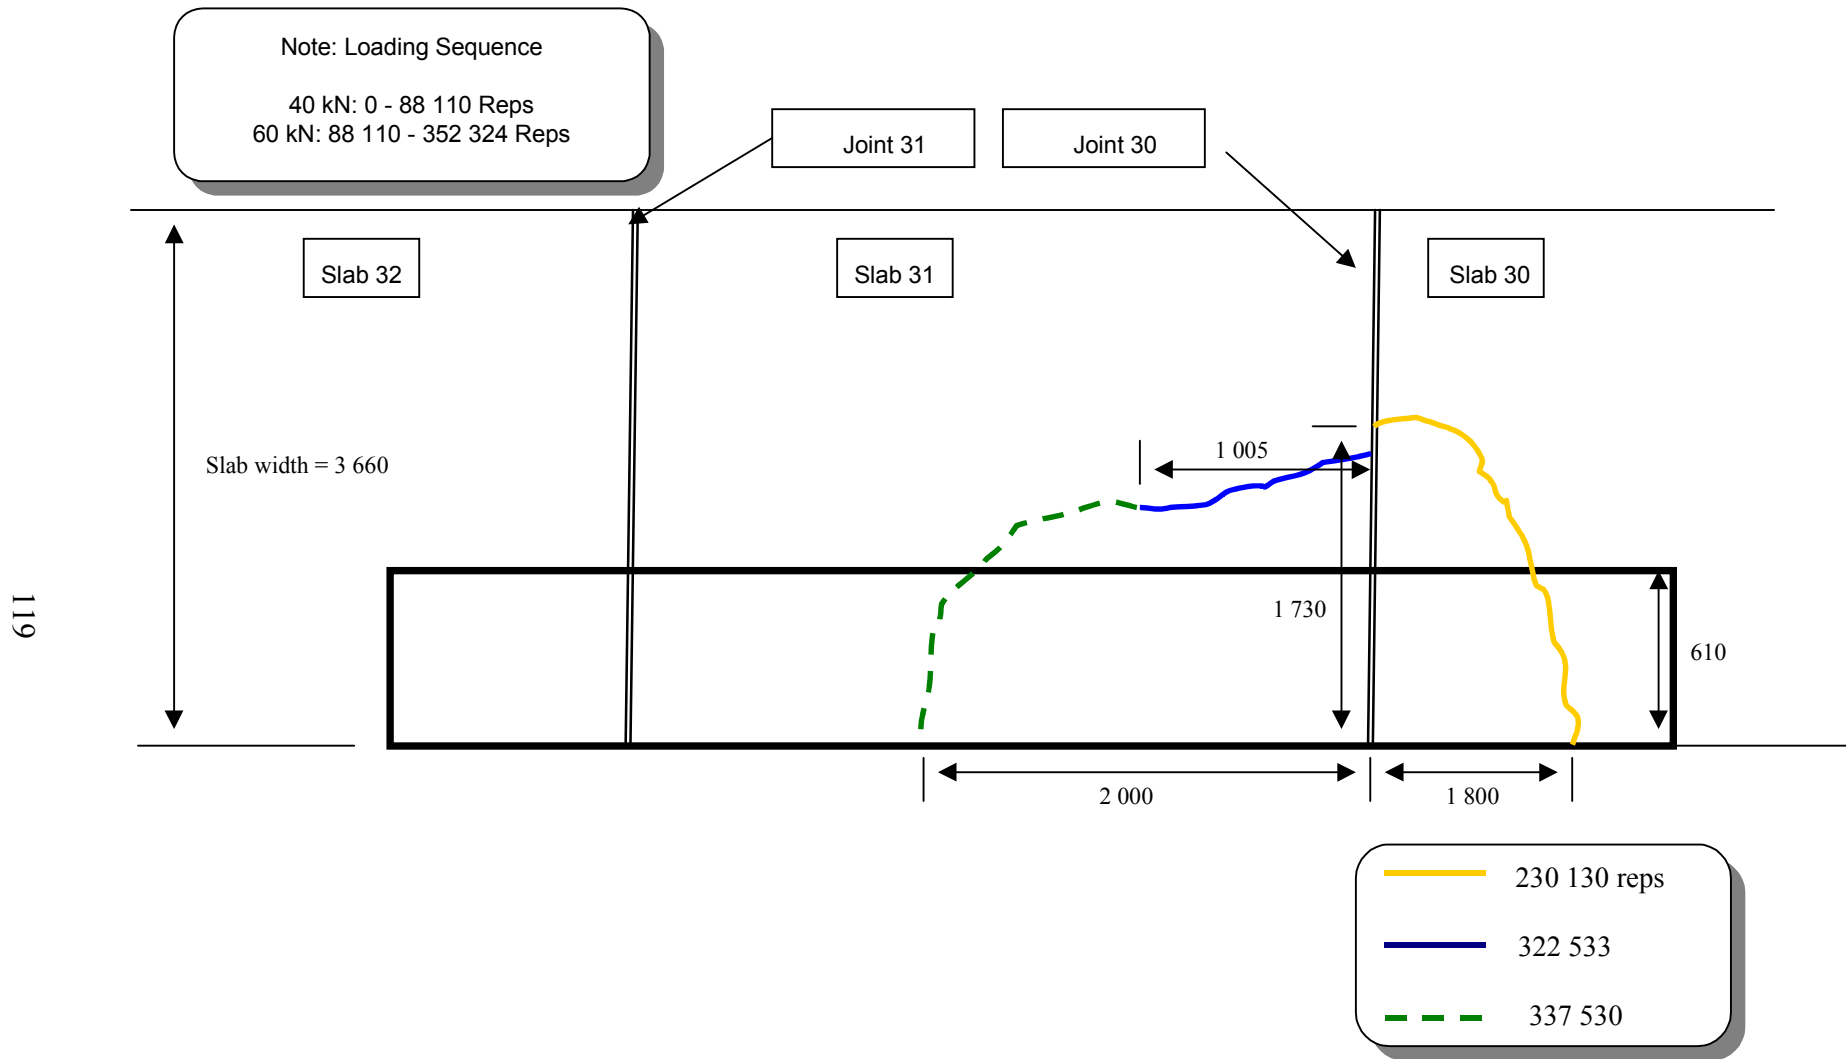
Figure 4.32. Schematic of crack development, Test Section 529FD (not to scale).

It is conjectured that the sawed joint did not propagate straight down to the base. It appears that the crack propagated down toward slab 32, which is directly to the left of the mid-slab (slab 31).

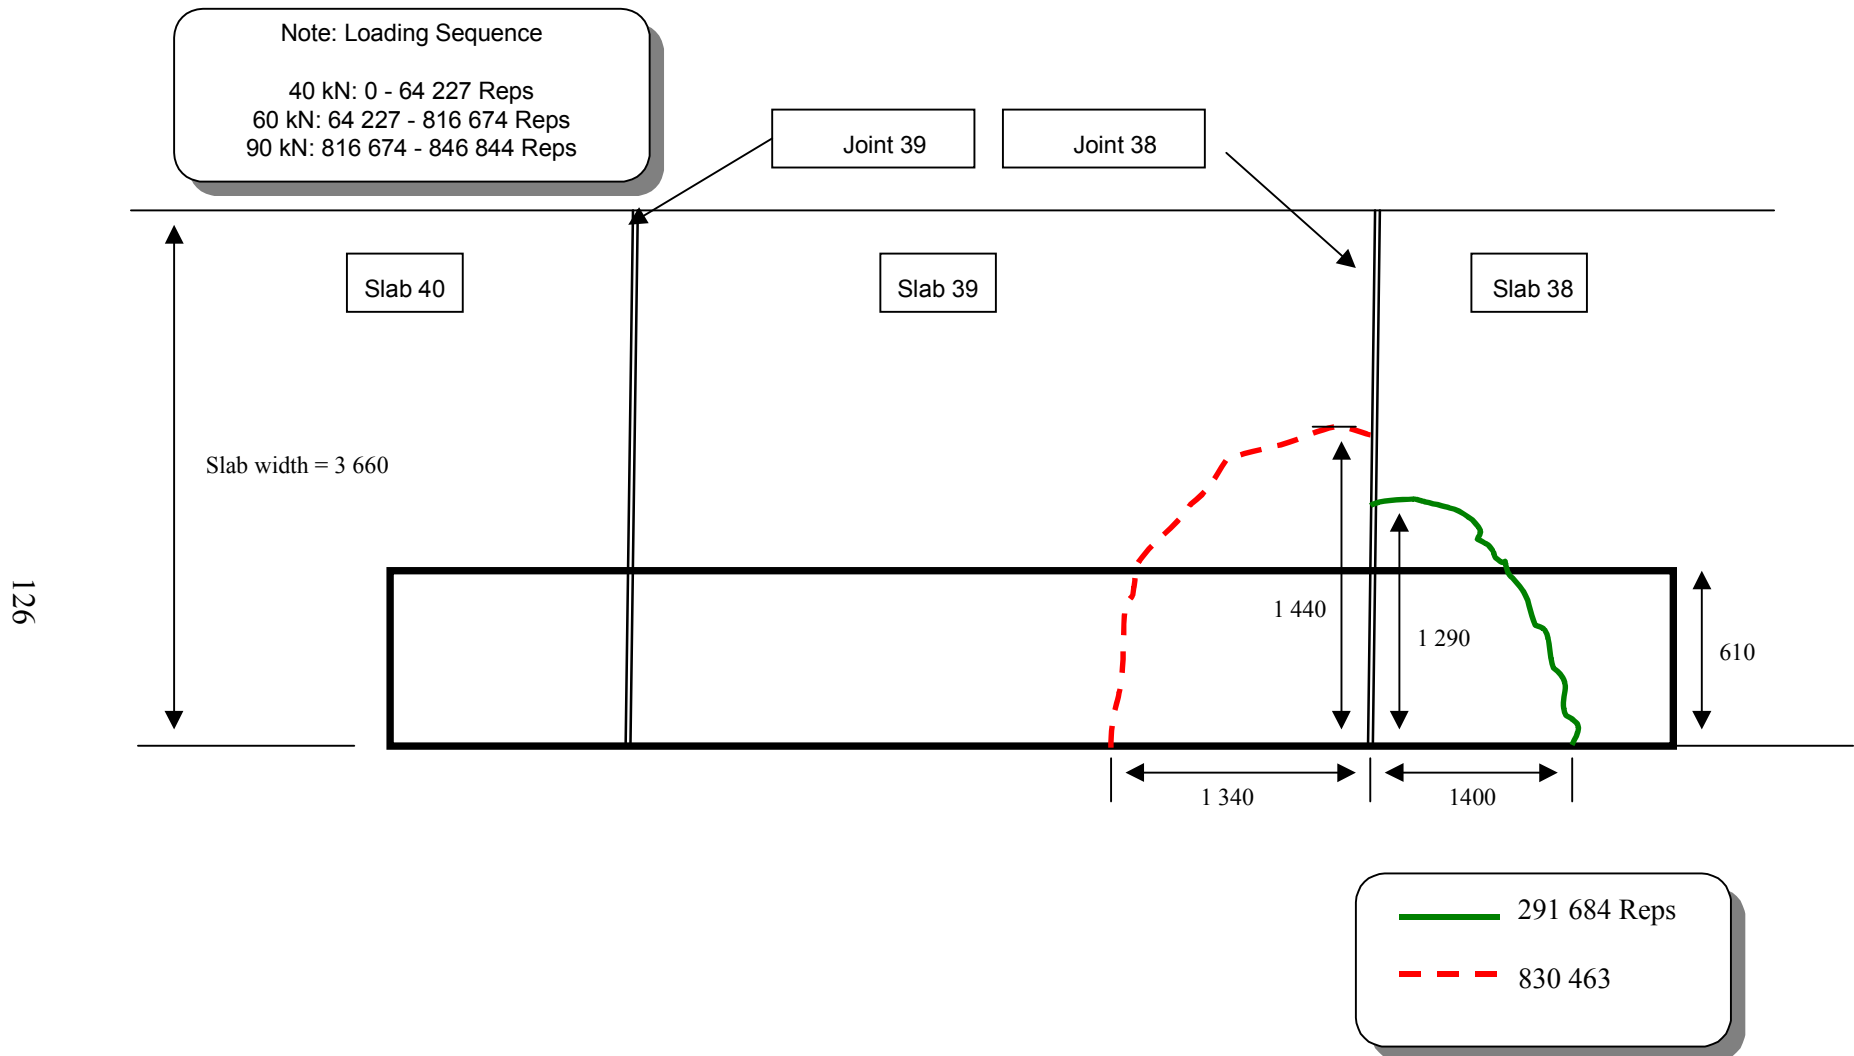
Figure 4.35. Schematic of crack development, Test Section 530FD (not to scale).

The crack pattern, as it developed with time, can be seen in Figure 4.35. Photograph 4.39 presents an overhead view of the test section at the completion of HVS trafficking. Photograph 4.39 also clearly shows evidence of the Weigh-In-Motion piezometers that were installed on slab 40. Photograph 4.40 presents another view of the cracks on Test Section 530FD.

While the test load was 40 kN (to 64,227 repetitions), the deflections stayed relatively constant, in the order of 0.6 mm at the edge midpoint and 1.6 to 2 mm on either side of joint 38. After 227,457 repetitions at 60 kN (291,684 total repetitions), a corner crack developed on slab 38. This is shown in Figure 4.37, where the deflection reading of the JDMD on the slab 38 side of the joint decreases significantly. When the load was raised to 90 kN, a corner crack developed on slab 39 at approximately 5,000 90kN load repetitions (830,463 total repetitions), which is shown by the drop in deflection for the slab 39 side of the joint in Figure 4.38.

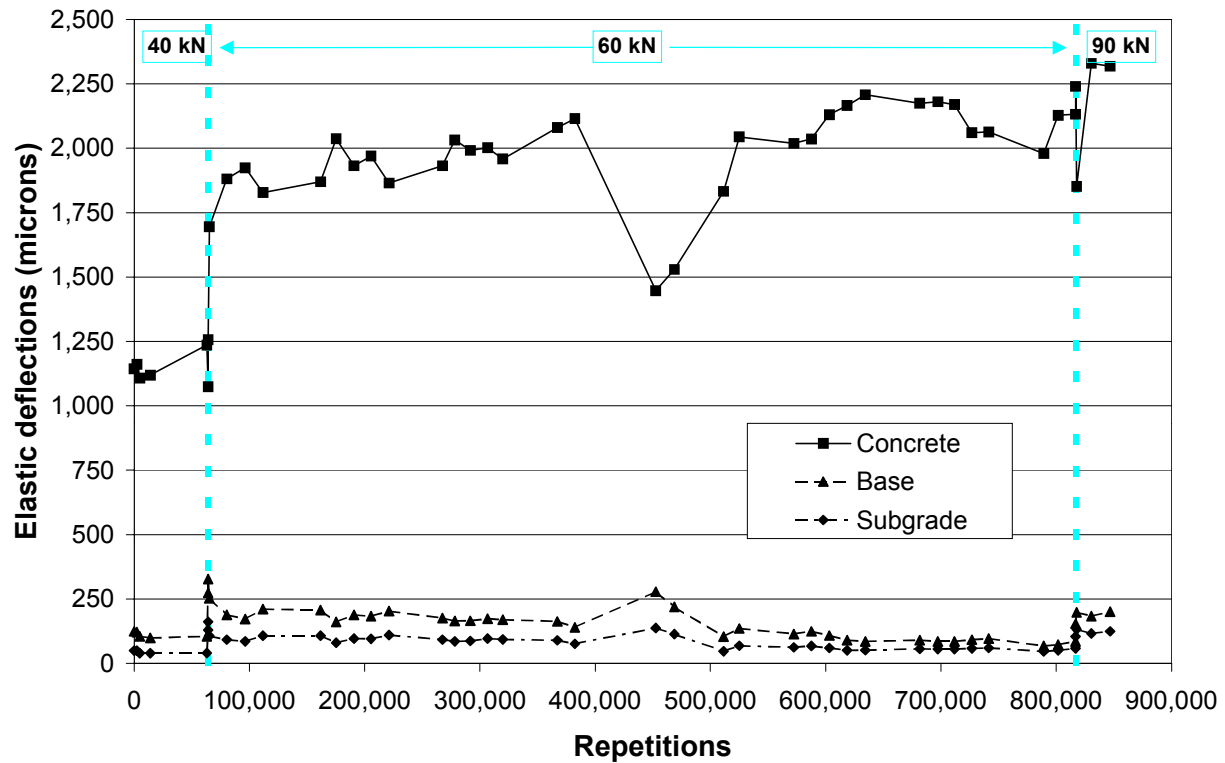
Figure 4.39. In-depth MDD deflections, Test Section 530FD.

One MDD was installed on Section 530FD, near joint 39 on slab 39. This MDD was installed between the wheel paths of the dual wheels about 0.3 m from the edge of the slab. MDD modules were installed inside the 200-mm thick concrete slab at a depth of 50 mm as well as at the top of the base course (225 mm) and the top of the in-situ soil (425 mm). The results of the peak MDD deflections can be seen in Table 4.52 and Figure 4.39.

Figure 4.39 shows that the deflection of the concrete is significantly higher than the aggregate base or subgrade. This may result from curling of the slab in an upward direction. This same trend is noted for the 100- and 150-mm test sections.

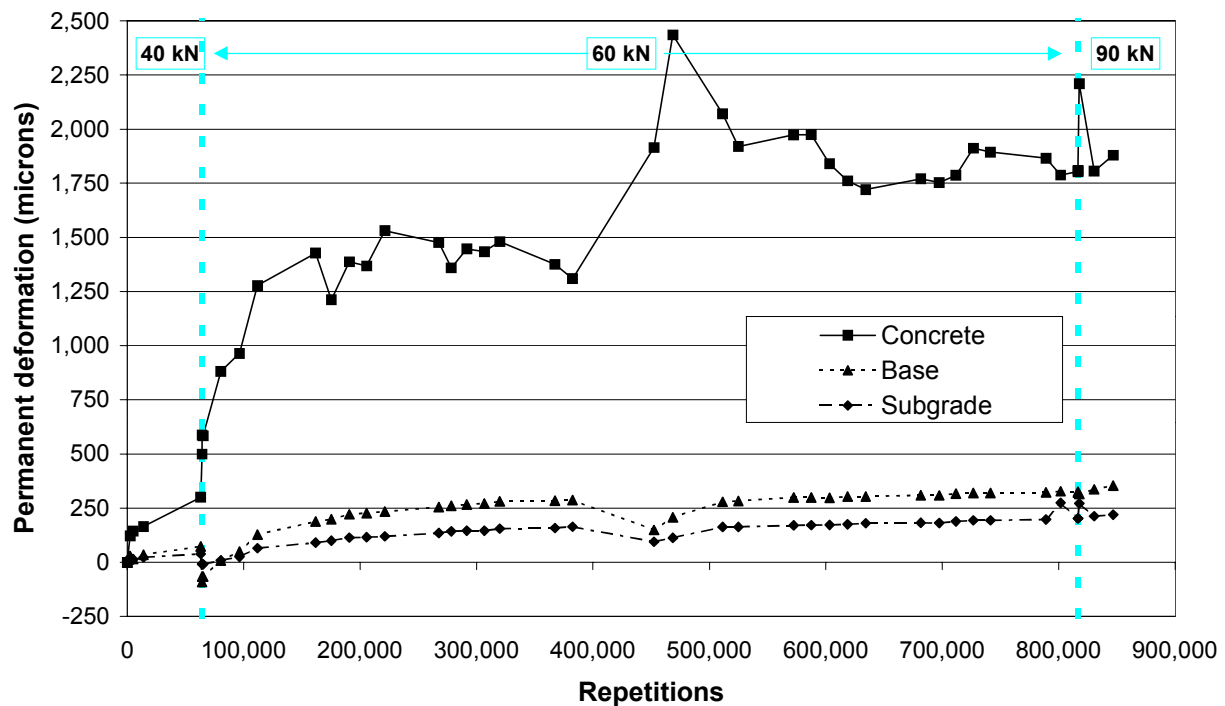
Figure 4.40. Permanent deformation, Test Section 530FD.

From the preceding tables and Figure 4.40 at some 450,000 load repetitions, there is a significant increase in the concrete permanent deformation and a decrease in both the base and subgrade deformation values. This may be due to movement of the modules inside the MDD hole, or a crack in the concrete layer that was not discovered because it was either microscopic or initiated at the bottom of the layer.

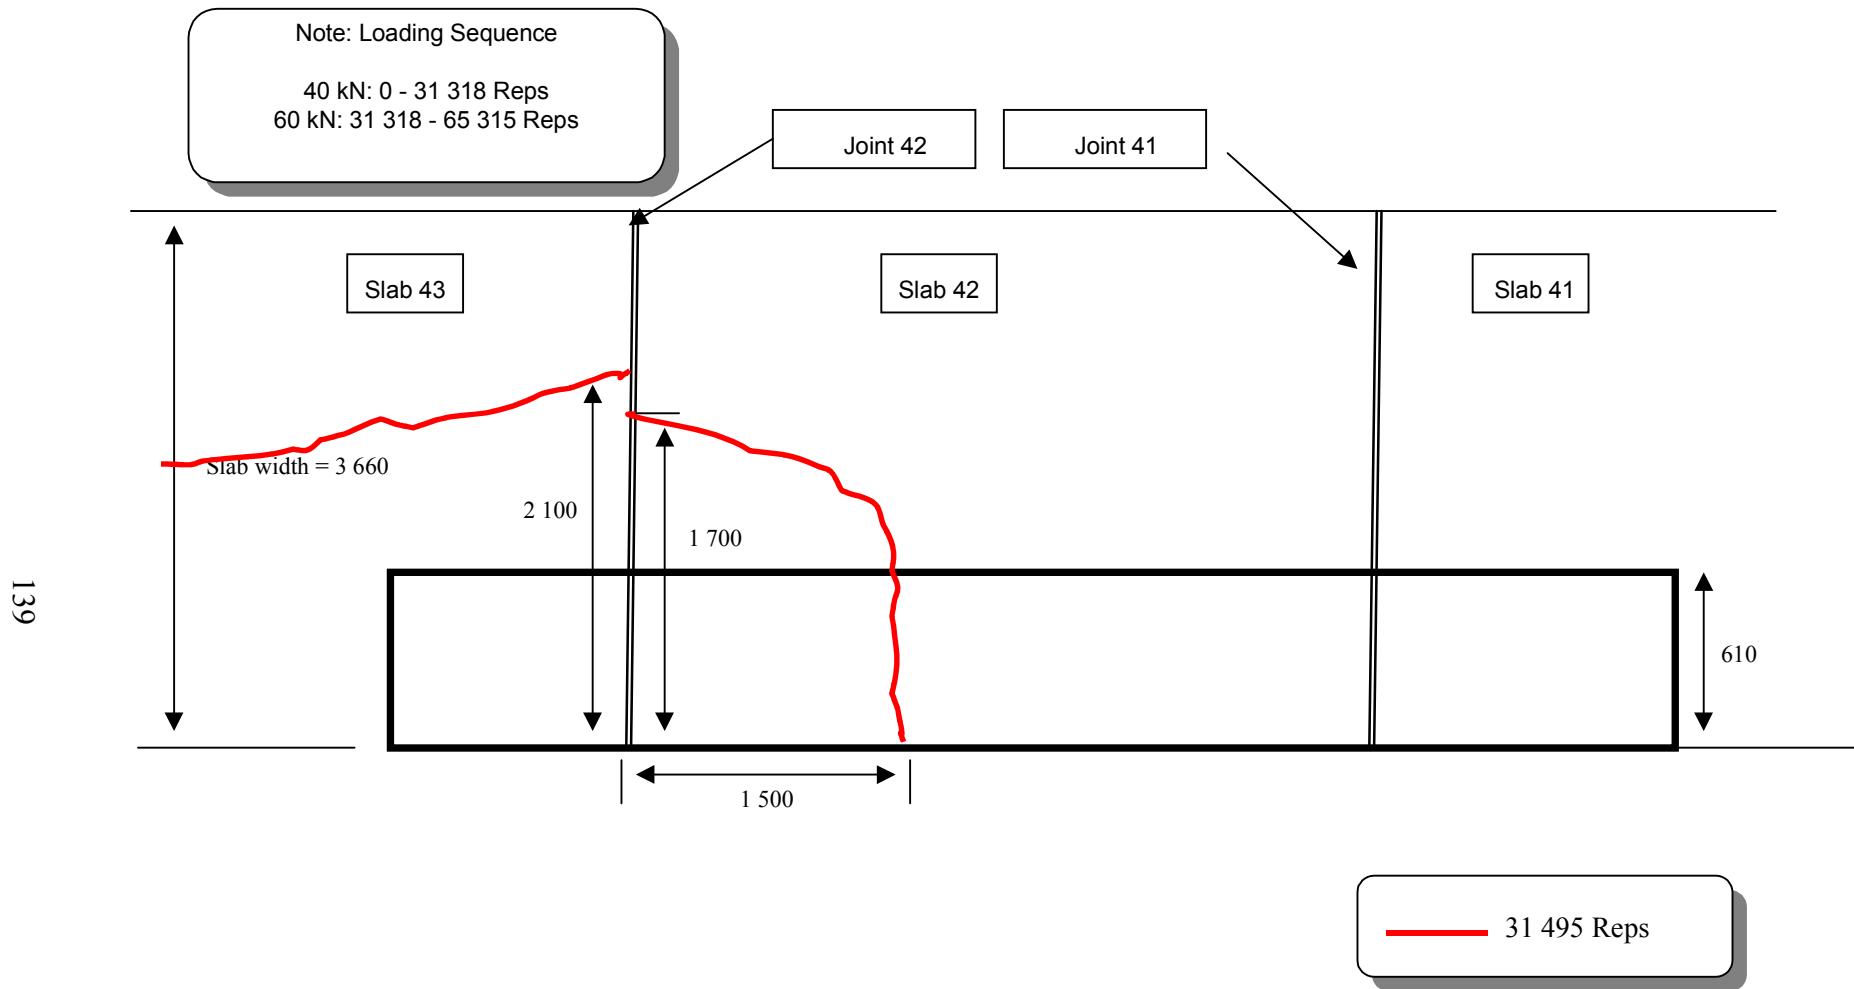
Figure 4.41. Schematic of crack development, Test Section 531FD (not to scale).

Test Section 531FD was conducted on slabs 41, 42 and 43 and was the last HVS test performed on the South Tangent. The test was conducted with temperature control. As shown in Figure 4.41, slab 42 (total length of 4.7 m) was fully tested, together with some area on either side of joints 41 and 42. The test started with a 40-kN dual wheel load, which was kept constant up to 31,318 repetitions, after which it was increased to 70 kN for an additional 33,997 repetitions. The test was stopped at 65,315 total load repetitions. The crack pattern, as it developed with time, can be seen in Figure 4.41. A photo composite of the test section with cracks after HVS trafficking is presented in Photograph 4.41.

The deflections recorded at both load levels remained relatively constant. The failure that occurred (crack pattern) developed somewhat prematurely, which may be the result of a lack of aggregate interlock at joint 42 due to the installation of the WIM instrumentation.

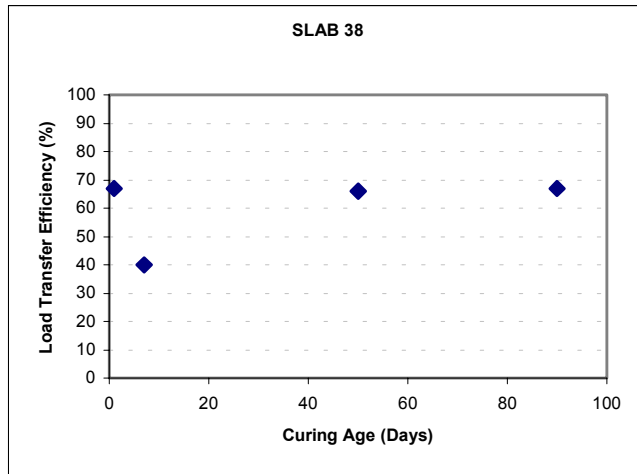
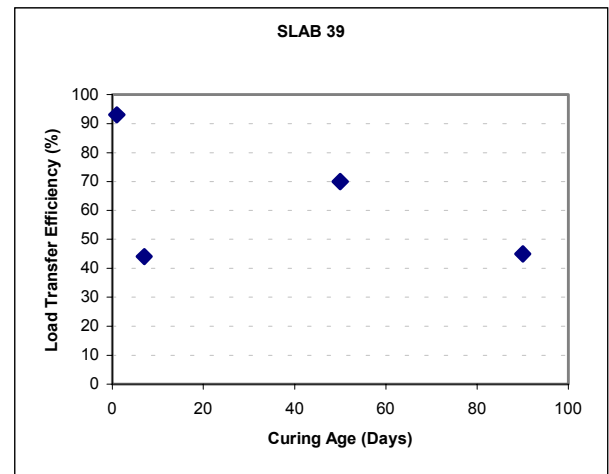
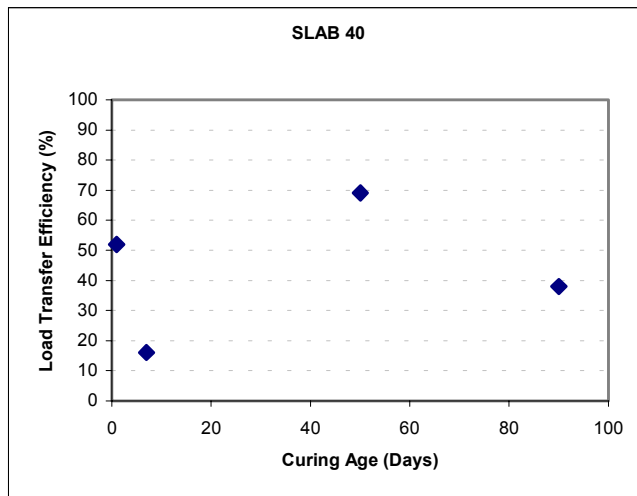
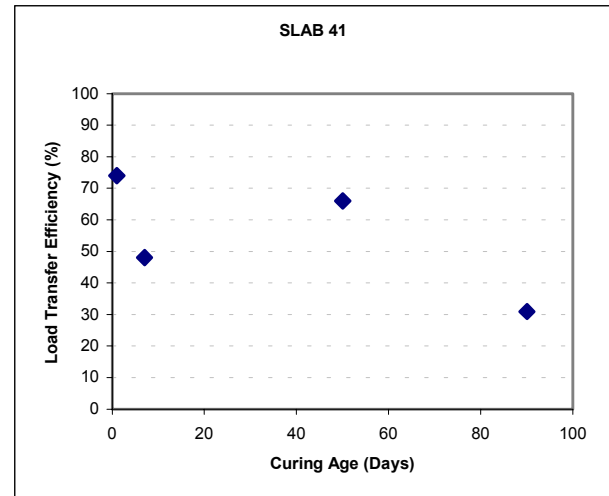
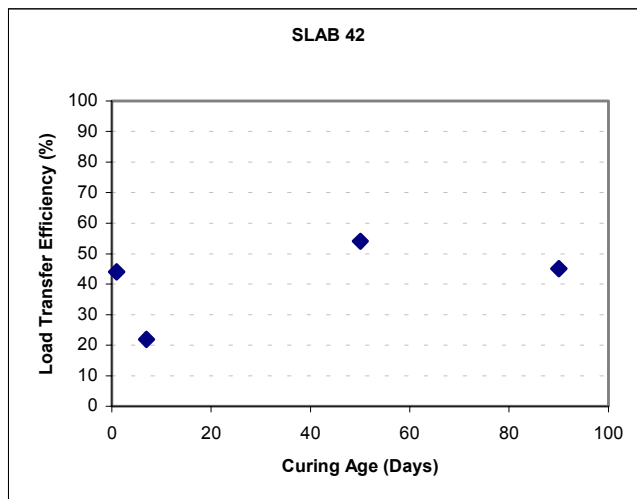
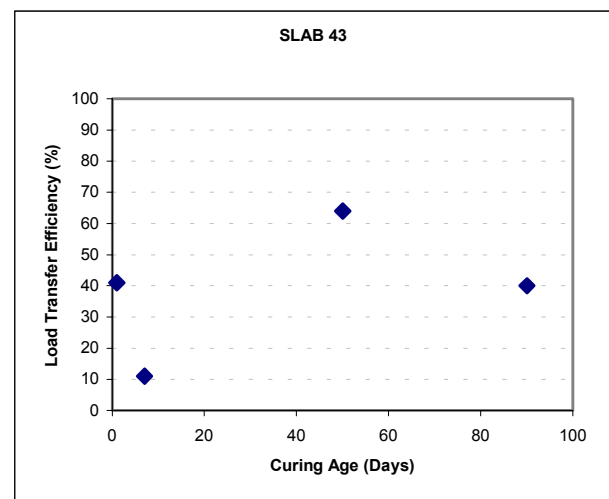
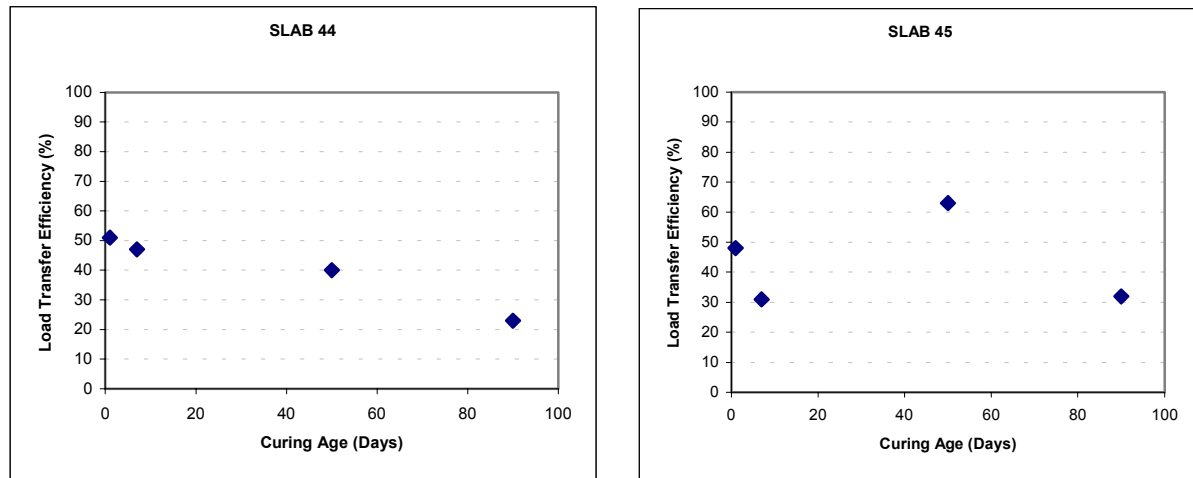
Figure 6.3. Load transfer efficiency versus curing age

The Load Transfer Efficiency (LTE) between different slabs at different curing ages is summarized in Table 6.2. No apparent relationship exists between the LTE and the curing age. It should be noted that temperature variations are not accounted for in these plots. The LTE percentages at different curing ages are shown in Figure 6.3.
