HVS Test Results on Fast-Setting Hydraulic Cement Concrete, Palmdale, California Test Sections, South Tangent

## **HVS Test Results on Fast-Setting Hydraulic Cement Concrete**

### **Palmdale, California Test Sections, South Tangent**

Research report prepared for the  
California Department of Transportation by:

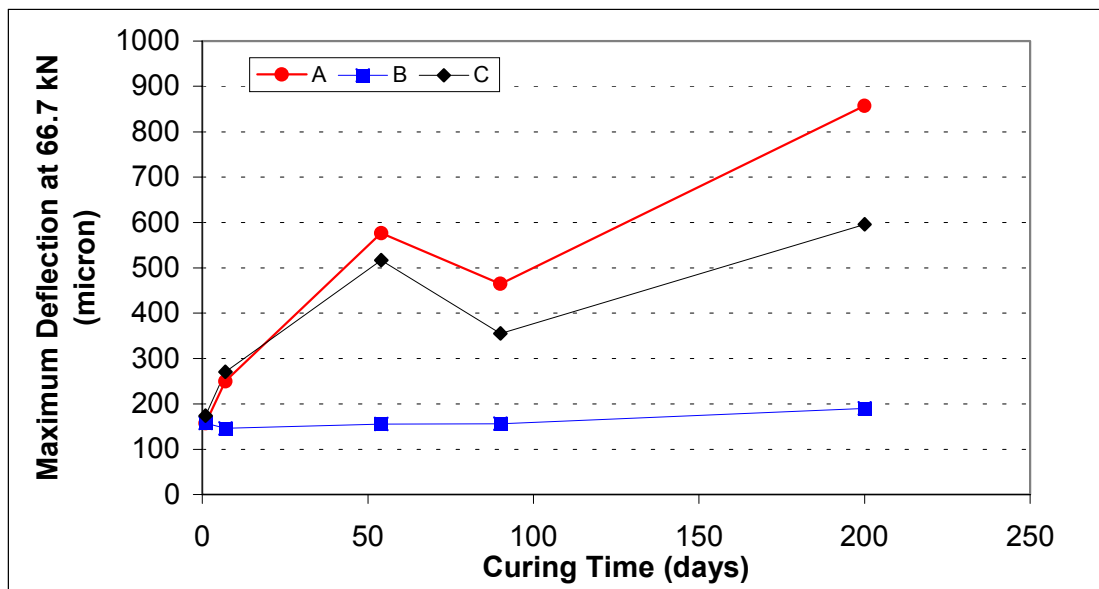
Figure 6.4. HWD deflections versus curing time, Test Section 528FD.

The influence of curing time on the deflections taken within the HVS test sections is illustrated in Figures 6.4 through 6.6. The deflections shown in these figures have been normalized to 66.7 kN, and are centerline deflections taken at the transverse joints and at the center of the middle slab of each HVS test section. In all cases, the deflections at the transverse joints are significantly higher than those situated at the center of the given slab. A general increase in deflections with curing time is noted in all cases. This observation corresponds with the trend noted for some of the slabs in Figure 6.2.

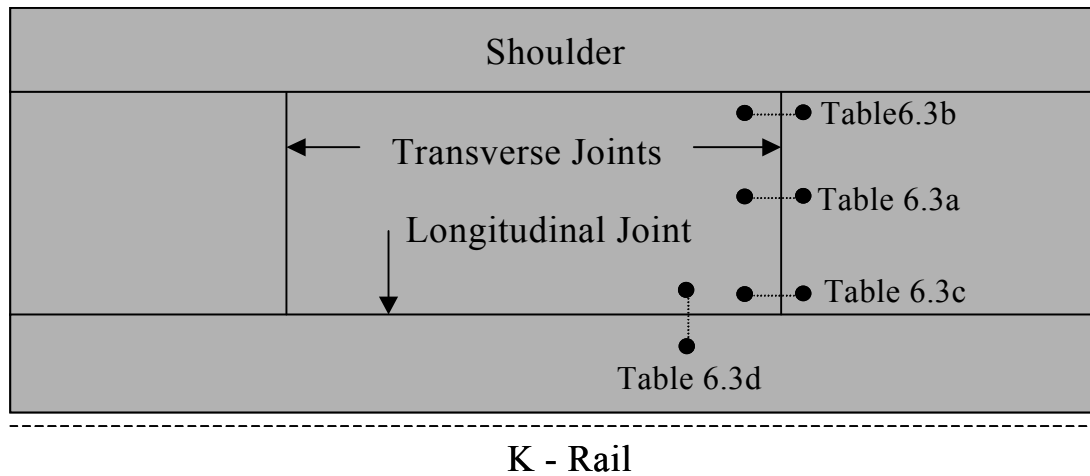
**Figure 6.7. Positions at which load transfer efficiency was determined.**

After all HVS tests were completed, FWD measurements were recorded across all joints as well as over visible cracks on the slabs. These measurements are summarized in Tables 6.3a through 6.3d. Measurements were taken approximately twelve hours apart during the coolest part of the night and hottest part of the day, at each of the following positions (See Figure 6.7):

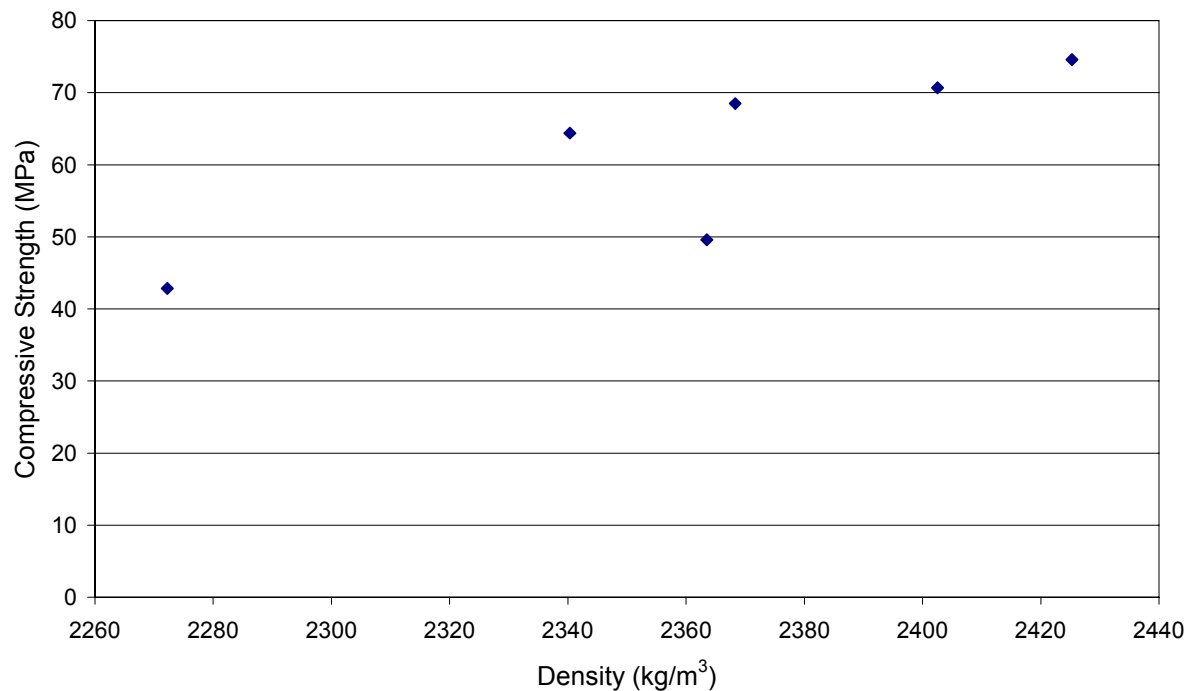
**Figure 7.1. Density versus compressive strength, cores taken after HVS testing.**

The relationship between compressive strength and core density is more clear in the set of cores taken after HVS testing. Seven cores were tested and show a definite trend (refer to Figure 7.1). The straight line fit to the trend is:
