Reflective Cracking Study: HVS Test Section Forensic Investigation

D. Jones, B. Steven, and J. Harvey

Partnered Pavement Research Program (PPRC) Contract Strategic Plan Element 4.10:  
Development of Improved Rehabilitation Designs for Reflective Cracking

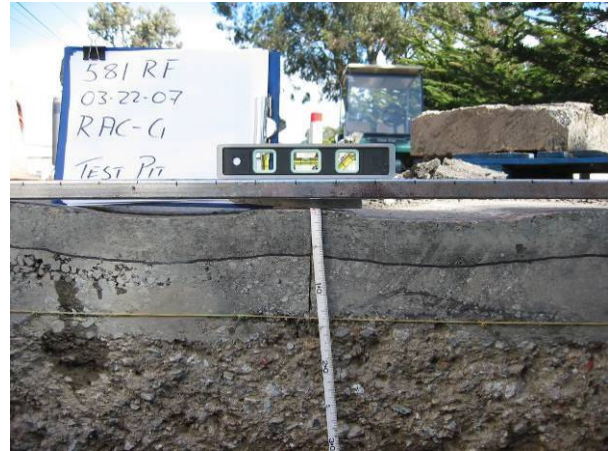
- Some densification (approximately 2 to 3 mm) was noted in the overlay in the trafficked area. Most of the rutting occurred in the DGAC layer (Figure 3.9). No rutting was recorded in the base and subgrade. Some displacement was recorded on either side of the trafficked area.

**Figure 3.9: 581RF test pit profile (1).**

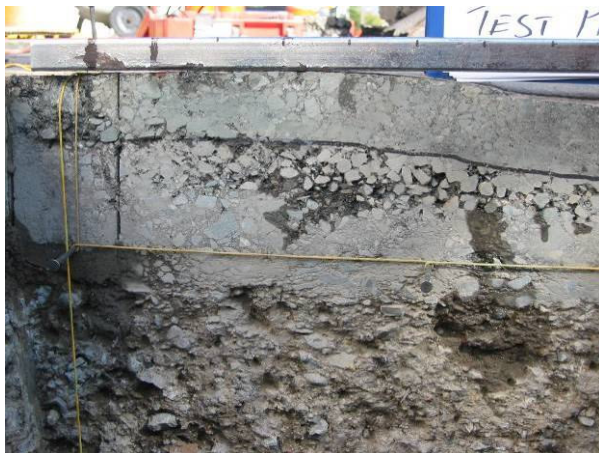
- The overlay was well bonded to the DGAC in the trafficked area, but some debonding was noted on the edge of the pit. Poor bonding was also noted between the two lifts in the DGAC in some areas. Water from the saw cutting operation was still clearly visible in these poorly bonded areas after the rest of the profile had dried (Figure 3.10). The DGAC was well bonded to the aggregate base.

- Some segregation was noted in the DGAC layer on the traffic side of the section (Figure 3.10). Apart from this and the rutting, no other distresses were noted in the asphalt layers.

**Figure 3.10: 581RF segregation in DGAC layer.**

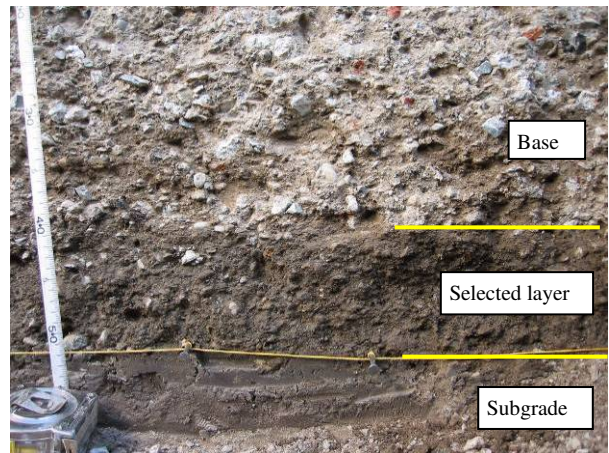
- The base under the trafficked area was thinner than the design (average 373 mm). Two distinct layers were noted in the base and although the material appeared to be from the same source, the lower layer was far wetter and appeared to have a weaker structure (Figure 3.11). This layer was designated as a selected layer in the profile assessment. The material in the two layers was dark grey-brown and consisted primarily of non-plastic recycled construction rubble, which included various types of natural aggregate (including andesite, chert, phyllite, quartz, and quartzite pebbles) and small quantities of glass, fabric, metal, and organic matter. The structure was generally homogenous. Grain size varied from fine to coarse with maximum particle size typically between 19 mm and 25 mm. Consistency was rated as hard in the top 50 mm, very hard between 50 and 250 mm, and hard to firm in the selected layer as moisture content increased and structure changed (Figures 3.12 and 3.13).

**Figure 3.11: 581RF selected layer.**

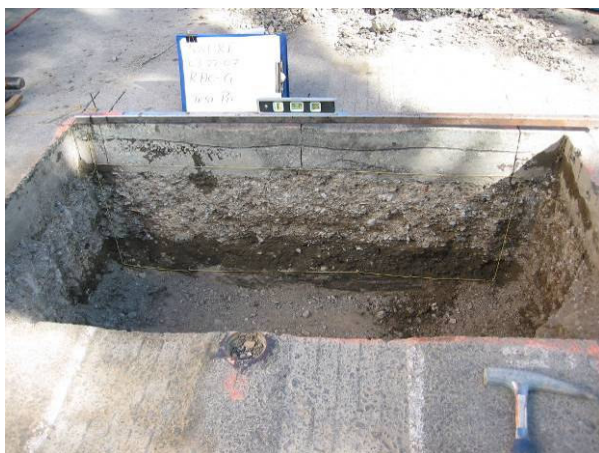
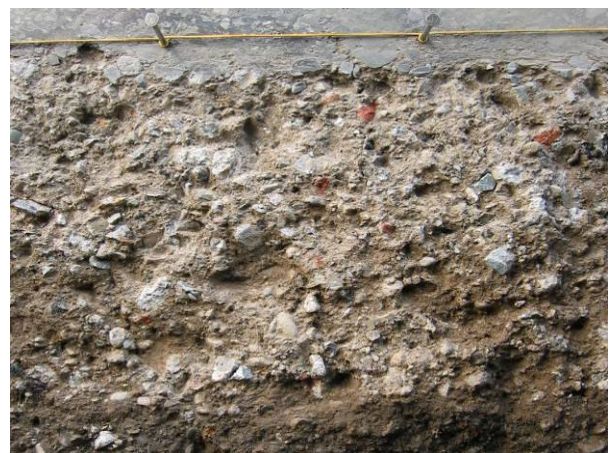
**Figure 3.12: 581RF test pit profile. (2)**

**Figure 3.13: 581RF test pit profile. (3)**

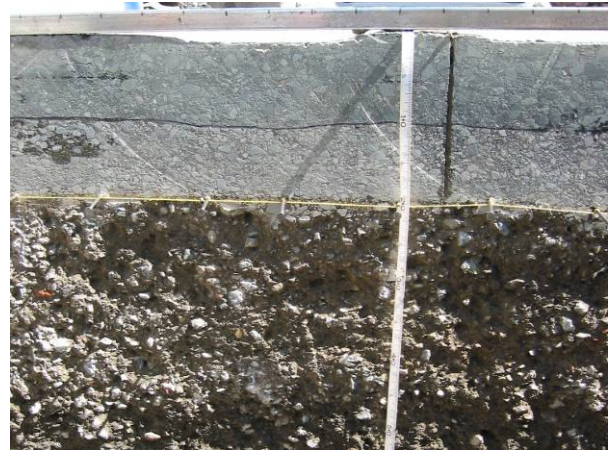
- The average thicknesses of the overlay (101 mm) and underlying DGAC (97 mm) were greater than the design.
- Rutting was noted in both the overlay and the underlying layer (Figure 3.15). No rutting was noted in the base and subgrade. Slight displacement was recorded on either side of the trafficked area.

**Figure 3.15: 582RF test pit profile (1).**

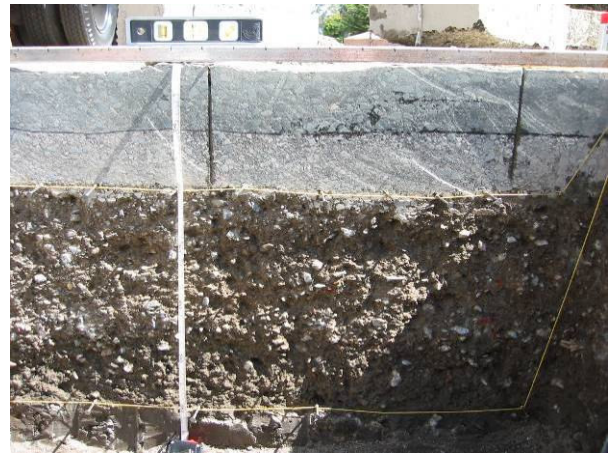
- The base under the trafficked area was marginally thinner (average 394 mm) than the design. The material was dark grey-brown and consisted primarily of non-plastic recycled construction rubble, which included various types of natural aggregate (including chert, quartzite pebbles, and basalt) and small quantities of glass, fabric, metal wire, and organic matter. The structure was generally homogenous. Grain size varied from fine to coarse with maximum particle size typically between 19 mm and 25 mm. Consistency was rated as hard in the top 100 mm, very hard between 100 and 300 mm, and hard below 300 mm (Figure 3.17).

**Figure 3.17: 582RF test pit profile. (2)**

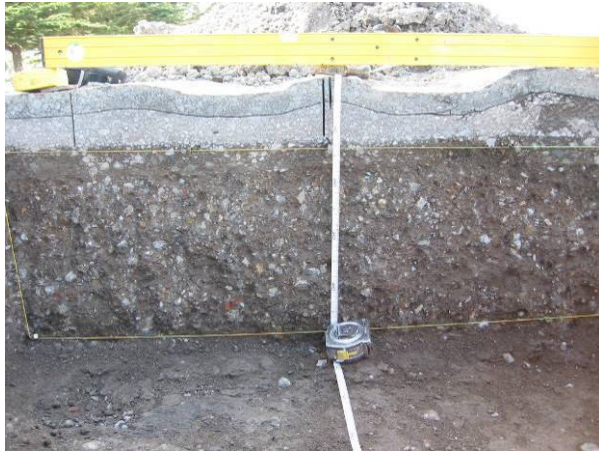
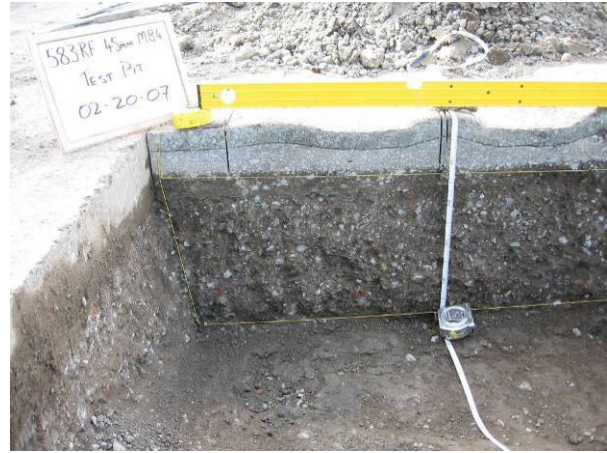
- Apart from rutting, no other distresses were noted in the asphalt layers.
- The base was thinner (average 361 mm) than the design across the full width of the test pit. The base material was dark grey-brown and consisted primarily of non-plastic, recycled construction rubble, which included various types of natural aggregate (including quartz, quartzite pebbles, phyllite, and andesite) and small quantities of glass, fabric, and organic matter. The structure was generally homogenous. Grain size varied from fine to coarse with maximum particle size typically between 19 mm and 25 mm. Consistency was rated as very hard in the top 220 mm, and hard to firm below as moisture content increased (Figures 3.20 and 3.21).

**Figure 3.20: 583RF test pit profile. (2)**

**Figure 3.21: 583RF test pit profile. (3)**

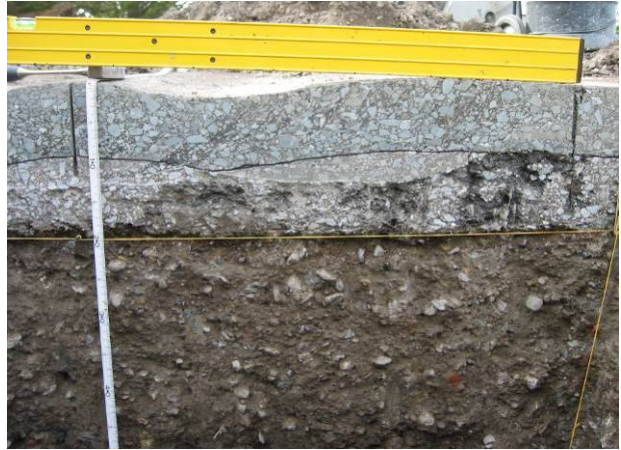
- Some densification (approximately 4 to 5 mm) was noted in the overlay in the wheelpaths, but most of the rutting occurred in the DGAC layer (Figure 3.23). No rutting was noted in the base and subgrade. Some displacement was recorded on either side of the trafficked area.

**Figure 3.23: 584RF test pit profile. (1)**

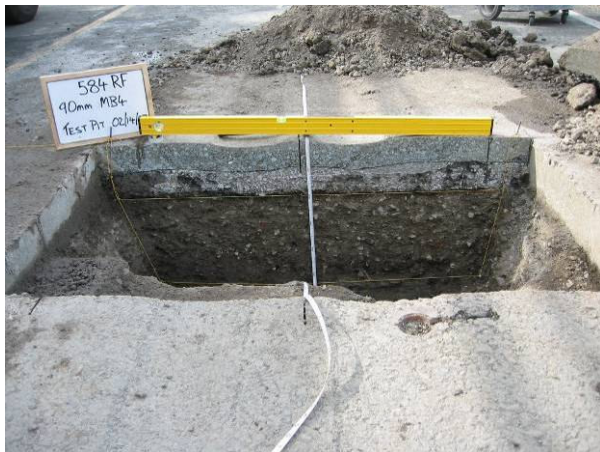
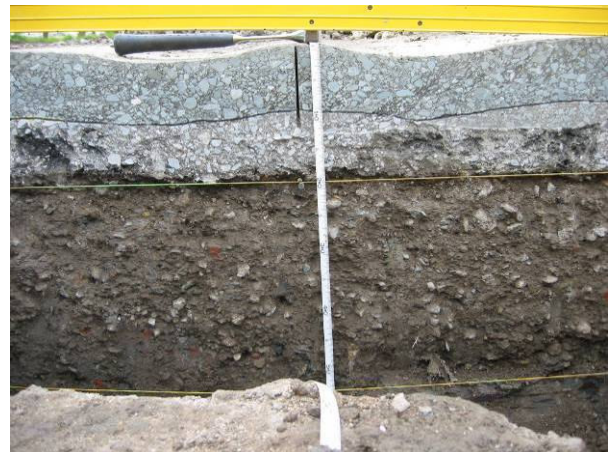
- The base under the trafficked area was significantly thinner (average 332 mm) than the design. The base material was dark grey-brown and consisted primarily of non-plastic, recycled construction rubble, which included various types of natural aggregate (including quartz, quartzite pebbles, phyllite, granite, and andesite) and small quantities of glass, fabric, metal (nails and wire), and some organic matter. The structure was generally homogenous. Grain size varied from fine to coarse with maximum particle size typically between 19 mm and 25 mm. Consistency was rated as very hard in the top 200 to 250 mm, and hard to firm below that as moisture content increased (Figures 3.24 and 3.25).

**Figure 3.24: 584RF test pit profile. (2)**

**Figure 3.25: 584RF test pit profile. (3)**

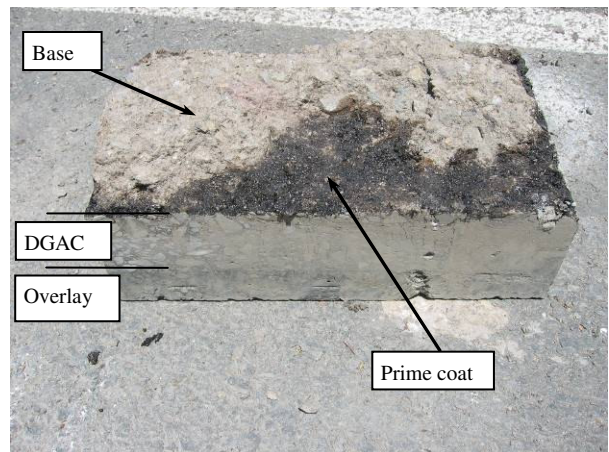
**Figure 3.31: 586RF bond between DGAC and base.**

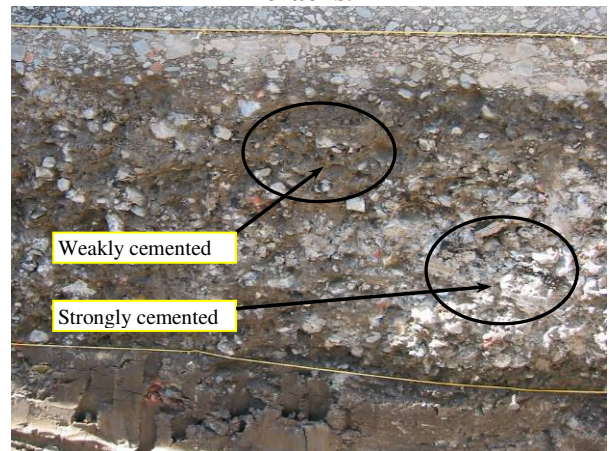
**Figure 3.41: 587RF#12 areas of strong and weak base cementation.**

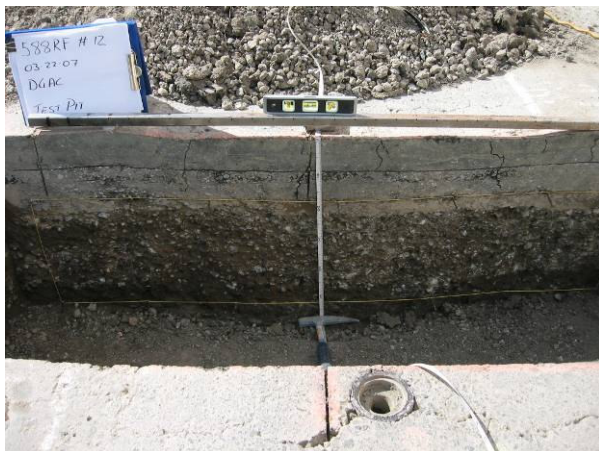
**Figure 3.44: 588RF#12 test pit profile.**

- Bottom-up cracking was noted in the underlying DGAC and in the overlay in both test pits. Some of the cracks originated at the bottom of the underlying DGAC and continued all the way to the surface (Figure 3.44), while some appeared to have stopped at the bond between the two lifts of the overlay. A few bottom-up cracks originating from the weak bond between the overlay and the underlying layer and between the overlay lifts were also noted (Figure 3.47). Some segregation was noted in the underlying DGAC layer (Figure 3.46).

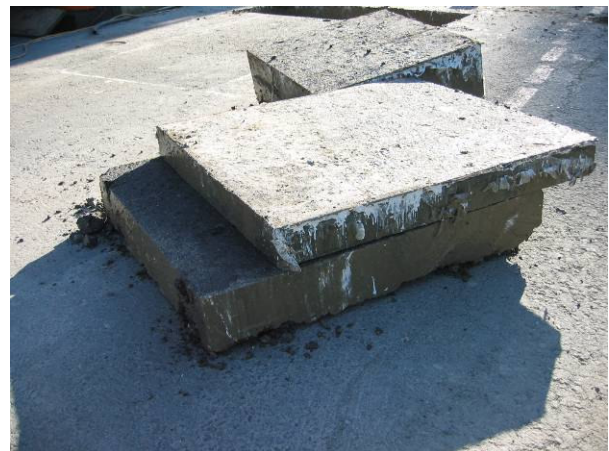
**Figure 3.45: 588RF debonding between overlay and underlying layer.**

- The overlay was generally poorly bonded to the underlying layer (Figure 3.45). Bonding between lifts was also unsatisfactory (Figure 3.46). Water from the saw cutting operation was still clearly visible in these poorly bonded areas after the rest of the profile had dried. The DGAC was well bonded to the aggregate base.

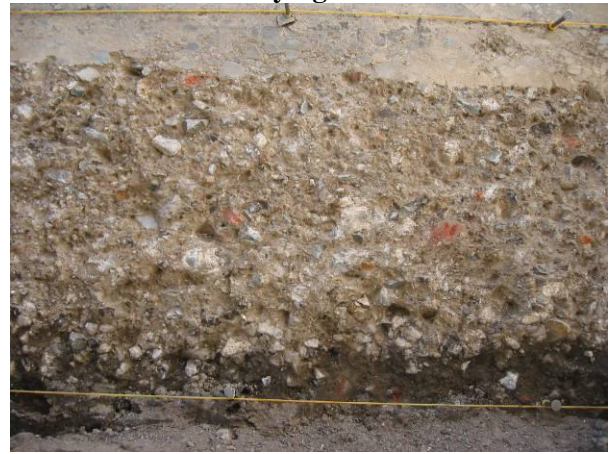
**Figure 3.49: 588RF#4 areas of strong base cementation.**

- Recementation of the base material was visibly apparent in both test pits, although bond strengths appeared weaker in the test pit at Station 12 (Figure 3.48) compared to the material at Station 4 (Figure 3.49). Relatively strong hydrochloric acid and phenolphthalein reactions were recorded in both test pits.

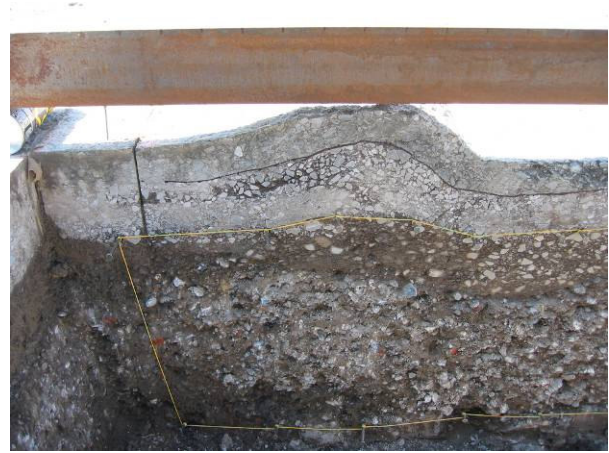
**Figure 3.53: 589RF#12 severe displacement on edge of rut.**

- The average thickness of the overlay generally equaled the design thickness, while the average thickness of the underlying DGAC was considerably less than the design (84 mm and 75 mm at Stations 4 and 12 respectively).
- Very little rutting/densification was evident in the overlay. Rutting in the underlying DGAC from the Phase 1 trafficking was noted in the Station 4 profile (Figure 3.51), but no rutting was noted in the base and subgrade on this profile. At Station 12, the severe rutting observed occurred predominantly in the underlying DGAC layer, with some rutting in the base and only minor densification in the overlay (Figure 3.52). No rutting was recorded in the subgrade. Severe displacement was recorded on either side of the trafficked area at the Station 12 test pit (Figure 3.53).
- The overlay was well bonded to the DGAC, which was well bonded to the aggregate base.

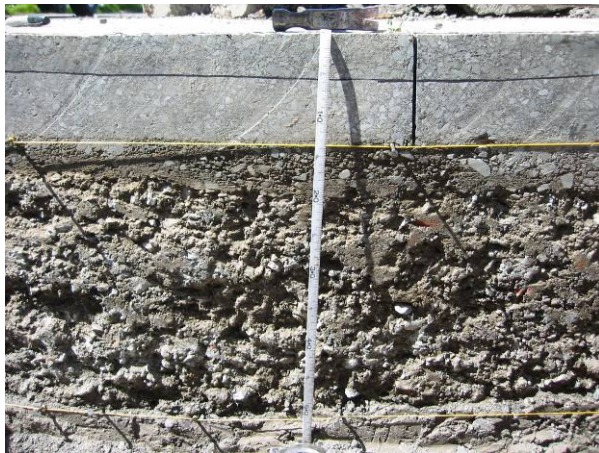
**Figure 3.54: 589RF#4 base material.**

- The average thickness of the base was less than the design (average 362 mm to 385 mm). The base material was dark grey-brown and consisted primarily of non-plastic recycled construction rubble, which included various types of natural aggregate (predominantly basalt, andesite, quartz and quartzite pebbles) and small quantities of brick, glass, fabric, and organic matter. The structure was generally homogenous. Grain size varied from fine to coarse with maximum particle size typically between 19 mm and 25 mm. The material from the test pit at Station 12 appeared coarser than in other pits (Figures 3.54 and 3.55). Consistency was rated as very hard in the top 250 mm, hard between 250 mm and 290 mm, and hard to firm below as moisture content increased.

- Recementation of the base material was visibly apparent. A cement odor was present and moderate hydrochloric acid and phenolphthalein reactions were noted in some areas.

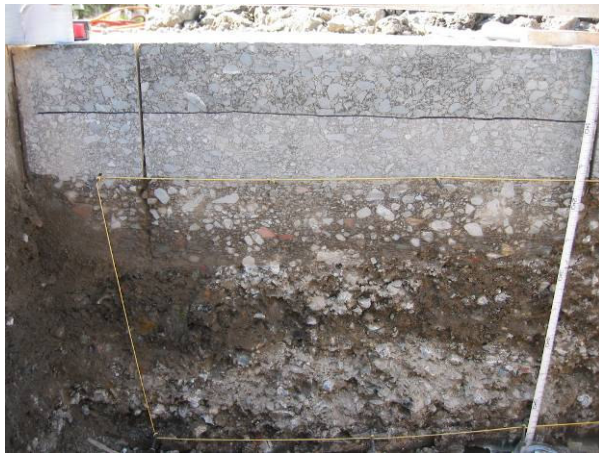
**Figure 3.60: 590RF#4 base material.**

- The average thickness of the base was less than the design (average 359 mm to 366 mm). The base material was dark grey-brown and consisted primarily of non-plastic recycled construction rubble, which included various types of natural aggregate (predominantly basalt, andesite, quartz and quartzite pebbles) and small quantities of brick, glass, fabric, and organic matter (Figures 3.60 and 3.61). The structure was generally homogenous. Grain size varied from fine to coarse with maximum particle size typically between 19 mm and 25 mm. Consistency was rated as very hard in the top 200 mm, as hard between 200 mm and 220 mm, and as firm below.

- Recementation of the base material was visibly apparent. A cement odor was present and moderate hydrochloric acid and phenolphthalein reactions were noted in some areas.

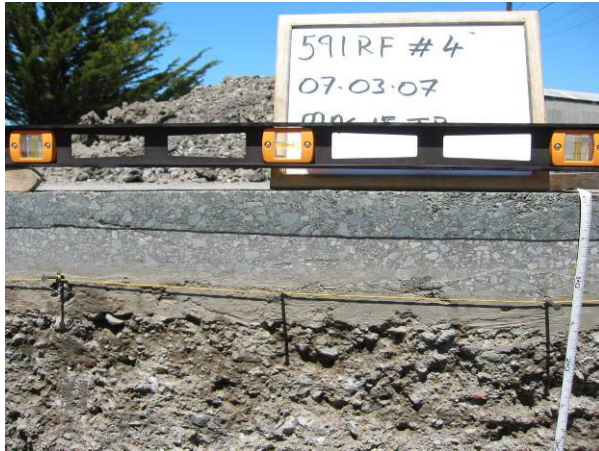
**Figure 3.64: 591RF#4 rutting from Phase 1 trafficking.**

- The average thickness of the overlay was slightly thicker than the design (51 mm at Station 4 and 49 mm at Station 12), while the average thickness of the underlying DGAC was considerably less than the design (72 mm and 80 mm at Stations 4 and 12 respectively).
- Very little rutting/densification was evident in the overlay. Rutting in the underlying DGAC from Phase 1 trafficking was noted in both test pits (Figures 3.63 to 3.65). Some rutting, attributed to Phase 1 trafficking, was noted at the top of the base in both test pits. No rutting was observed in the subgrade and no displacement was recorded on either side of the trafficked area.
- The overlay was well bonded to the DGAC, which was well bonded to the aggregate base.

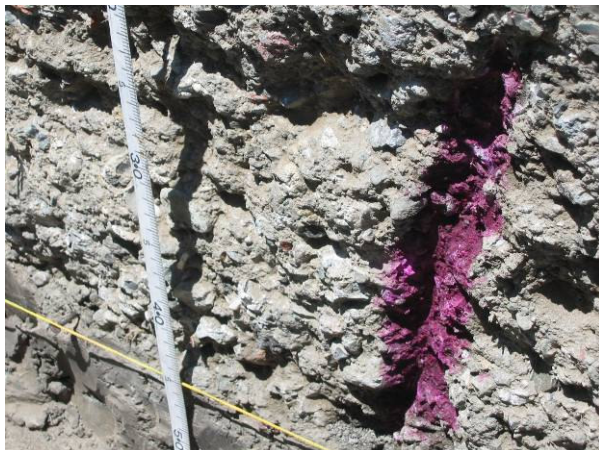
**Figure 3.68: 591RF strongly cemented base.**

- The average thickness of the base was considerably less than the design (average 325 mm and 333 mm for the two test pits, respectively). The base material was dark grey-brown and consisted primarily of non-plastic recycled construction rubble, which included various types of natural aggregate (including andesite, phyllite, quartz and quartzite pebbles) and small quantities of brick, glass, wire, fabric, and organic matter (Figure 3.67). The structure was generally homogenous. Grain size varied from fine to coarse with maximum particle size typically between 19 mm and 25 mm. Consistency was rated as hard to very hard in the top 200 mm, and hard below that (Figure 3.68).

- Recementation of the base material was visibly apparent. A cement odor was present and strong hydrochloric acid and phenolphthalein reactions were noted.

- Moisture content in the base was rated as moist.
- The layer definition between the base and subgrade was clear. Some punching of the base into the in situ material was noted (Figure 3.68).

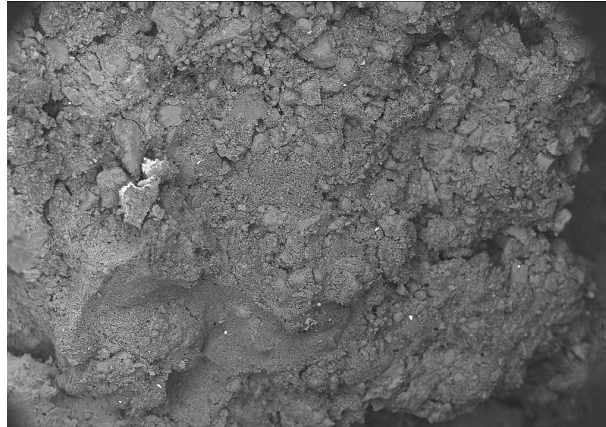
**Figure 3.77: General SEM view of Sample 1 at  $\pm 60x$  magnification.**

This material was the essentially uncarbonated matrix material. Figure 3.77 shows the overall view at a magnification of about 60 times.

The material was generally intact and showed mostly particles of about  $100\ \mu\text{m}$  diameter within a cemented matrix. At a greater magnification (Figure 3.78 [optical microscope with  $\pm 200x$  magnification] and Figure 3.79 [SEM with  $\pm 600x$  magnification]), definite interlocking needle-like crystals can be identified in fragments of the original stabilized material. These are typical of the cementitious products in old, well-stabilized road materials. Closer examination showed that some subsequent (i.e. after construction) crystal development had also occurred.

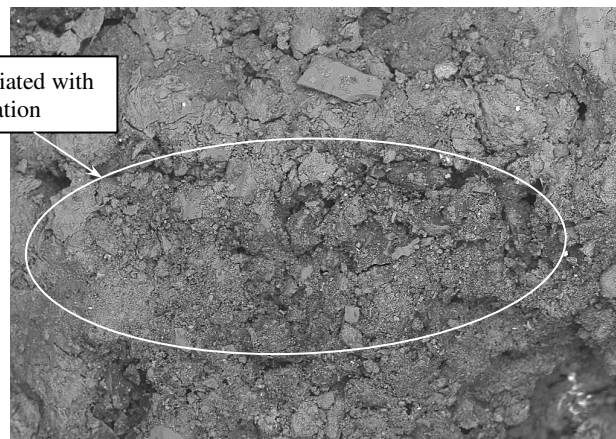
**Figure 3.81: SEM view ( $\pm 55\times$ ) of Sample 2.**

Sample 2 was exactly the same as Sample 1 except that the specimen was exposed to atmospheric carbon dioxide prior to preparation for the microscope studies. The overall effect is shown in Figure 3.80 (optical microscope at  $\pm 100\times$  magnification) and Figure 3.81 (SEM at  $\pm 55\times$  magnification), in which significant cracking is visible. This is the typical result of carbonation where the development of calcite (calcium carbonate,  $\text{CaCO}_3$ ) from lime (calcium hydroxide,  $\text{Ca(OH)}_2$ ) in the material results in expansion and cracking of the material. Such cracking is unlikely to result from drying as it was not seen in the uncarbonated specimen, which was also dried, albeit under slightly different conditions. Figure 3.82 (optical microscope at  $\pm 100\times$  magnification), Figure 3.83 (optical microscope at  $\pm 200\times$  magnification), and Figure 3.84 (SEM at  $\pm 140\times$  magnification) show the presence of calcite crystals associated with the cracking in the carbonated sample, none of which were evident in the uncarbonated material. The well-crystallized nature of the material is indicative of recent formation (during the week before examination). There was also a conspicuous absence of calcium hydroxide, indicating severe carbonation.
